As-Built Baseline Monitoring Report
FINAL VERSION
Pen Dell Mitigation Project
Monitoring Year 0
Calendar Year of Data Collection: 2018

NCDEQ DMS Project Identification # 97079
NCDEQ DMS Contract # 6824
Neuse River Basin (Cataloging Unit 03020201)
USACE Action ID Number: SAW-2016-00885
NCDEQ DWR Project # 2016-0403
Johnston County, NC
Contracted Under RFP # 16-006477
Data Collection Period: March-May 2018, Submission Date: March 2019

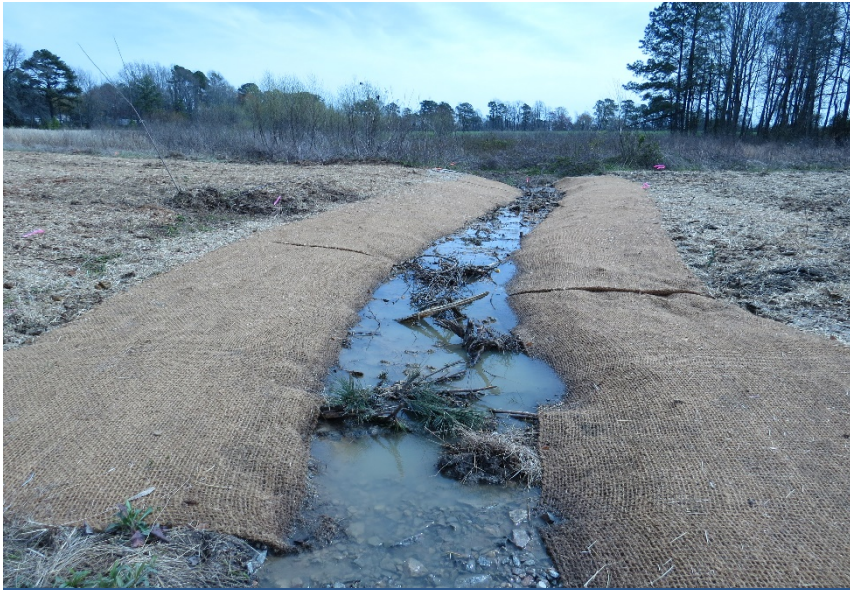
R1, facing upstream, Sta 20+00, March 29, 2018 (MY-00)

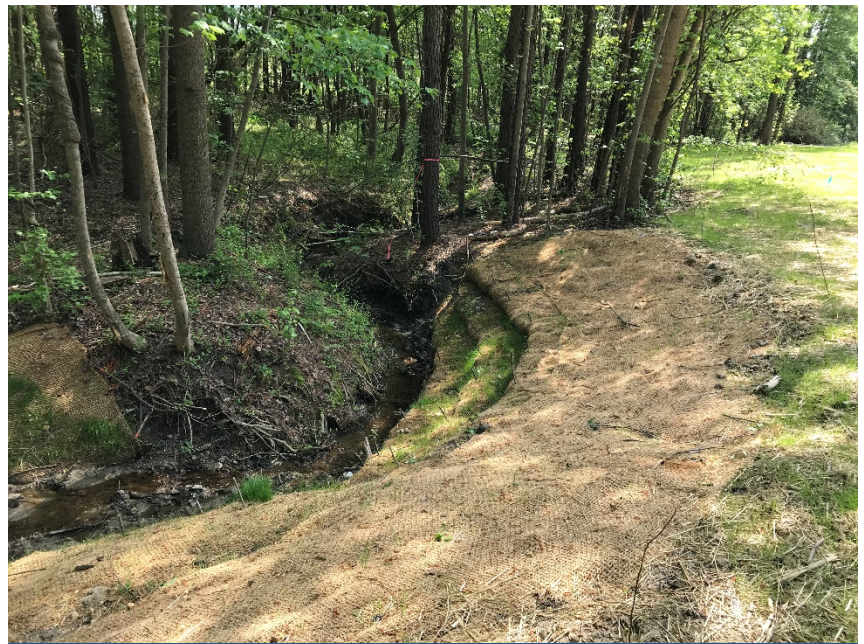
R2, facing downstream, Sta 21+50, April 27, 2018 (MY-00)

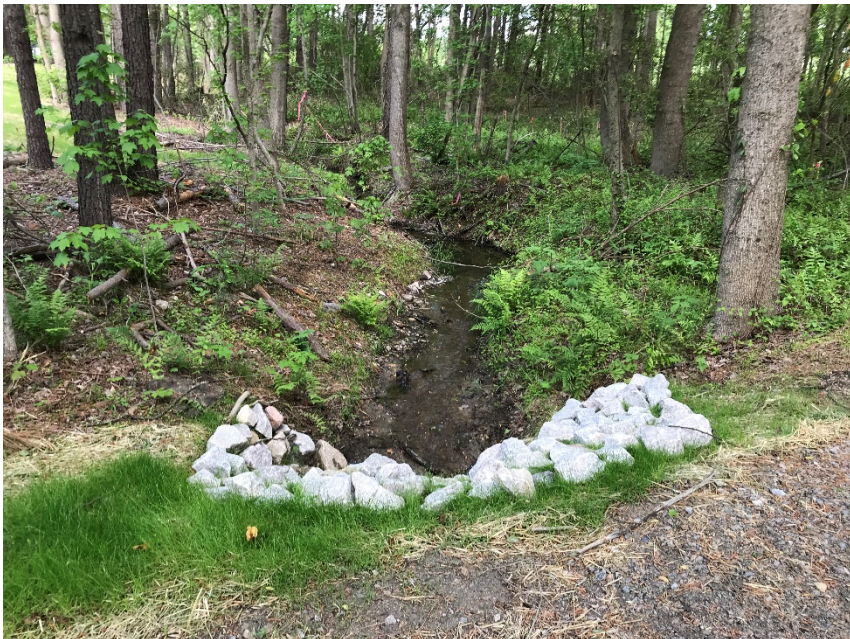
R2, facing upstream at crossing, Sta 23+00, April 27, 2018 (MY-00)

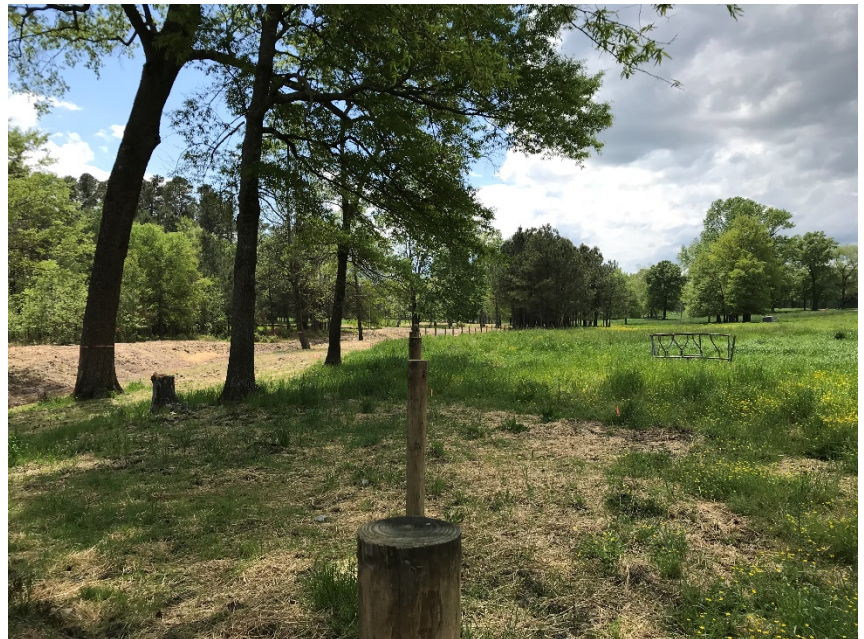
R3, facing downstream, Sta 31+00, April 27, 2018 (MY-00)

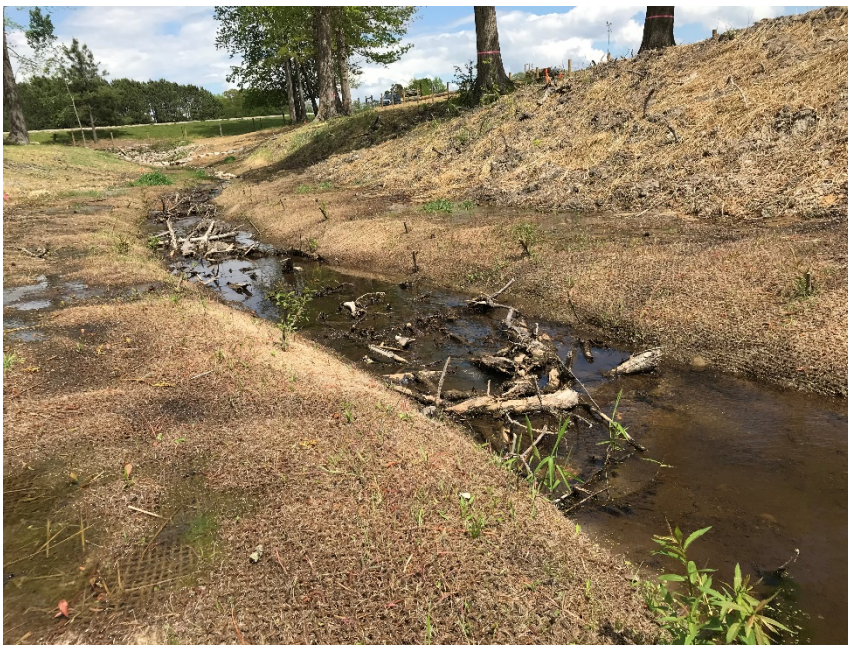
R3, facing upstream, Sta 33+00, April 27, 2018 (MY-00)

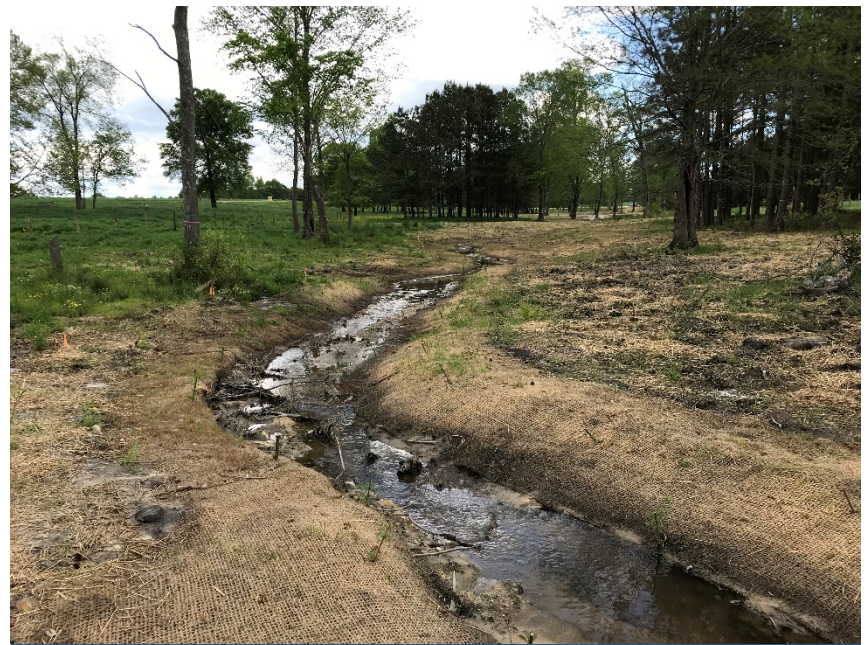
R4, facing upstream, Sta 43+50, April 27, 2018 (MY-00)

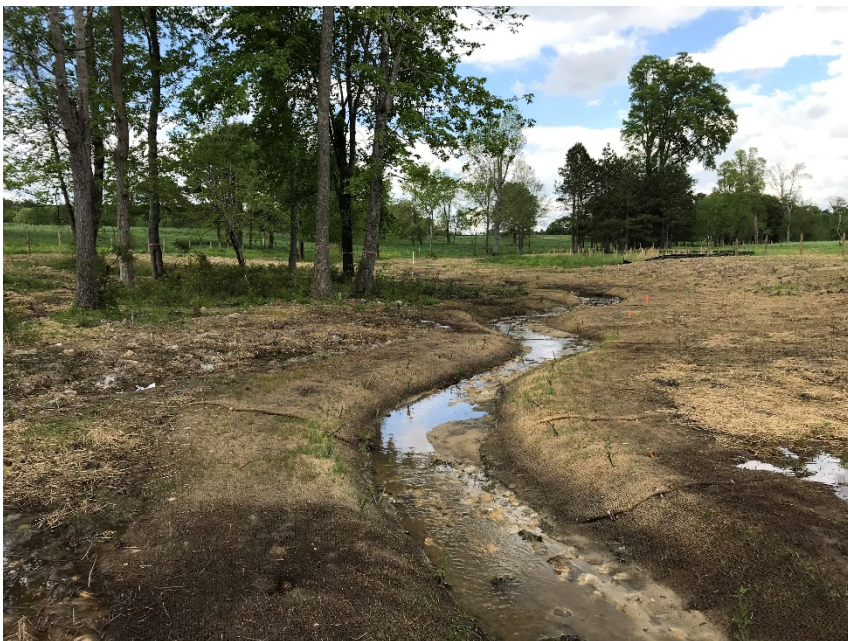
R4, facing upstream, Sta 44+50, April 27, 2018 (MY-00)

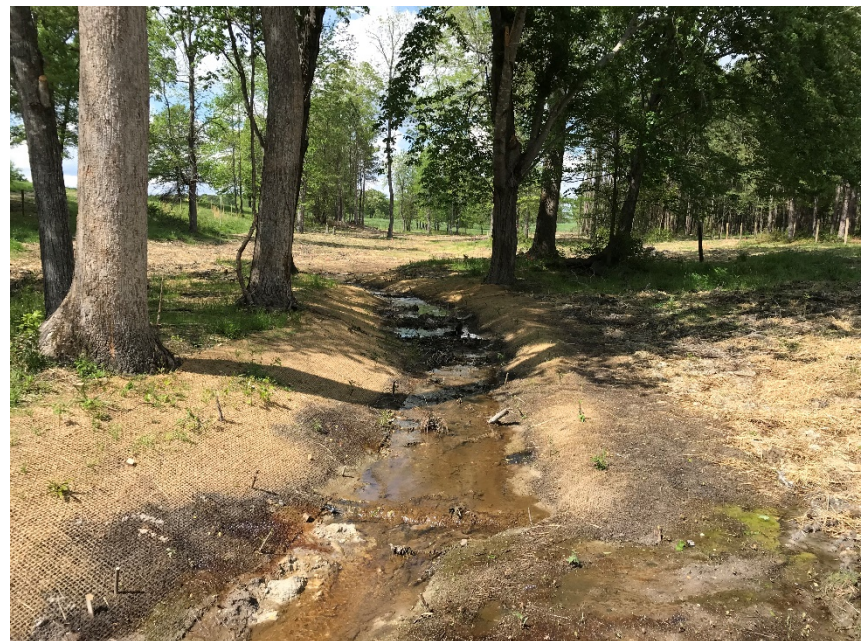
R4, facing upstream, Sta 52+00, April 27, 2018 (MY-00)

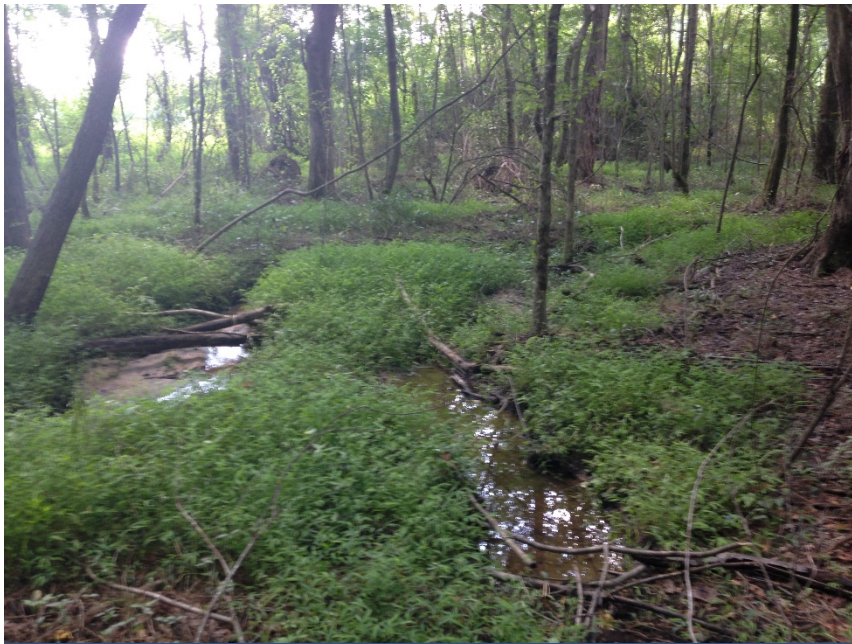
R5, facing upstream, near Sta 62+00, Sept 1, 2015, 2018 (MY-00)

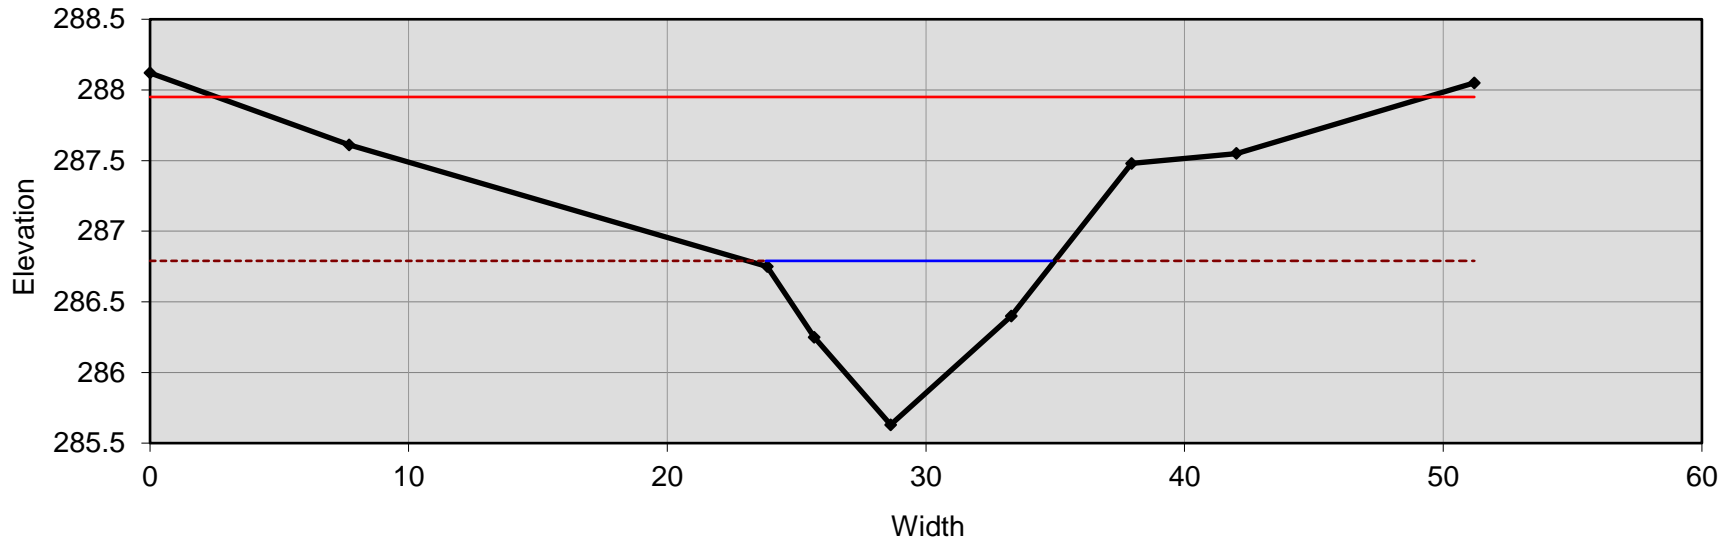
Cross Section X-1

19 + 31 Pen Dell Mitigation Project - As-Built (MY0), Riffle

7.0	x-section area (ft.sq.)
11.1	width (ft)
0.6	mean depth (ft)
1.2	max depth (ft)
11.4	wetted parimeter (ft)
0.6	hyd radi (ft)
17.7	width-depth ratio

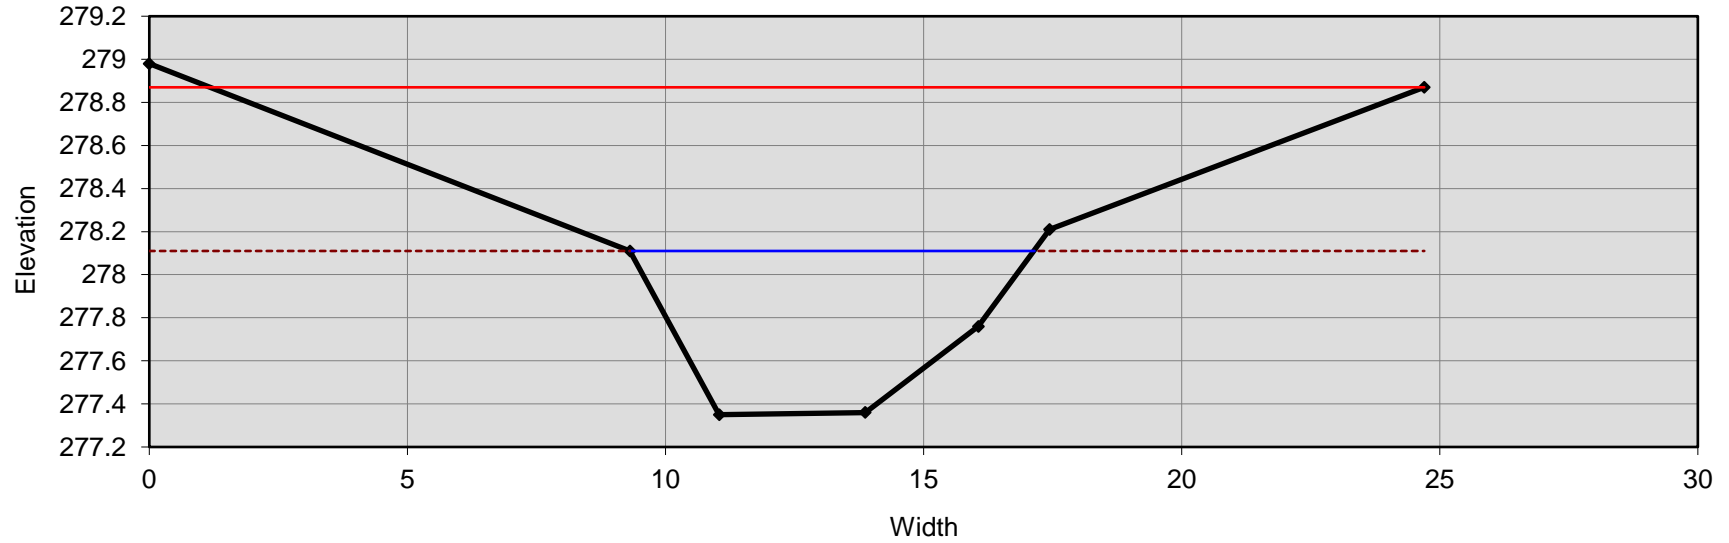
Cross Section X-2

23 + 51 Pen Dell Mitigation Project - As-Built (MY0), Riffle

4.2	x-section area (ft.sq.)
7.8	width (ft)
0.5	mean depth (ft)
0.8	max depth (ft)
8.1	wetted parimeter (ft)
0.5	hyd radi (ft)
14.6	width-depth ratio

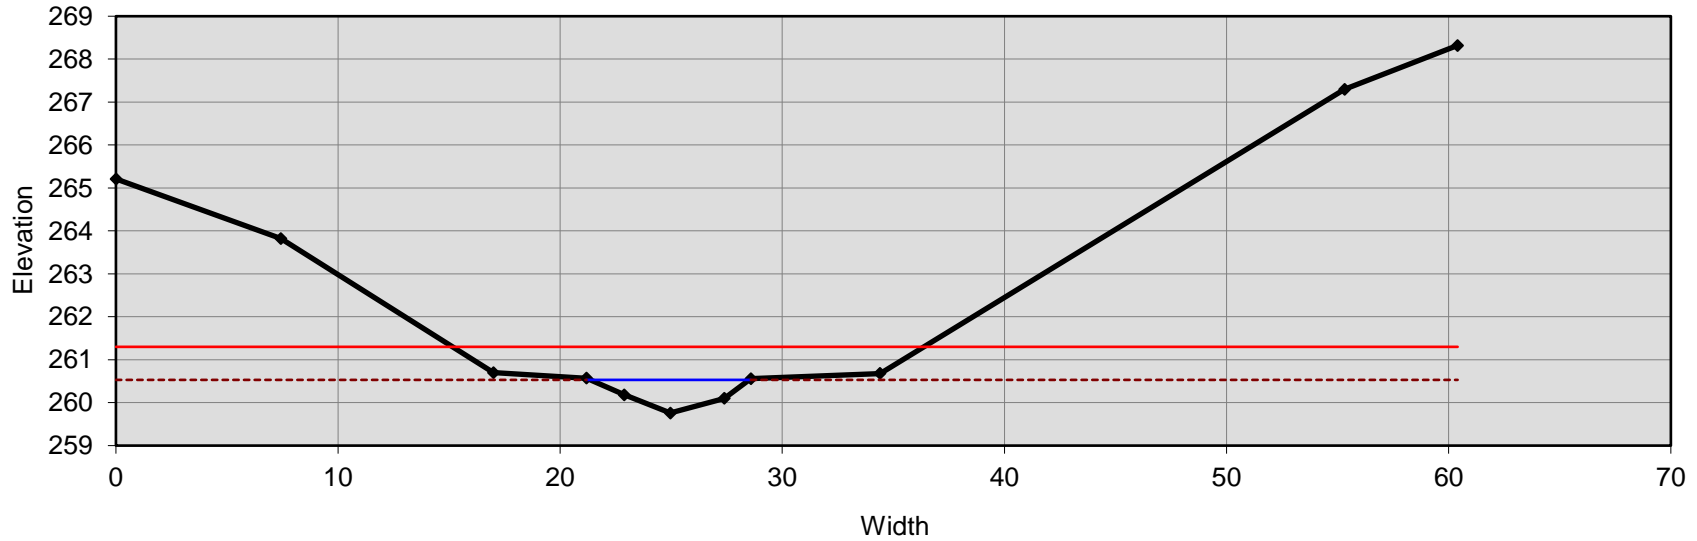
Cross Section X-3

32 + 84 Pen Dell Mitigation Project - As-Built (MY0), Riffle

3.1	x-section area (ft.sq.)
7.1	width (ft)
0.4	mean depth (ft)
0.8	max depth (ft)
7.3	wetted parimeter (ft)
0.4	hyd radi (ft)
16.3	width-depth ratio

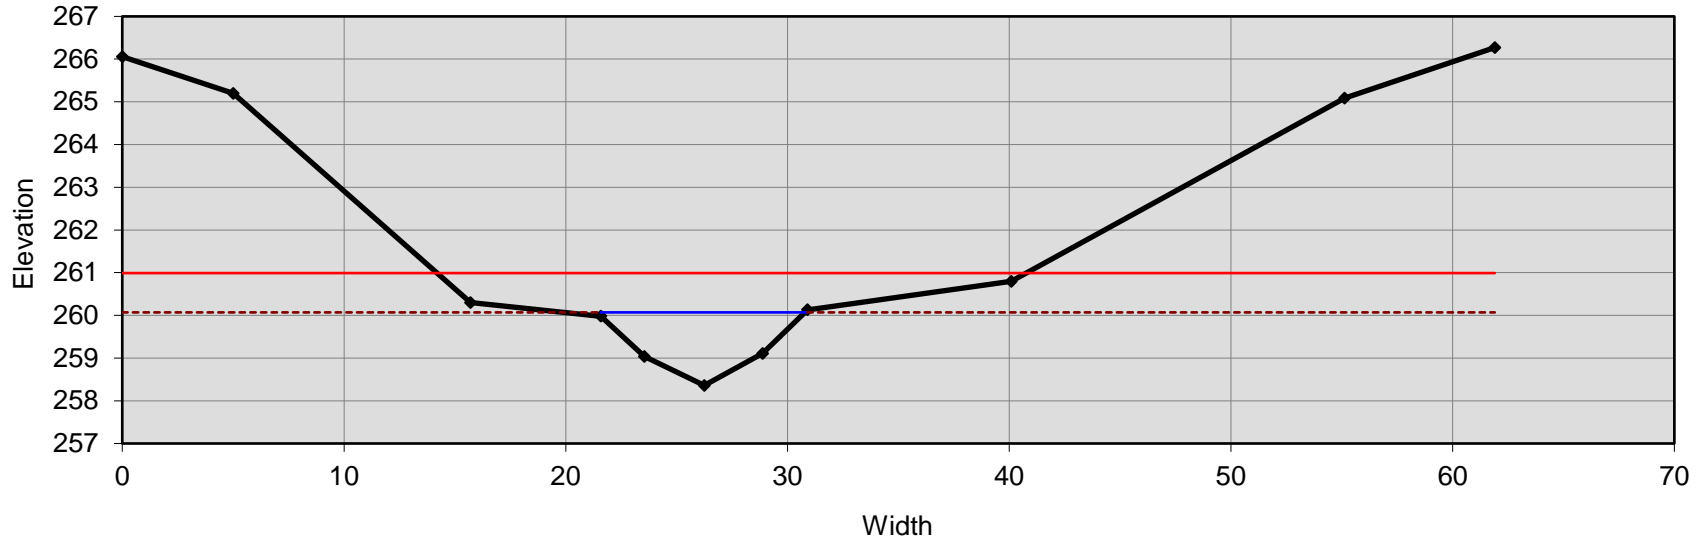
Cross Section X-4

33 + 35 Pen Dell Mitigation Project - As-Built (MY0), Pool

Bankfull Dimensions	
9.2	x-section area (ft.sq.)
9.2	width (ft)
1.0	mean depth (ft)
1.7	max depth (ft)
9.8	wetted parimeter (ft)
0.9	hyd radi (ft)
9.2	width-depth ratio

Flood Dimensions	
29.6	W flood prone area (ft)
3.2	entrenchment ratio
1.7	low bank height (ft)
1.0	low bank height ratio

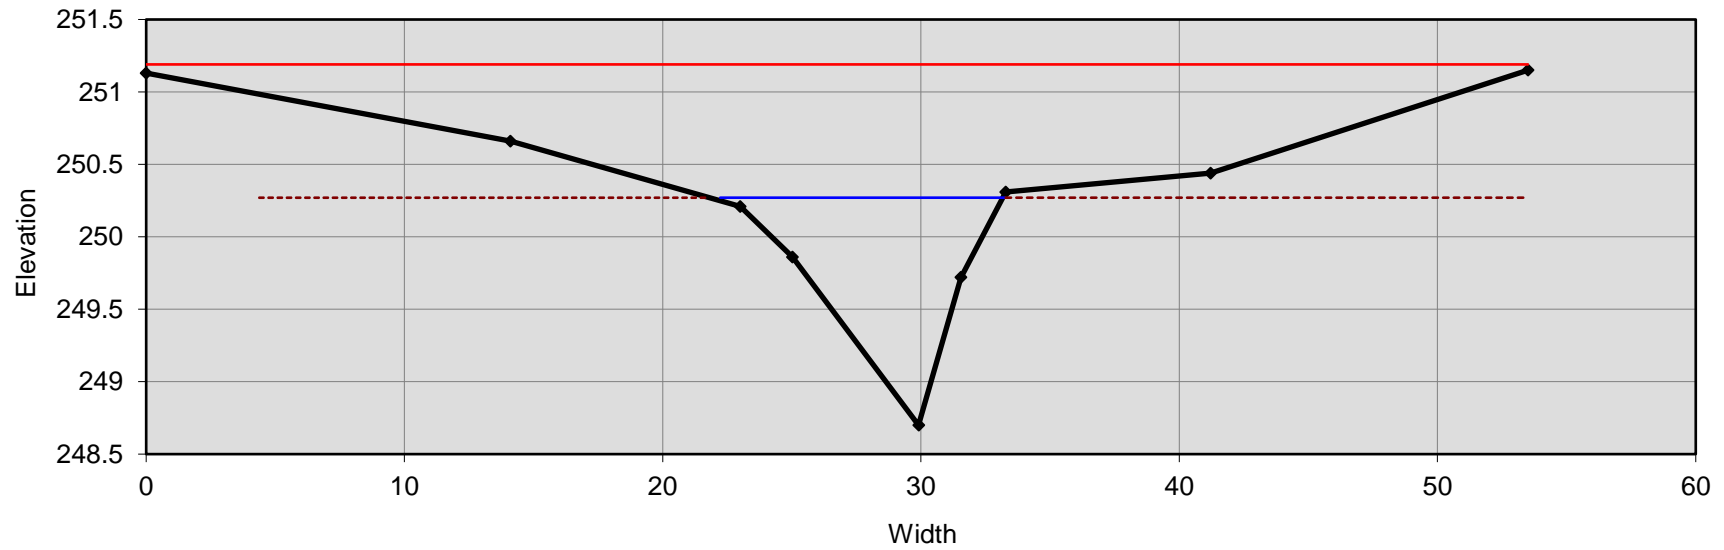
Cross Section X-5

44 + 13 Pen Dell Mitigation Project - As-Built (MY0), Pool

7.5	x-section area (ft.sq.)
10.2	width (ft)
0.7	mean depth (ft)
1.6	max depth (ft)
10.7	wetted parimeter (ft)
0.7	hyd radi (ft)
13.8	width-depth ratio

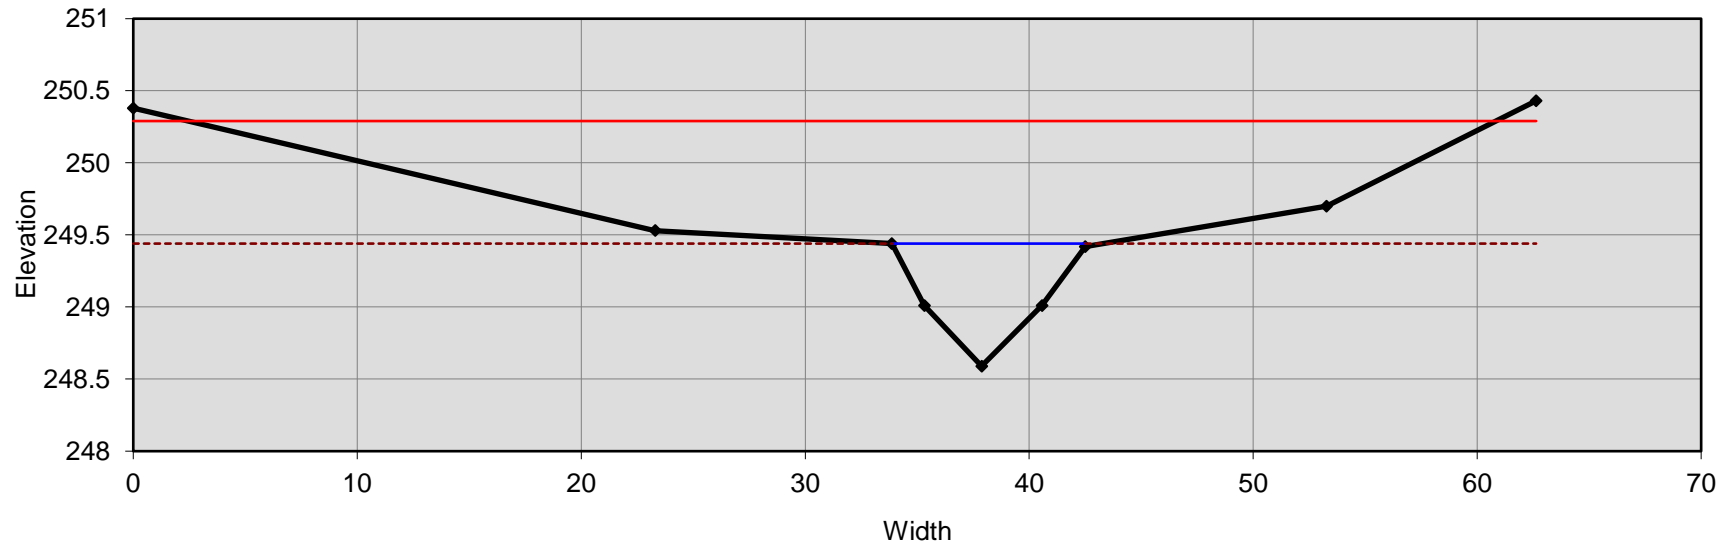
Cross Section X-6

45 + 16 Pen Dell Mitigation Project - As-Built (MY0), Riffle

4.1	x-section area (ft.sq.)
8.6	width (ft)
0.5	mean depth (ft)
0.9	max depth (ft)
8.8	wetted parimeter (ft)
0.5	hyd radi (ft)
18.1	width-depth ratio

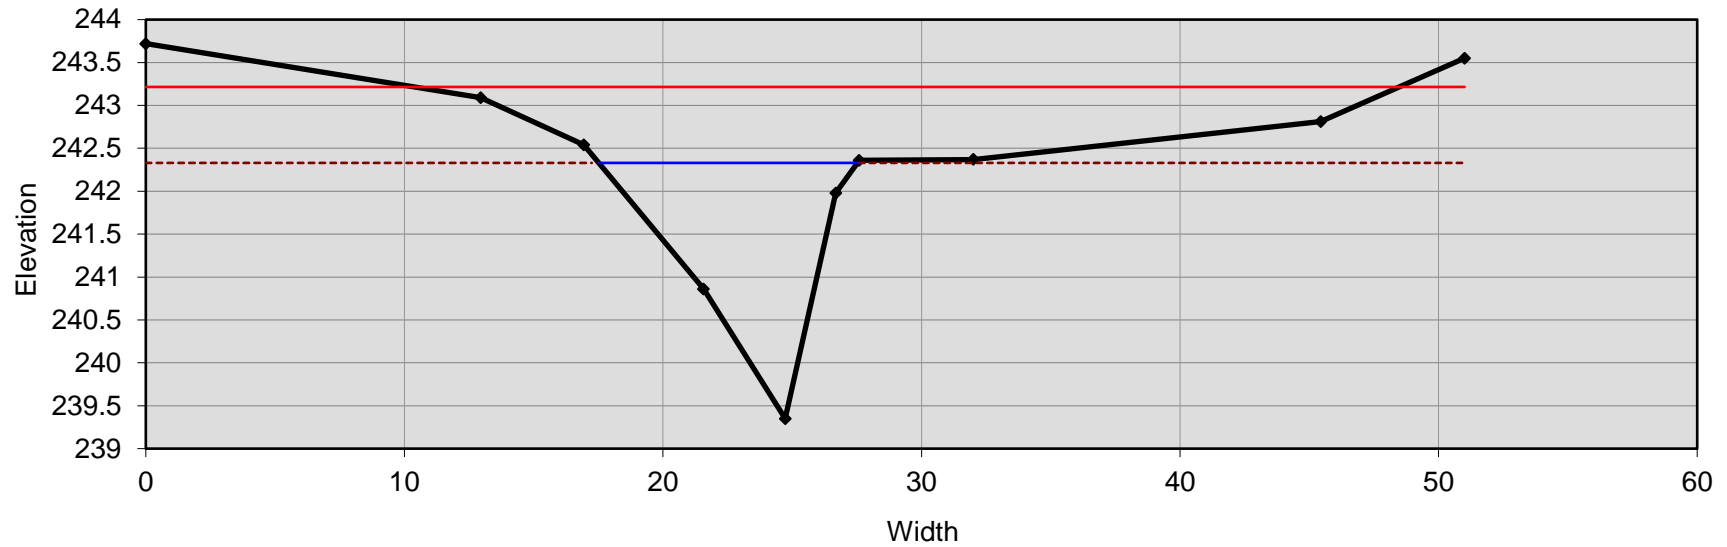
Cross Section X-7

50 + 71 Pen Dell Mitigation Project - As-Built (MY0), Pool

13.4	x-section area (ft.sq.)
10.0	width (ft)
1.3	mean depth (ft)
3.0	max depth (ft)
12.0	wetted parimeter (ft)
1.1	hyd radi (ft)
7.5	width-depth ratio

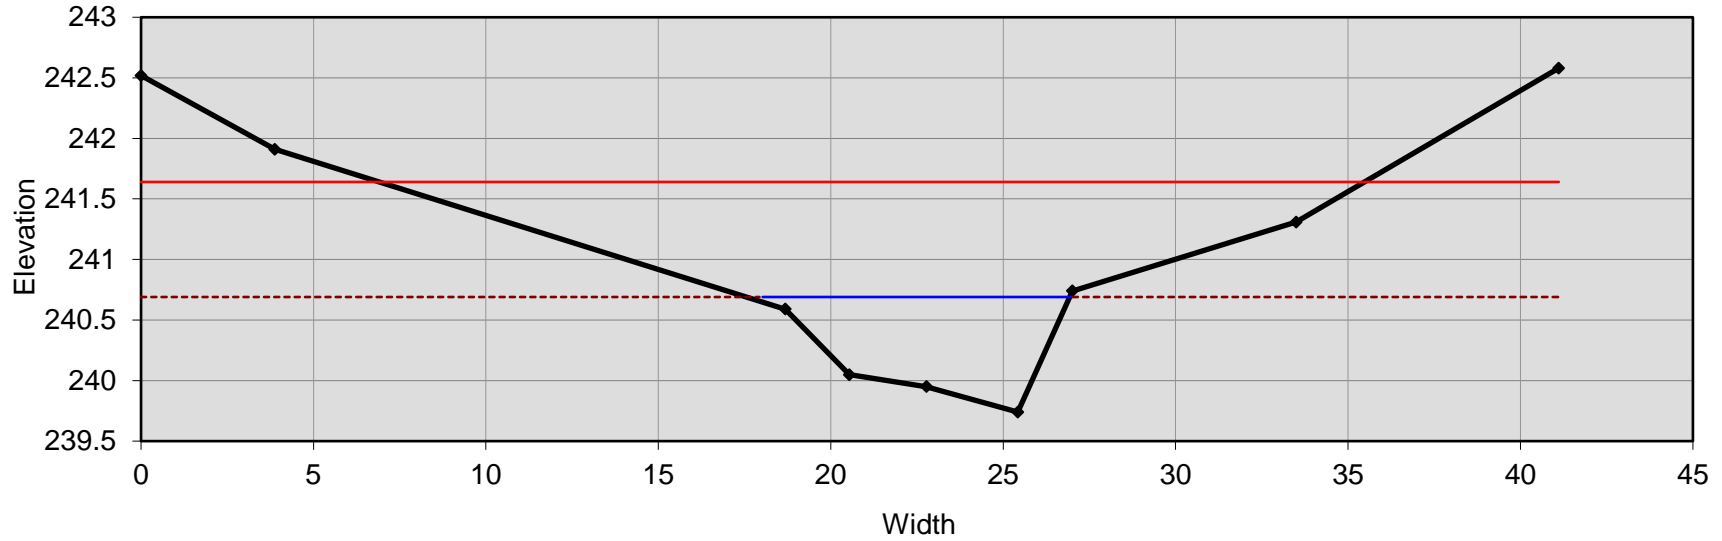
Cross Section X-8

51 + 79 Pen Dell Mitigation Project - As-Built (MY0), Riffle

5.2	x-section area (ft.sq.)
8.3	width (ft)
0.6	mean depth (ft)
0.9	max depth (ft)
8.6	wetted parimeter (ft)
0.6	hyd radi (ft)
13.1	width-depth ratio

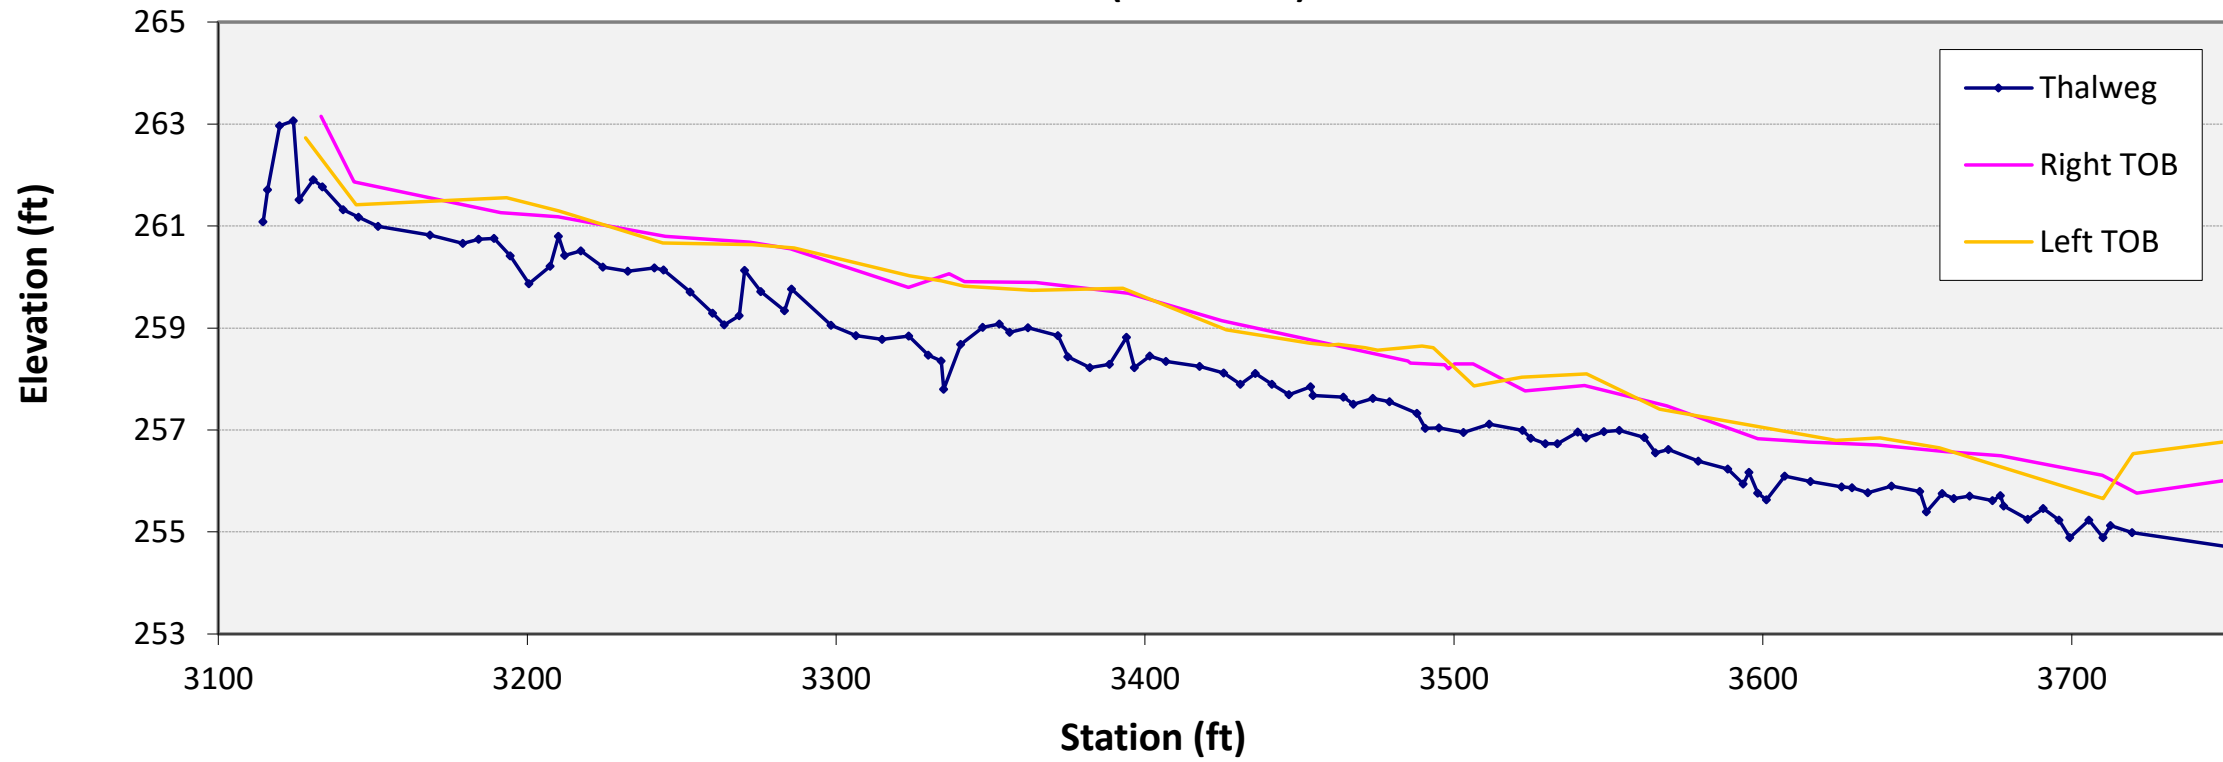
**Pen Dell Mitigation Project
Longitudinal Profile - R3
As-Built (MY0 2018)**

A longitudinal profile has been surveyed for the entire length of restored channel to document as-built baseline conditions for the first year of monitoring only. The survey was tied to a permanent benchmark and measurements include thalweg, water surface, bankfull, and top of low bank. Measurements were taken at the head of each feature (e.g., riffle, pool) and at the maximum pool depth. The longitudinal profile shows that the bedform features installed are consistent with intended design stream type. The longitudinal profiles will not be taken during subsequent monitoring years unless vertical channel instability has been documented or remedial actions/repairs are deemed necessary. These measurements will demonstrate that the restored stream profile provides more bedform diversity than the old channel with multiple facet features (such as scour pools and riffles) that provide improved aquatic habitat, as per the restoration objectives. BHRs will be measured along each of the restored reaches using the results of the longitudinal profile to demonstrate that the BHRs shall not exceed 1.2 along the restored project reaches.

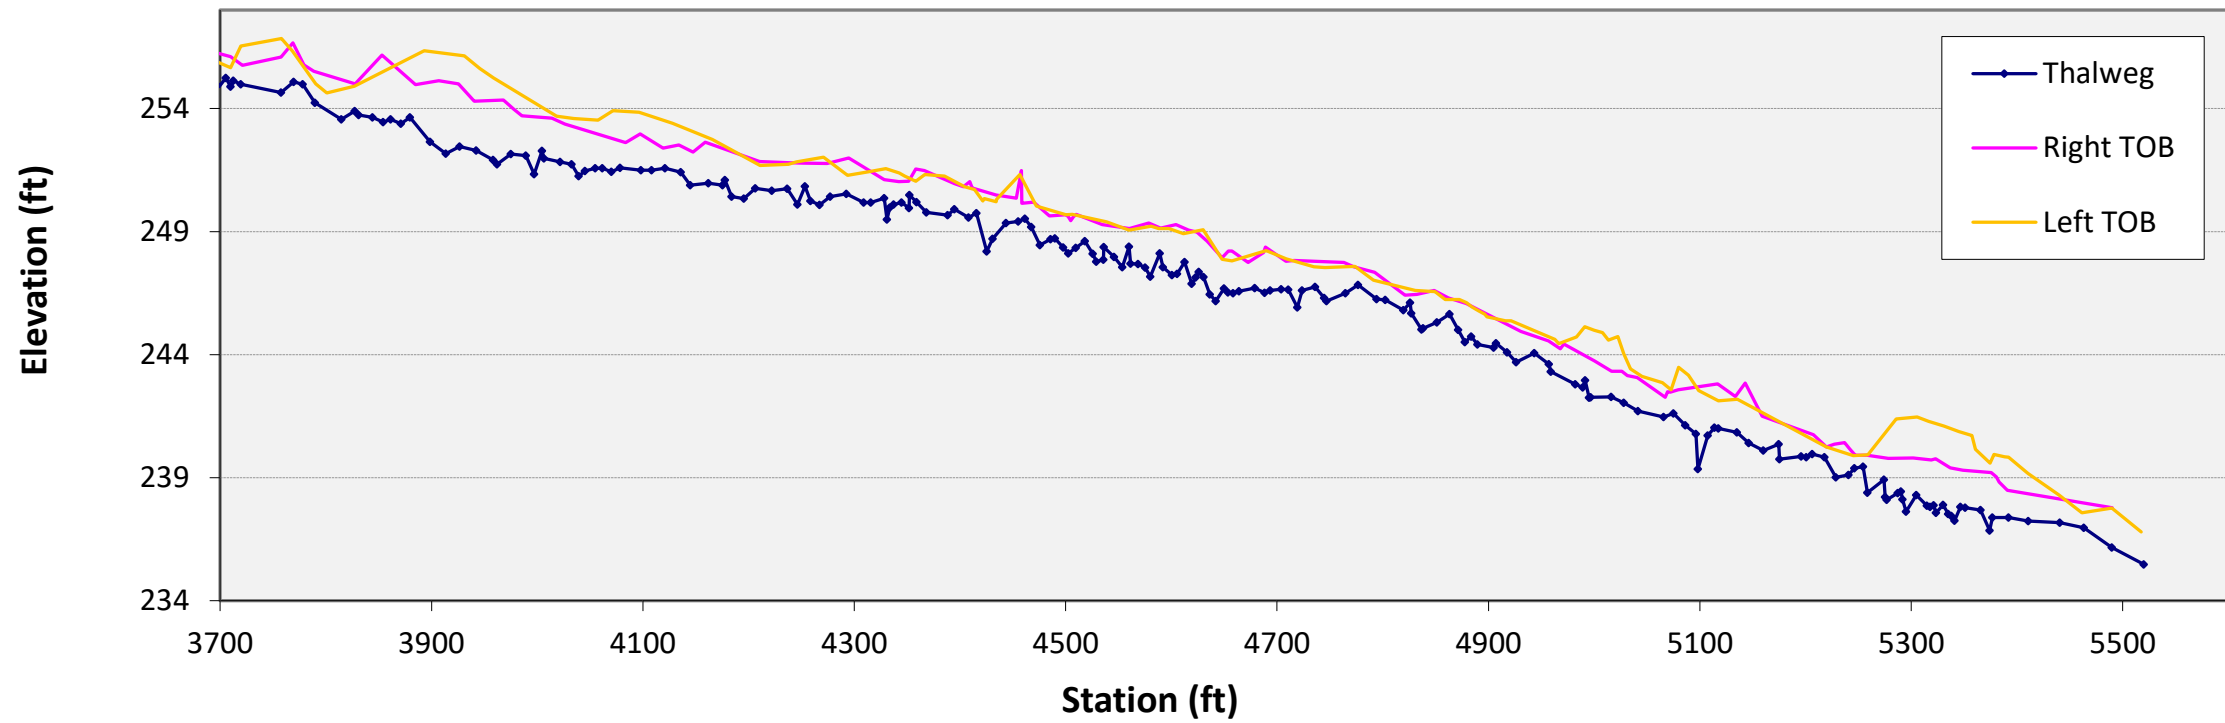
**Pen Dell Mitigation Project
Longitudinal Profile - R4
As-Built (MYO 2018)**

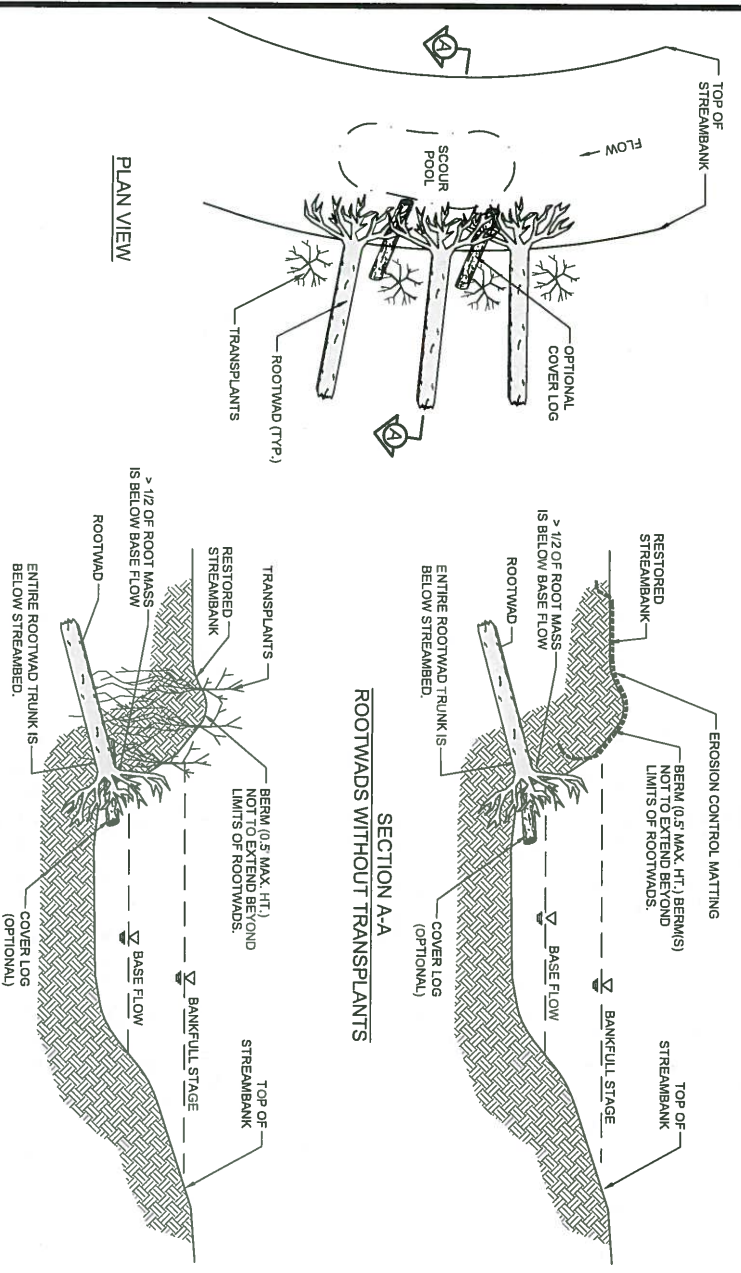
SECTION A-A
ROOTWADS WITHOUT TRANSPLANTS

NOTES:
1. THE TRENCHING METHOD REQUIRES THAT A TRENCH BE EXCAVATED FOR THE LOG PORTION OF THE ROOTWAD. A COVER LOG SHOULD BE INSTALLED UNDERNEATH THE ROOTWAD IN A TRENCH EXCAVATED PERPENDICULAR TO THE BANK AND BELOW THE RESTORED STREAMBED. ONE-THIRD OF THE ROOTWAD SHOULD REMAIN BELOW NORMAL BASE FLOW CONDITIONS.

ROOTWADS
NOT TO SCALE

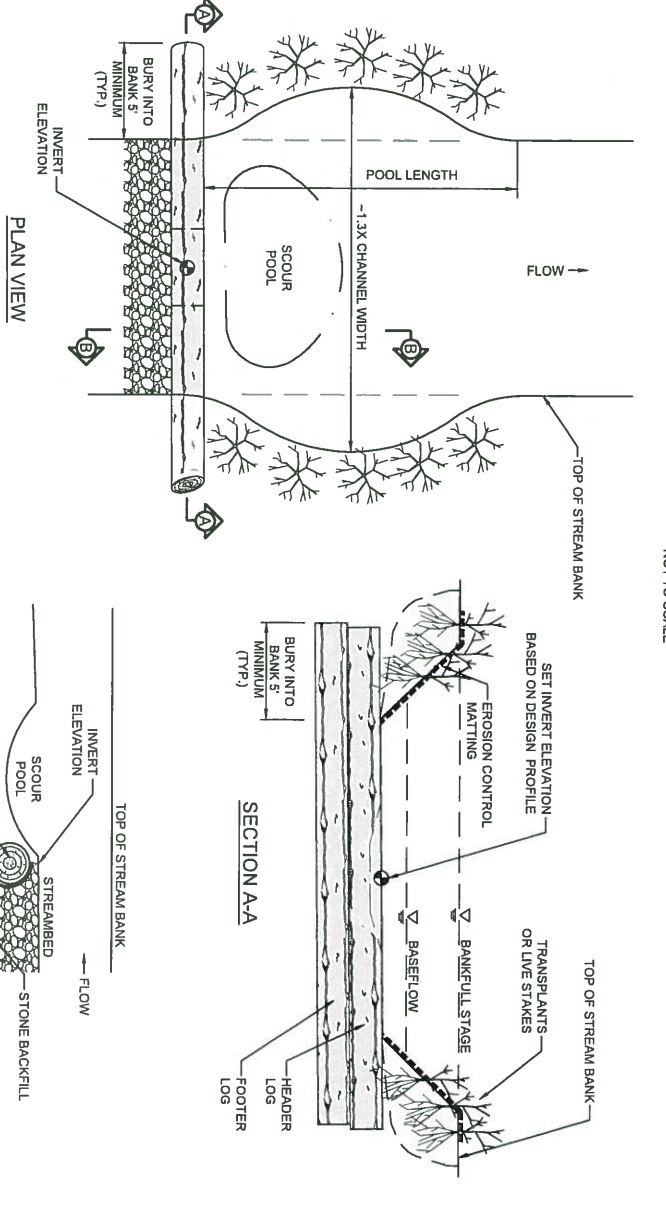
SECTION A-A
LOG WEIR

NOTES:
1. LOGS SHOULD BE AT LEAST 12 INCHES IN DIAMETER, RELATIVELY STRAIGHT, HARDWOOD AND RECENTLY HARVESTED.
2. LOGS >24 INCHES IN DIAMETER MAY BE USED ALONE WITHOUT AN ADDITIONAL LOG FILTER FABRIC SHOULD STILL BE USED TO SEAL AROUND LOG. LOGS SHOULD EXTEND INTO THE BANKS 5" ON EACH SIDE.

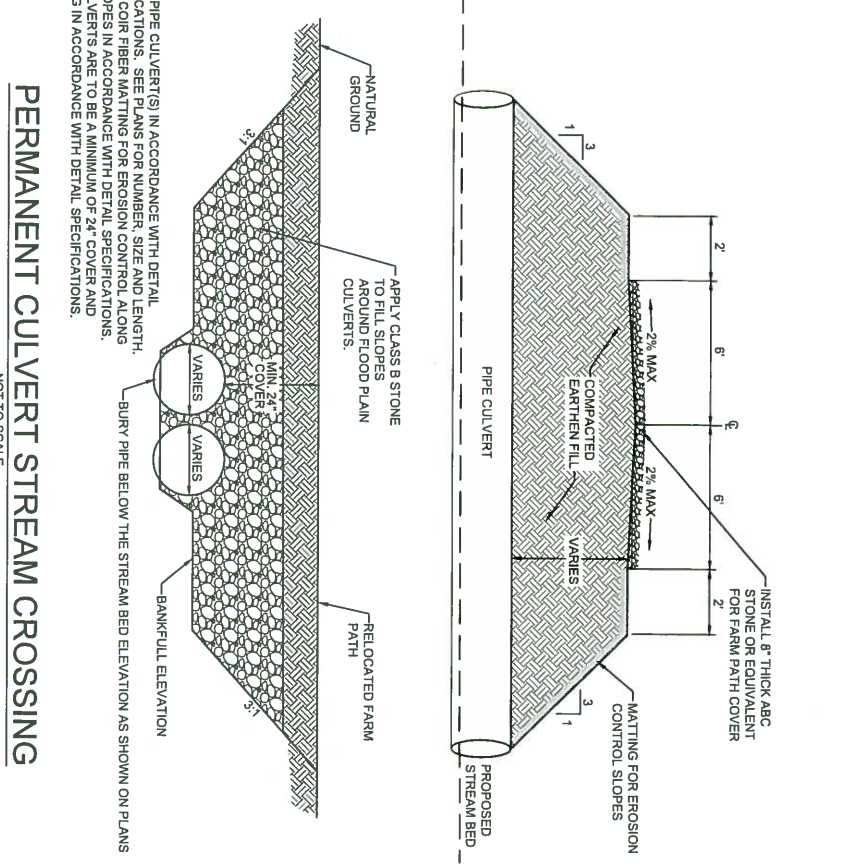
- NOTES:
1. INSTALL PIPE CULVERT(S) IN ACCORDANCE WITH DETAIL SPECIFICATIONS. SEE PLANS FOR NUMBER, SIZE AND LENGTH.
 2. INSTALL COIR FIBER MATTING FOR EROSION CONTROL ALONG SLOPES IN ACCORDANCE WITH DETAIL SPECIFICATIONS.
 3. PIPE CULVERTS ARE TO BE A MINIMUM OF 24" COVER AND SPACING IN ACCORDANCE WITH DETAIL SPECIFICATIONS.

PERMANENT CULVERT STREAM CROSSING
 NOT TO SCALE

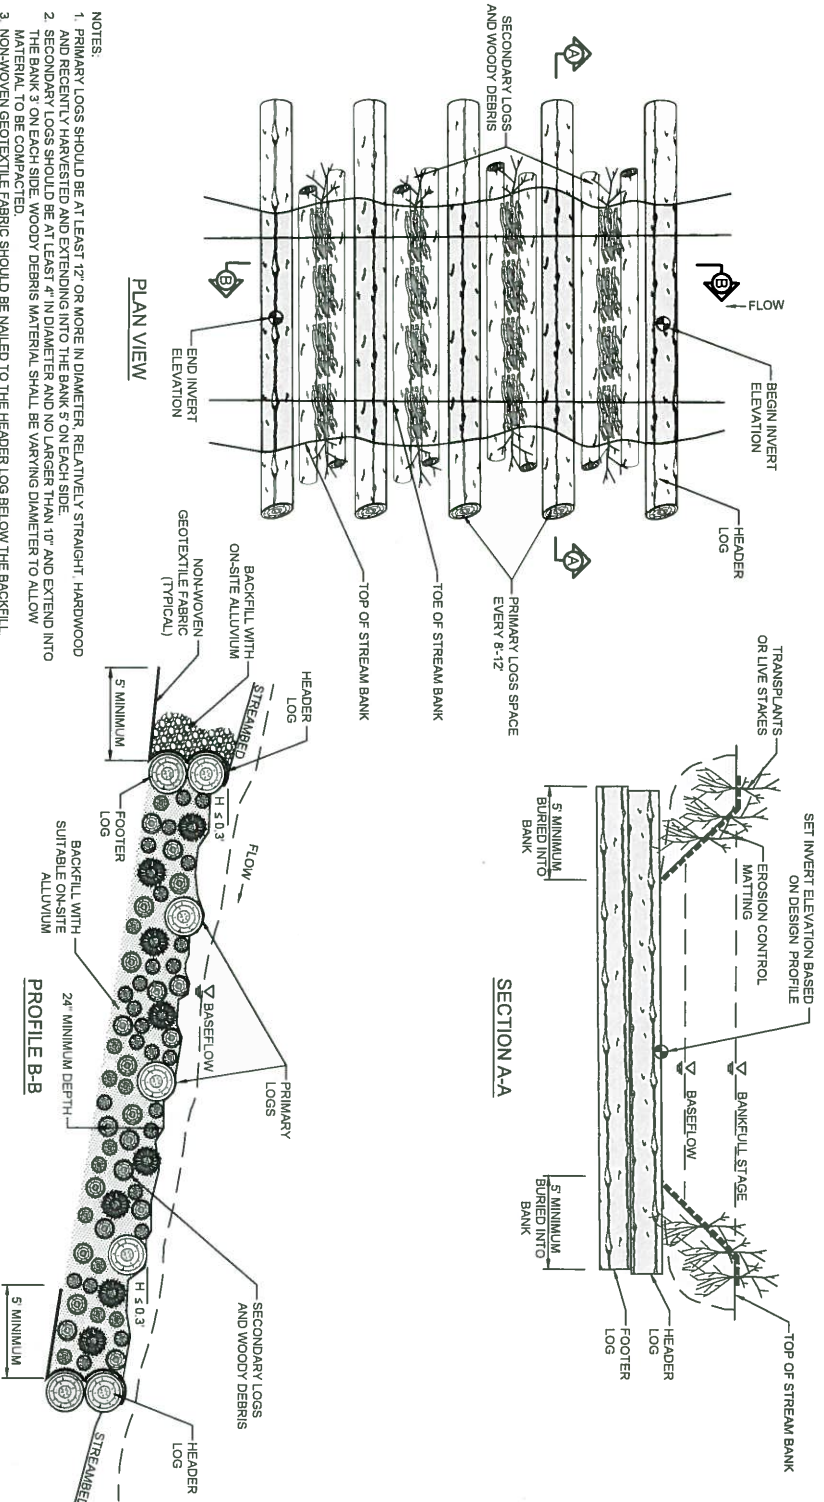
- NOTES:
1. PRIMARY LOGS SHOULD BE AT LEAST 12" OR MORE IN DIAMETER, RELATIVELY STRAIGHT, HARDWOOD AND RECENTLY HARVESTED AND EXTENDING INTO THE BANK 5' ON EACH SIDE.
 2. SECONDARY LOGS SHOULD BE AT LEAST 4" IN DIAMETER AND NO LARGER THAN 12" AND EXTEND INTO THE BANK 3' ON EACH SIDE. WOODY DEBRIS MATERIAL SHALL BE VARYING DIAMETER TO ALLOW MATERIAL TO BE COMPACTED.
 3. NON-WOVEN GEOTEXTILE FABRIC SHOULD BE NAILED TO THE HEADER LOG BELOW THE BACKFILL.
 4. ROOT WADS AND EROSION CONTROL MATTING CAN BE USED INSTEAD OF TRANSPIRANTS OR LIVE STRIPES PER DIRECTION OF ENGINEER.
 5. A LAYER OF SECONDARY LOGS AND WOODY DEBRIS SHOULD BE PLACED WITH MINIMAL GAPS. A LAYER OF ON-SITE ALLUVIUM SHOULD BE APPLIED TO FILL Voids BETWEEN SECONDARY LOGS BEFORE ADDITIONAL LAYERS ARE PLACED.
 6. SEE TYPICAL SECTION FOR CHANNEL DIMENSIONS.

CONSTRUCTED LOG RIFFLE
 NOT TO SCALE

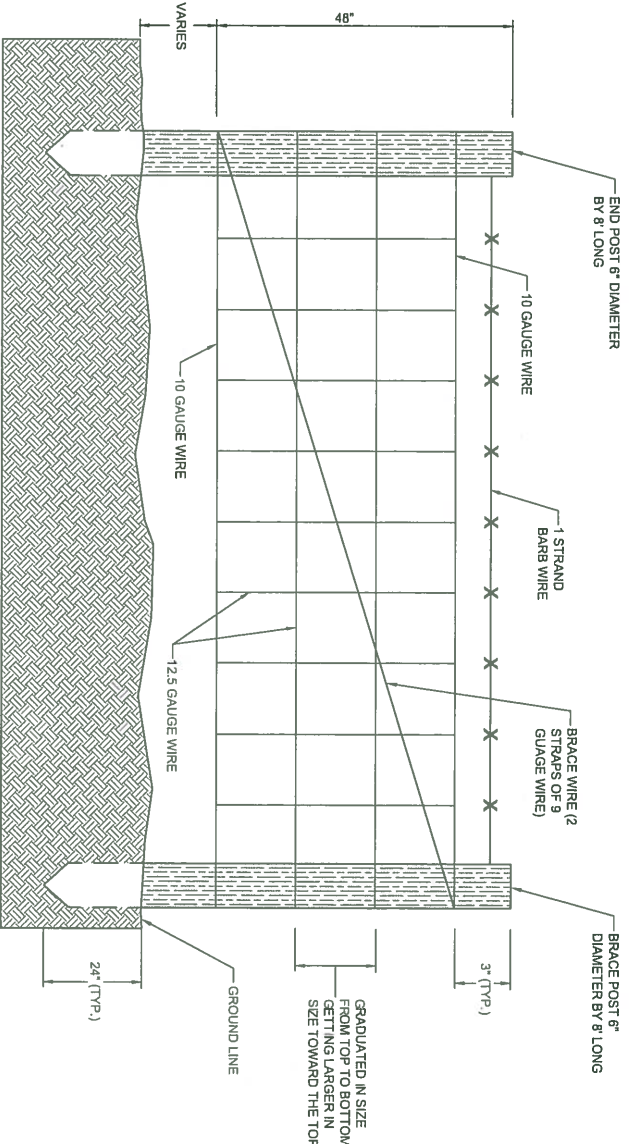
- NOTE:
1. END POSTS SHALL BE INSTALLED AT A SPACING OF 10-15 FEET.

WOVEN FIELD FENCE
 NOT TO SCALE

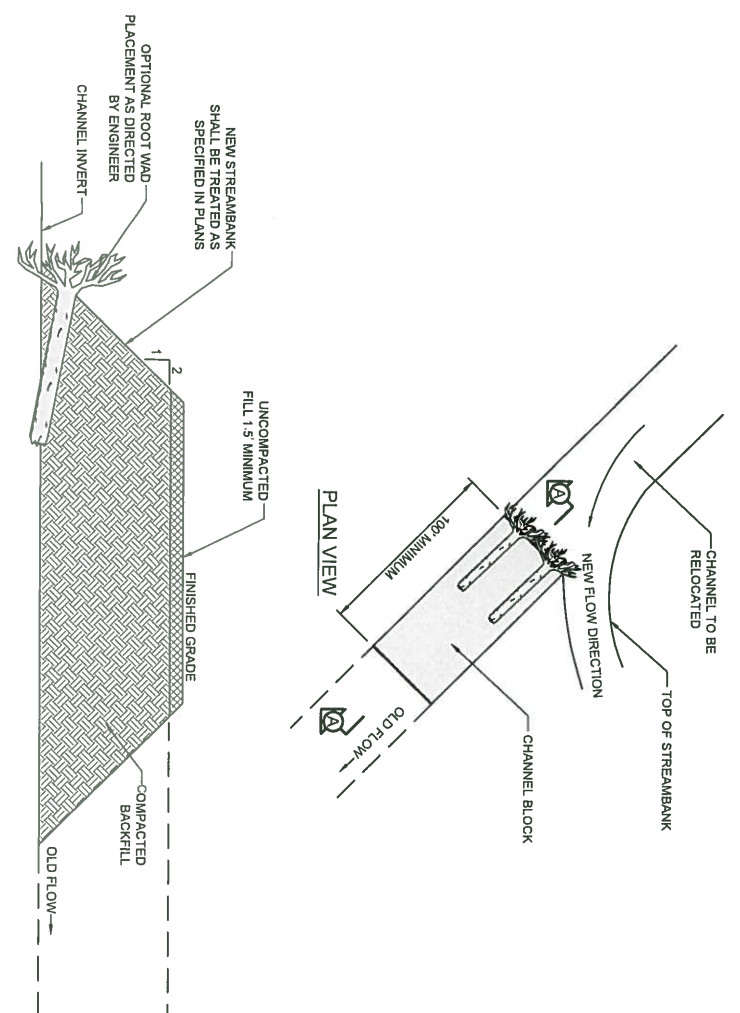
CHANNEL BLOCK
NOT TO SCALE

- NOTES:
1. COMPACT BACKFILL USING ON-SITE HEAVY EQUIPMENT IN 10 INCH LIFTS.
2. FILL DITCH PLUG TO TOP OF BANKS OR AS DIRECTED BY ENGINEER.
