As-Built Baseline Monitoring Report
FINAL VERSION
Pen Dell Mitigation Project
Monitoring Year 0
Calendar Year of Data Collection: 2018

NCDEQ DMS Project Identification # 97079
NCDEQ DMS Contract # 6824
Neuse River Basin (Cataloging Unit 03020201)
USACE Action ID Number: SAW-2016-00885
NCDEQ DWR Project # 2016-0403
Johnston County, NC
Contracted Under RFP # 16-006477
Data Collection Period: March-May 2018, Submission Date: March 2019

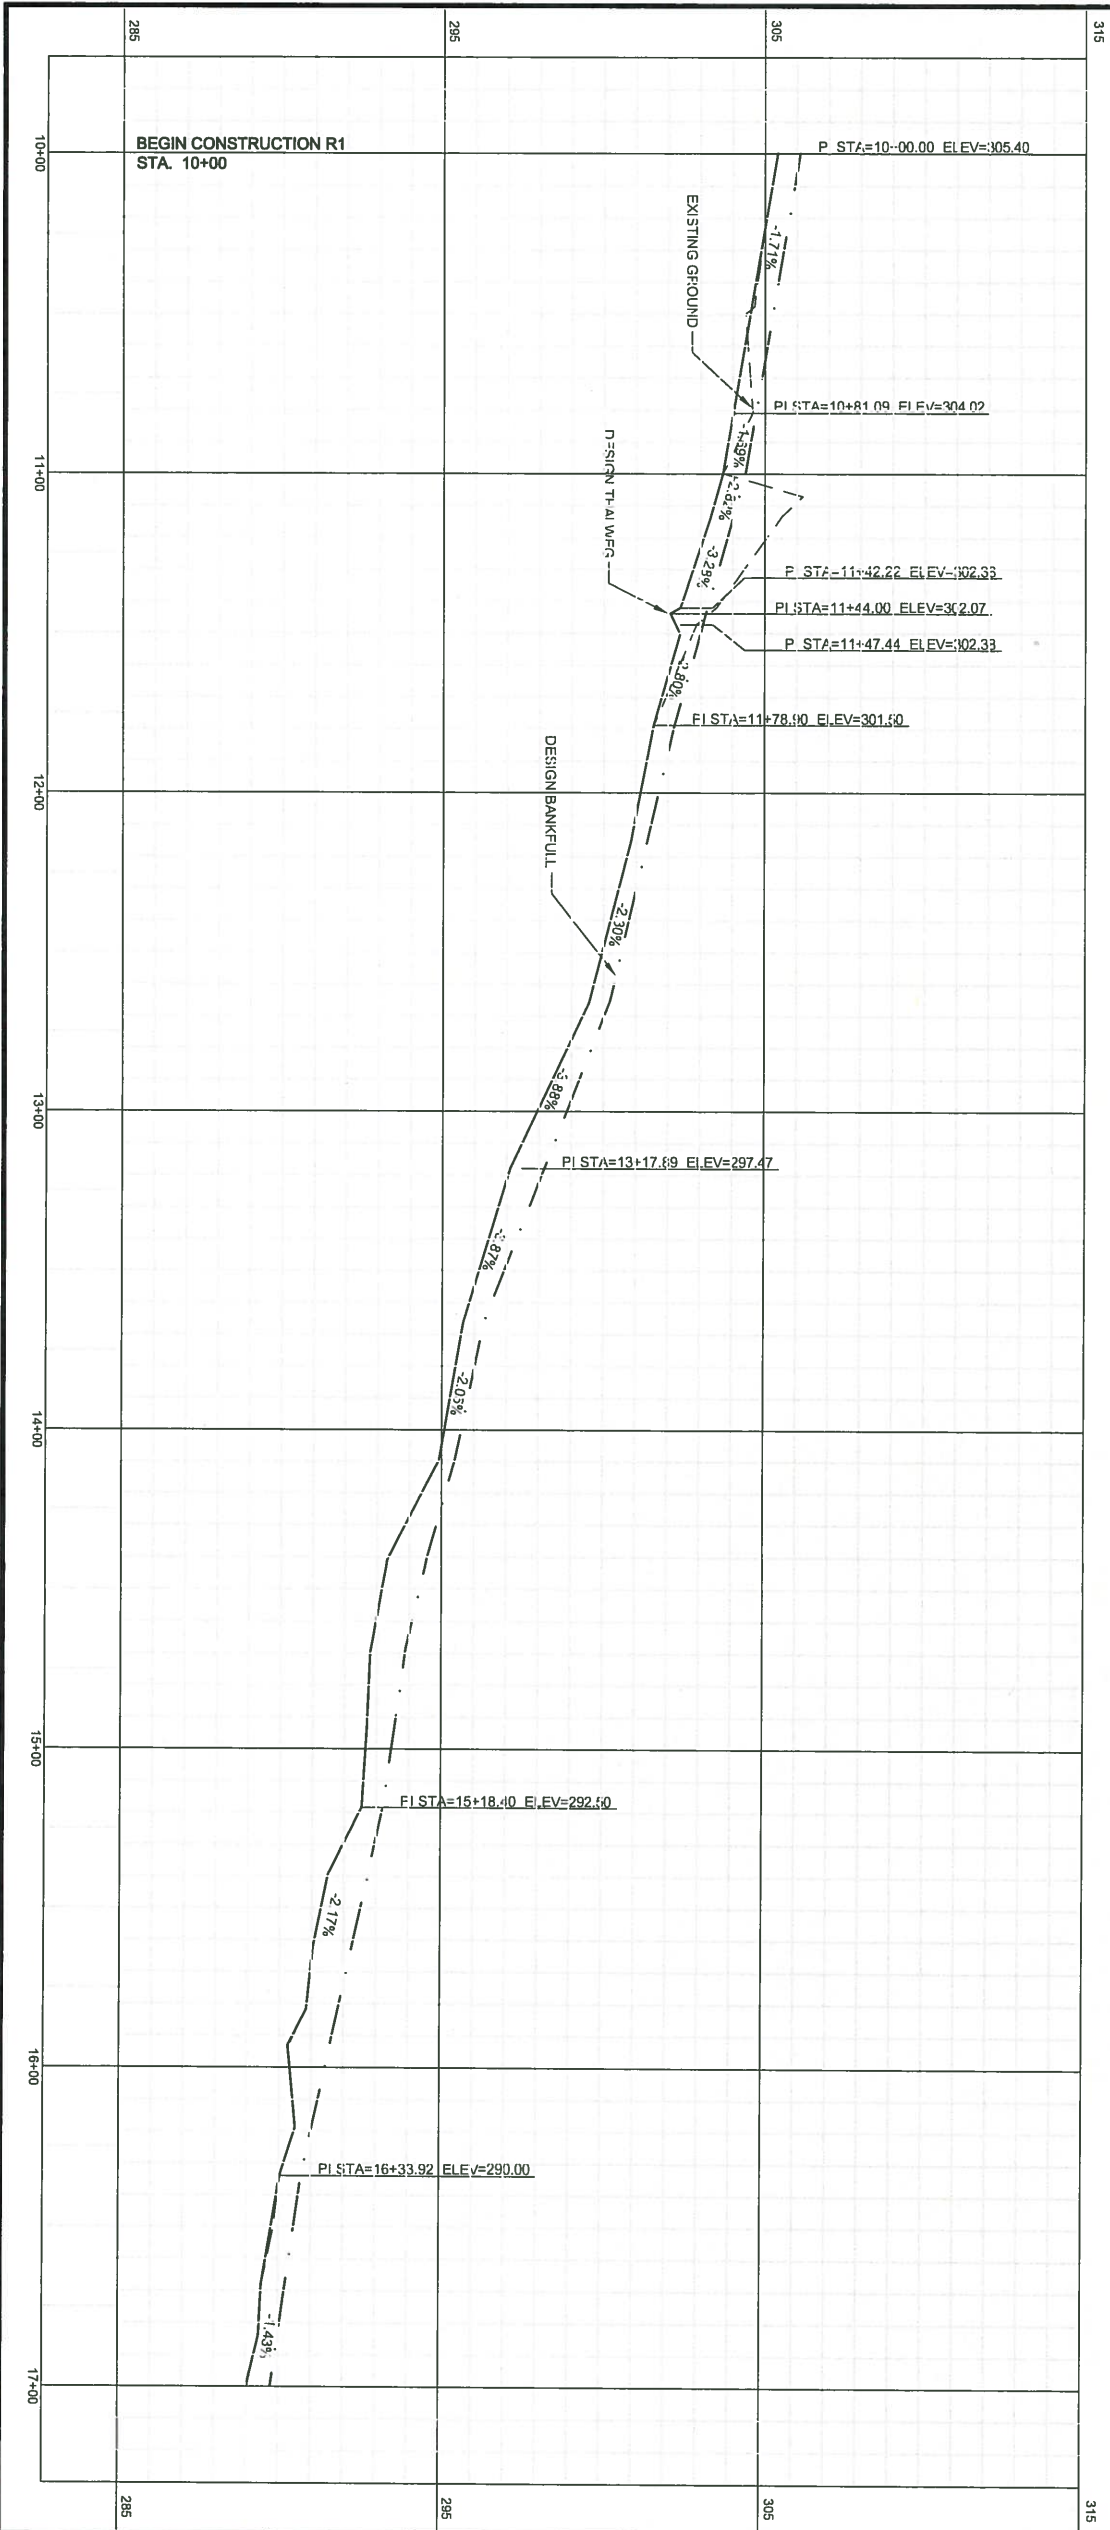
SHEET NUMBER
 8

**PLAN AND
 PROFILE**

REMOVE EXISTING RCP
CULVERT CROSSING. INSTALL
CONSTRUCTED LOG RIFFILE
(TYP.)
