**YEAR 3 (2016) ANNUAL MONITORING REPORT**

**PEPPERWOOD FARM RIPARIAN BUFFER MITIGATION SITE**

Wake County, North Carolina

DMS Project ID: 95713

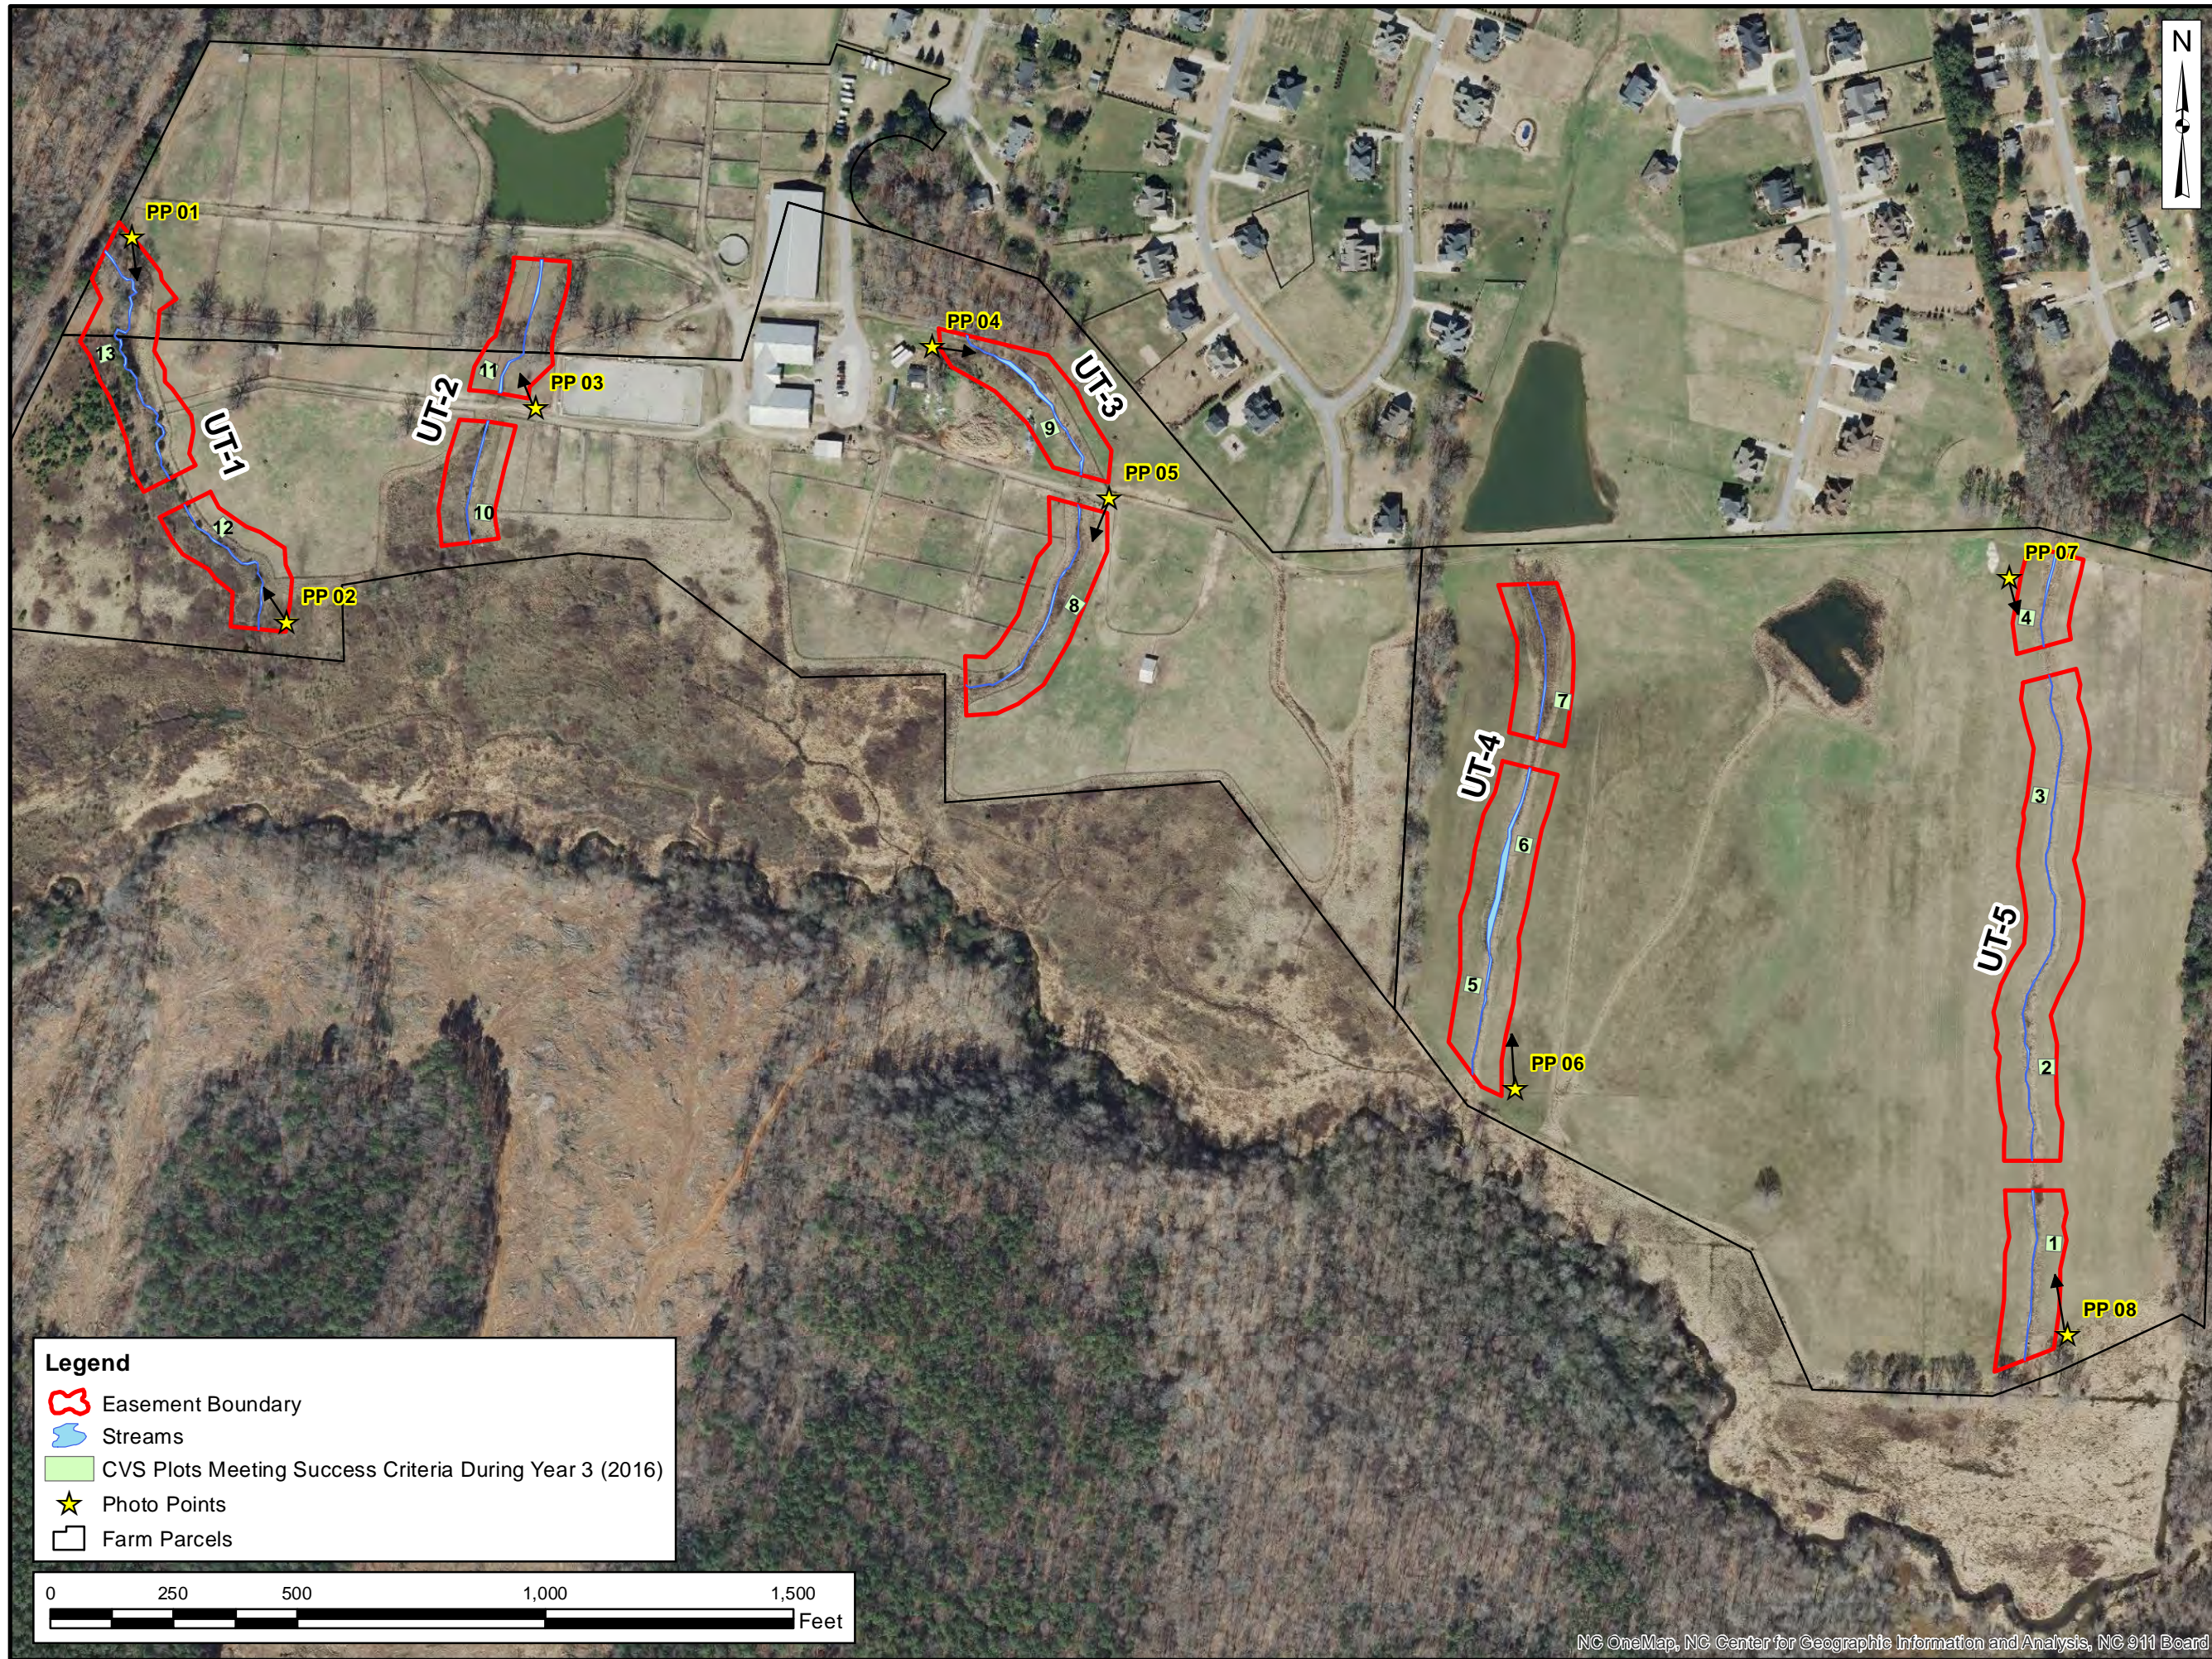
**FIGURE  
3**

- Easement Boundary
- Streams
- CVS Plots Meeting Success Criteria During Year 3 (2016)
- Photo Points
- Farm Parcels

**CURRENT CONDITIONS  
PLAN VIEW**
