FINAL MITIGATION PLAN

PERRY HILL MITIGATION PLAN

Orange County, NC
NCDEQ Contract No. 7744
DMS ID No. 100093

Neuse River Basin
HUC 03020201

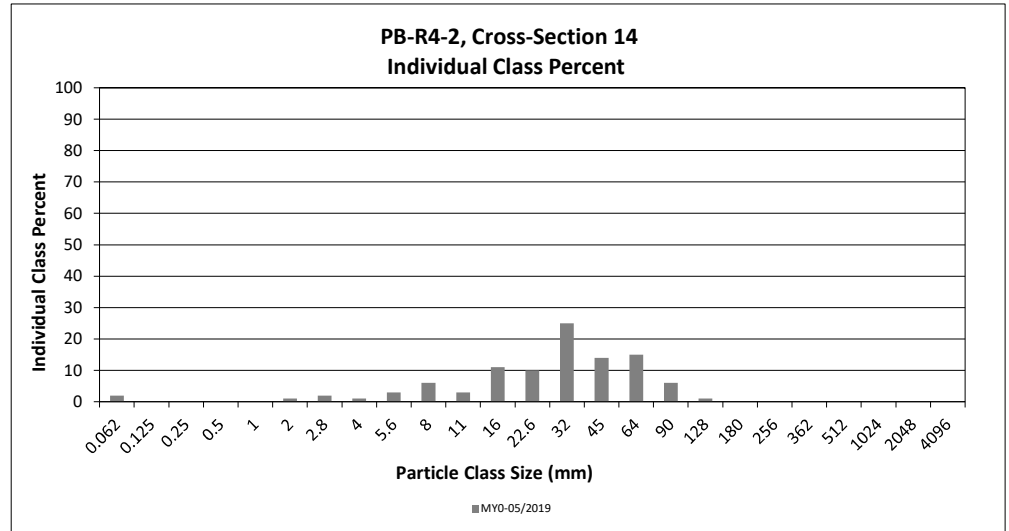
Reachwide and Cross-Section Pebble Count Plots

Cross-Section 14	
Channel materials (mm)	
D ₁₆ =	8.90
D ₃₅ =	19.68
D ₅₀ =	26.3
D ₈₄ =	51.8
D ₉₅ =	71.7
D ₁₀₀ =	128.0
