**MONITORING YEAR 2  
ANNUAL BUFFER REPORT  
FINAL**

**PERRY HILL MITIGATION SITE**

Orange County, NC  
NCDEQ Contract No. 7744  
DMS Project No. 100093  
NCDWR Project No. 2019-0157v2  
RFP No. 16-007576

Data Collection Period: September 2022  
Draft Submission Date: November 2022  
Final Submission Date: January 2023

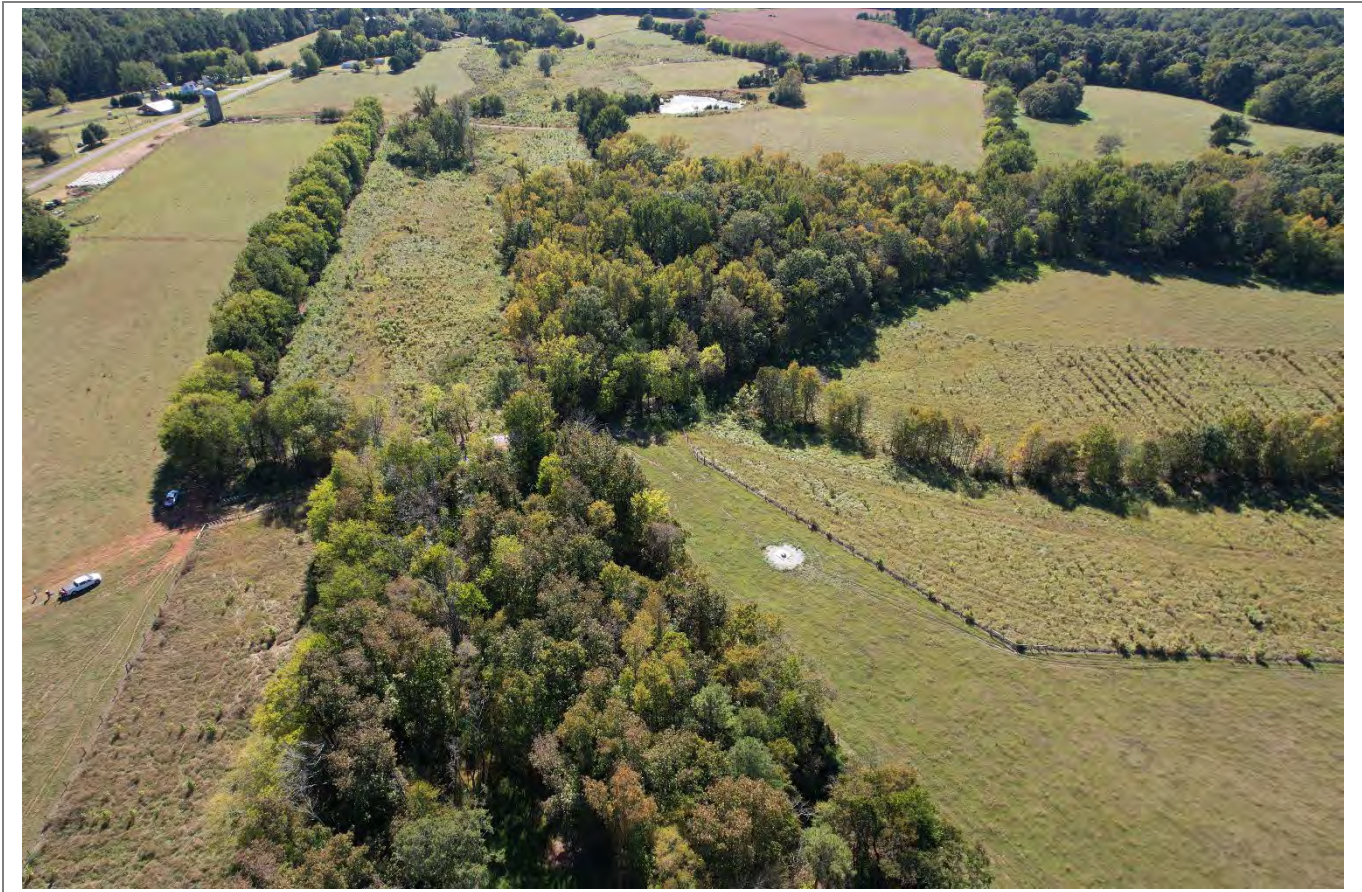
**VEGETATION AREAS OF CONCERN UPDATED PHOTOGRAPHS**  
**Conservation Easement Encroachment**

Perry Branch R2 – CE Encroachment Seeded and Stabilized (10/19/2022)

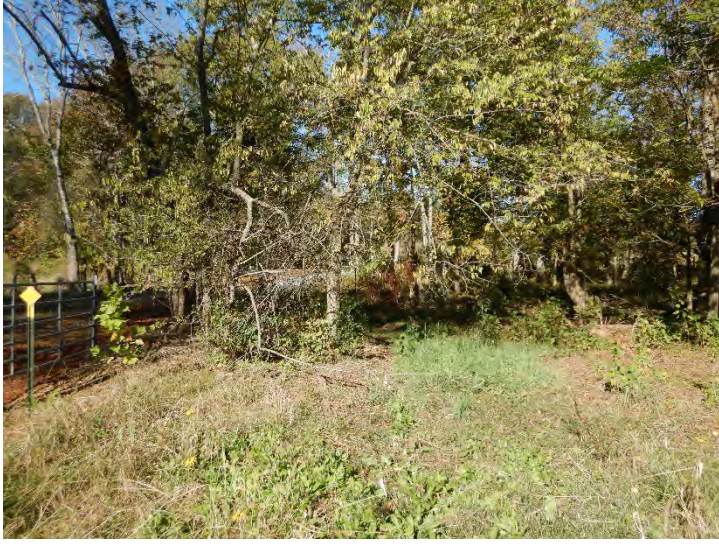
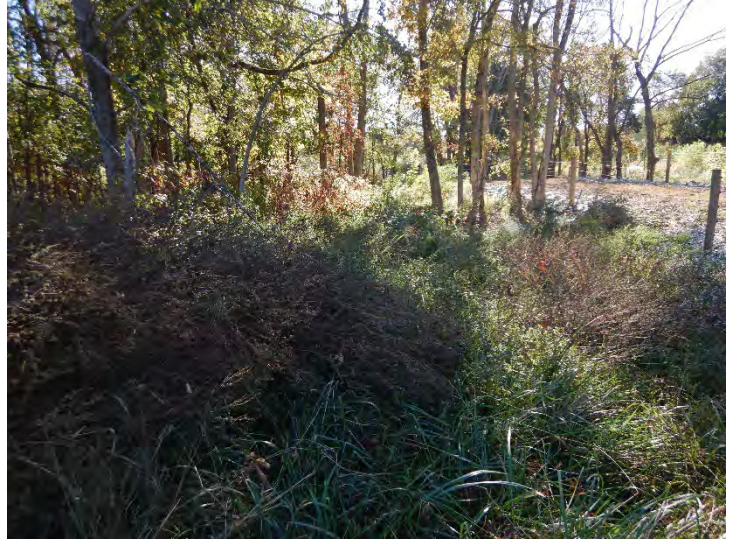
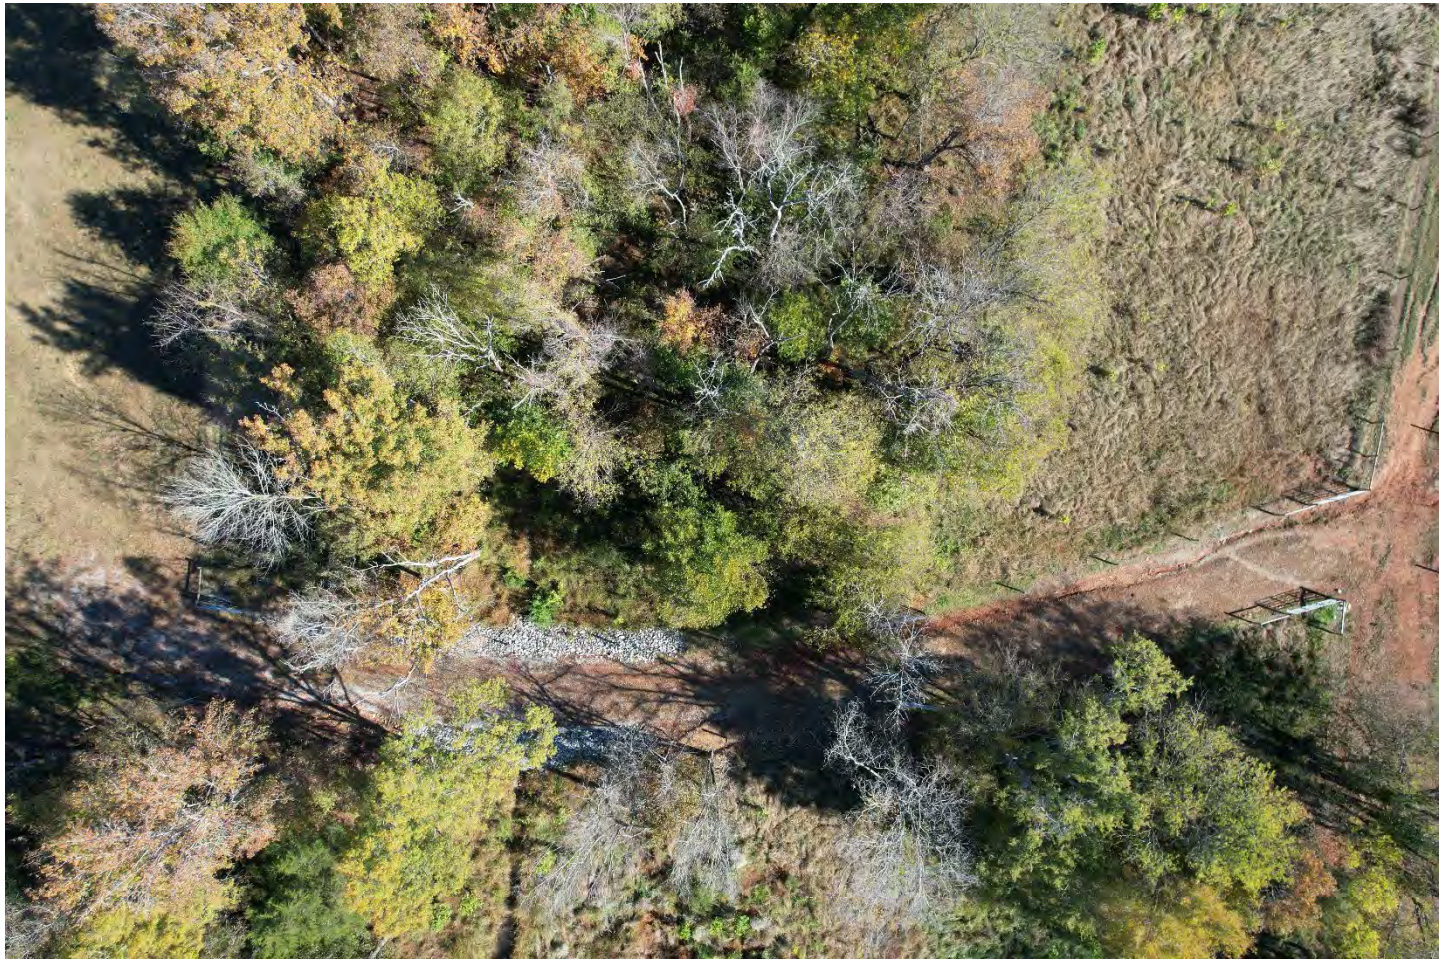
As was discussed above, an additional 20 feet (a total of 0.19 acres) was added alongside both internal crossings as a maintenance area due to the installation of waterlines in October 2021. The affected area was seeded, and herbaceous vegetation has grown over the disturbance. The soil is stabilized, and Wildlands does not anticipate any future problems in these areas. Recent photographs showing vegetation cover are included in Vegetation Areas of Concern Updated Photographs in Appendix 2.

Approximately 20 feet (or a total of 0.19 acres) was added alongside both internal crossings as a maintenance area. No credit is claimed in the maintenance area and project credits were reduced accordingly. Of the 26.88-acres, Neuse riparian buffer credits were generated by restoring 16.65 acres and enhancing 7.88 acres. No buffer credit will be generated from the remaining 2.35 acres. In general, riparian buffer restoration area widths on streams extend out to 50 feet from top of bank on each side of the stream channel. Figure 3 and Table 1 in Appendix 1 detail the buffer credit generation updated to include the maintenance area in Monitoring Year 2. Wildlands is working with a surveyor to mark the area.
