MY1 MONITORING REPORT

PIERCE TERRACE WETLAND MITIGATION SITE

Gates County, North Carolina
Chowan River Basin
Cataloging Unit 03010203 & 03010204

DMS Project No. 100139
Full Delivery Contract No. 7907-01
DMS RFP No. 16-007907 (issued 5/6/2019)
USACE Action ID No. SAW-2020-00046
DWR Project No. 2020-~~00034~~ 0034

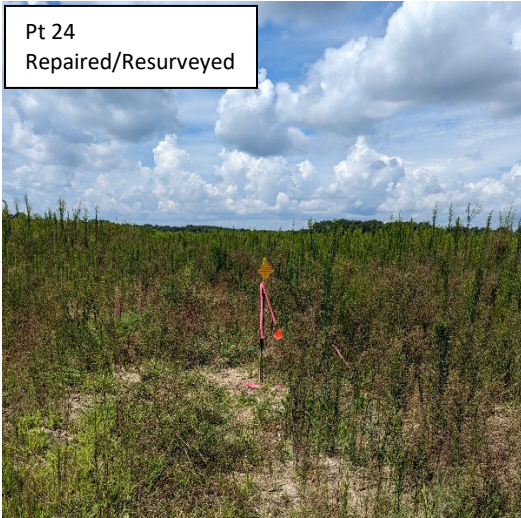
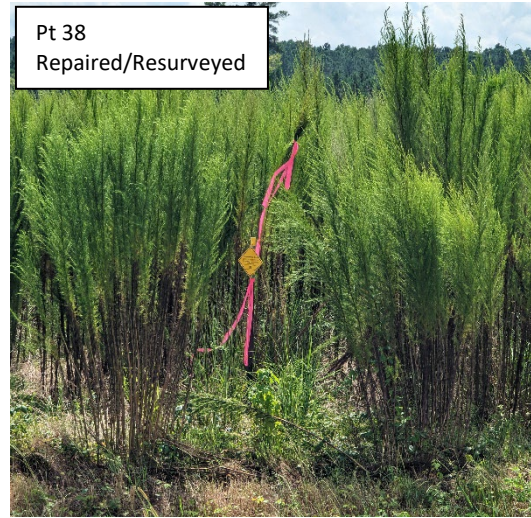
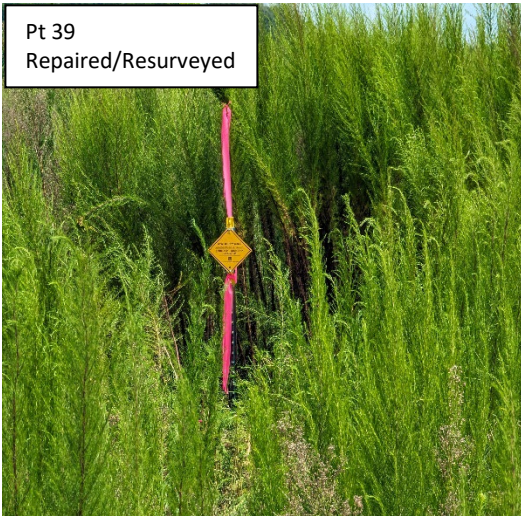
Pierce Terrace Site
MY1 (2023) Boundary Photographs

Visual assessments of the easement boundary and stabilized outfalls were conducted throughout the Year 1 (2023) monitoring period. A small area (0.02-acres) of encroachment was observed along the western boundary where ~5-rows of crops scalloped the edge of the easement boundary. The farmer was notified and treated wooden post with markings are scheduled to be installed once the crops are harvested. In addition, damaged witness and online markings noted in the as-built report have been repaired and/or

replaced. The three stabilized outlets have experienced surface water flow and remain stable without any issues. Please refer to Appendix A for Visual Assessment Photographs.

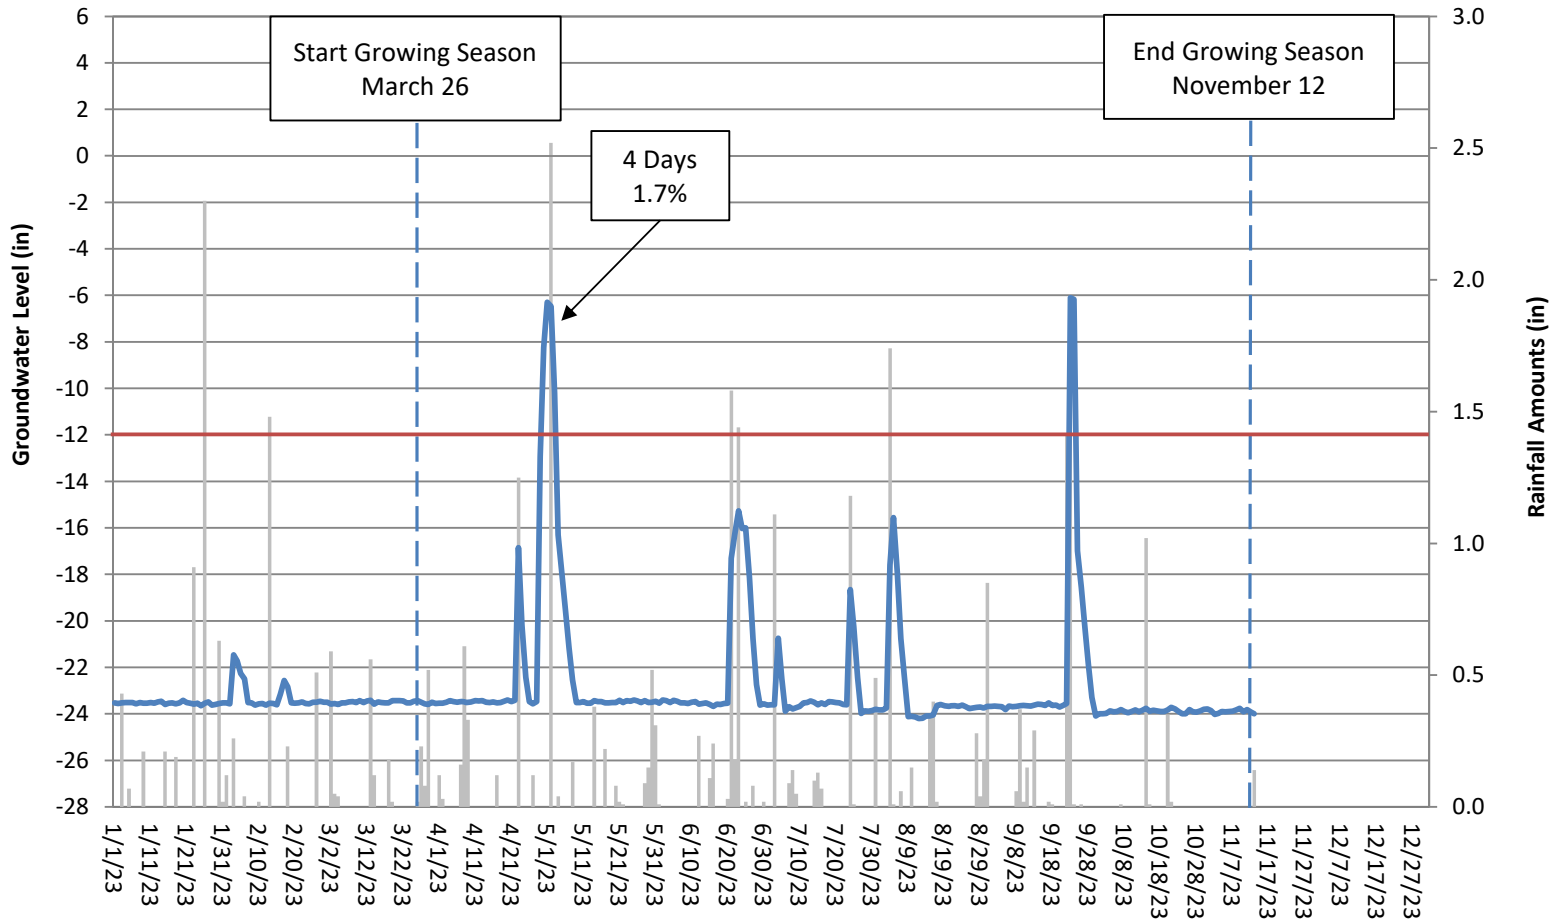
Pierce Terrace Groundwater Gauge 1 Year 1 (2023 Data)

Non-riverine Wet Hardwood Forest - Wetland Hydroperiod Success Criteria is 10% of Growing Season

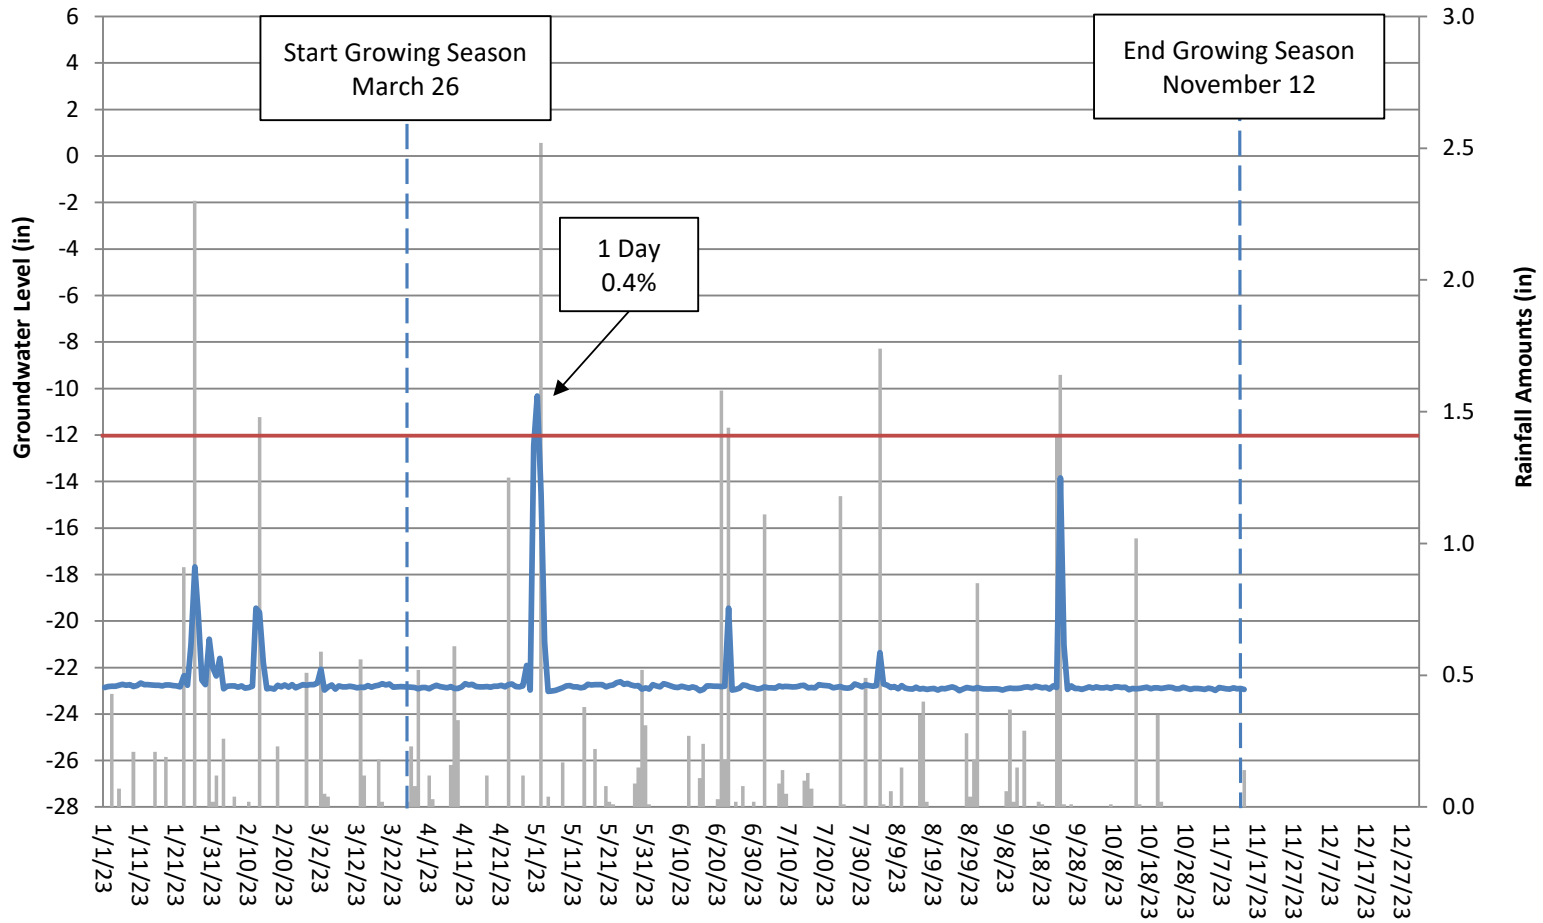
Pierce Terrace Groundwater Gauge 2 Year 1 (2023 Data)

Non-riverine Wet Hardwood Forest - Wetland Hydroperiod Success Criteria is 10% of Growing Season

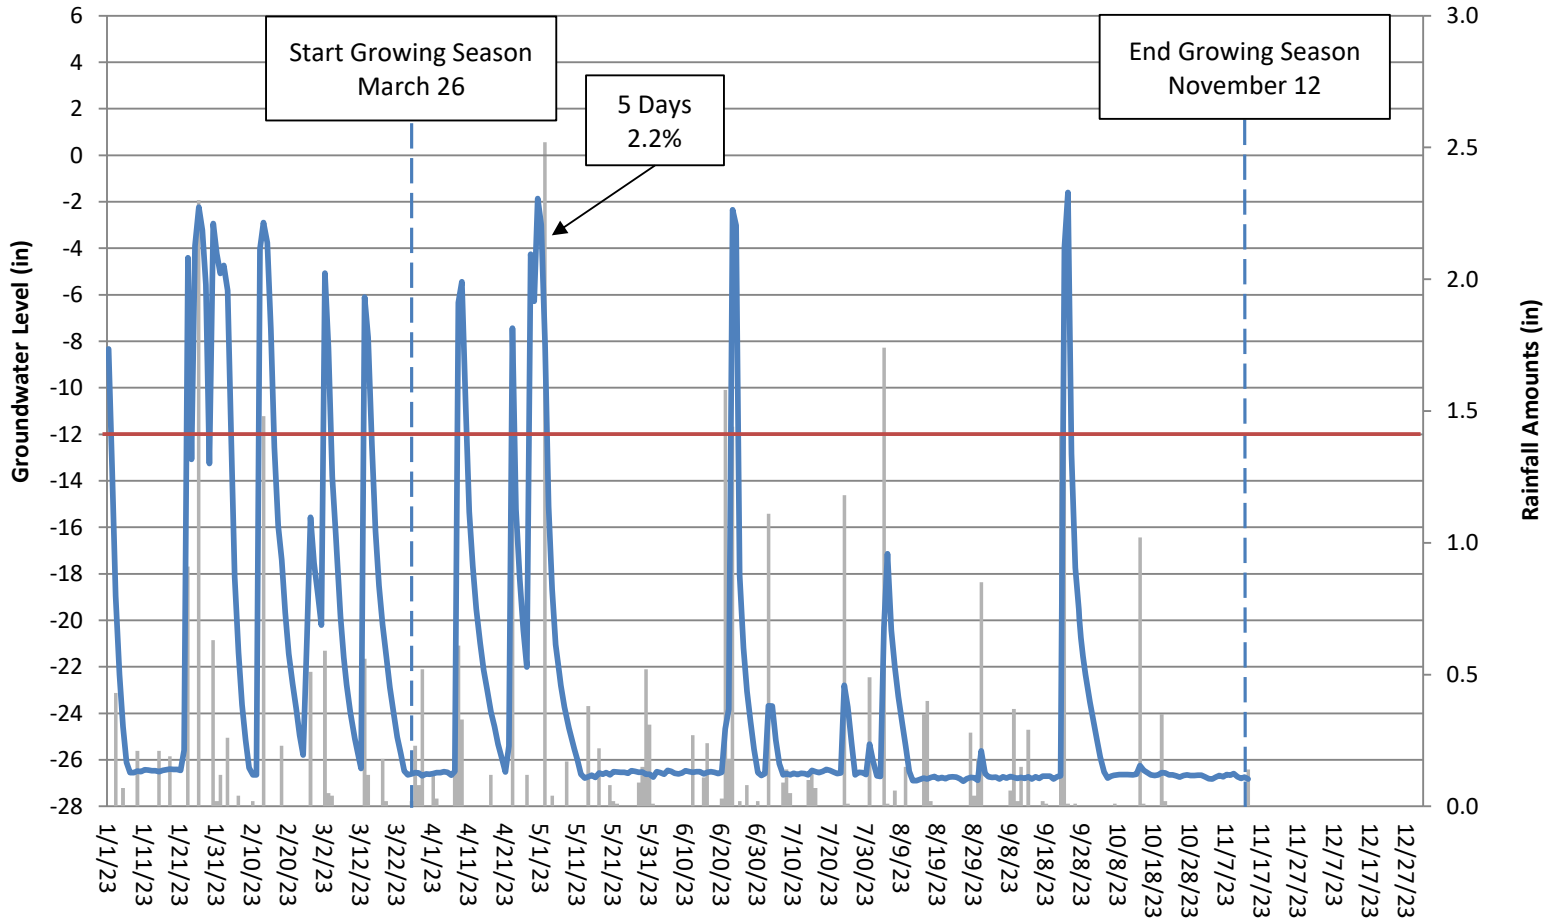
Pierce Terrace Groundwater Gauge 3 Year 1 (2023 Data)

Non-riverine Wet Hardwood Forest - Wetland Hydroperiod Success Criteria is 10% of Growing Season

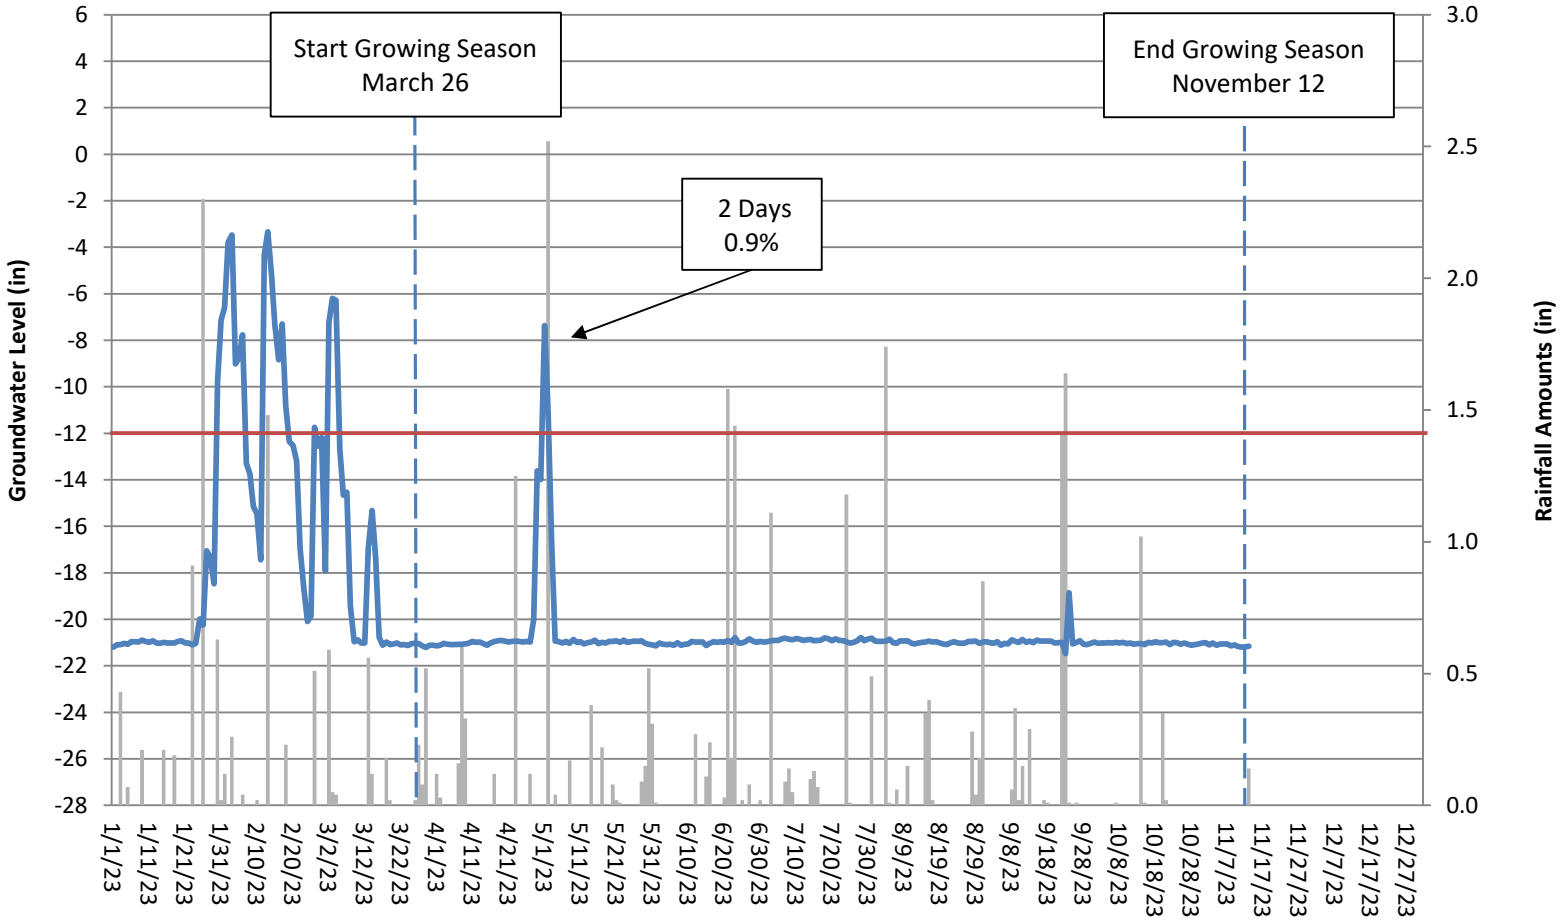
Pierce Terrace Groundwater Gauge 25 Year 1 (2023 Data)

Non-riverine Swamp Forest - Wetland Hydroperiod Success Criteria is 12% of Growing Season

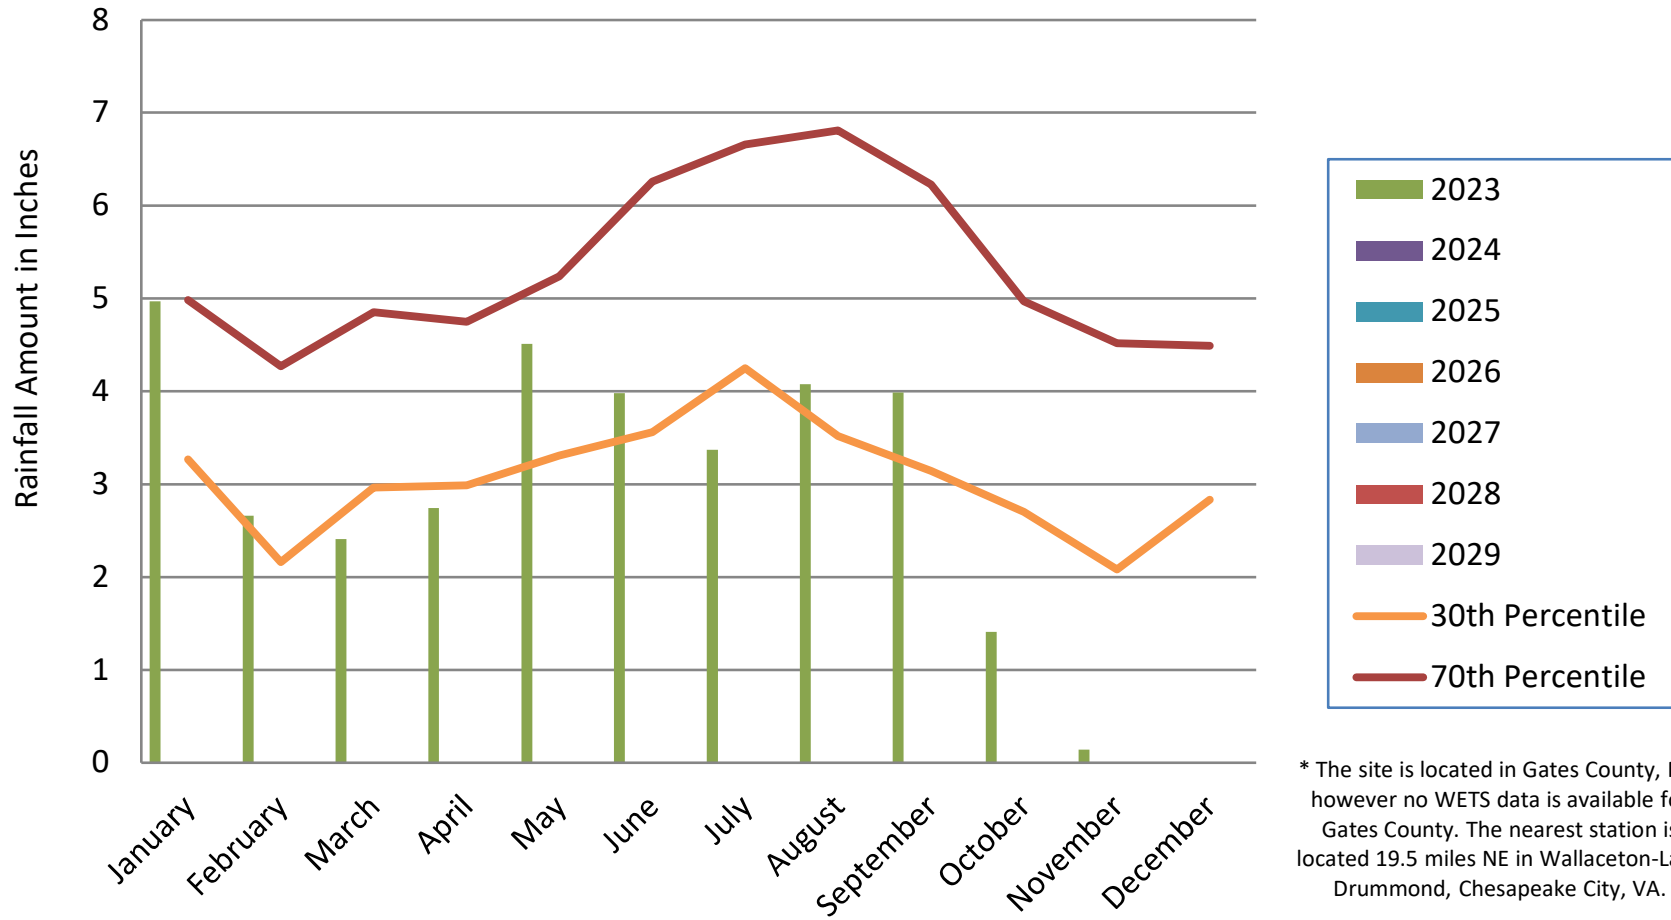
Figure C1: Pierce Terrace 30-70 Percentile Graph for Rainfall

30-70th percentile data from WETS Station: Wallaceton-Lake Drummond, VA*

* The site is located in Gates County, NC, however no WETS data is available for Gates County. The nearest station is located 19.5 miles NE in Wallaceton-Lake Drummond, Chesapeake City, VA.
