MYO FINAL MONITORING REPORT

PIERCE TERRACE WETLAND MITIGATION SITE

Gates County, North Carolina
Chowan River Basin
Cataloging Unit 03010203 & 03010204

Data Collection: January 2023–March 2023
Submission: April 2023

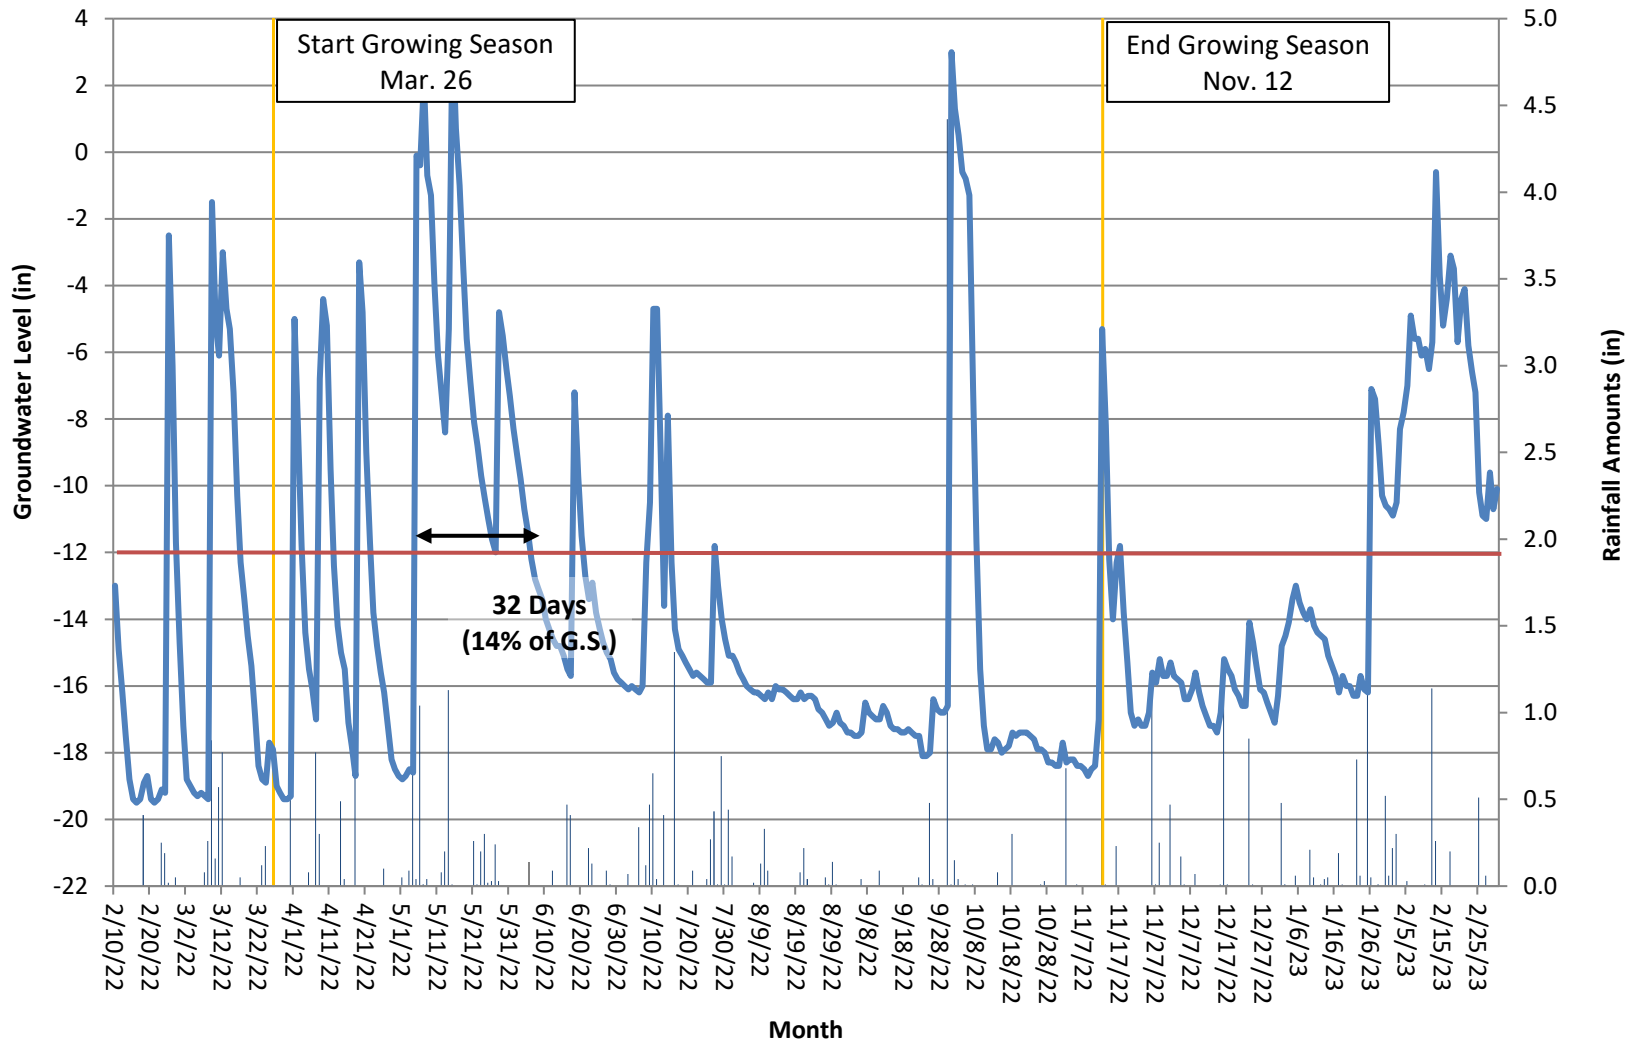
Pierce Terrace Groundwater Gauge 3 Pre-con (2022-23 Data)

Non-riverine Swamp Forest - Wetland Hydroperiod Success Criteria is 12% of Growing Season

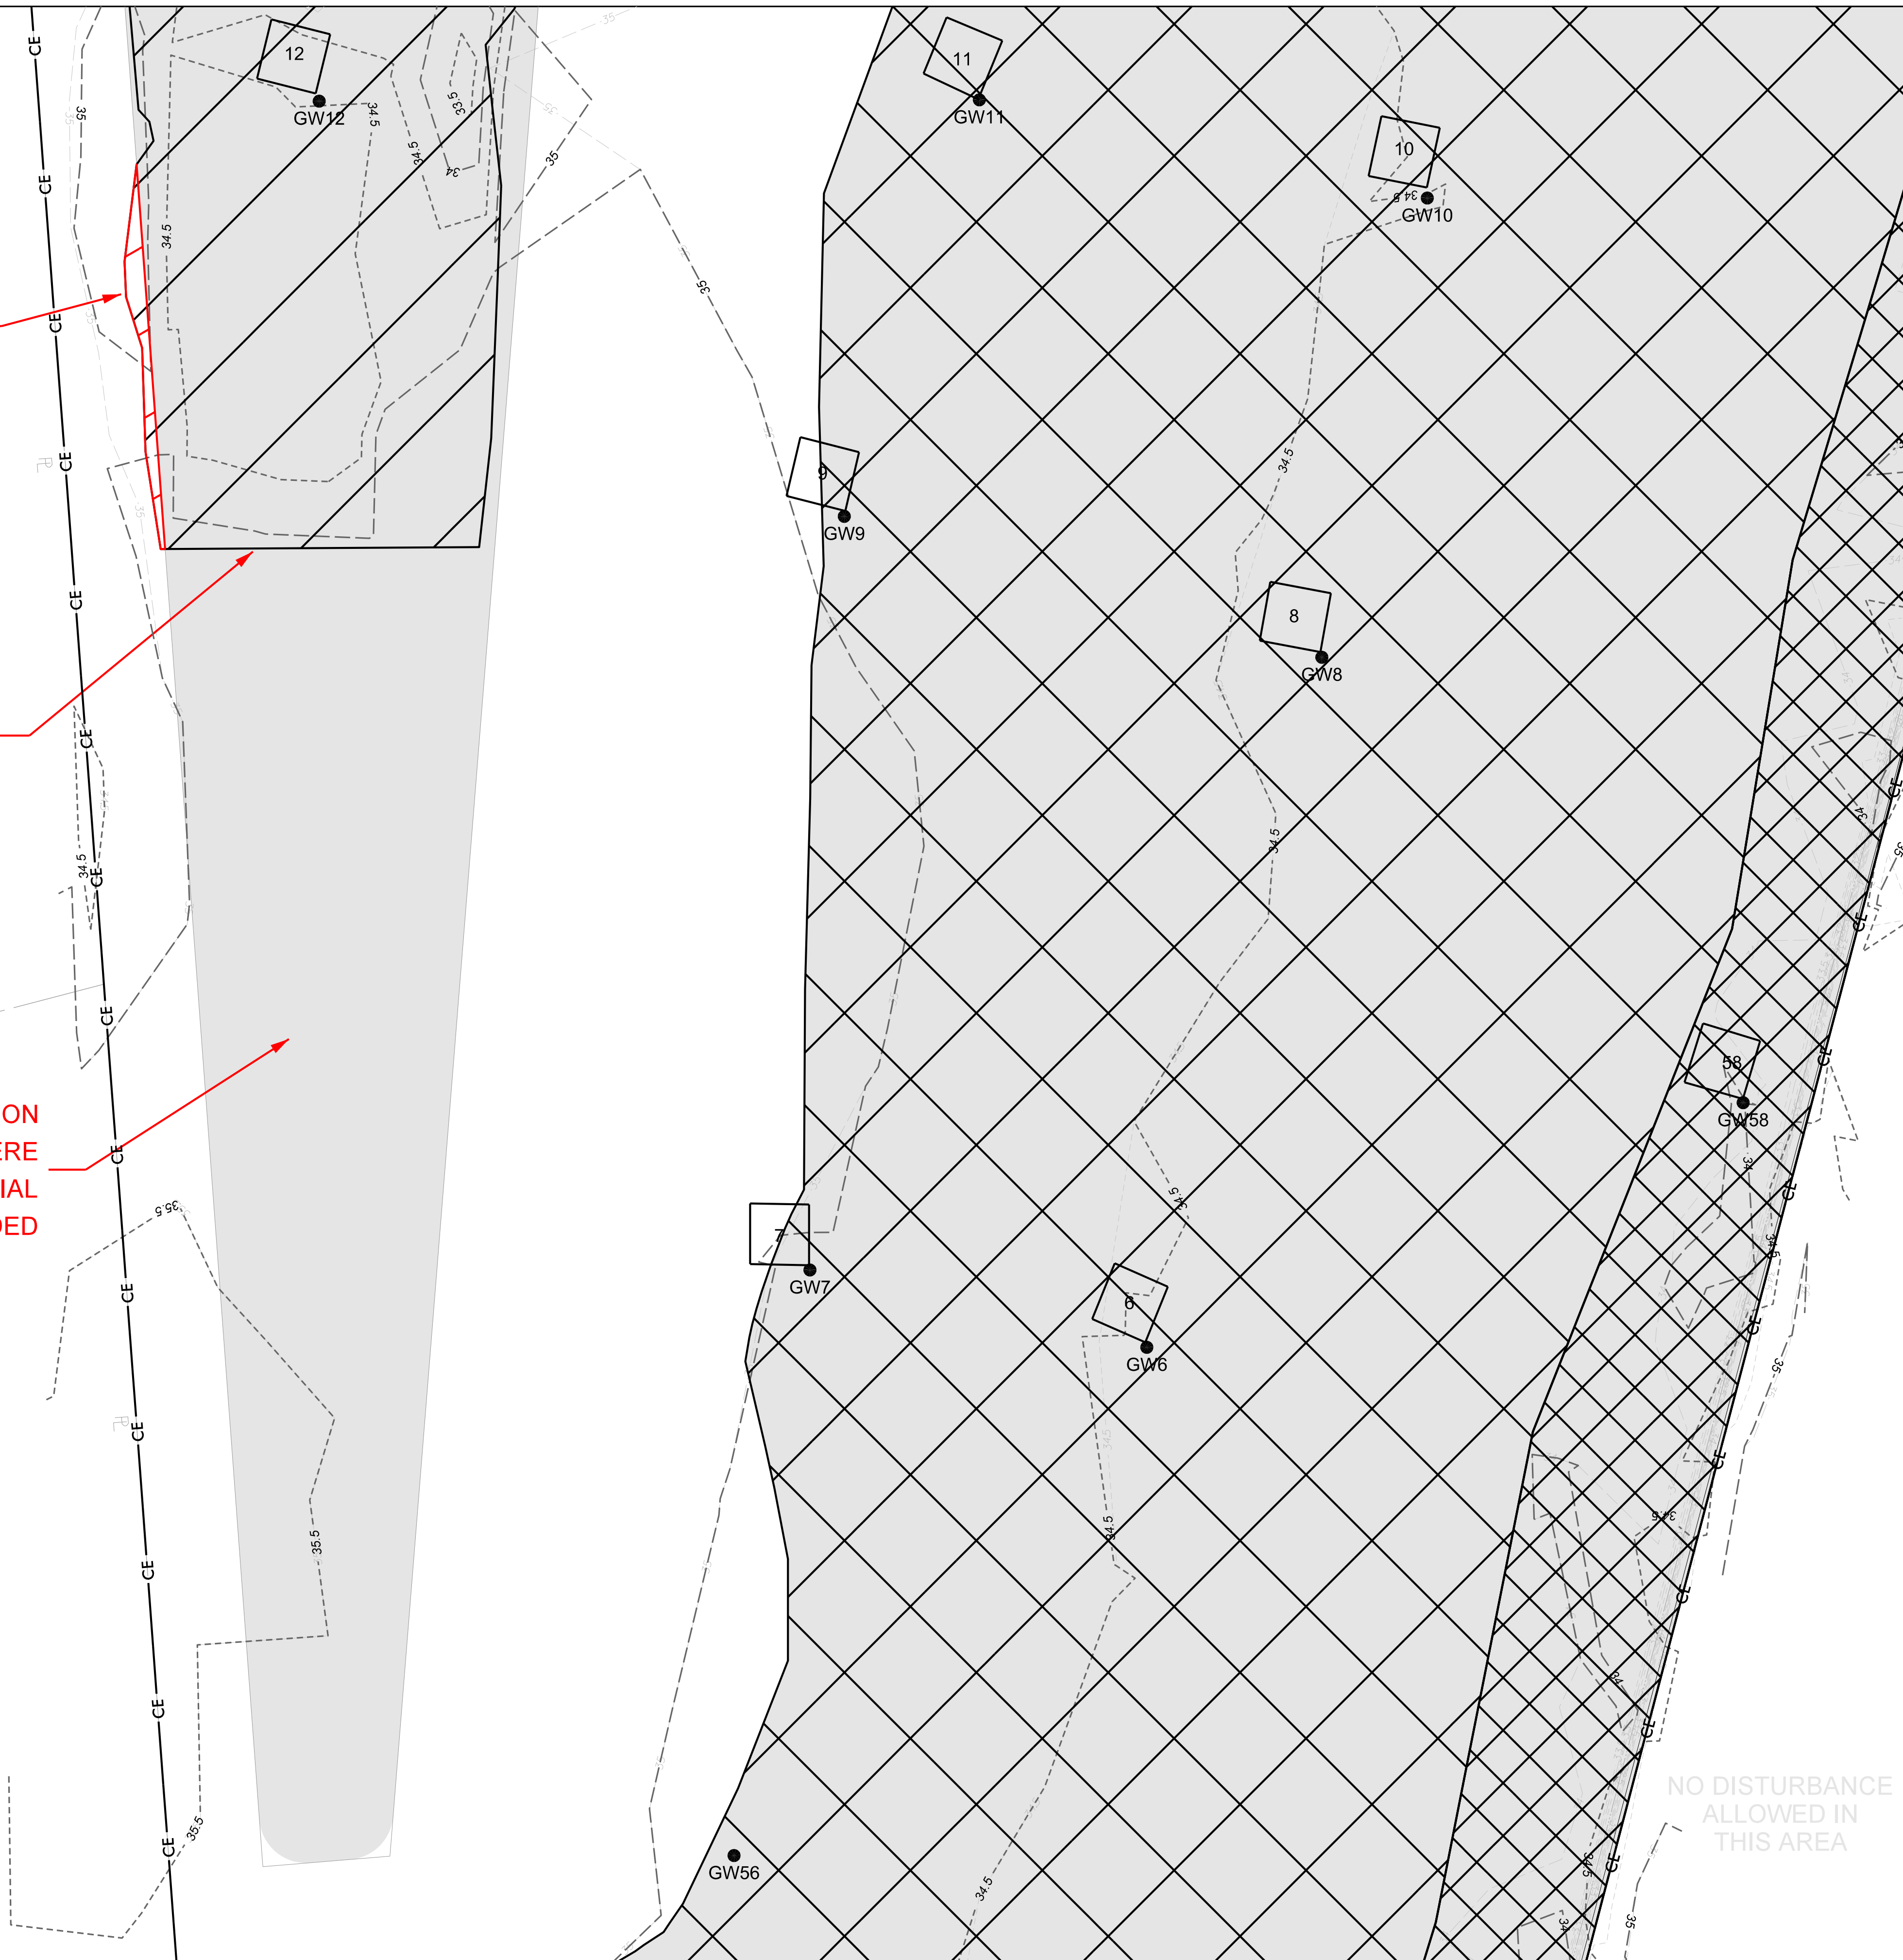
WETLAND CREATION
REMOVED HERE
AS BORROW MATERIAL
WAS NOT NEEDED

NO DISTURBANCE
ALLOWED IN
THIS AREA
