STREAM AND RIPARIAN RESTORATION PLAN
PLEMMONS/KIRKPATRICK MITIGATION SITE
SPRING CREEK, MADISON COUNTY

North Carolina Wildlife Resources Commission
Division of Inland Fisheries
Watershed Enhancement Group

December 2005

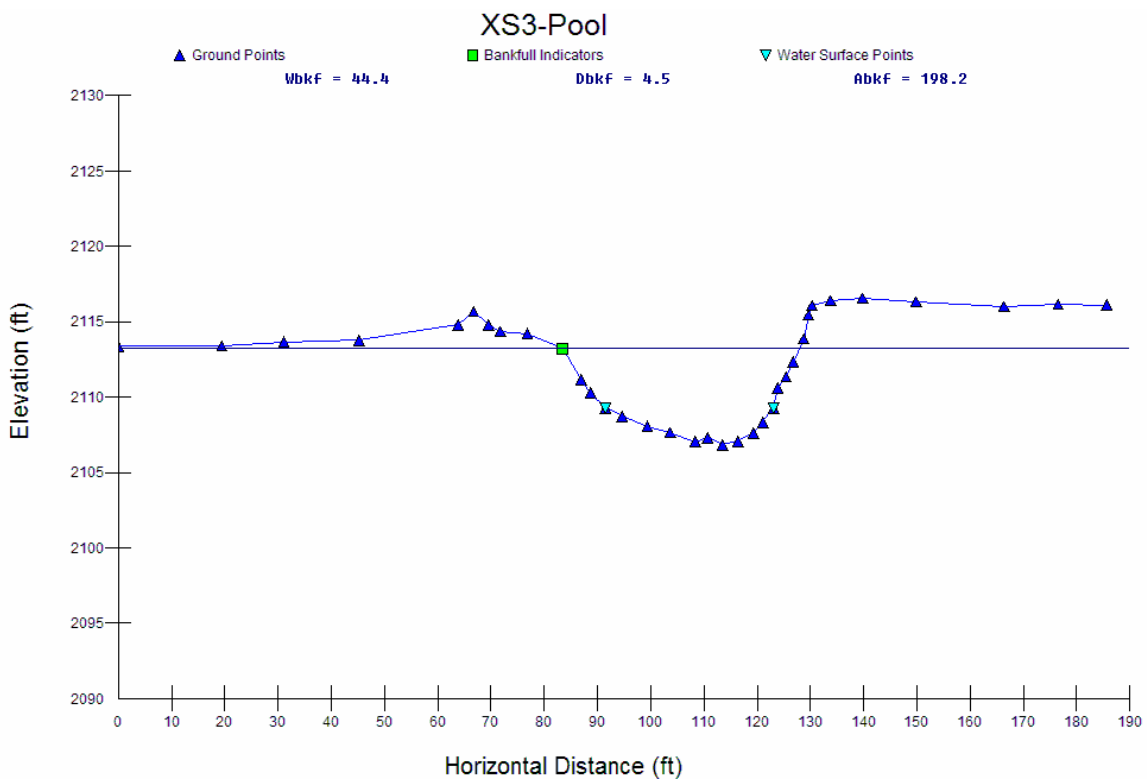
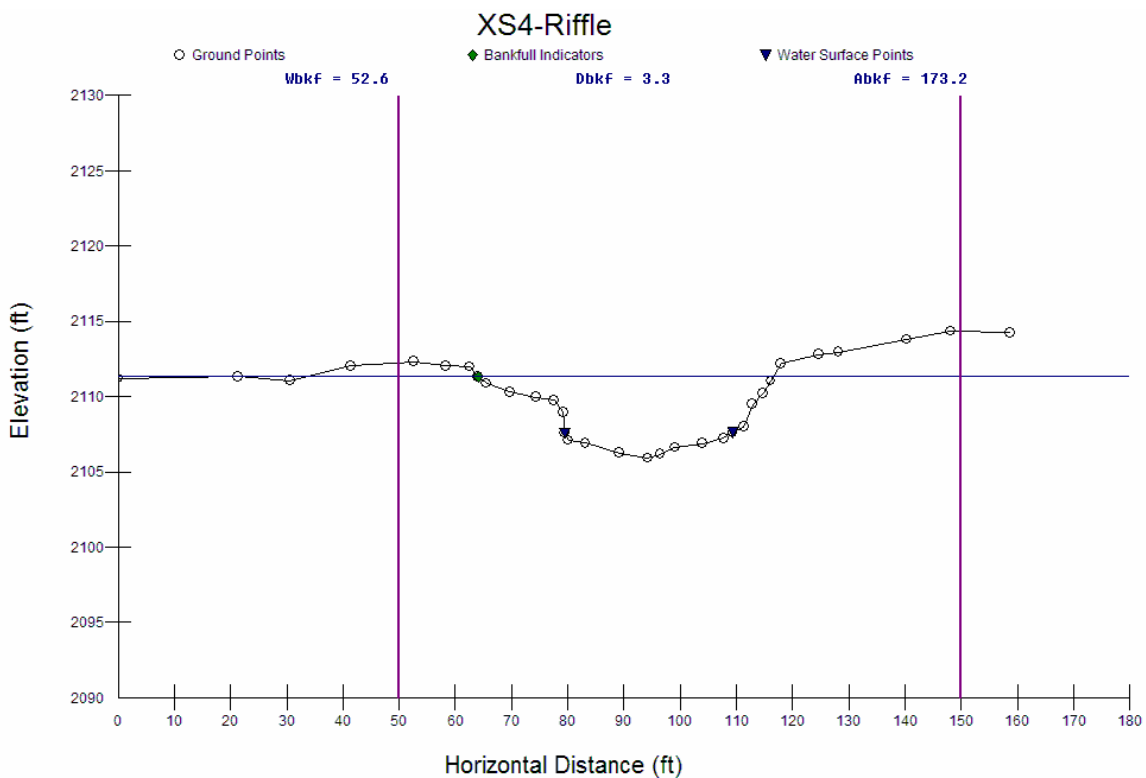
FIGURE 3.—Continued.

FIGURE 3.—Existing channel dimensions of four cross sections within the project reach of the Plemmons/Kirkpatrick mitigation site, Spring Creek, French Broad River drainage, Madison County. Vertical lines define the horizontal extent of the bankfull calculations. The horizontal line is the bankfull elevation.

Four cross-sections were surveyed to evaluate existing channel dimensions (Figure 3; Appendix 1). Bankfull was determined using field indicators that included a scour line along the bank, terraces, and the existing floodplain. The bankfull stage obtained from these measurements was evaluated using regional curve information (Harman et al. 1999; Doll et al. 2002). The cross-section at station 6+73 (cross section 4) was used as a representative of this reach. Bankfull width at this cross-section was 52.6 ft, bankfull depth was 3.3 ft, and cross-sectional area was 173.2 ft². The measured cross-sectional area for this reach was slightly lower than that predicted by the mountain regional curve. This is fairly typical for streams in Madison County as they generally fall below the mountain regional curve (M. Clemmons, Buck Engineering, personal communication).

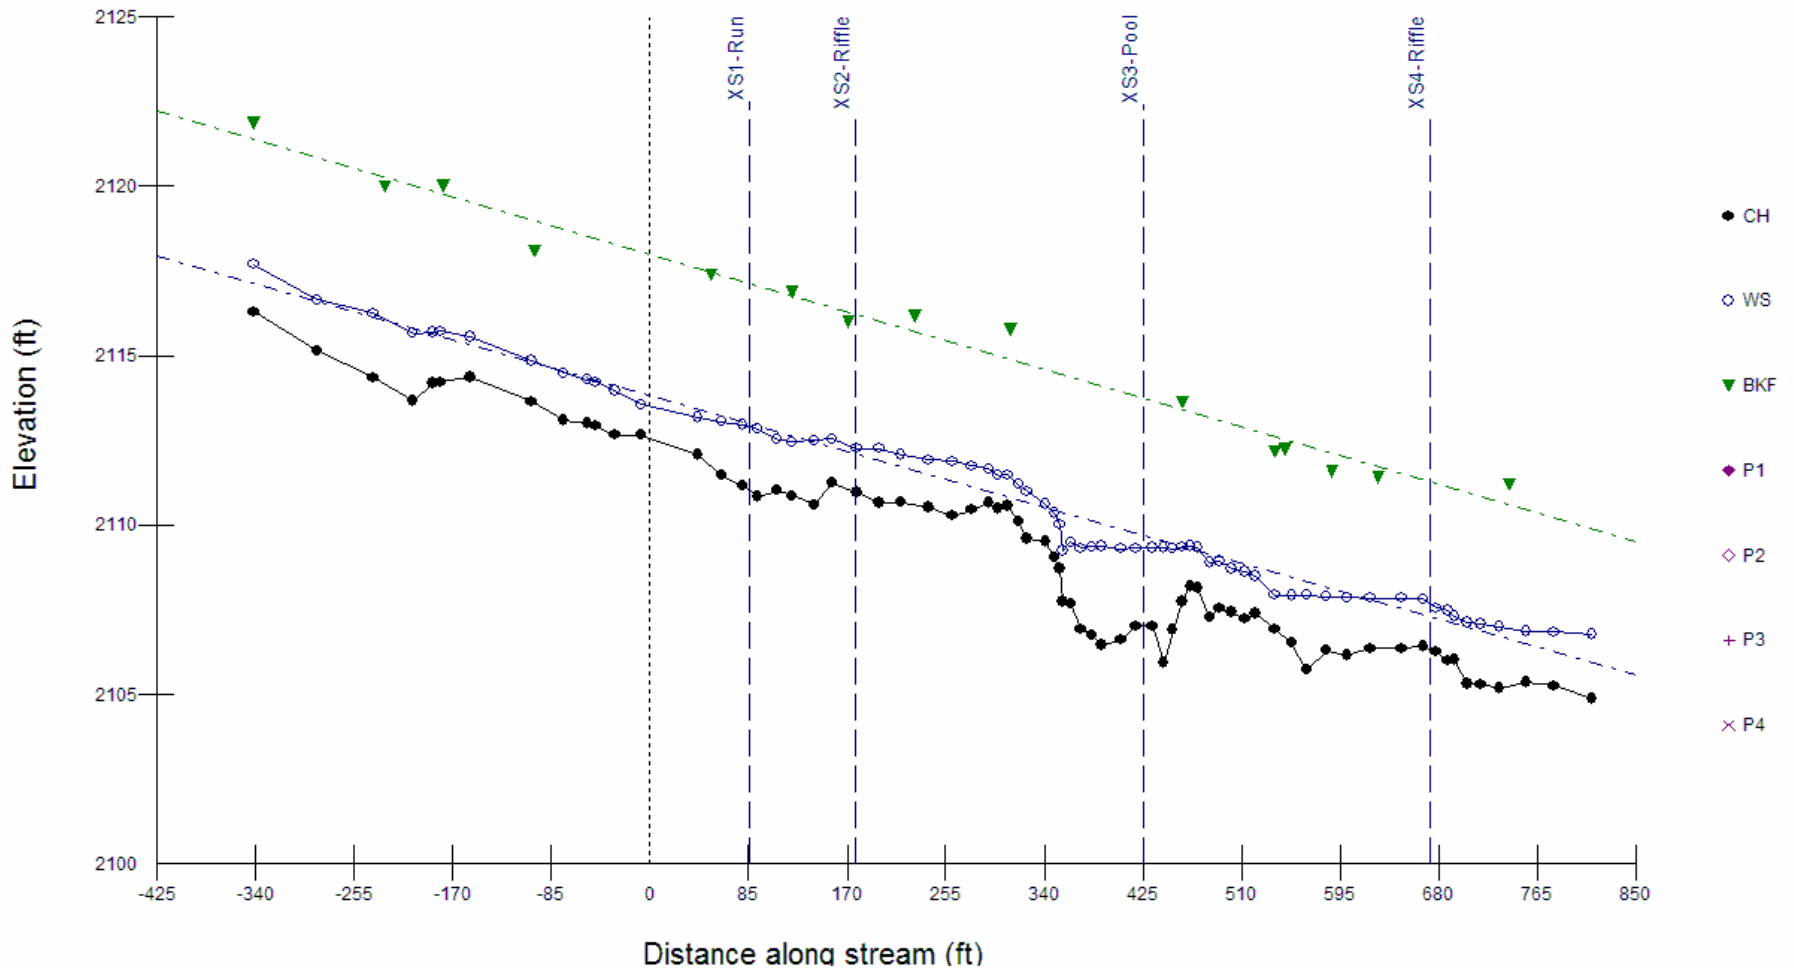
FIGURE 4.—Existing longitudinal profile at the Plemmons/Kirkpatrick mitigation site, Spring Creek, French Broad River drainage, Madison County. The locations of cross-sections relative to their station along the longitudinal profile are shown. Dashed line at station 0+00 represents upper project boundary.

The longitudinal profile of the reach was surveyed from a point approximately 300 ft upstream of the SR 1151 bridge and continuing to a point approximately 100 ft downstream of the property line (Figure 4). The location and length of riffles, runs, pools, and glides were measured along the profile. The project reach does not consist of a full meander wavelength. The upstream meander is constricted laterally and, therefore, not well developed. Channel straightening, dredging, and the placement of the SR 1151 bridge have likely altered the natural pattern. The upper half of the project reach is dominated by riffles and runs. A single over-sized pool exists between stations 4+00 and 4+70. The size of the pool has been exaggerated by the presence of several large boulders, automobile bodies, and a school bus. These structures form a “pinch” or choke point in the channel that causes instability of the right stream bank just downstream of the bus. Downstream of the bus for approximately 100 linear feet the outside (right) bank is vertical and sloughing. Down valley channel meander migration appears to be occurring at the downstream end of the pool. The channel is attempting to re-establish a

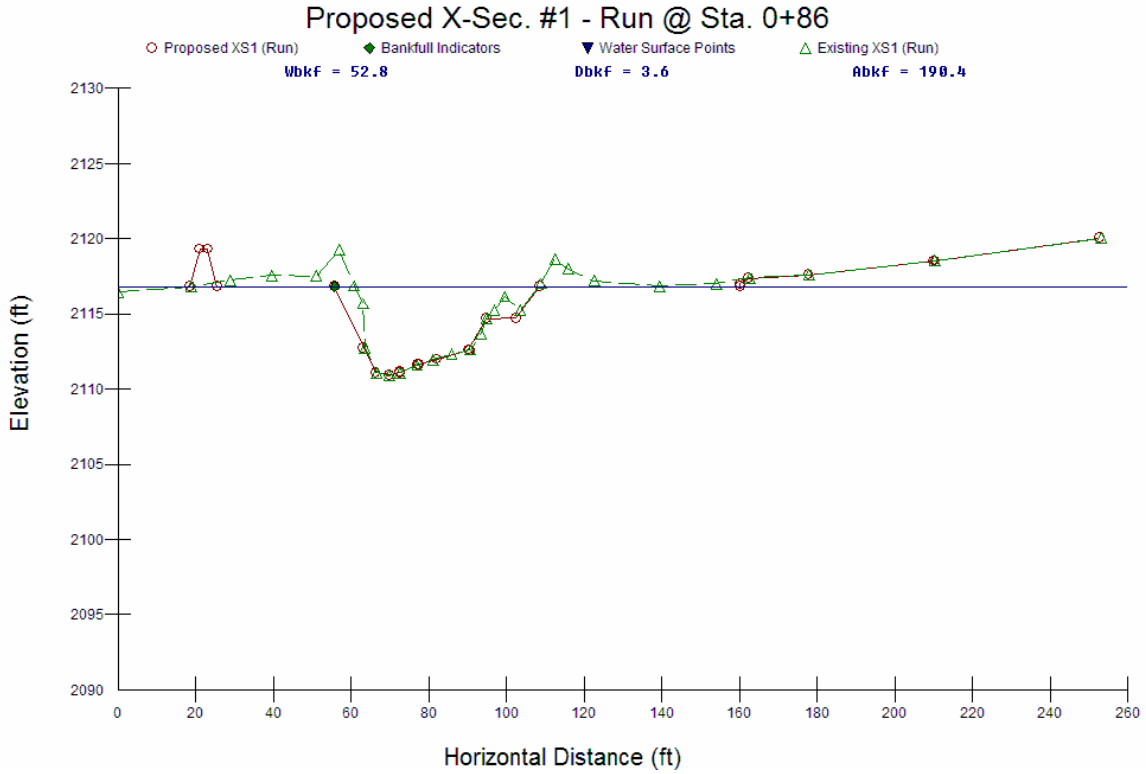
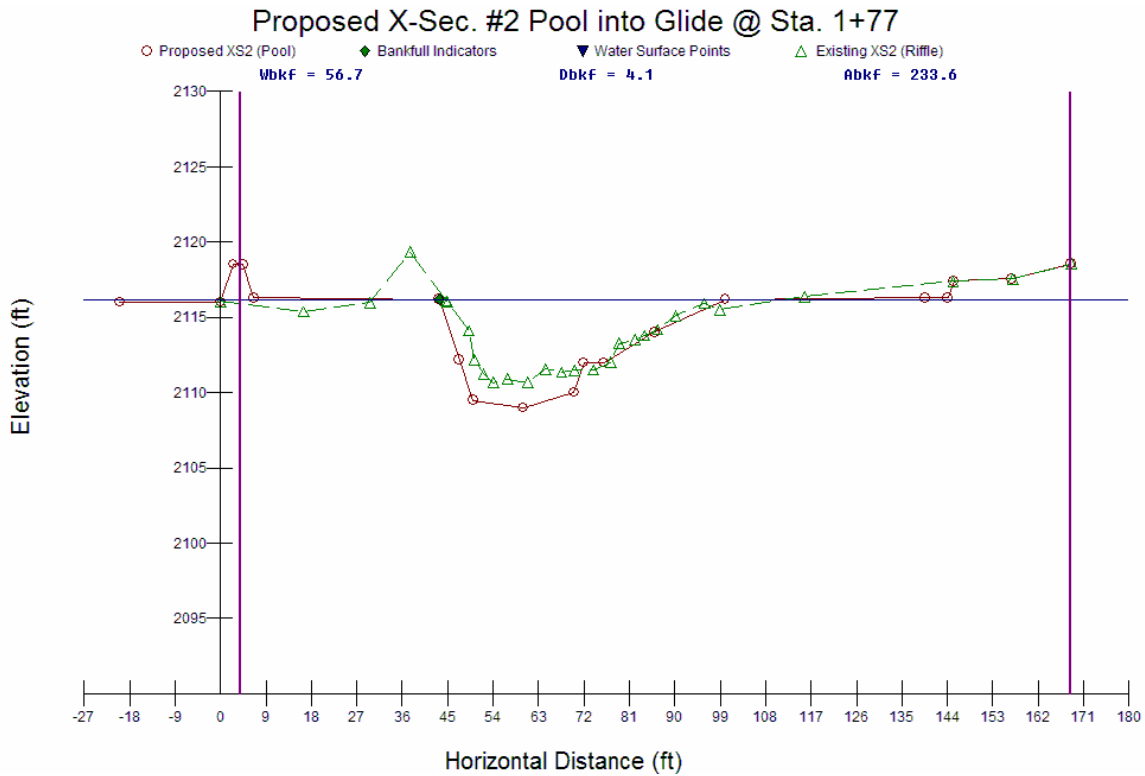
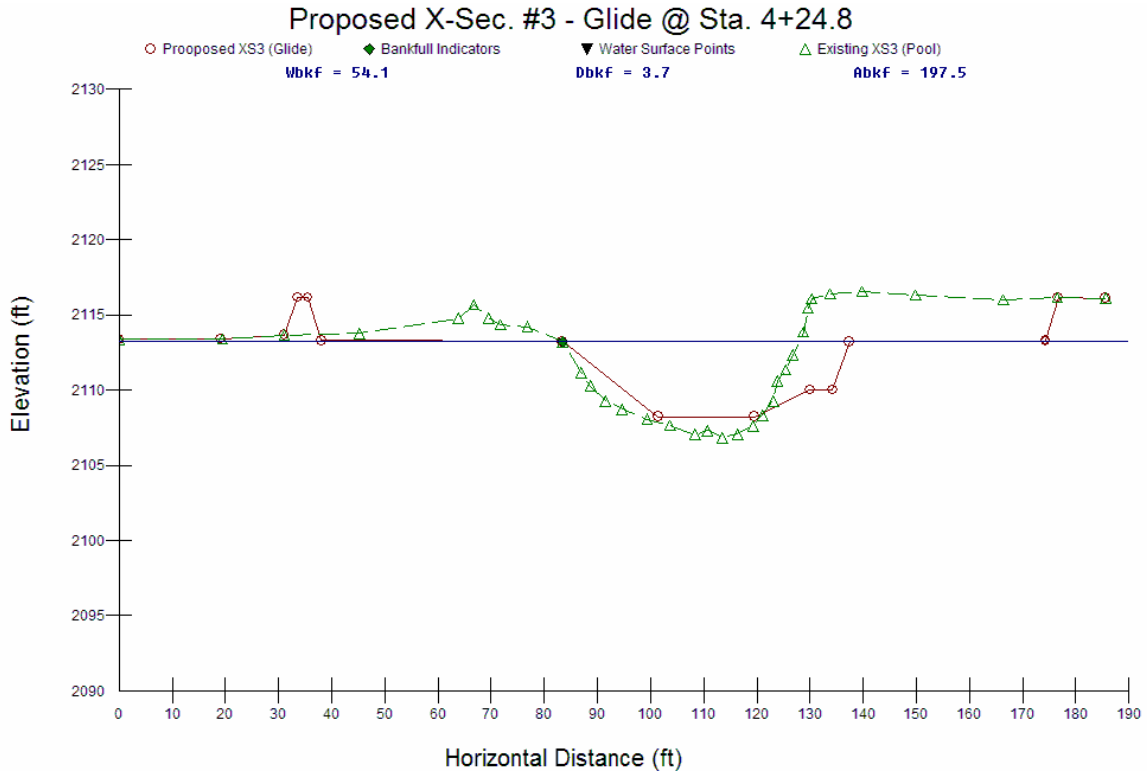
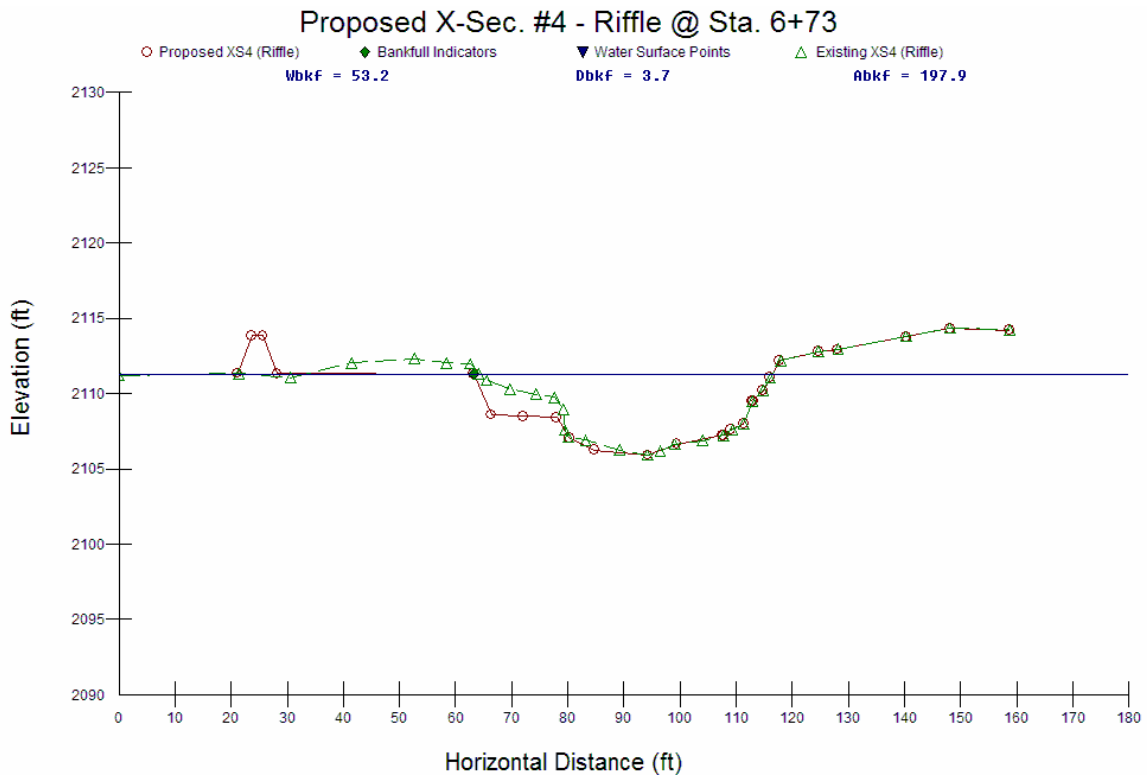
FIGURE 6.—Continued

FIGURE 6.—Proposed channel dimensions at the four cross sections within the project reach, Plemmons/Kirkpatrick mitigation site, Spring Creek, French Broad River drainage, Madison County. Vertical lines (X-sec 2, only) define the horizontal extent of the bankfull calculations. The horizontal line is the bankfull elevation.

The proper channel dimensions will be re-established for the entire project reach (Figure 6). All depths are relative to the bankfull elevation. Constructed riffles associated with the J-hooks will have a design mean depth of 3.6 ft, maximum depth of 5.4 ft, width of 54.0 ft, and width/depth ratio of 14.3 (Table 2). The invert depth of all J-hook structures will be 4.75 ft (0.9 times the maximum depth). Pools will have a mean depth of 4.1 ft and a maximum depth of 7.2 ft. Runs and glides will be transitional features between riffles and pools.

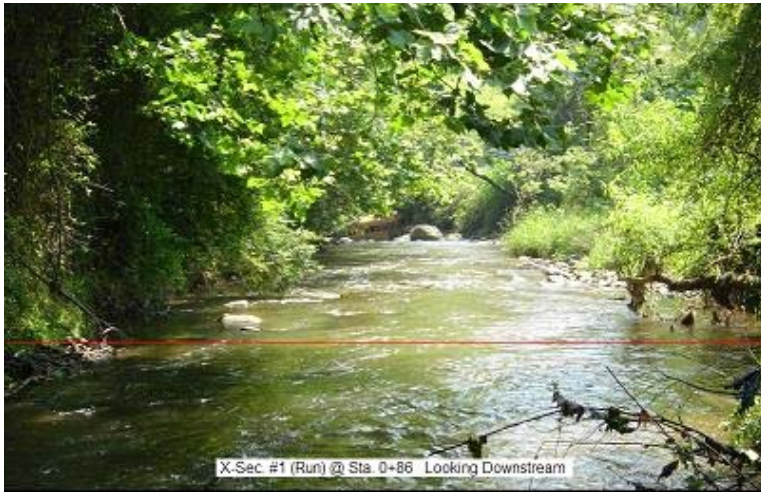
A1.1.—Cross-section 1, sta. 0+86, run, looking downstream.

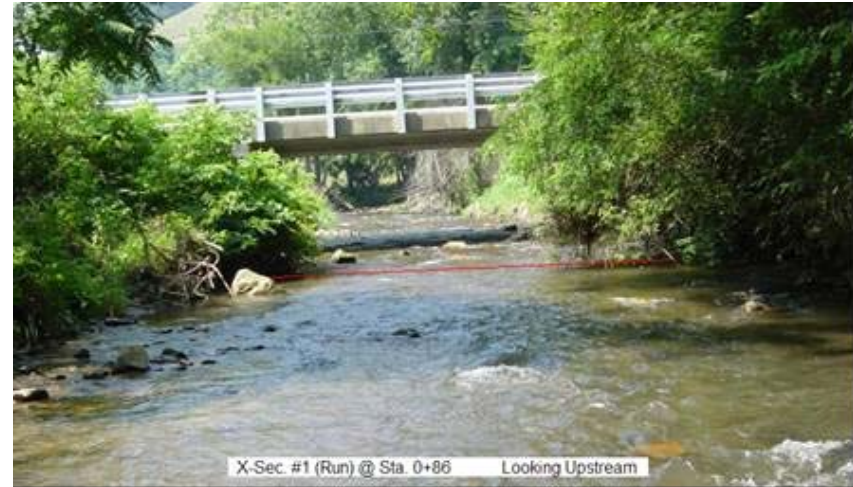
A1.2.—Cross-section 1, sta. 0+86, run, looking upstream.

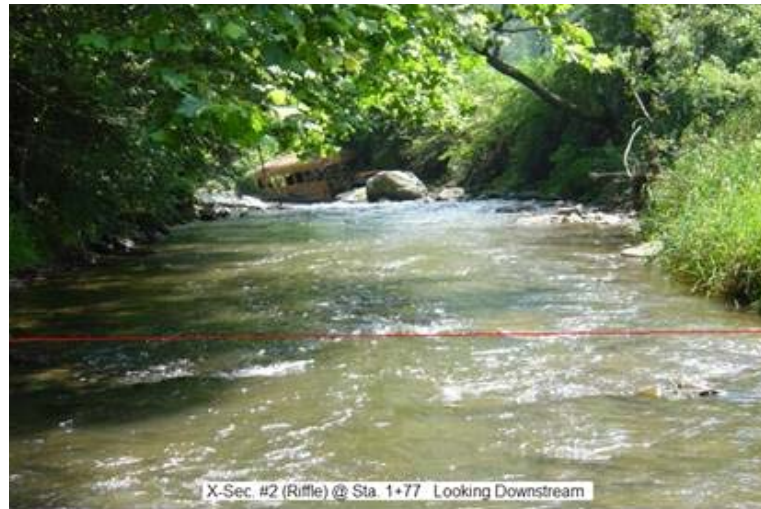
A1.3.—Cross-section 2, sta. 1+77, riffle, looking downstream.

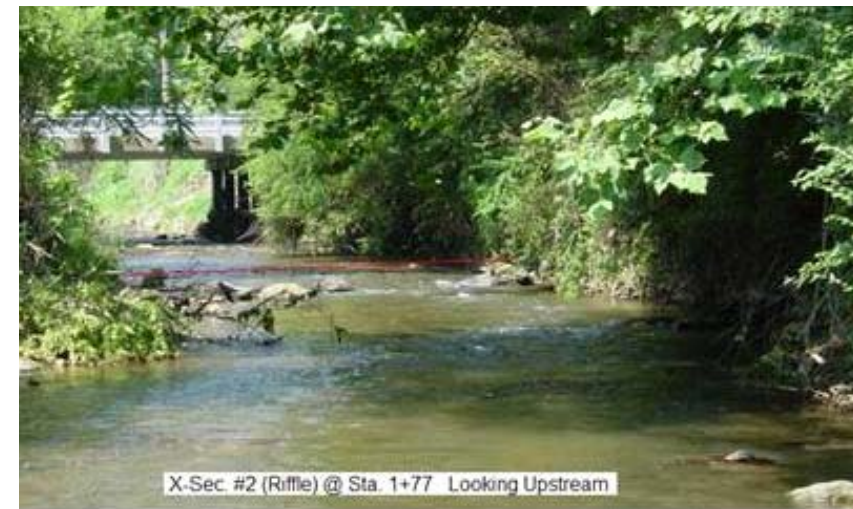
A1.4.—Cross-section 2, sta. 1+77, run, looking upstream.

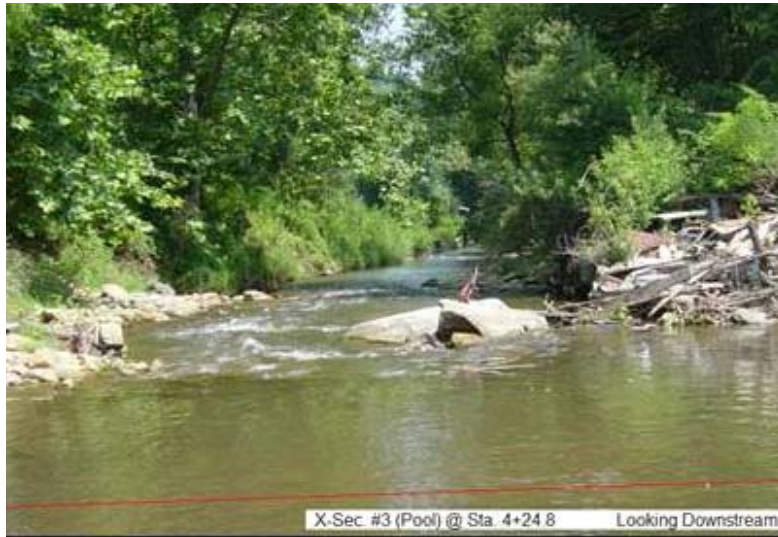
A1.5.—Cross-section 3, sta. 4+24.8, pool, looking downstream.

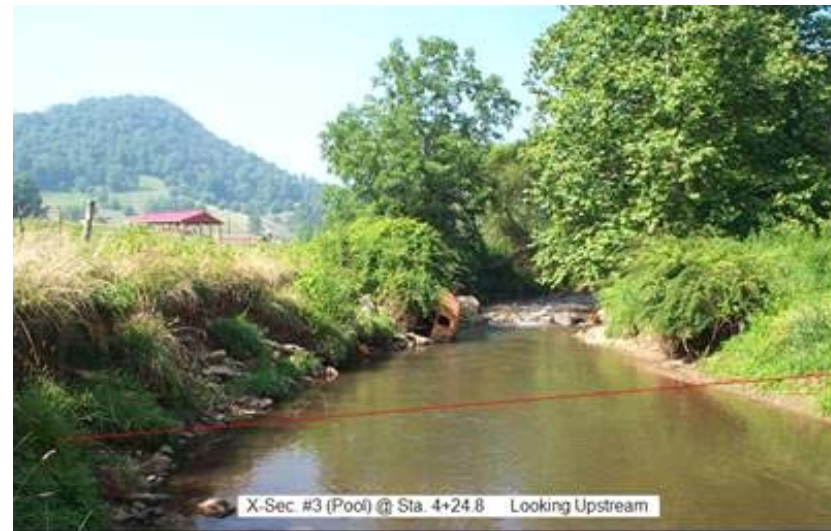
A1.6.—Cross-section 3, sta. 4+24.8, pool, looking upstream.

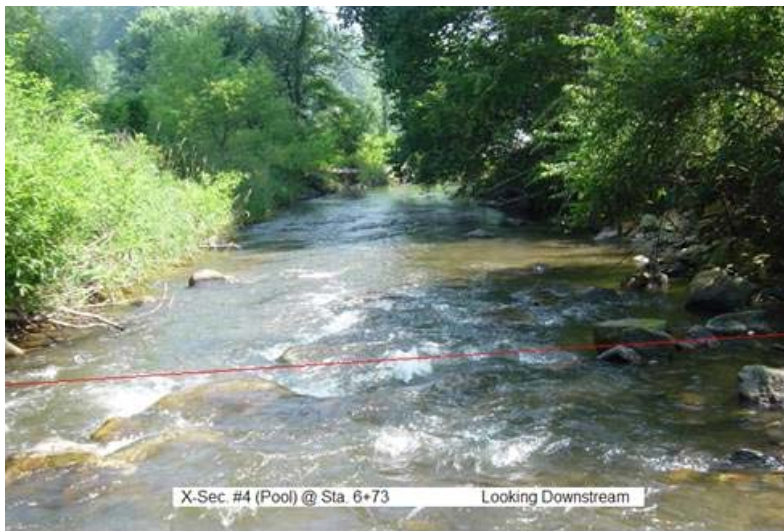
A1.7.—Cross-section 4, sta. 6+73, riffle, looking downstream.

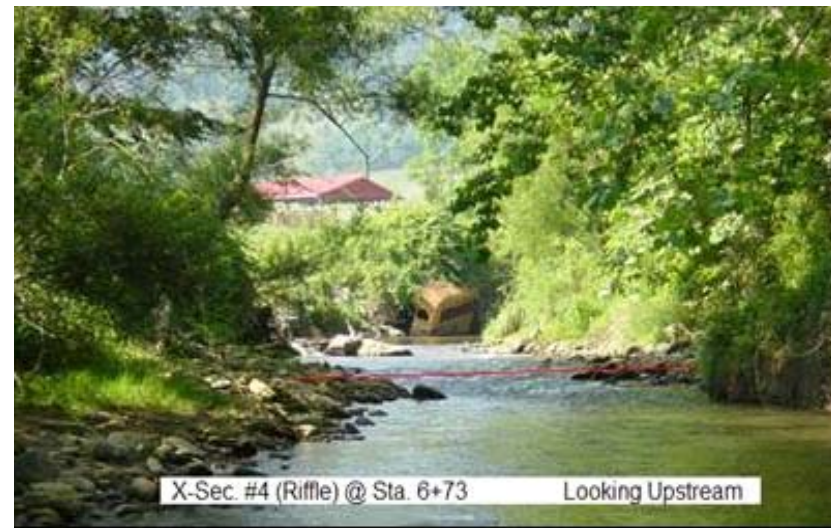
A1.8.—Cross-section 4, sta. 6+73, riffle, looking upstream.

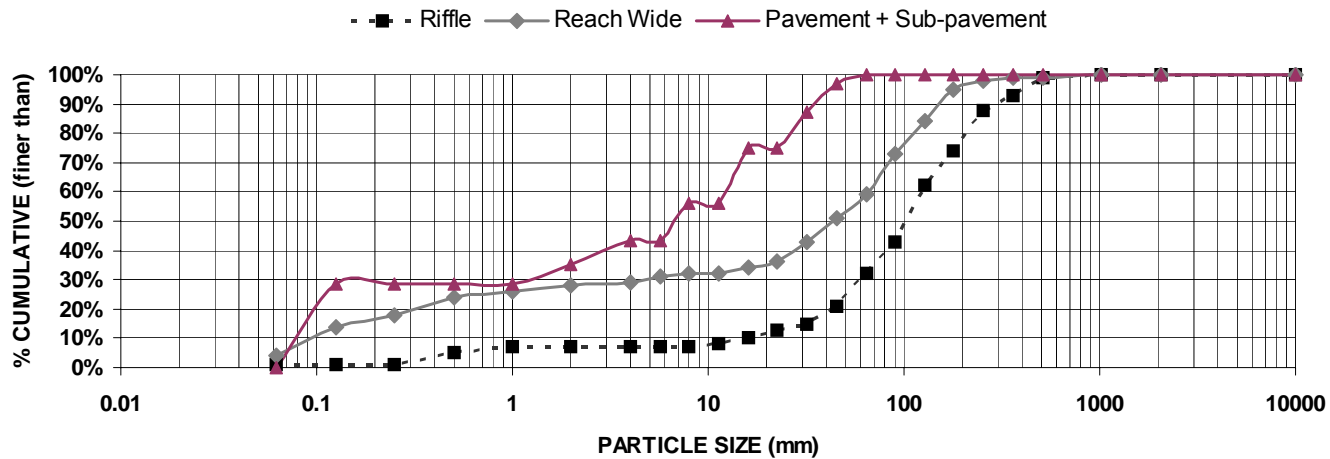
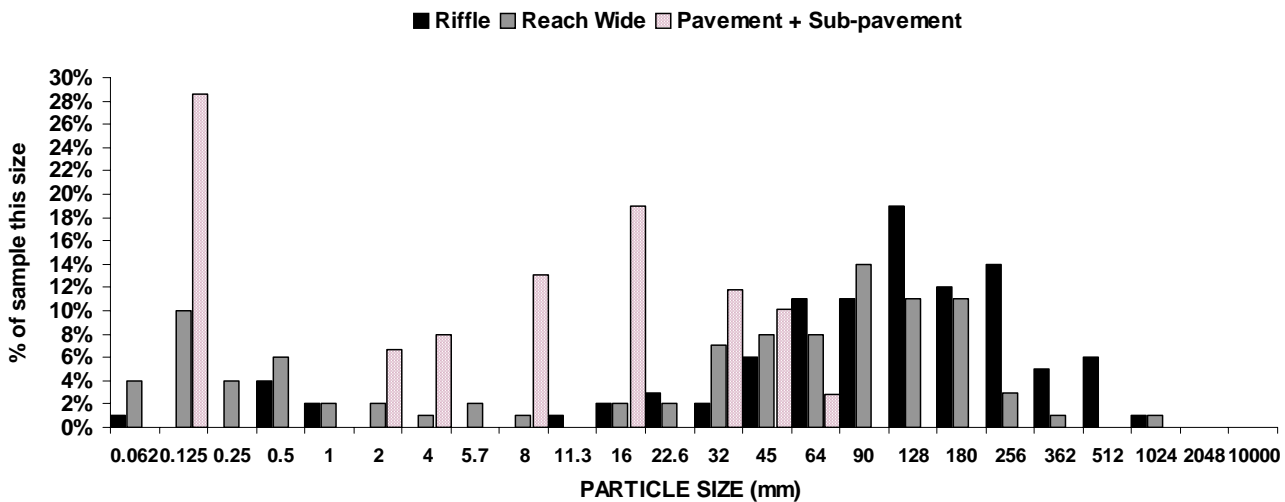
Appendix 2: Pebble count and bed material (pavement and sub-pavement) particle size data from the Plemmons/Kirkpatrick mitigation site, Spring Creek, French Broad River drainage, Madison County.

A1.—The top graph shows the cumulative percent finer than a specific particle size. The bottom graph shows the percent of the sample within a specific particle size range.

Pebble count data indicate that 50 percent (D_{50}) of the particles observed in the riffle were small cobble (104 mm) or finer, as measured on the intermediate axis (Table 1). However, the D_{50} particle size observed in the reach-wide and pavement/sub-pavement surveys indicate that the mean particle size was within the gravel category, 43 mm and 20 mm. This is likely due to a higher percentage of smaller particles found in the pool counts used for the reach wide survey as well as in the pavement and sub-pavement collections. The percent of particles by substrate class indicates again that cobble is the dominant component (56%) in the riffle sample, with gravel the primary component in the reach-wide (31%) and pavement/sub-pavement (57%) samples. There are no outcroppings of bedrock at this site; although several large boulders are present. The cumulative percent of particles finer than a specific particle size and the number of individual particles by sizes are summarized in Appendix 2.

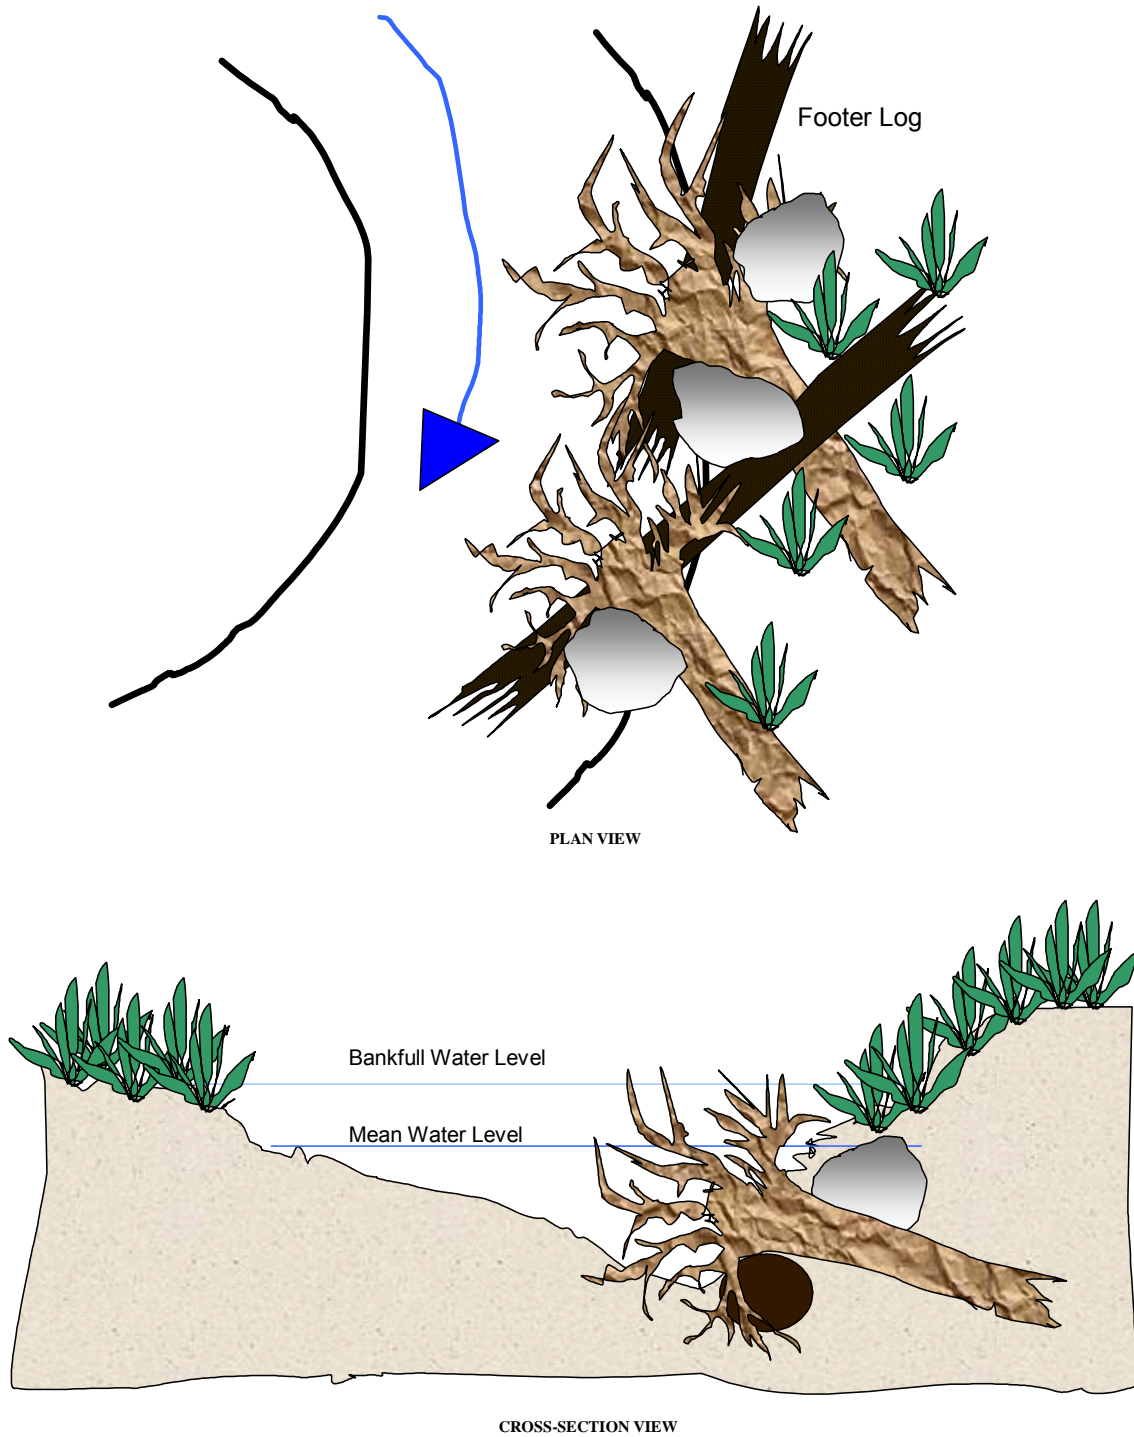
A3.2.—Typical root-wad structure showing plan and cross section views.

- 13) Install root-wads at locations shown on design drawing to provide added bank protection and enhance aquatic habitat.
- 14) Complete any final floodplain sloping, replant salvaged trees and shrubs, install bare-root, container grown and live stake plant material, seed any remaining disturbed areas with temporary and permanent seed mix. Inspect and add any needed erosion control practices.
