**PLUM CREEK WETLAND MITIGATION PROJECT  
2010 MONITORING REPORT  
MONITORING YEAR 2 OF 5**

**Brunswick County, NC  
Lumber River Basin  
Cataloging Unit: 03040207  
EEP Project Number D06040-A**

**2010 Monitoring Report – Year 2 of 5  
Final**

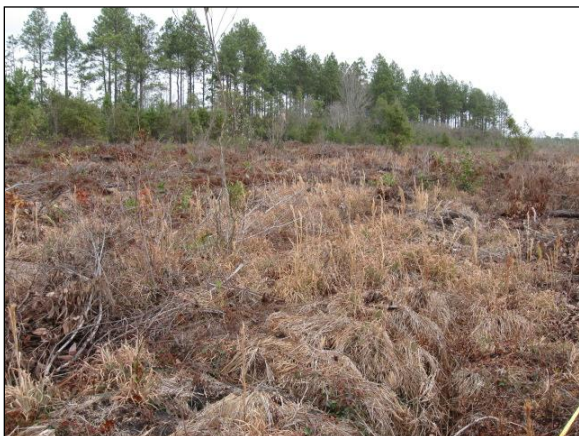
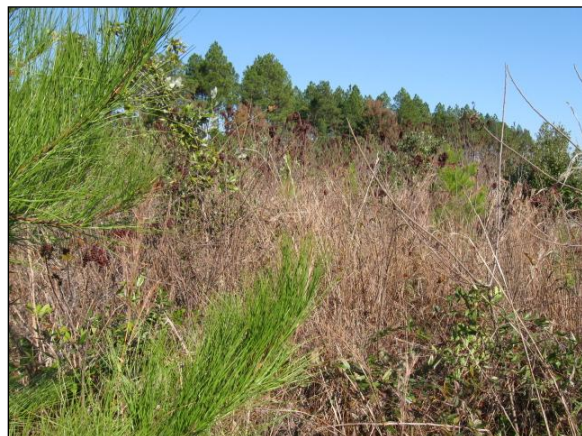
The Site met the vegetation survival rate success criteria in 8 of the 9 monitoring plots. The results from Year 1 had shown that three plots did not meet the criteria; Plots 4, 6, and 7. Year 2 monitoring results showed that Plots 4 and 7 now meet the criteria because stems that had been labeled missing in Year 1 or were not included in the As-Built inventory were located in Year 2. Plot 6 was one stem less than the 320 stems per acre target and therefore did not meet the criteria.

Veg Plot 6, view from southwest corner  
January 7, 2009

Veg Plot 6, view from southwest corner  
November 15, 2010

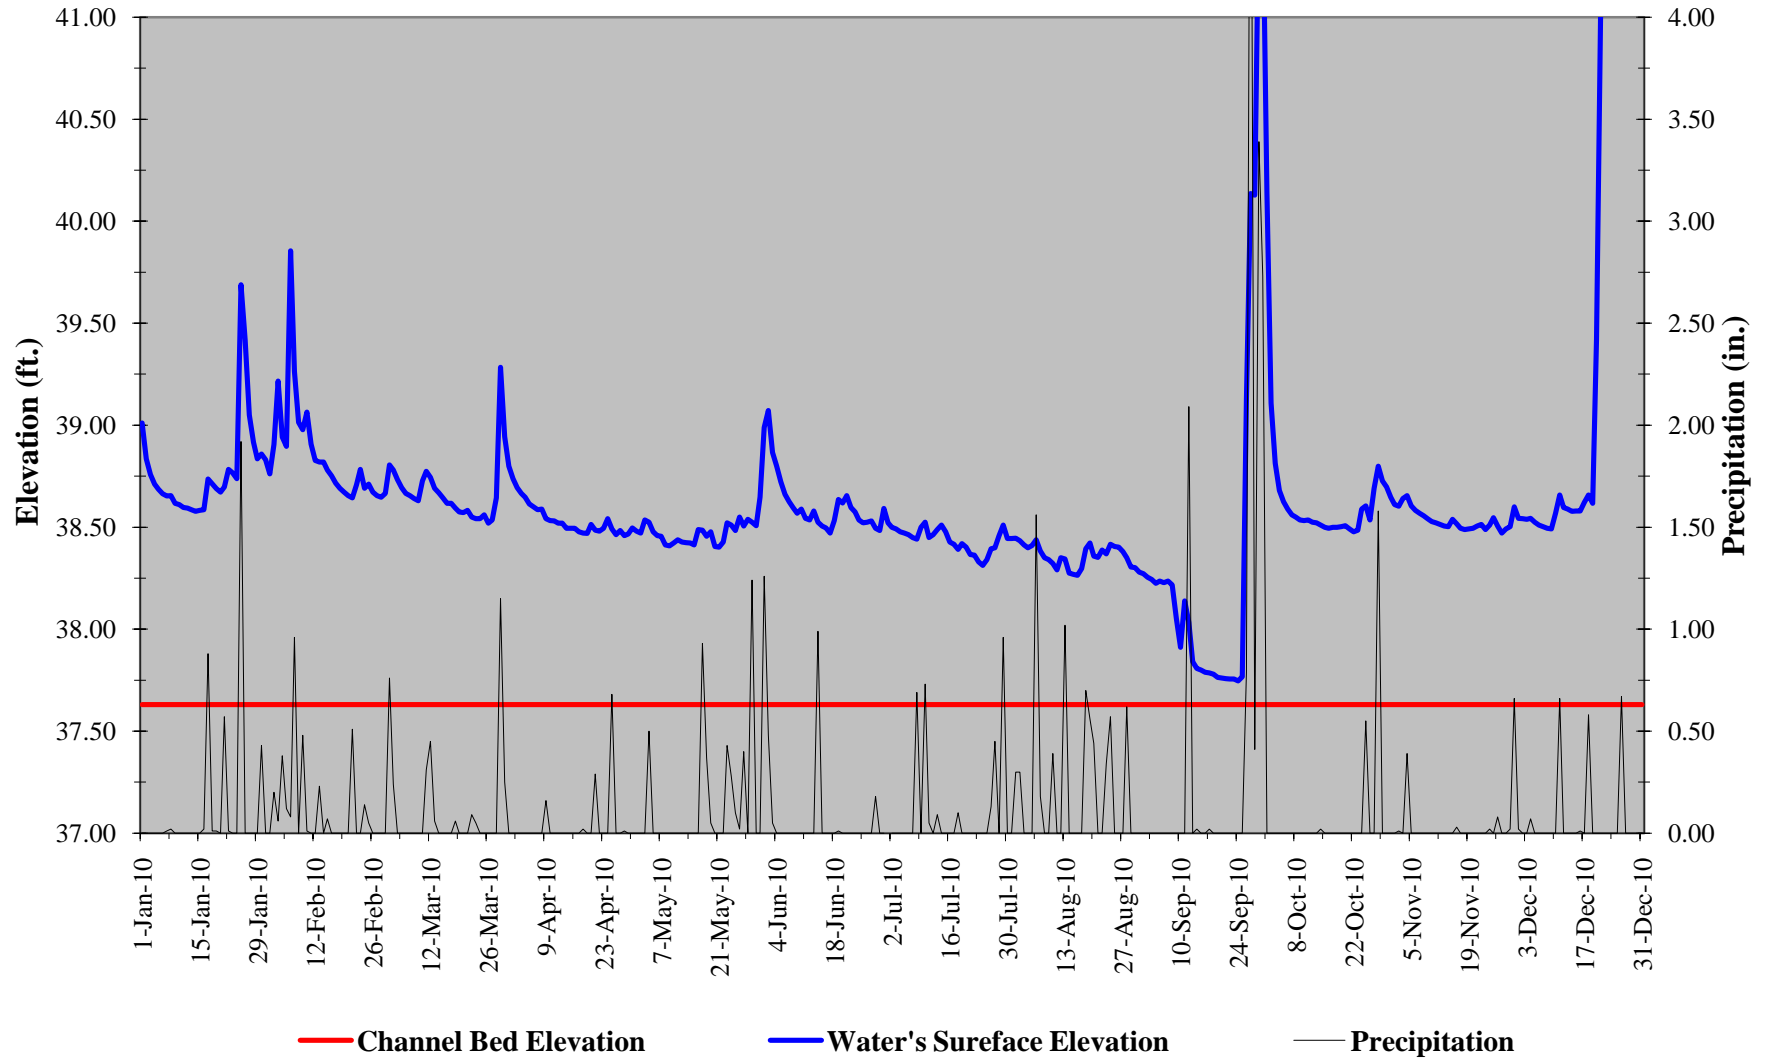
**Plum Creek Mitigation Site  
Stream Gauge SG-1 (Serial No. 9DE767F)**

A stream gauge was installed in Boggy Branch, within the property boundaries, for informational purposes only. The stream gauge will keep records of the level of water in Boggy Branch. No success criteria are attached to the gauge.
