**PLUM CREEK WETLAND MITIGATION PROJECT
2013 MONITORING REPORT
MONITORING YEAR 5 OF 6**

**Brunswick County, NC
Lumber River Basin
Cataloging Unit: 03040207
EEP Project Number: 92549
EEP Contract Number: D06040-A**

2013 Monitoring Report – Year 5 of 6

**Project Construction Completed: 2008
Data Collection for Monitoring Year 5 of 6: 2013
Report Submitted: September 2014**

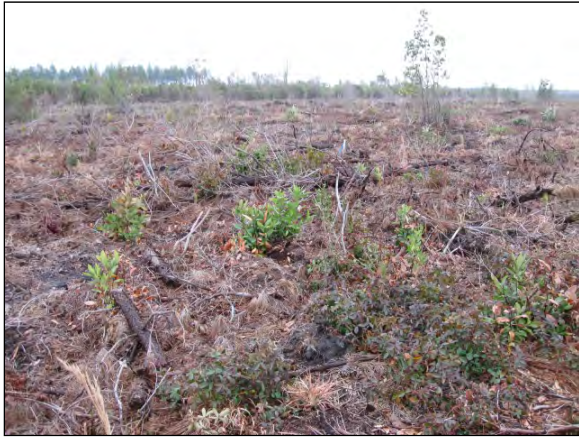
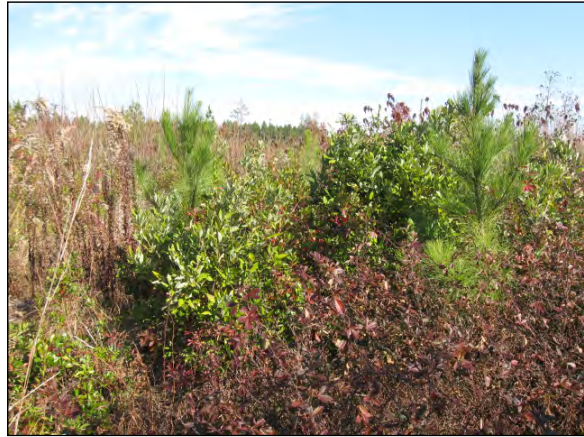
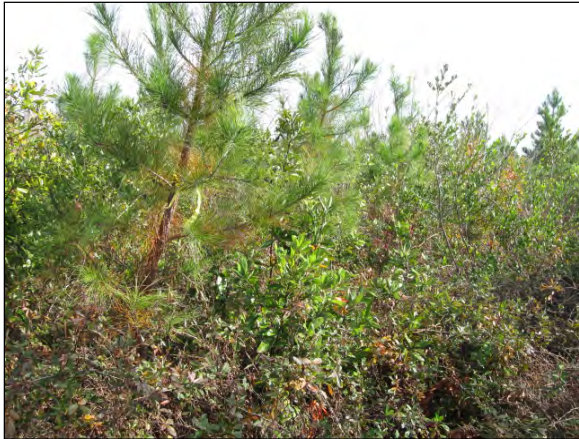
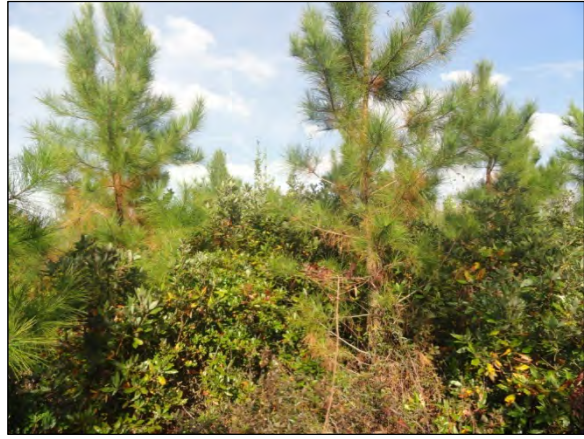
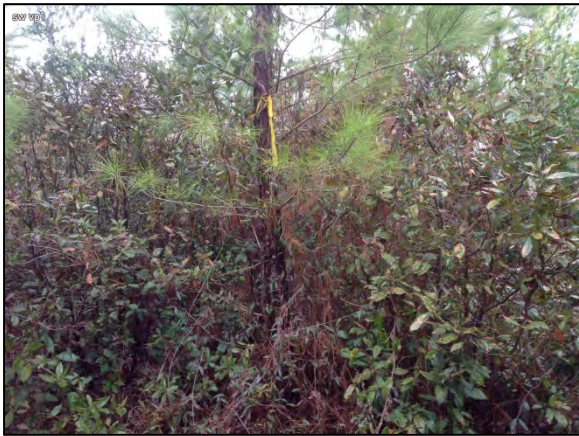
Veg Plot 1, view from southwest corner
January 7, 2009

Veg Plot 1, view from southwest corner
November 15, 2010

Veg Plot 1, view from southwest corner
November, 11 2011

Veg Plot 1, view from southwest corner
November 12, 2012

Veg Plot 1, view from southwest corner
March 18, 2014

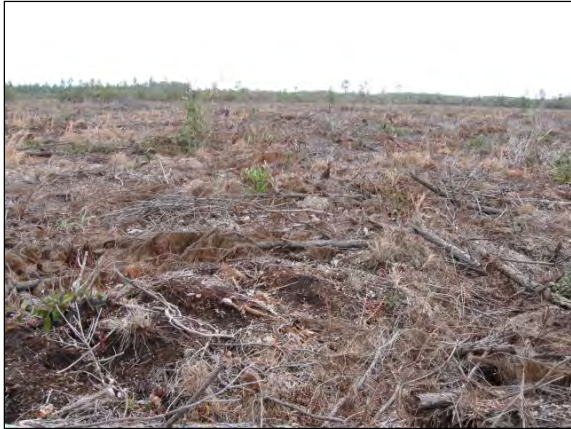
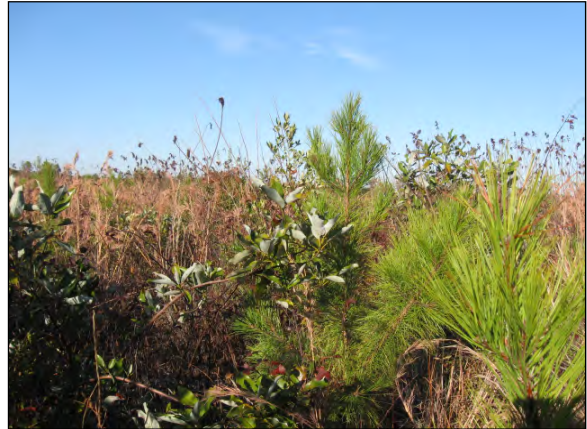
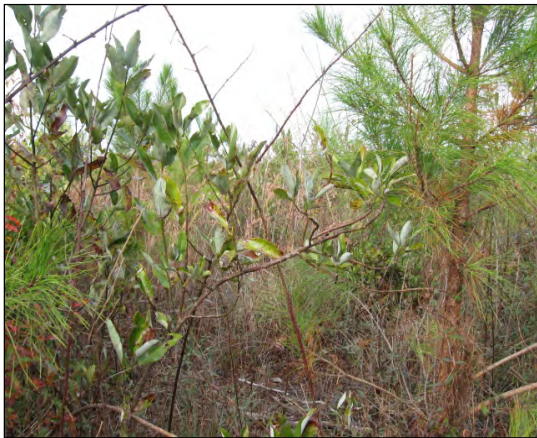
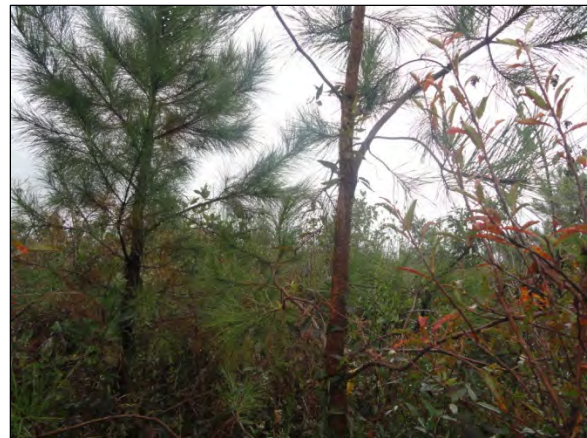
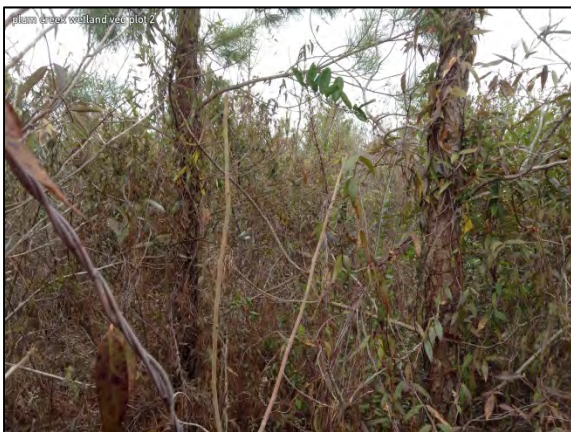
The Site met the vegetation survival rate success criteria in all 9 monitoring plots. The results from Year 1 had shown that three plots did not meet the criteria; Plots 4, 6, and 7. Year 2 monitoring results showed that Plots 4 and 7 met the criteria because stems that had been labeled missing in Year 1 or were not included in the As-Built inventory were located in Year 2. Year 4 monitoring confirmed the findings of previous years, again with Plot 6 falling short of the success criteria by just one stem count. Unlike previous years, Plot 2 fell one stem count short of meeting the success criteria in year 4.

Veg Plot 2, view from southwest corner
January 7, 2009

Veg Plot 2, view from southwest corner
November 15, 2010

Veg Plot 2, view from southwest corner
November 15, 2011

Veg Plot 2, view from southwest corner
November 13, 2012

Veg Plot 2, view from southwest corner
March 19, 2014

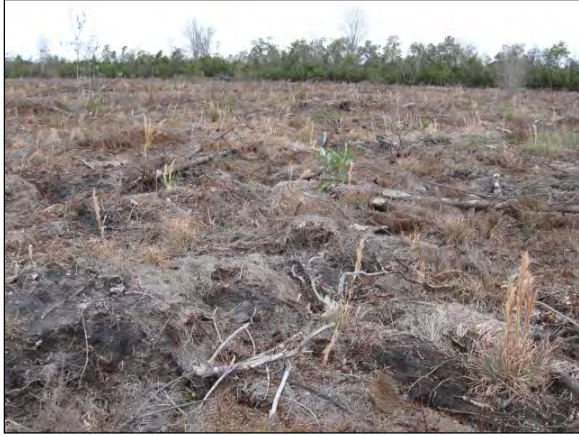
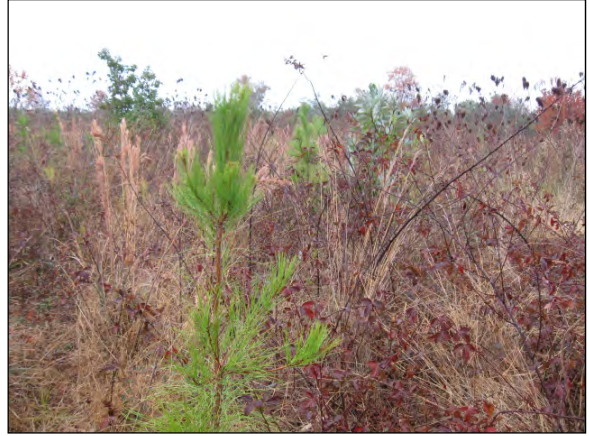
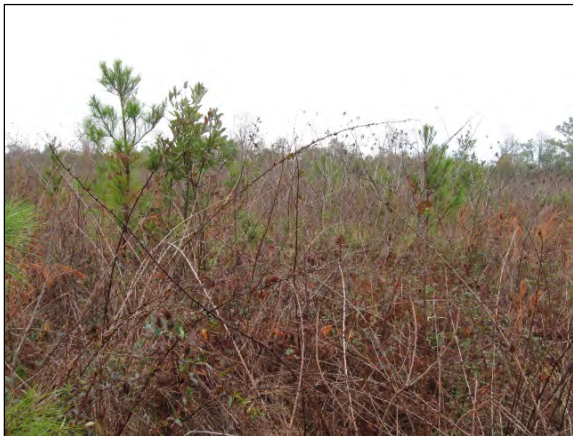
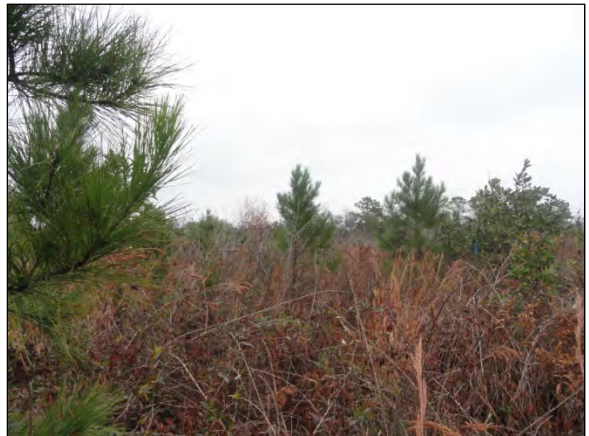
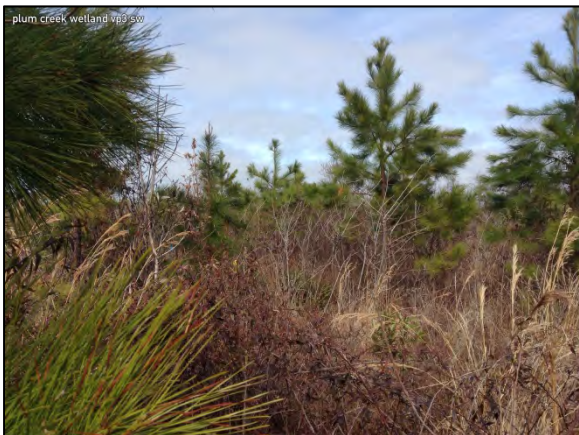
Veg Plot 3, view from southwest corner
January 8, 2009

Veg Plot 3, view from southwest corner
November 16, 2010

Veg Plot 3, view from southwest corner
November 16, 2011

Veg Plot 3, view from southwest corner
November 13, 2012

Veg Plot 3, view from southwest corner
March 19, 2014

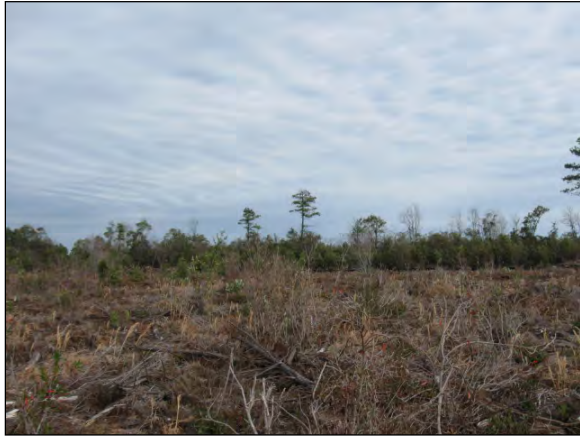
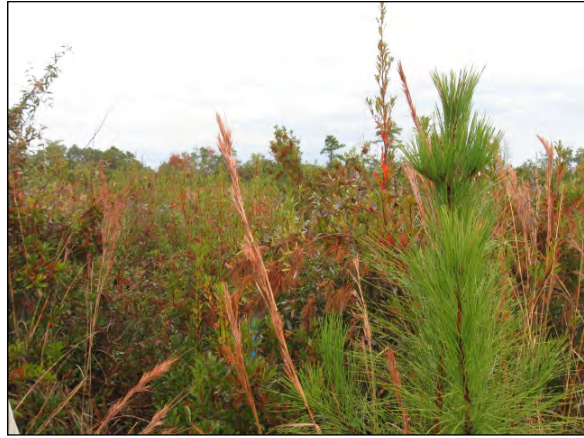
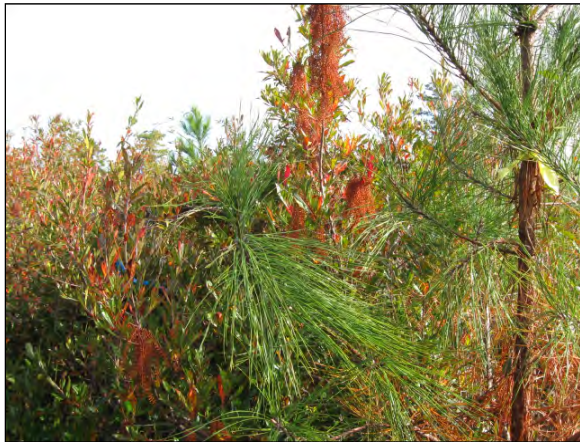
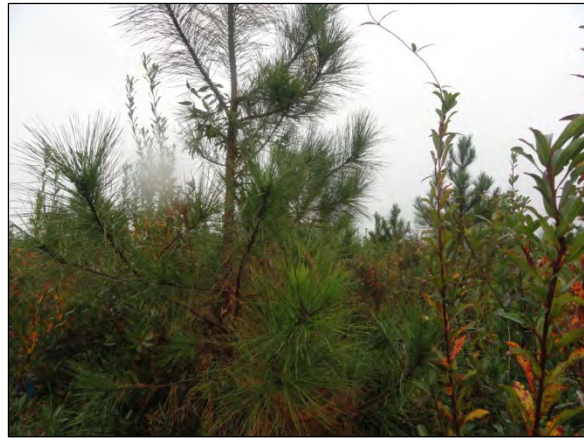
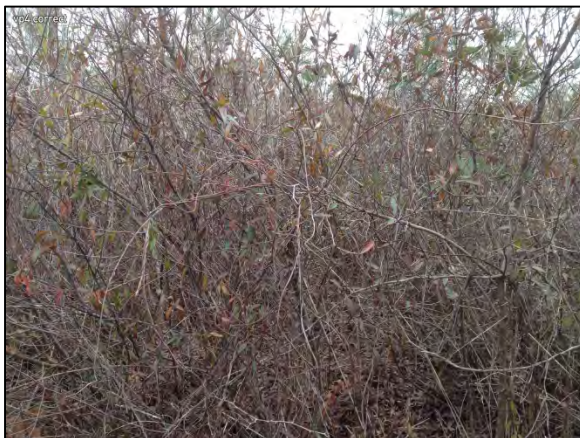
Veg Plot 4, view from southwest corner
January 8, 2009

Veg Plot 4, view from southwest corner
November 16, 2010

Veg Plot 4, view from southwest corner
November 16, 2011

Veg Plot 4, view from southwest corner
November 13, 2012

Veg Plot 4, view from southwest corner
March 19, 2014

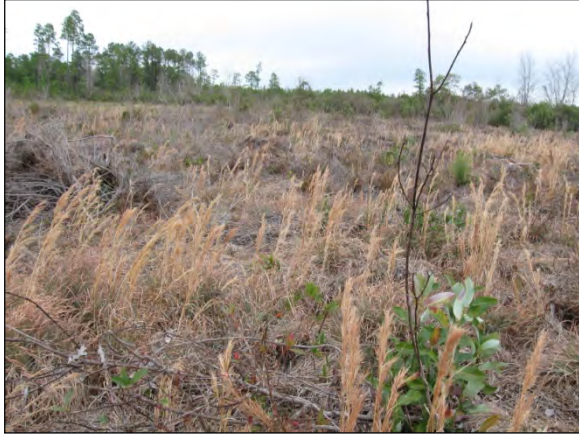
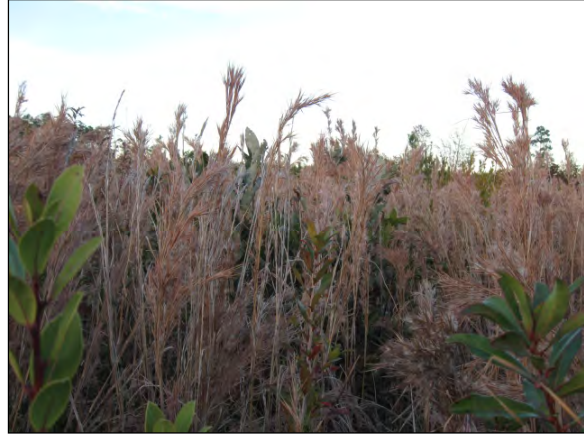
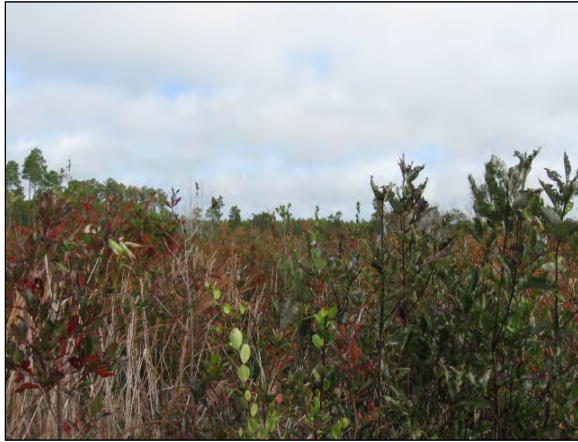
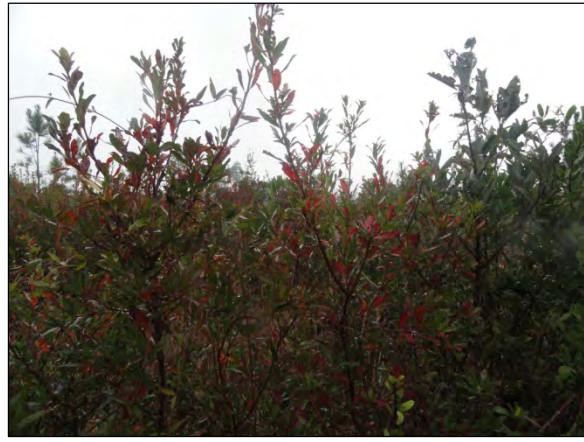
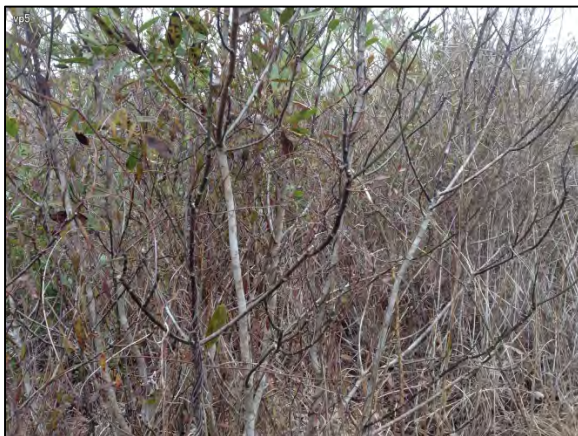
Veg Plot 5, view from southwest corner
January 8, 2009

Veg Plot 5, view from southwest corner
November 15, 2010

Veg Plot 5, view from southwest corner
November 16, 2011

Veg Plot 5, view from southwest corner
November 13, 2012

Veg Plot 5, view from southwest corner
March 19, 2014

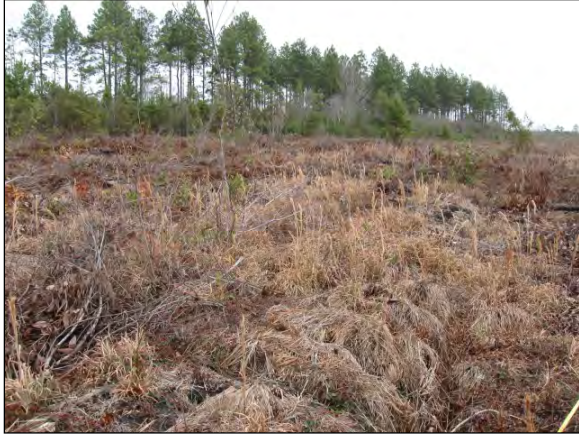
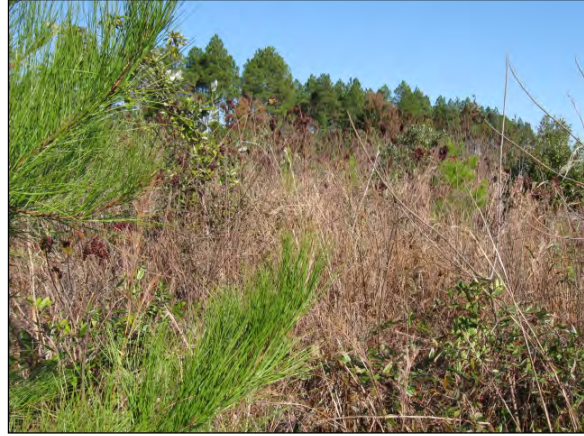
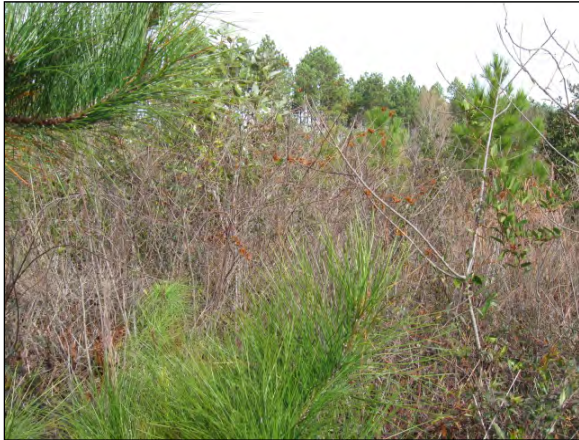
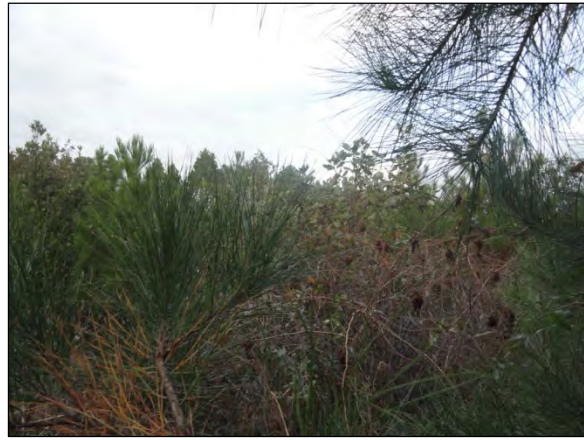
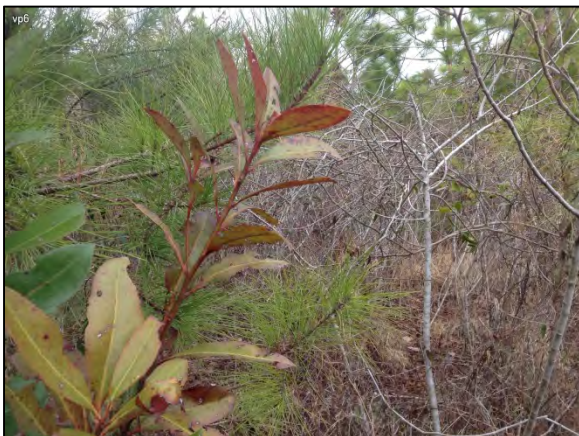
Veg Plot 6, view from southwest corner
January 7, 2009

Veg Plot 6, view from southwest corner
November 15, 2010

Veg Plot 6, view from southwest corner
November 15, 2011

Veg Plot 6, view from southwest corner
November 12, 2012

Veg Plot 6, view from southwest corner
March 18, 2014

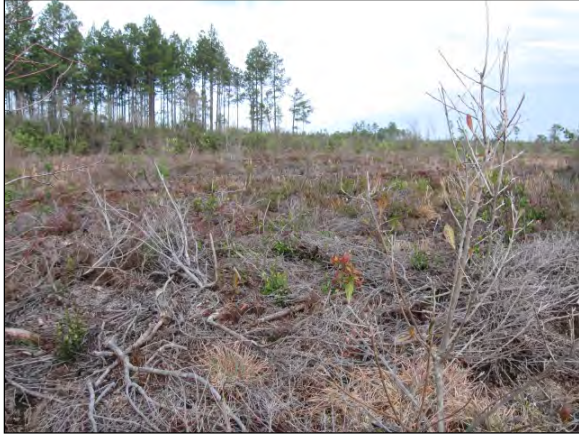
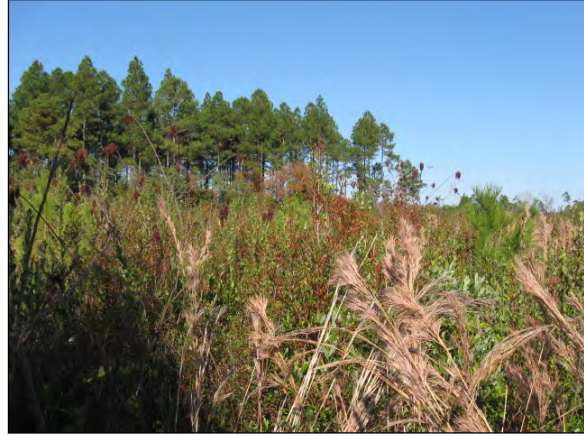
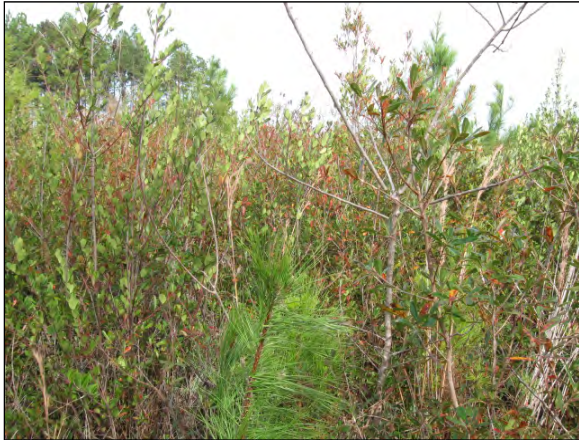
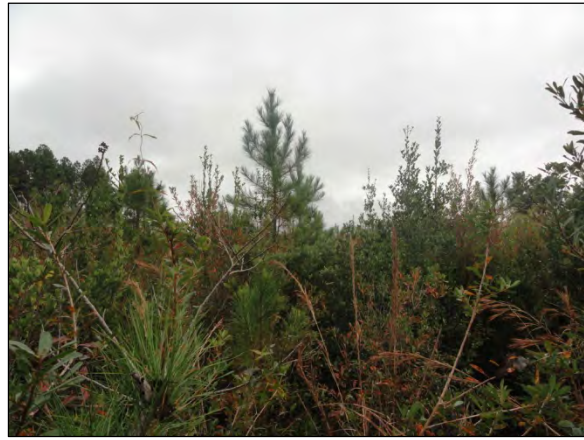
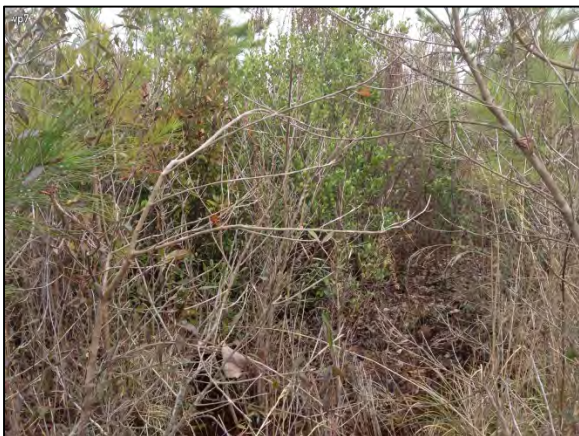
Veg Plot 7, view from southwest corner
January 7, 2009

Veg Plot 7, view from southwest corner
November 15, 2010

Veg Plot 7, view from southwest corner
November 15, 2011

Veg Plot 7, view from southwest corner
November 13, 2012

Veg Plot 7, view from southwest corner
March 19, 2014

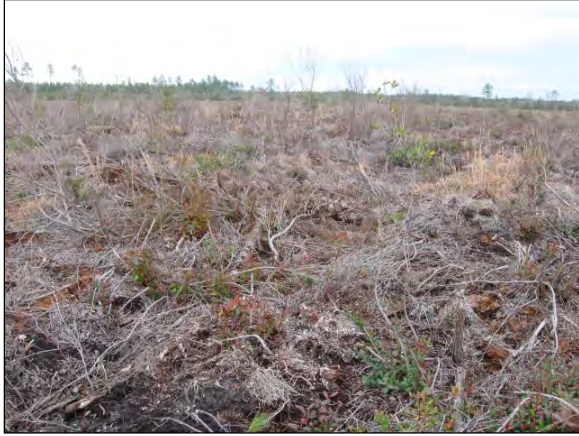
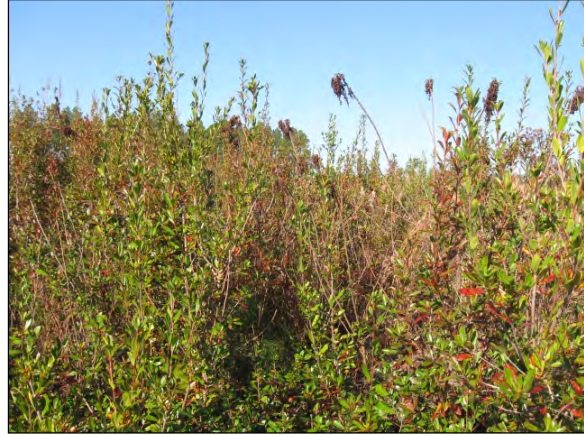
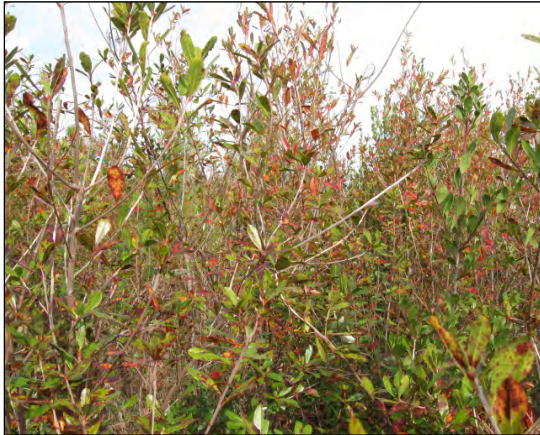
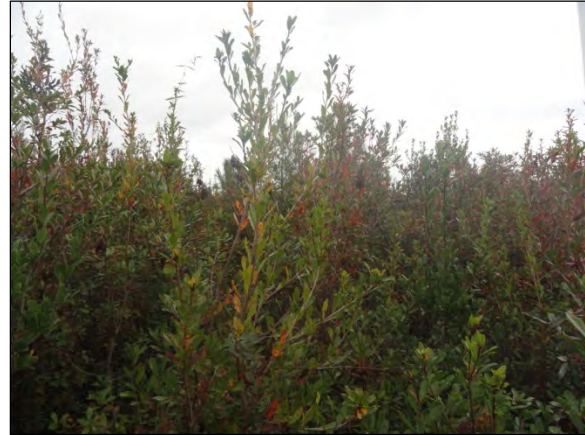
Veg Plot 8, view from southwest corner
January 7, 2009

Veg Plot 8, view from southwest corner
November 15, 2010

Veg Plot 8, view from southwest corner
November 15, 2011

Veg Plot 8, view from southwest corner
November 13, 2012

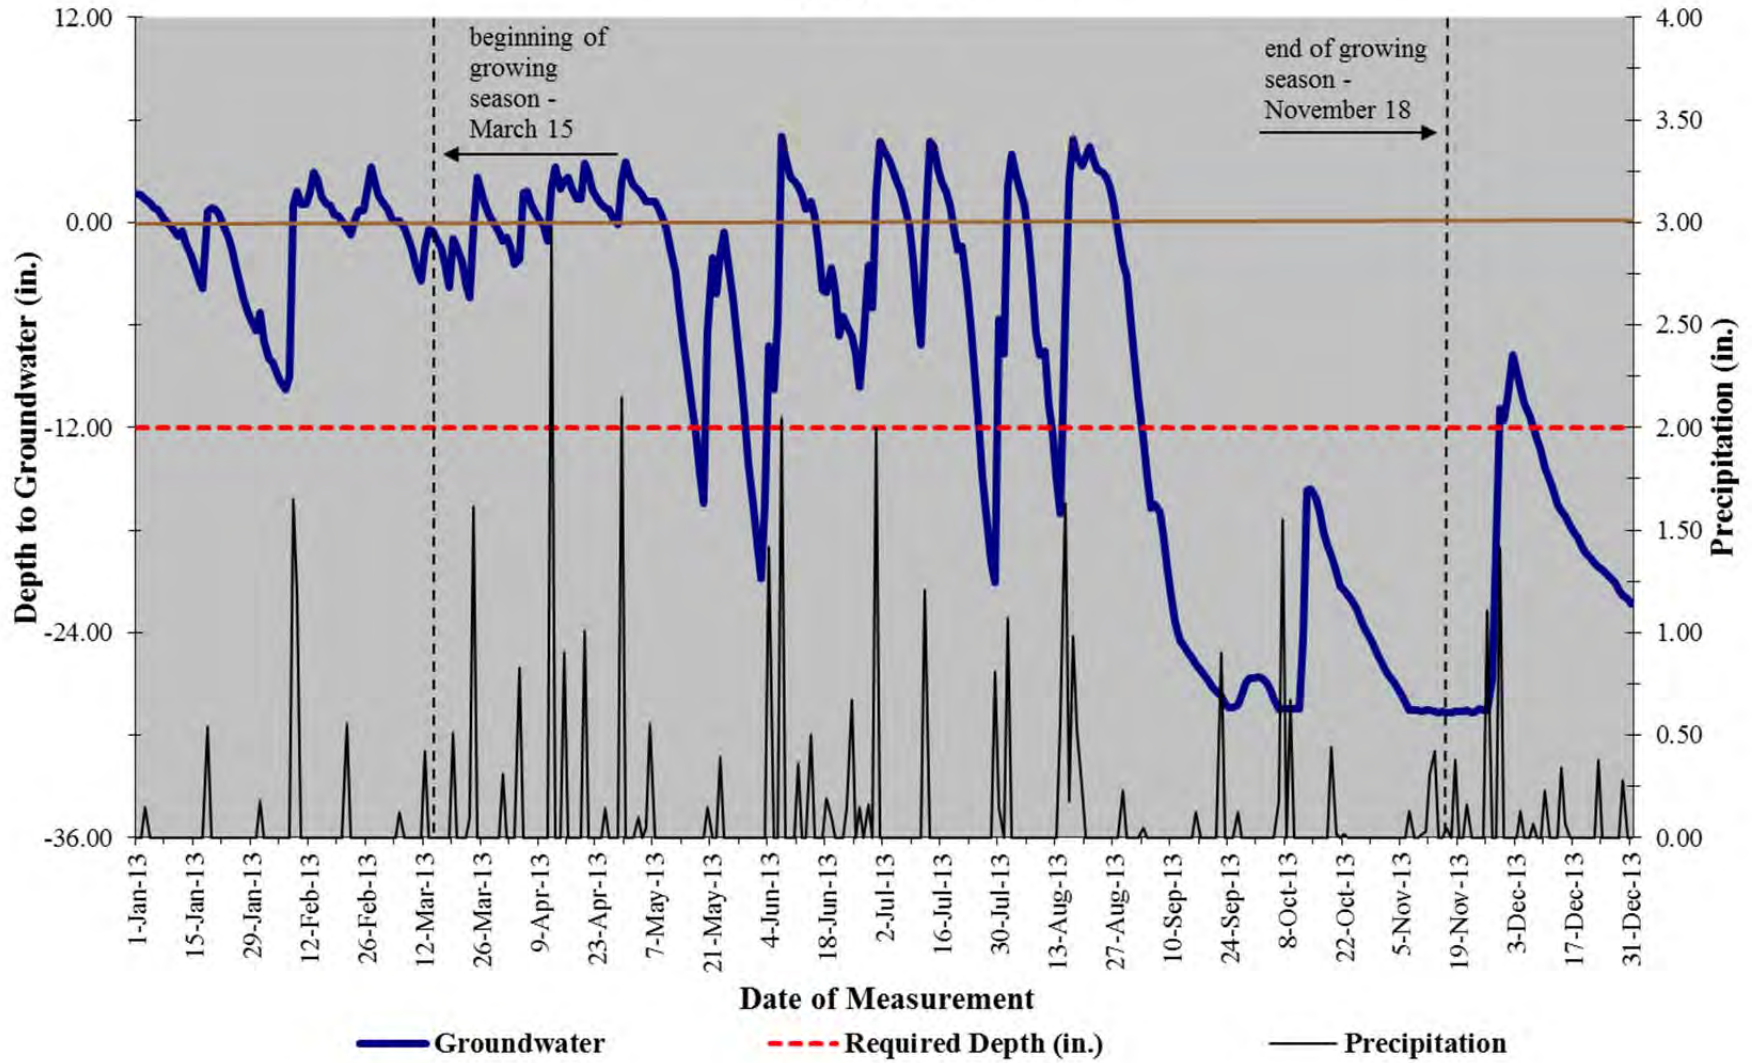
**Plum Creek Wetland Mitigation
Gauge G-5 (Serial No. 11313B7D)
Project Site**

G-5	Yes / 41 days (16.5 percent)	Yes / 20 days (8 percent)	Yes / 22 days (8.8 percent)	Yes / 22 days (8.8 percent)	Yes / 63 days (25.3 percent)
G-6	No / 3 days (1.2 percent)	No / 8 days (3.2 percent)	No / 7 days (2.8 percent)	No / 2 days (0.8 percent)	No / 9 days (3.6 percent)
G-7	Yes / 24 days (9.6 percent)	No / 18 days (7.2 percent)	Yes / 58 days (23 percent)	Yes / 35 days (14.1 percent)	Yes / 65 days (26.1 percent)
G-8	Yes / 22 days (8.8 percent)	No / 19 days (7.6 percent)	Yes / 50 days (20 percent)	Yes / 31 days (12.4 percent)	Yes / 64 days (25.7 percent)
G-9	No / 12 days (4.8 percent)	No / 15 days (6 percent)	No / 12 days (4.8 percent)	No / 6 days (2.4 percent)	No / 15 days (6.0 percent)
