SUBJECT: Poplin Ridge- NCIRT Comments During 30-day Mitigation Plan Review

NCEEP Project Name: Poplin Ridge Stream Mitigation Site, Union County, NC

USACE AID#: SAW-2012-01079

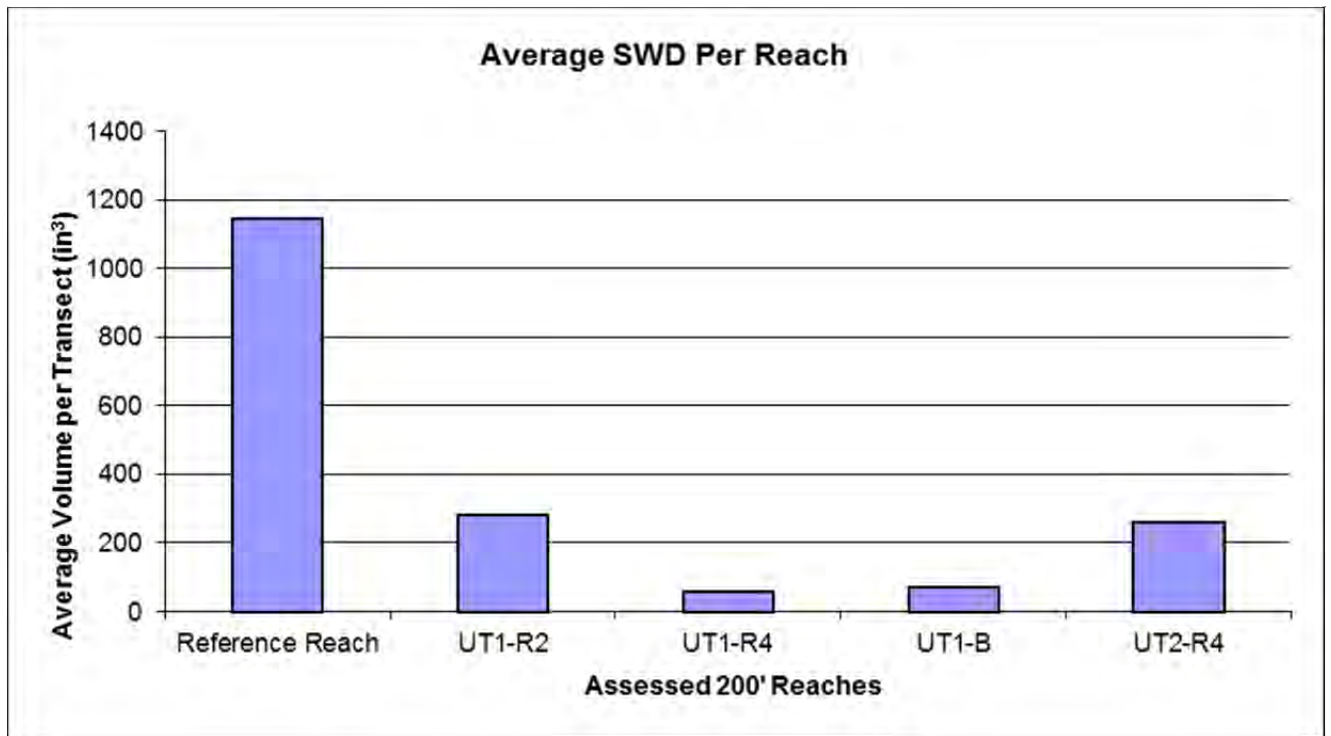
Chart 1. Average volume (cubic inches) of SWD per assessed reach. This chart represents existing conditions in all assessed reaches.

In addition to the habitat assessment conducted at the reference site, UT1 and UT2 of the project site were assessed in order to measure representative habitat gains over time post-construction. Based on these assessments, there is a large disparity of SWD volume between the reference reach and the design reaches (**Chart 1**).

Woody debris collected in streams provides habitat for macroinvertebrates, fish, and amphibians, and increases stream productivity by retaining carbon in the channel. While it would be difficult to replicate the volume and spatial distribution of SWD found in the reference channel, this quantitative habitat assessment provides guidance for improving habitat conditions through specifically placed and sized SWD structures, and provides a means for assessing functional gains over time. These structures are included in the design plans (**Appendix D**).

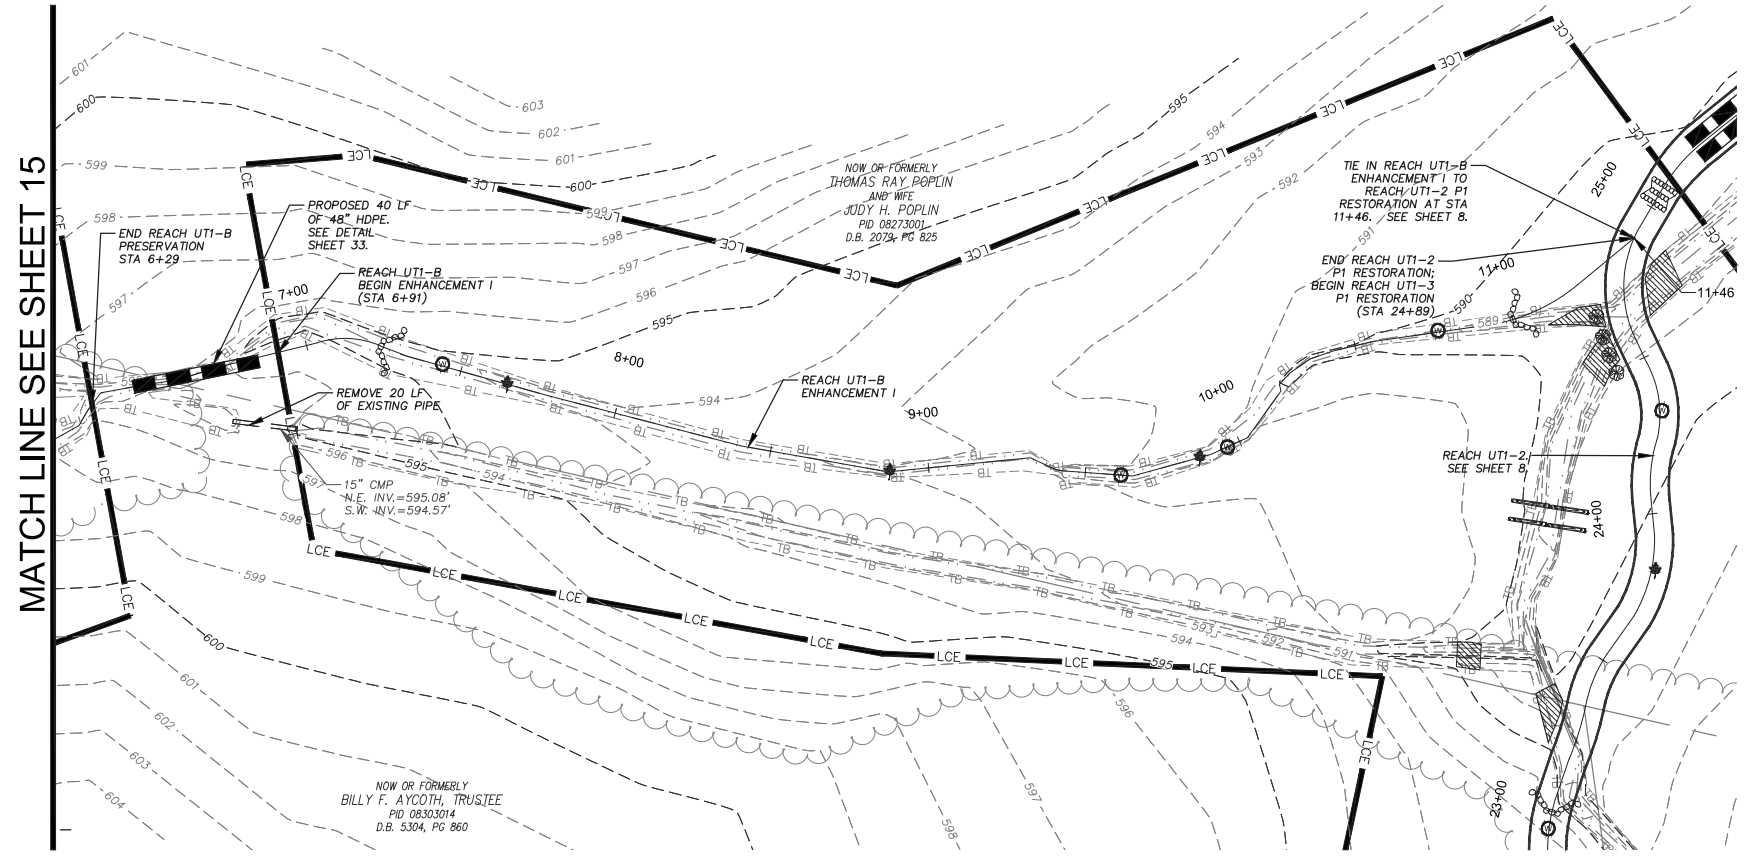
UT1-B NOTE:
 REGRADE CHANNEL WITH DIMENSIONS PROVIDED IN TYPICAL CROSS SECTION BELOW, FROM STA 6+30 TO STA 9+42, AND STA 11+00 TO CONFLUENCE WITH REACH UT1-2.
