**Powell Property Wetland and Stream Mitigation Project
Bertie County, NC**

**2012 Annual Monitoring Report
Year 4**

**NCEEP Project Number D06065-B
Chowan River Basin
USGS Catalog Unit 03010203
IMS #92548**

Date: December, 2012

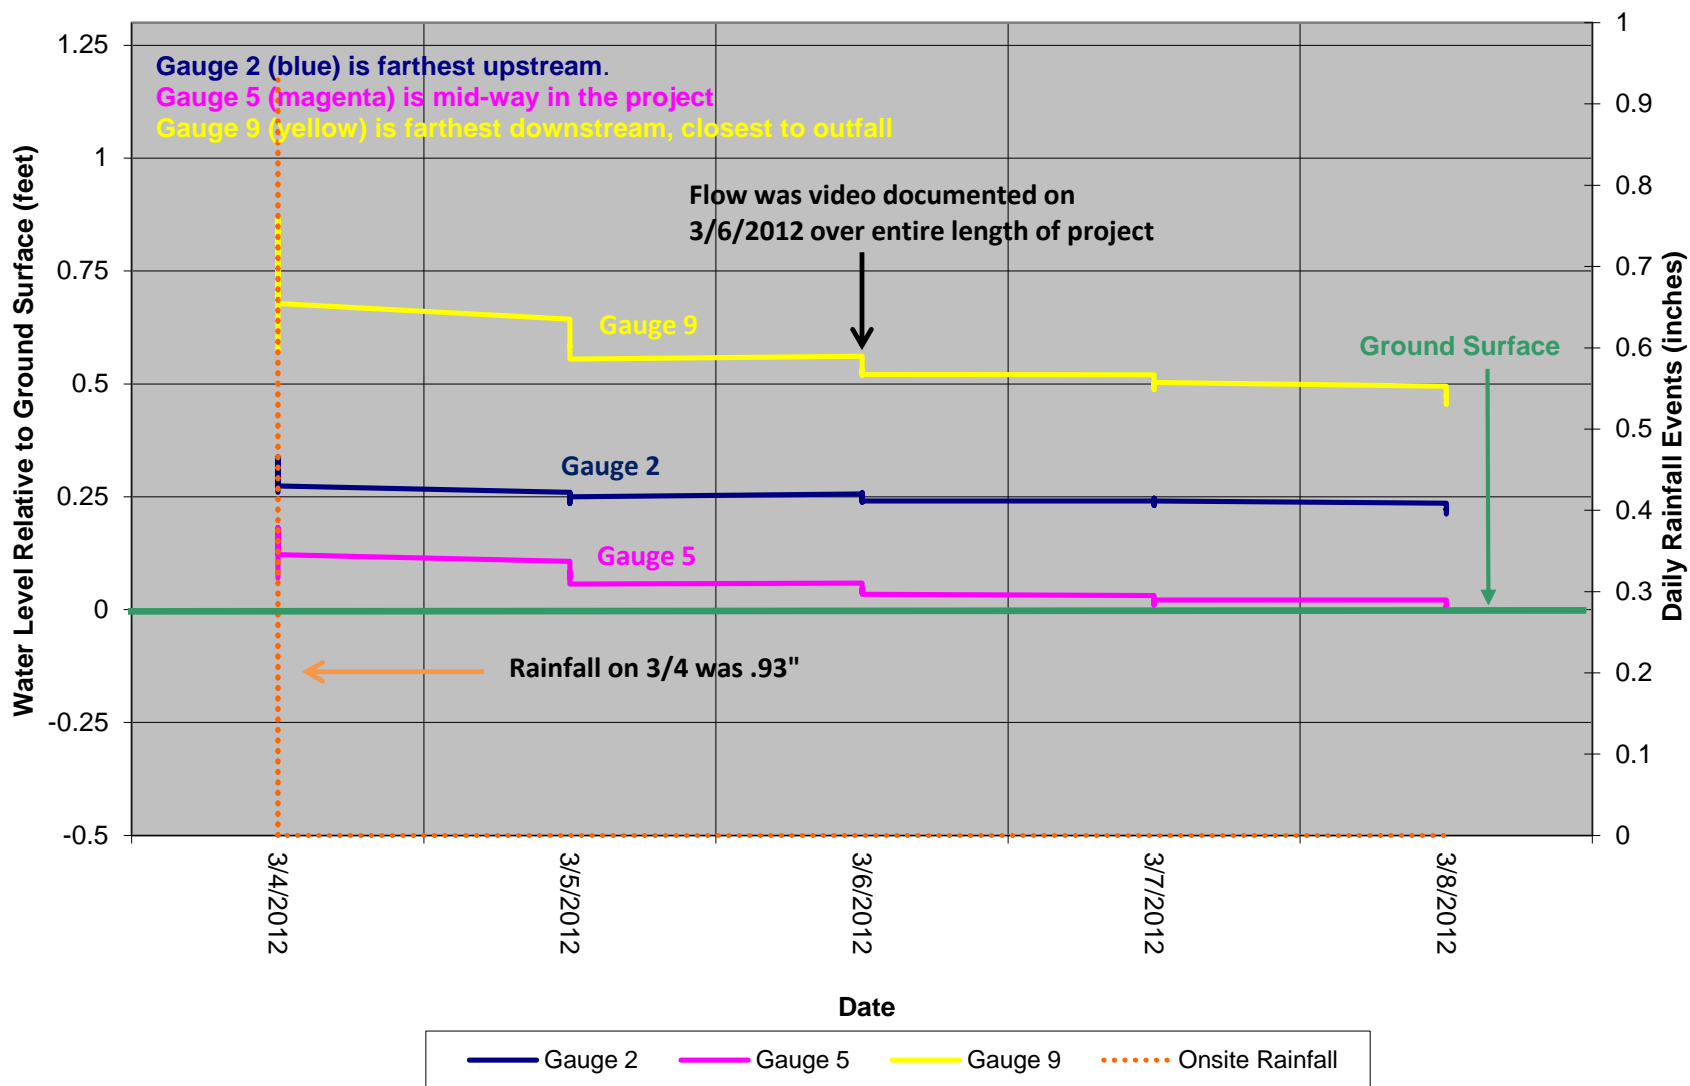
**Figure F1.
Monitoring Gauges 2, 5 & 9
Indicating Flow in March, 2012**

Refer to Figures F1 and F2 which are composite charts for Gauges 2, 5 & 9, for the following discussion of evidence of flow within the swamp runs. Figure F1 is a composite chart showing a period of flow in March, 2012. Figure F2 is a composite chart showing flow in late October, 2012 after Hurricane Sandy produced enough rainfall to briefly recharge the watershed. As can be seen on the hydrographs, prior to that storm, the site was very dry. Both flow events were video documented and those files are included on the CD accompanying this report.

By comparison, Reference Gauge 11, which is in the center of the reference swamp run, showed no water flowing in October. This was confirmed during a site visit in November; the reference run was found to be dry and both reference gauges were empty. The project area appears to be more sensitive to rainfall, producing flow patterns that may be shorter lived, but more frequent than the reference area which may take longer to recharge, but continues to flow for longer periods.

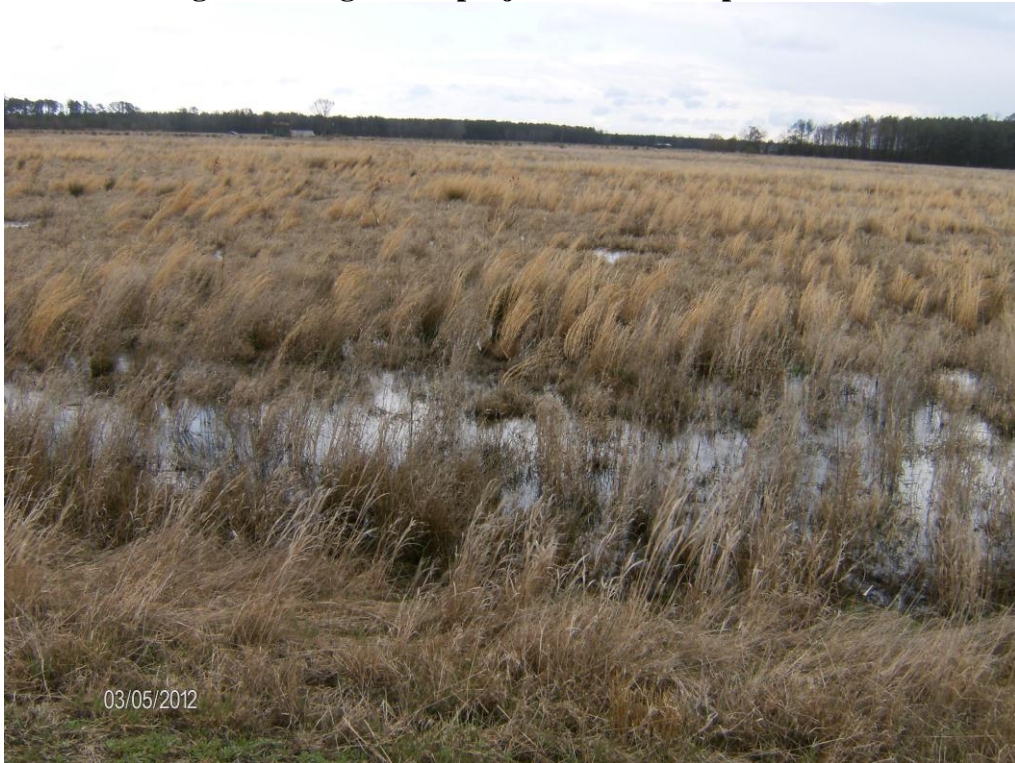
Near Gauge 6 looking across project toward midpoint March 2012

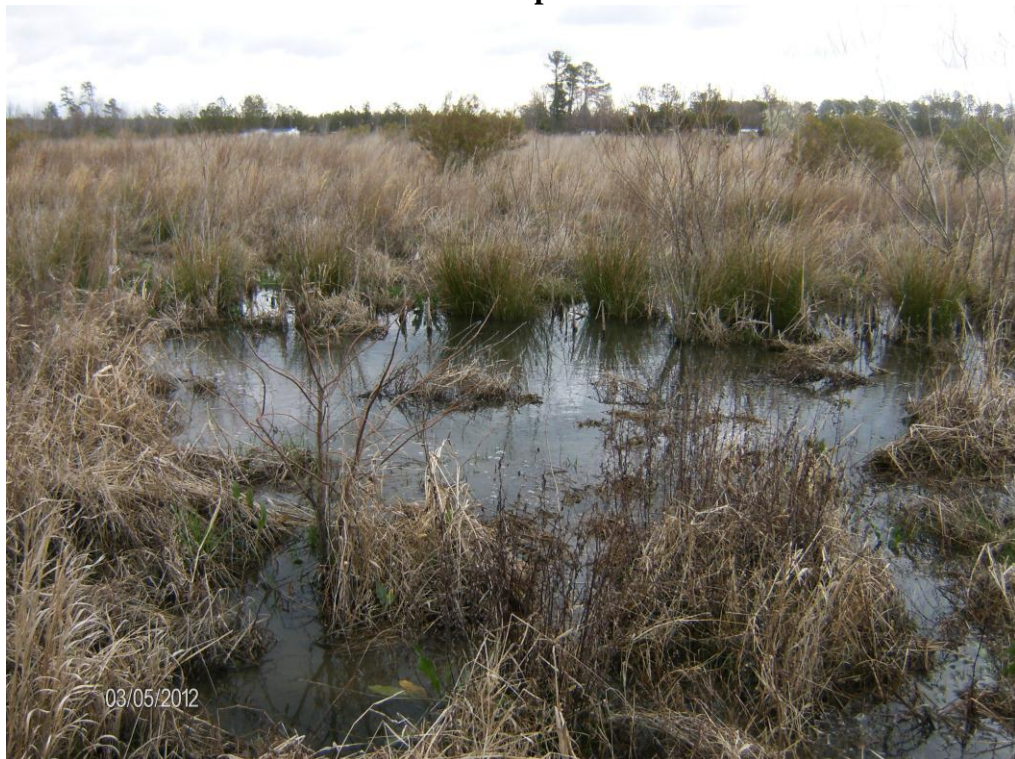
Stream center at midpoint March 2012

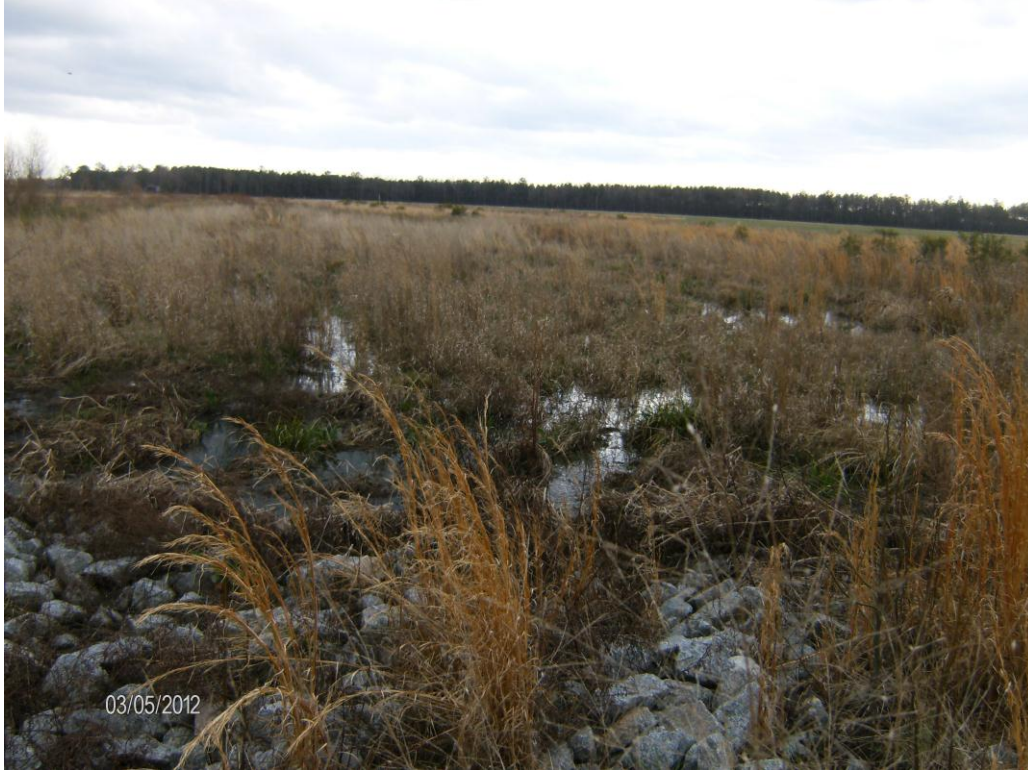
Outflow end looking upstream toward midpoint March 2012. Note low water level.

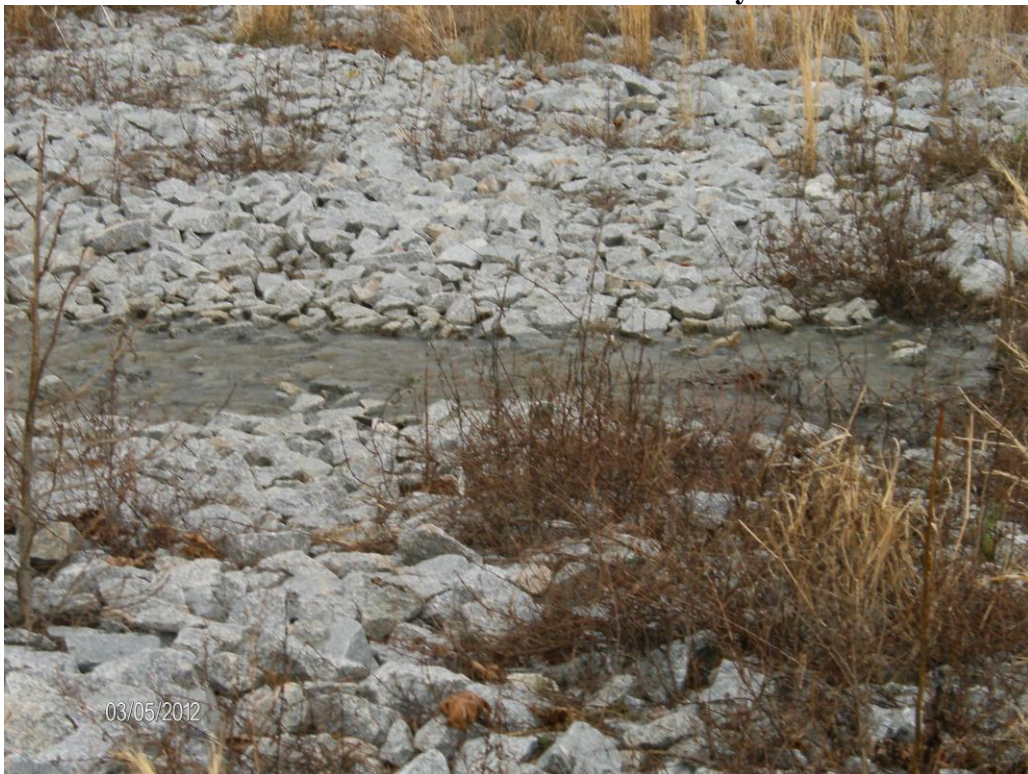
Outflow volume March 2012 relatively low.

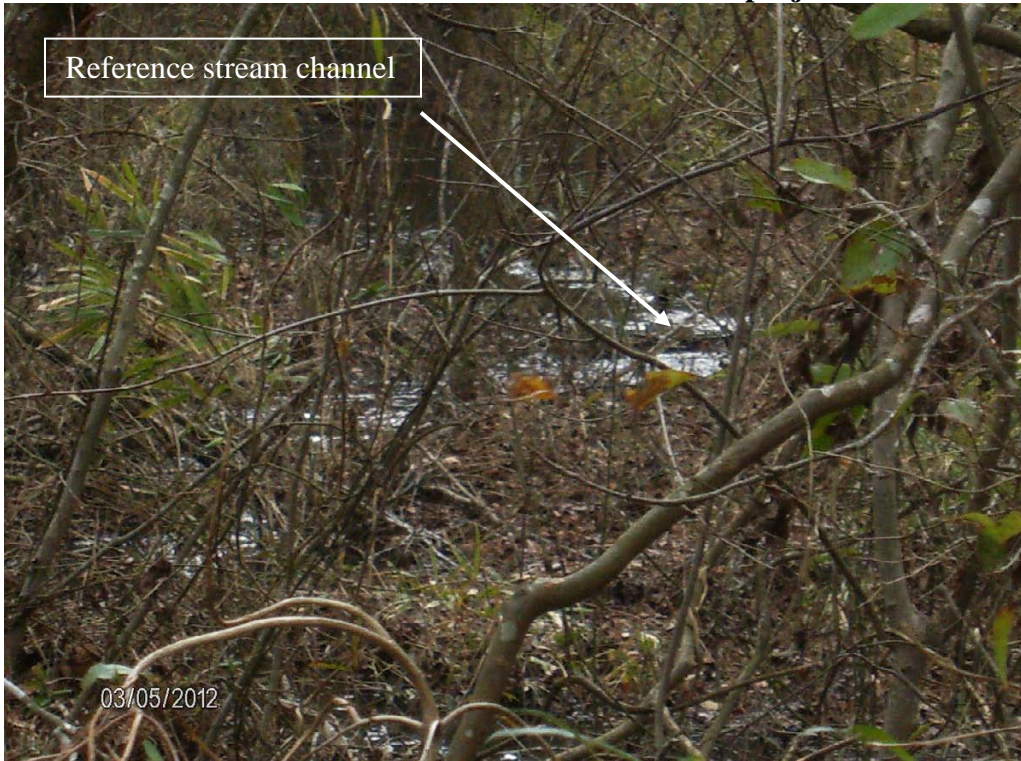
Reference area flow volume in March 2012 similar to project flow volume

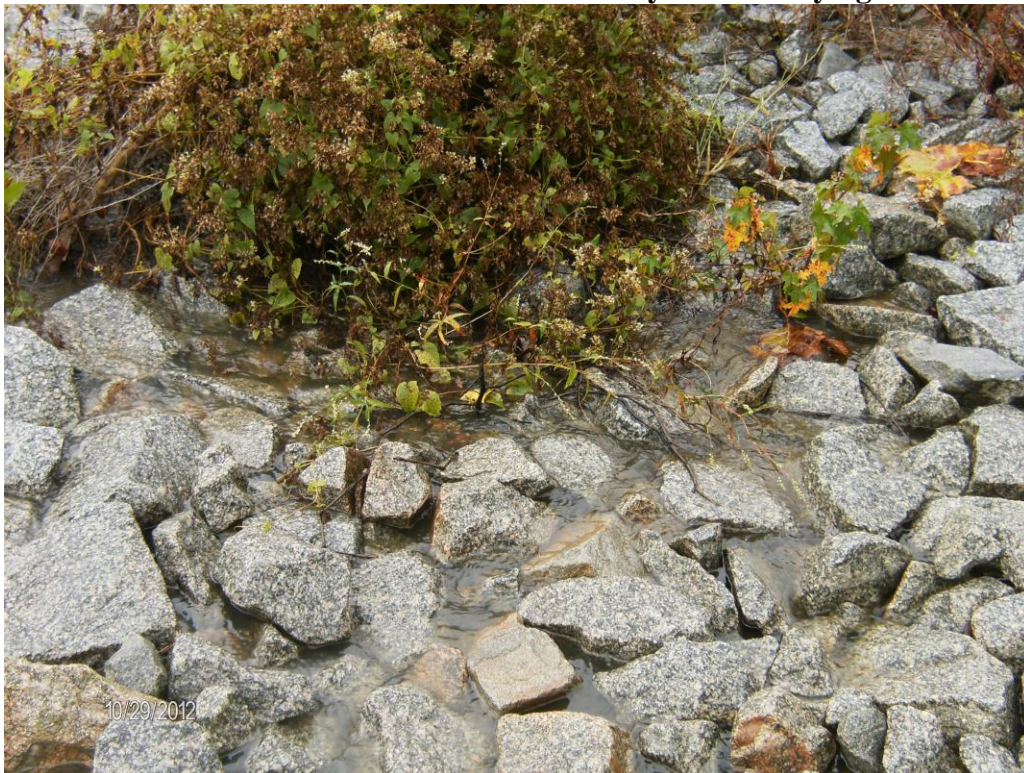
Outflow volume after Hurricane Sandy is relatively light.
