■
*Executive Summary of
Restoration Plan*

Purlear Creek
Stream Restoration Project
Wilkes County, North Carolina
Project ID No. 010547501

Prepared for:
NCDENR-Wetlands Restoration Program
Raleigh, North Carolina

October 2002

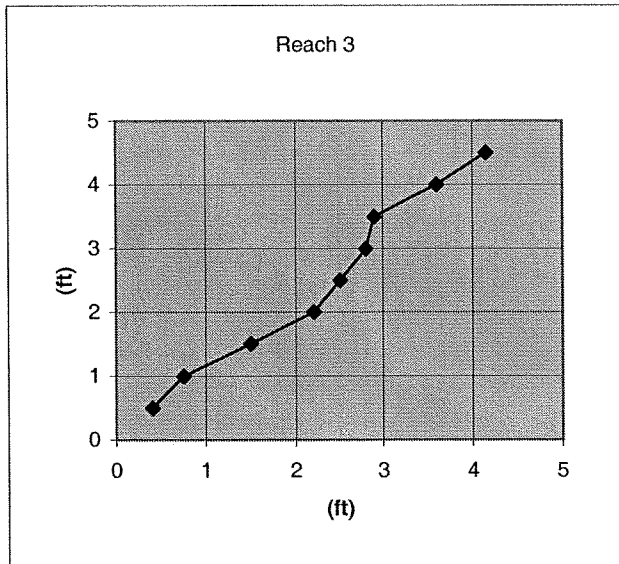
Purlear Creek
Reach 3 - Bank Erosion Hazard Index

BEHI Variables		Measurement	Hazard Rating
A	Highest Bank	5.5	
B	Max Bankfull	1.9	
C	A/B	2.894736842	10
D	Root Depth	1	
E	Study Bankheight	4.5	
F	D/E	0.222222222	6.5
G	Root Density	25	6.2
H	G*F	5.555555556	
I	Bank Angle	47	3
J	Bank Height Protection	0.5	
K	Surface Protection	25	6.5
Hazard Subtotal			32.2
Bank Material Adjustment		Sand	10
Stratification Adjustment		No Stratification	0
BEHI Rating			42.2
BEHI Description			Very High

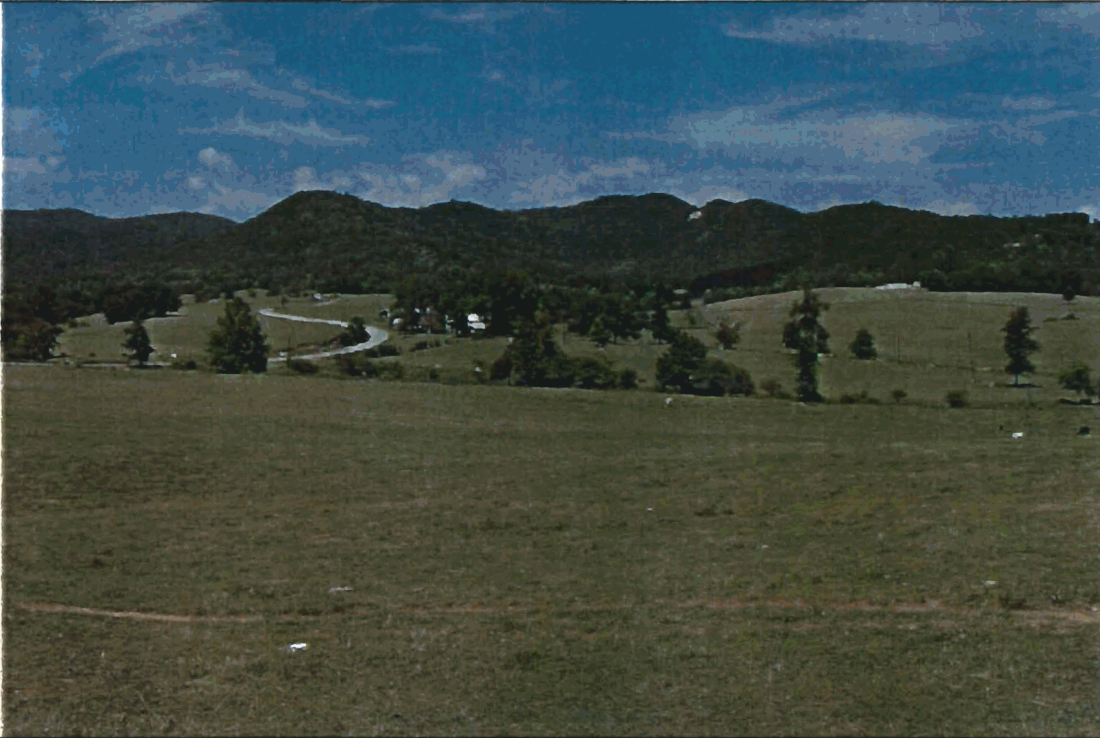
Photo 1: Project area in foreground with watershed in background

The drainage area for the downstream most point of Purlear Creek within the project area is approximately 3 square miles. Most of the headwaters within the watershed are forested, and owned by the State of North Carolina as educational forest (Rendezvous Mountain). There are other farms/pasture upstream of the project site, which may present future opportunities for restoration. GIS analysis of watershed landuse using the National Landcover Data derived in 1991 by the United States Geological Service (USGS NLCD 1991) shows approximately 76% of watershed area in forested cover, approximately 24% in cultivation or pasture, and less than 1% as wetlands. From a windshield survey of the watershed, it appears that a small portion of the watershed area surrounding a the offsite portion of reach 4 east and northeast of the project area has been converted from forest and farmland to low density residential use. A significant increase in development for the watershed is not expected because a large portion of the watershed is state forest land. Drainage area by stream segment is shown in Table 1. Figure 3 shows the location of the stream segments. Appendix I, photo 1 shows the landuse and land cover of the watershed.

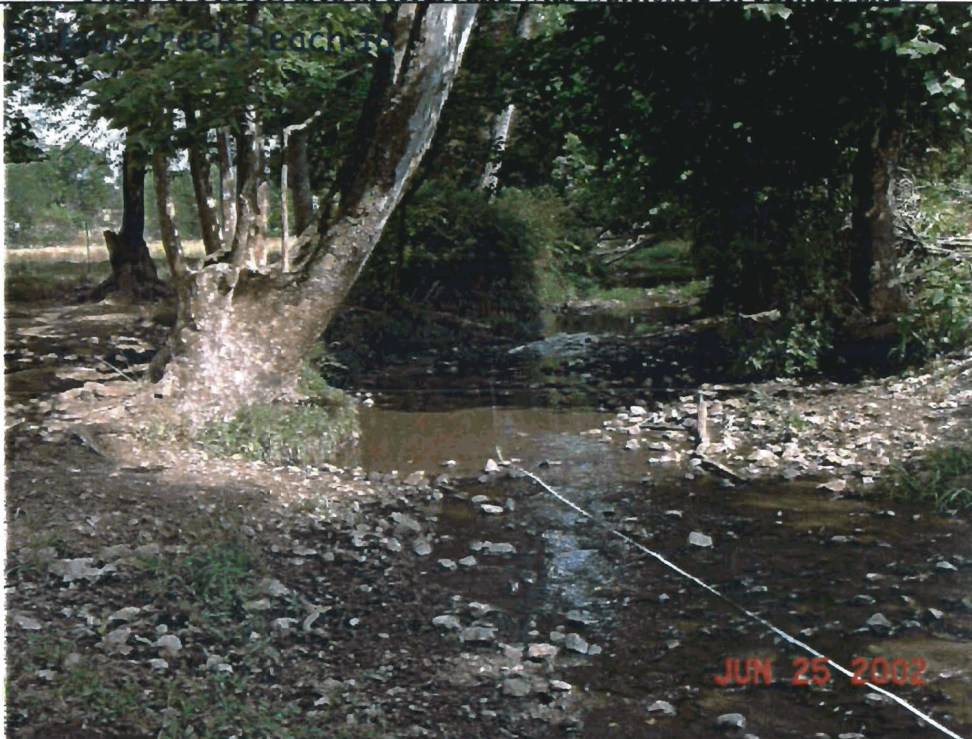
Photo 2: Looking downstream in channel 1a, notice thinly vegetated buffer of mature hardwoods

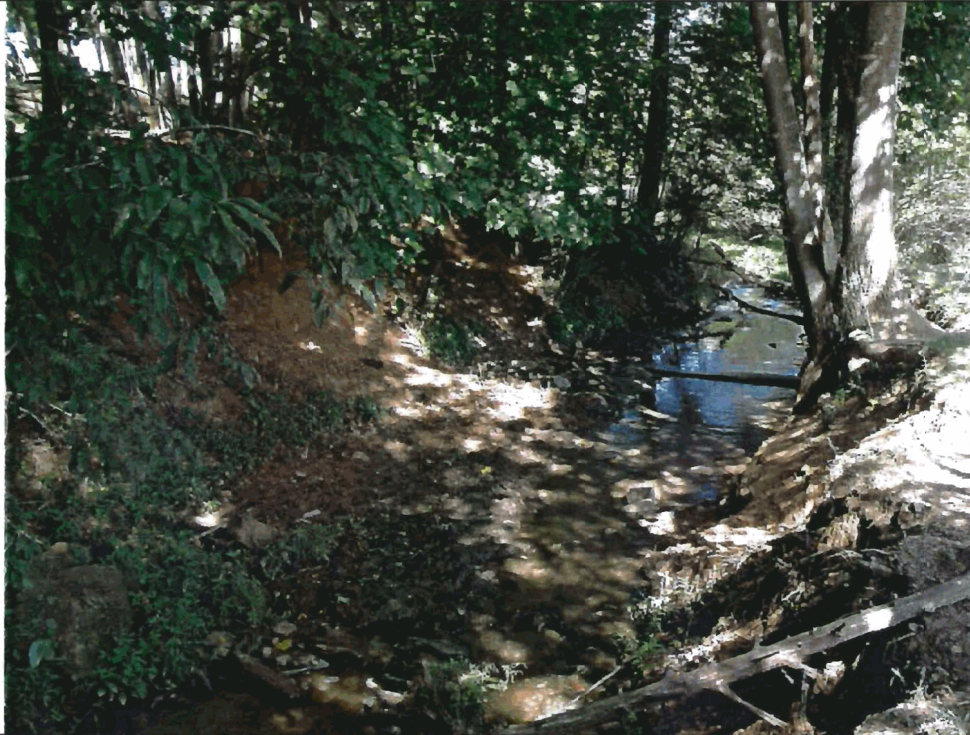
Photo 3: Looking upstream in channel 1a at eroding banks

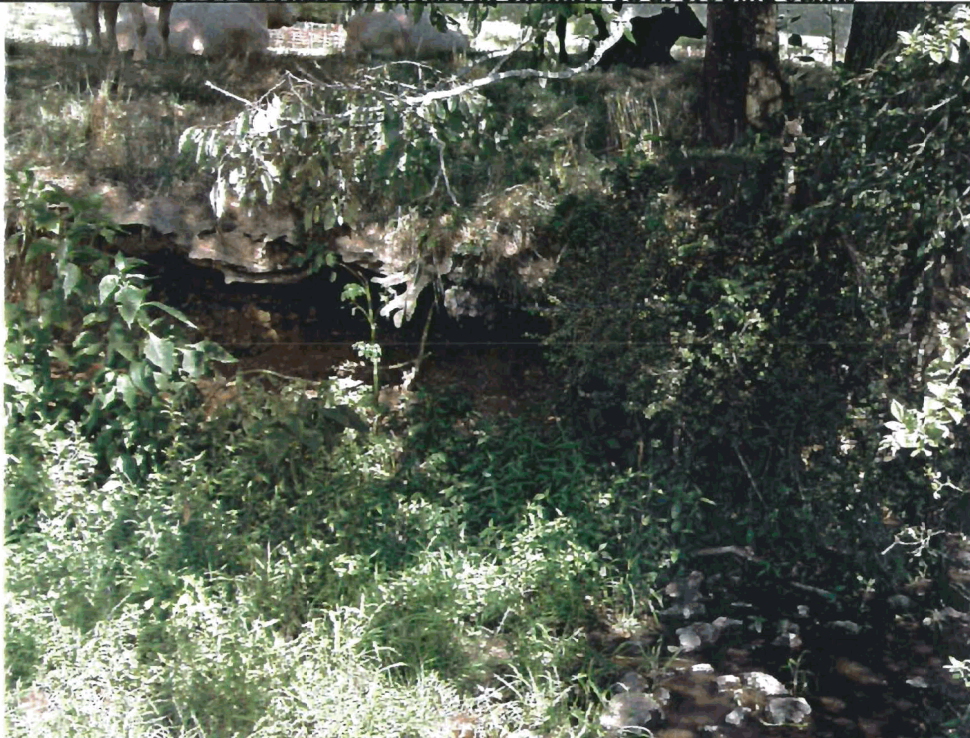
Photo 4: Looking upstream from right bank to left bank at bank undercutting of reach 2

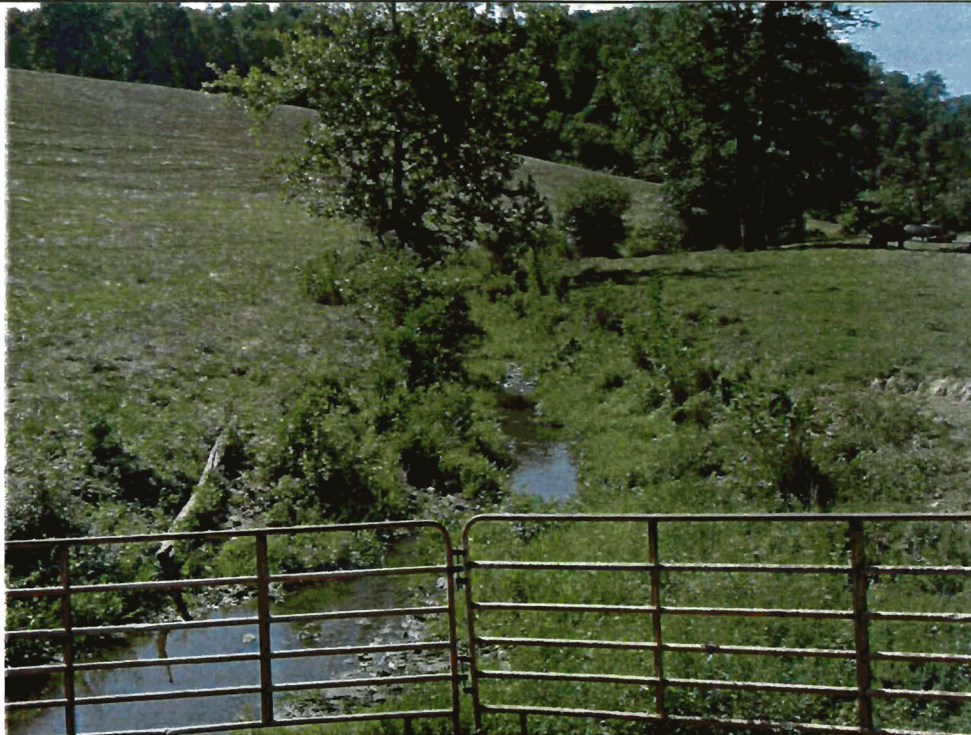
Photo 5: Looking upstream of Reach 2, notice spotty buffer of isolated hardwoods

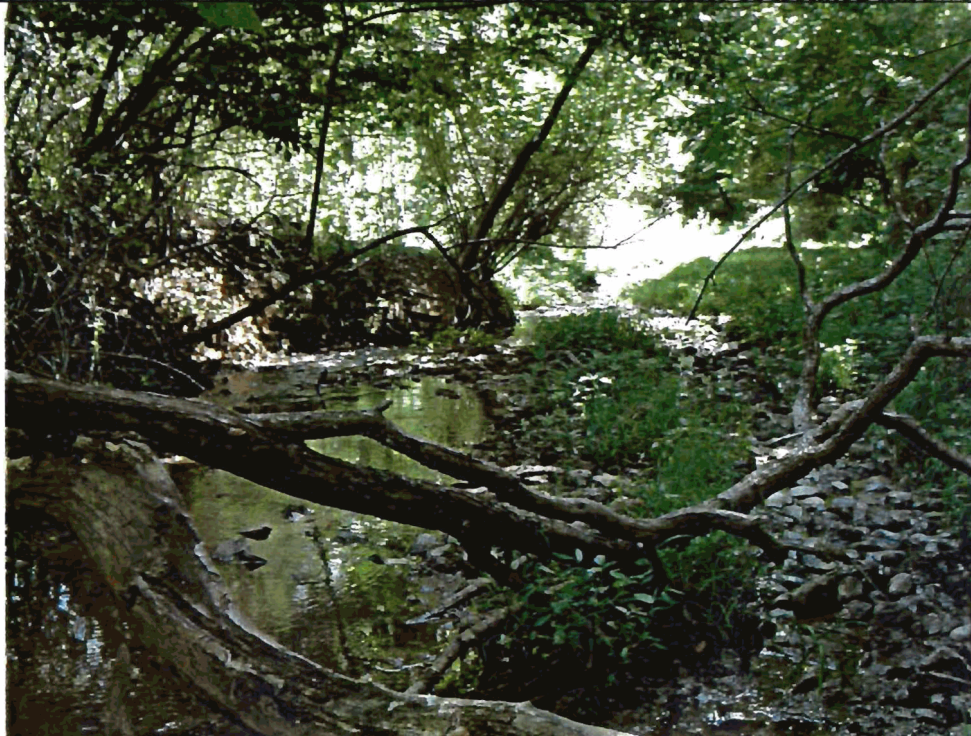
Photo 6: Looking downstream of reach 2a, notice steep banks but increased hardwood buffer

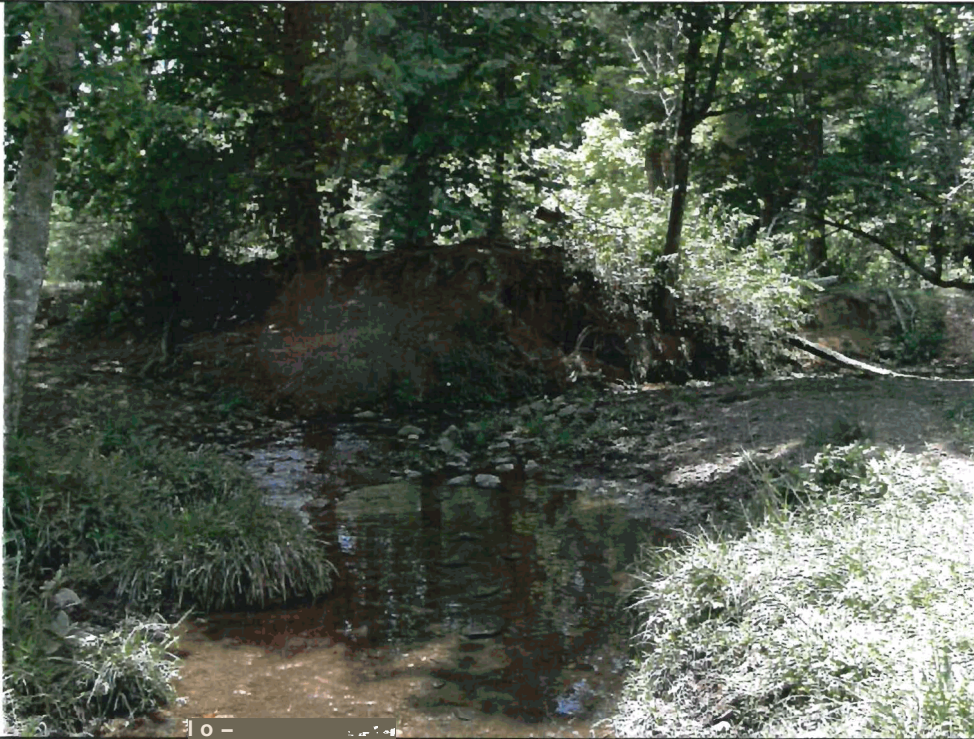
Photo 7: Looking upstream of reach 2a2, notice exposed banks but increased hardwood buffer

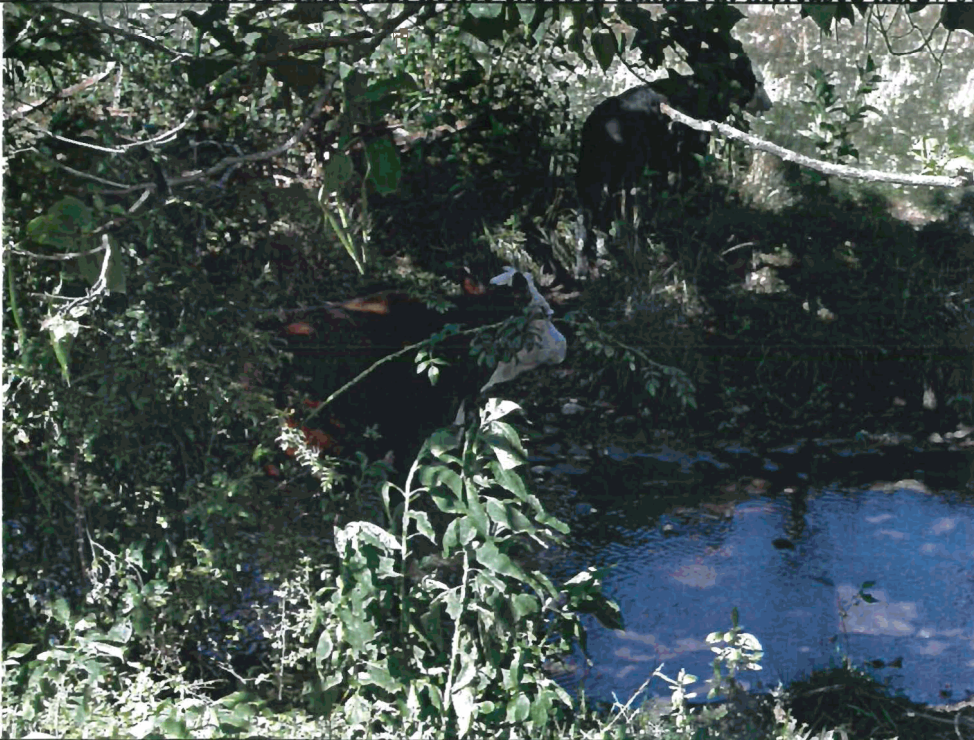
Photo 8: Looking within reach2, this and all other channels are easily accessible to cattle

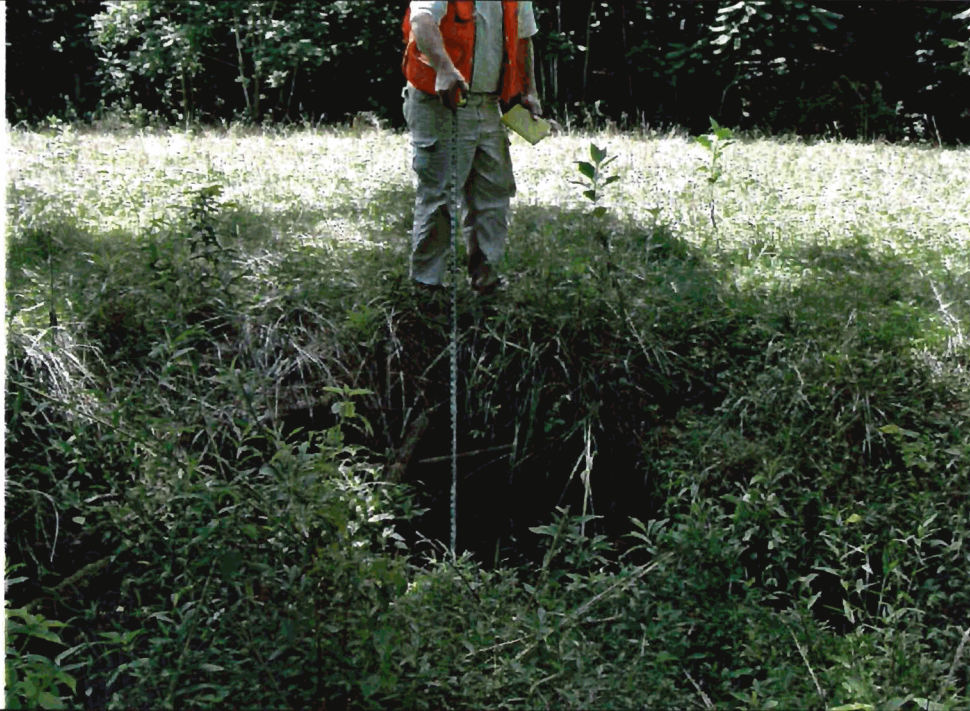
Photo 9: Looking from left bank to right bank on reach 2a1, notice steep bank and lack of woody vegetation on outside of severe curve

Reach 2A₁, which joins the main channel in the northwest section of the property, appears to be stream type E5b migrating to a G5 through downcutting. With continued down cutting, the banks may fail, facilitating lateral erosion and conversion to a F5 stream type. The reaches tortuous meanders and steep, near vertical banks will likely fail because the bank vegetation's root length and density is inadequate to maintain bank stability (see Appendix I, photo 9). The BEHI rating for the reach is extreme. Cattle have open access to the reach and appear to be contributing to bank erosion and stream instability. Upstream of the property boundary, the stream also lies within an open pasture and is exposed to similar stresses as the onsite portion of the reach.

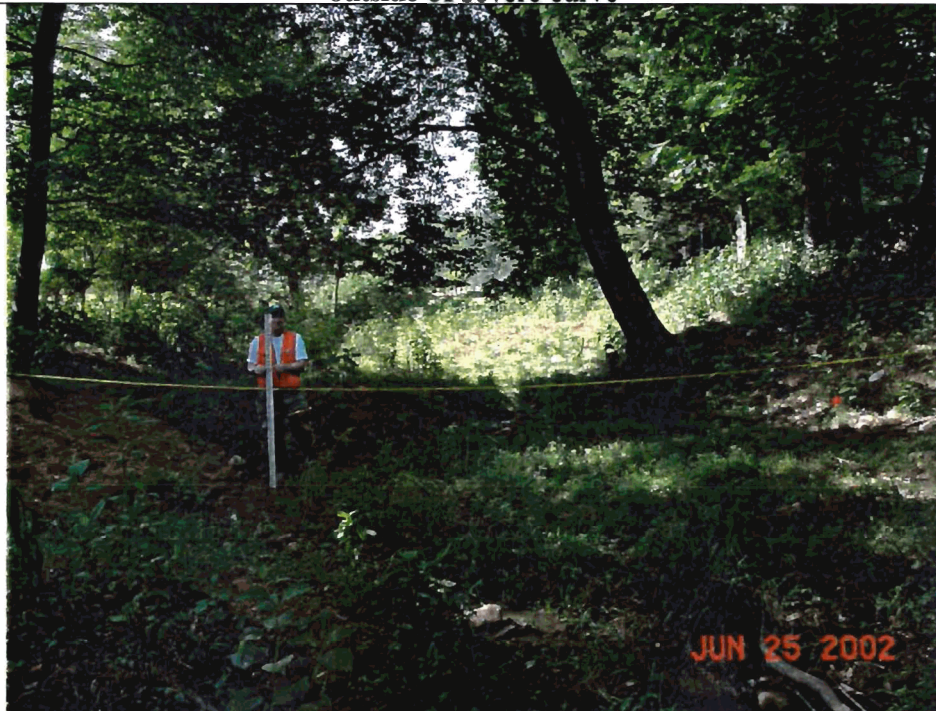
Photo 10: Looking upstream of reach 2b. more stable section of reach with buffer of hardwoods

Reach 2B joins the main channel from the northern section of the property west of C.C Hayes Road. The upper section of 2B is set within a steep valley that flattens to a broad valley. During the field visits, it was noted that the reach does not maintain surface water through the length of the reach. The stream flow appears to go subterranean 1,200 feet upstream of the confluence with the main channel. It appears that the reach's channel has been relocated along this lower portion. The channel banks appear to be unstable with a BEHI score of High/Very High. The upper section of the reach within the steeper valley is a B5c stream type. This section is moderately stable (Appendix I, photo 10). However, the downstream section of the reach within the broader valley is

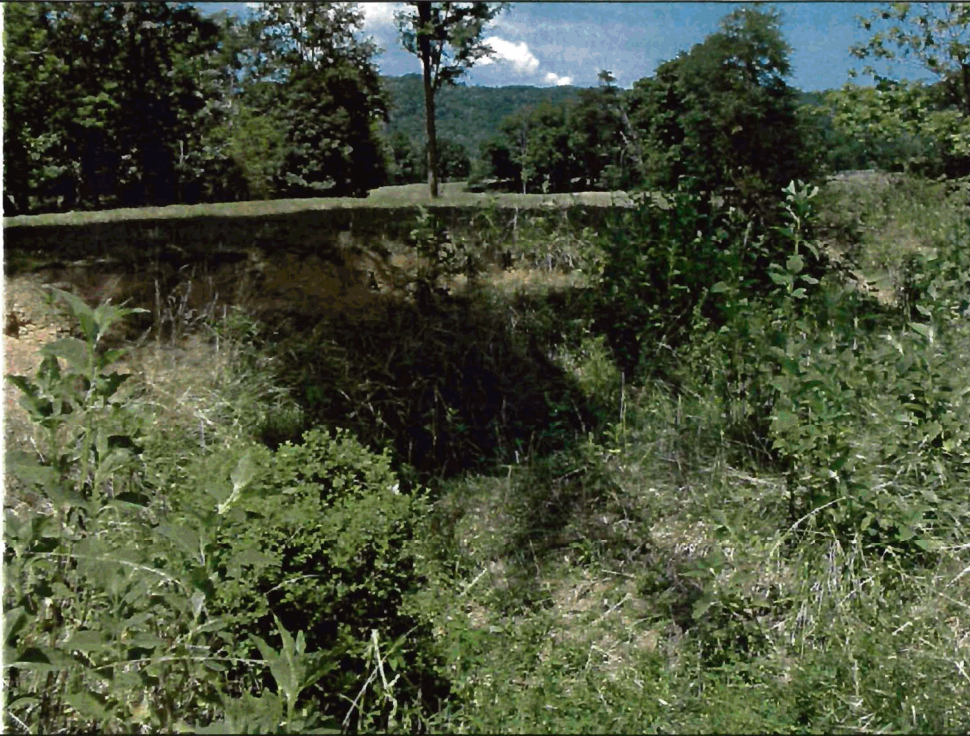
Photo 11: Looking upstream of reach 2b. incised segment of reach with dry channel

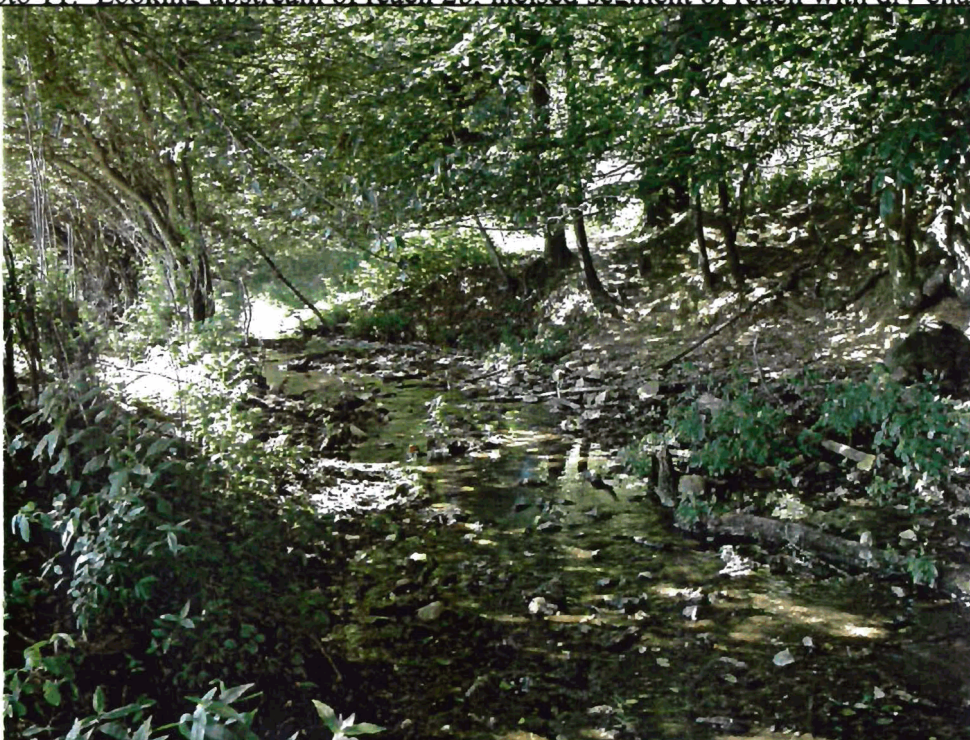
Photo 12: Looking downstream of reach 3. section of reach with hardwood buffer

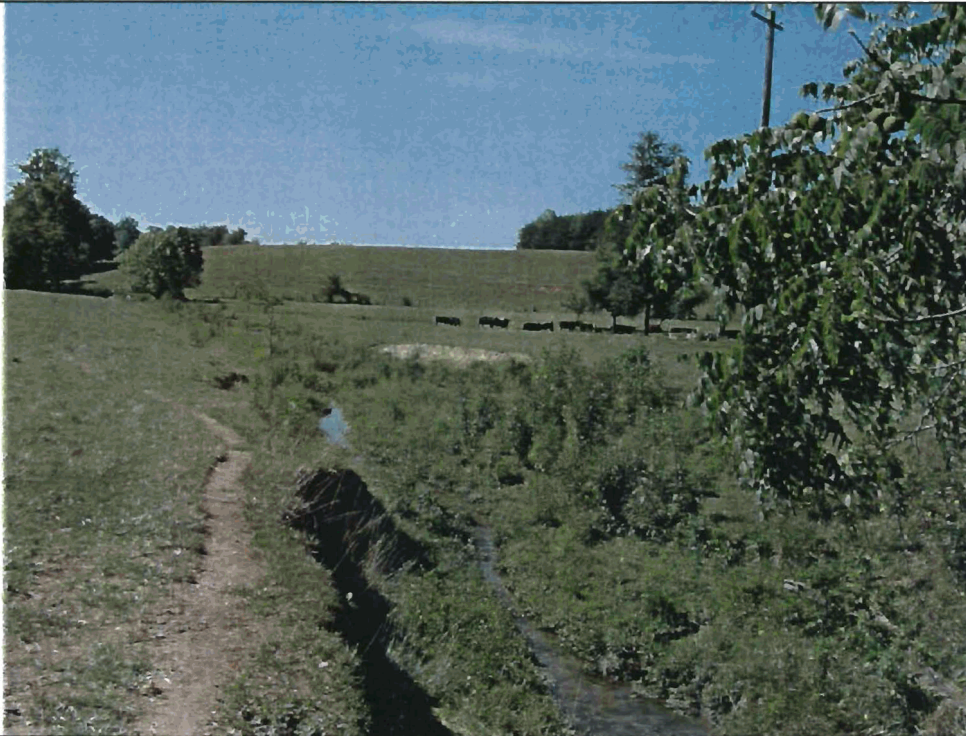
Photo 13: Looking downstream of reach 3. lower section of reach lacking woody buffer

Reach 3 joins the main channel from the northern section of the property east of C.C. Hayes Road. From the furthestmost point upstream to approximately 1,200 feet downstream, the channel retains a vegetative buffer that ranges in widths of 10 to 40 feet. Vegetation within this buffer is mature and features several types of hardwoods (Appendix I, photo 12). Further downstream to the point where the reach joins the main channel, the buffer becomes discontinuous comprised of low-lying shrubs and grazed over grasses (Appendix I, photo 13). This buffer within the lower section provides limited bank protection. Based on field observations, the channel has been relocated to one side of the valley, likely to maximize available pasture for cattle. Abandoned oxbows were visible near the upper section of the reach (Appendix I, photo 14). From field measurements, the stream type is determined to be G4 with a high bank height ratio of 2.4 and a BEHI rating of Very High (Appendix I, photo 15 for picture of steep banks). Entrainment calculations (Appendix D) predict that the channel will continue to degrade and downcut causing further exasperation of bank instability. With further bank instability, the banks may fail, allowing the channel to widen and convert to F stream type. The entire reach is open to grazing and the stream banks have been impacted by cattle access.

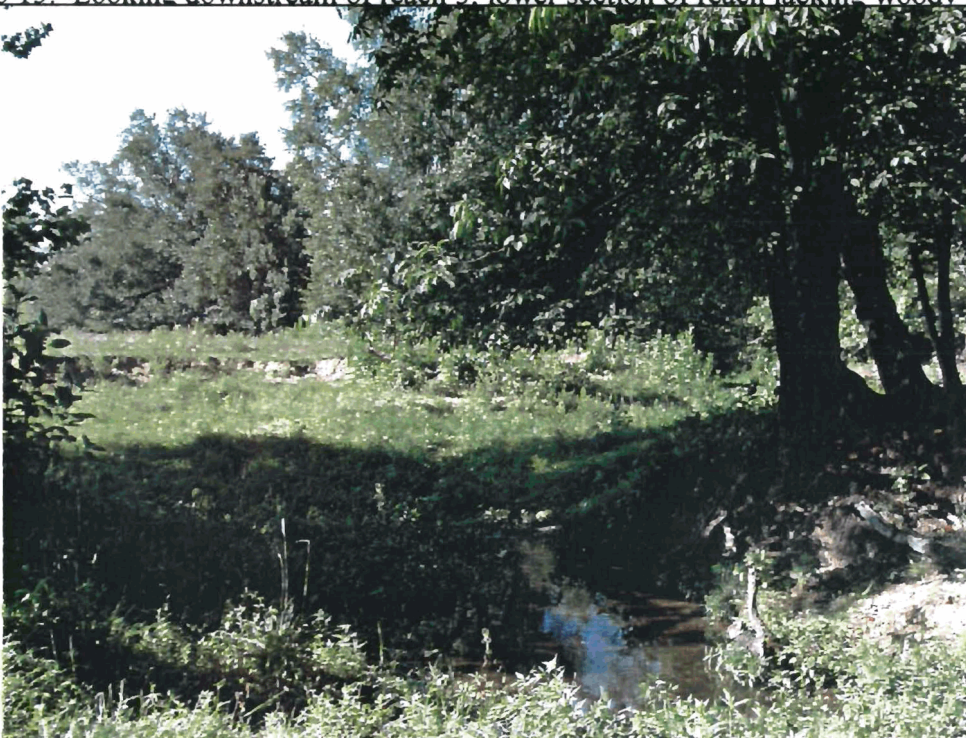
Photo 14: Looking downstream of reach 3. abandoned oxbow to the left of existing stream channel

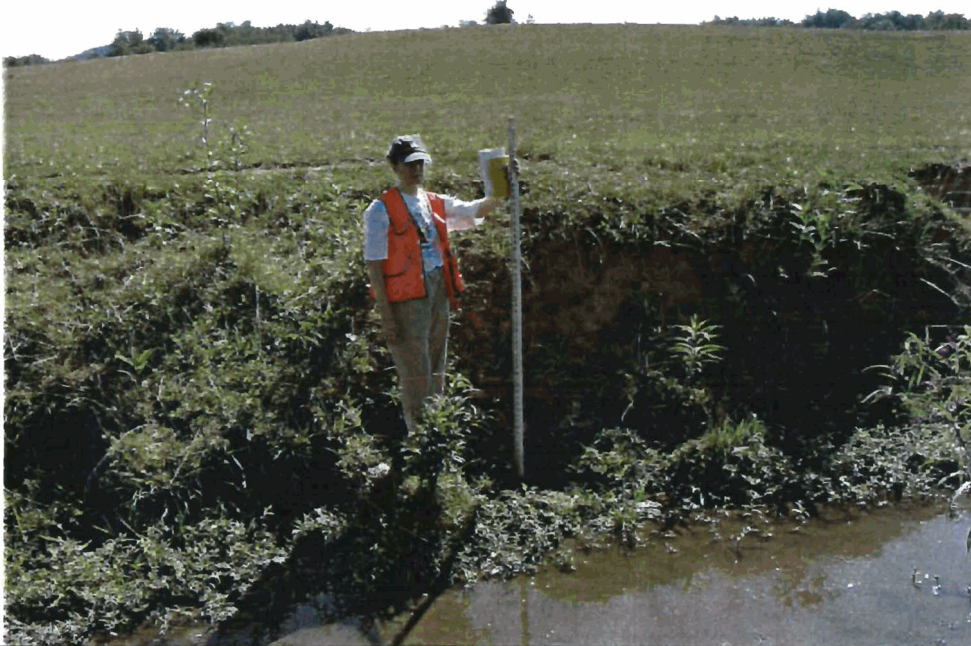
Photo 15: Looking from left bank to right bank of reach 3. notice steep banks
