Executive Summary of Restoration Plan

**Purlear Creek Phase II
Stream and Wetland Restoration Project
Wilkes County, North Carolina
Project ID No. 010559701**

**Prepared by:
Kimley-Horn and Associates, Inc.
3001 Weston Parkway
Cary, North Carolina 27513**

**April 2004
011795013**

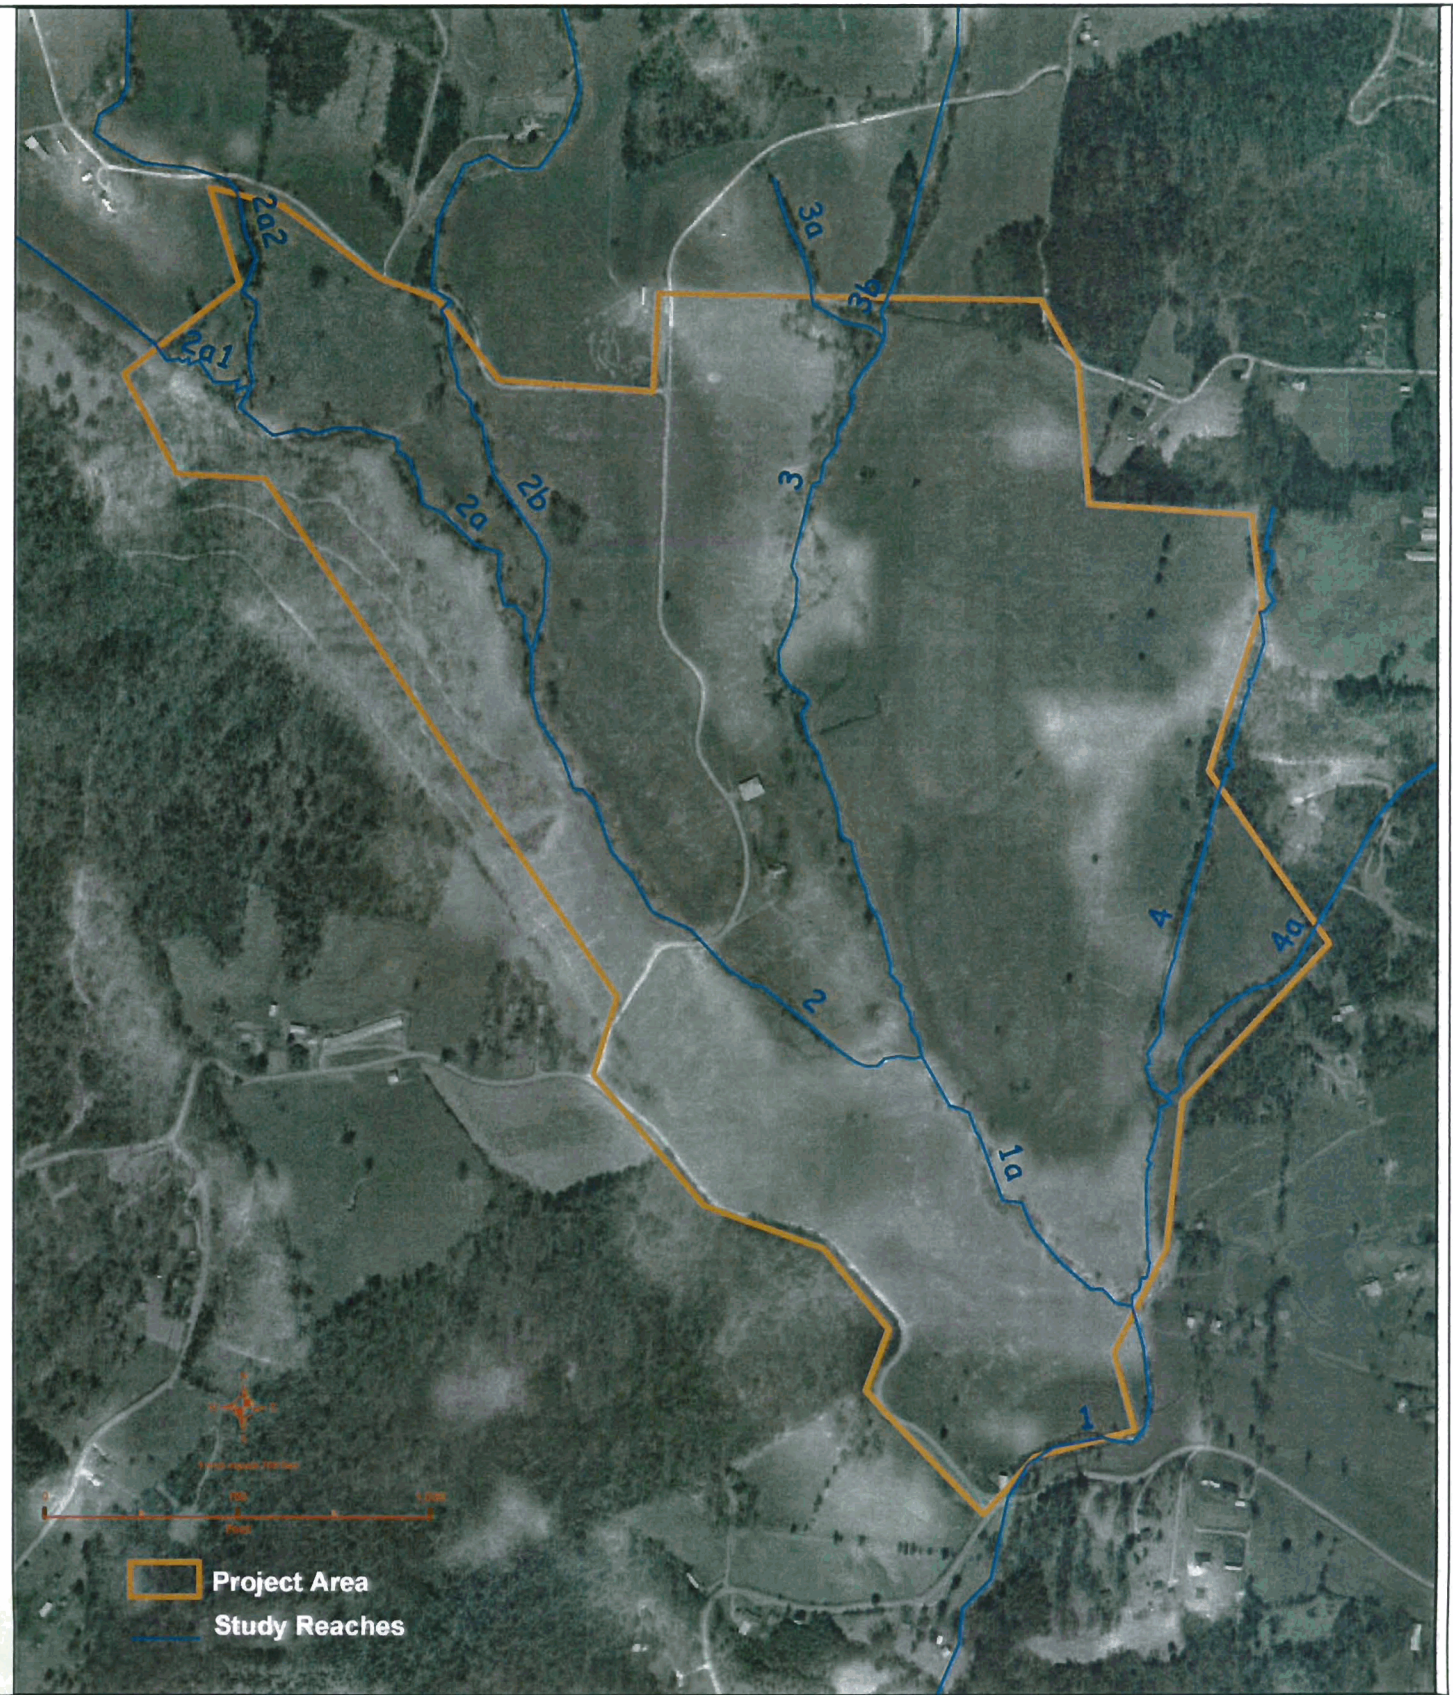
Project: Purlear Creek Restoration, Wilkes County @ Hayes Farm		
Date: 3/3/2004	Scale: 1 inch = 750 feet	Project No. 011795011	Figure: 3

Title: Project Aerial

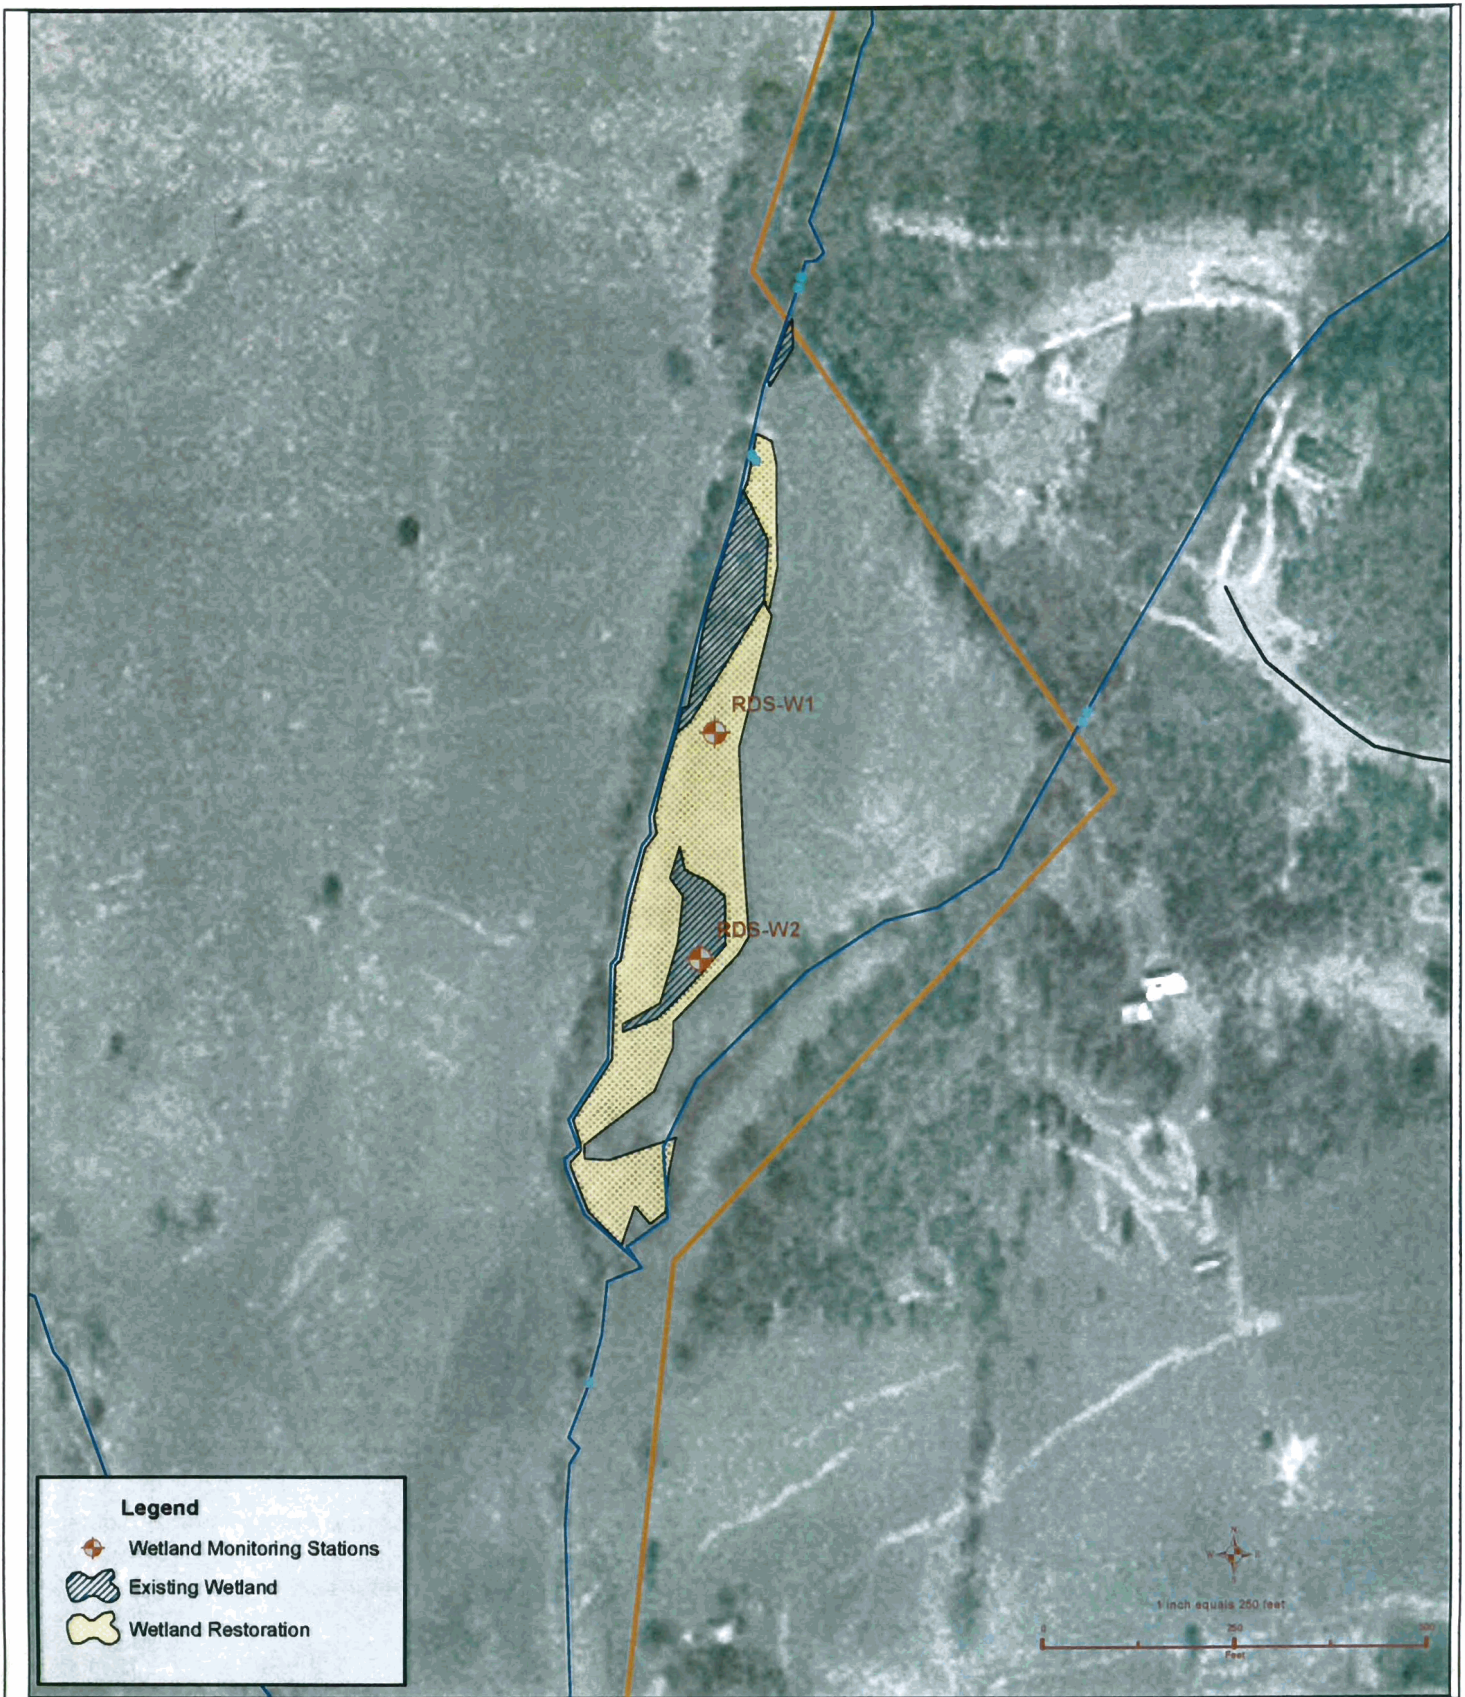
Figure:
6

Title: Wetland Area Monitoring Locations

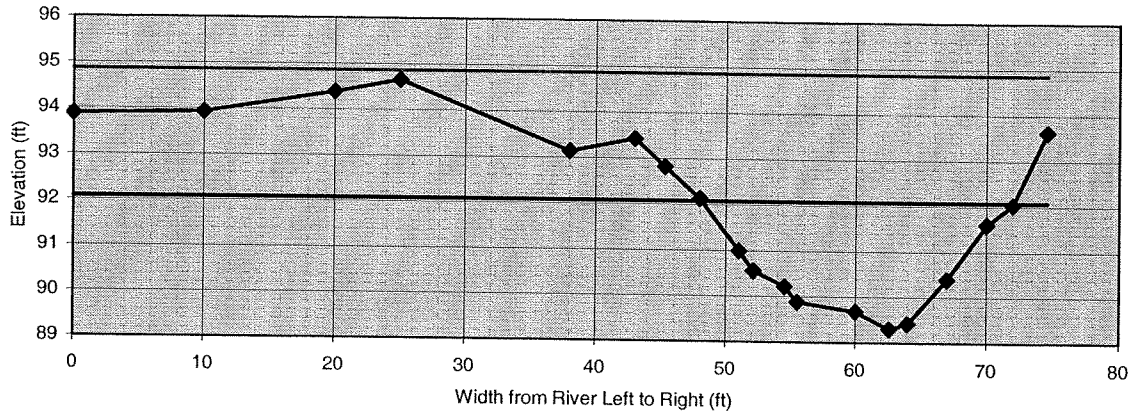
section: Reach 1
 Riffle
 Purlear Creek
 Upper Yadkin (03040101010090) - 03-07-01
 description: X1

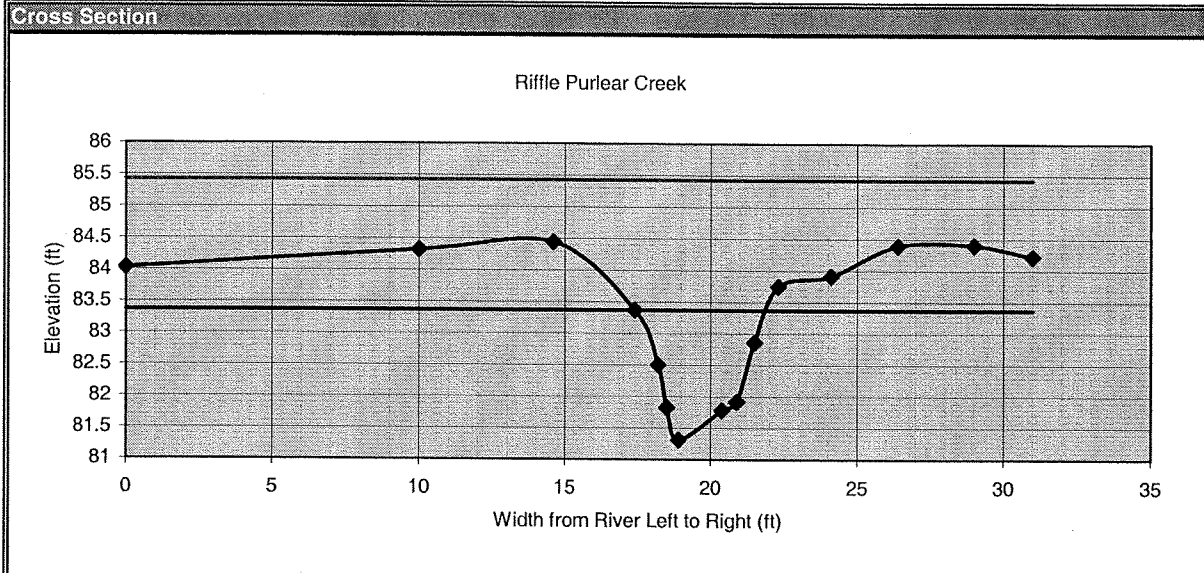
Purlear Creek Reach 4

section: Riffle Purlear Creek

Upper Yadkin (03040101010090) - 03-07-01

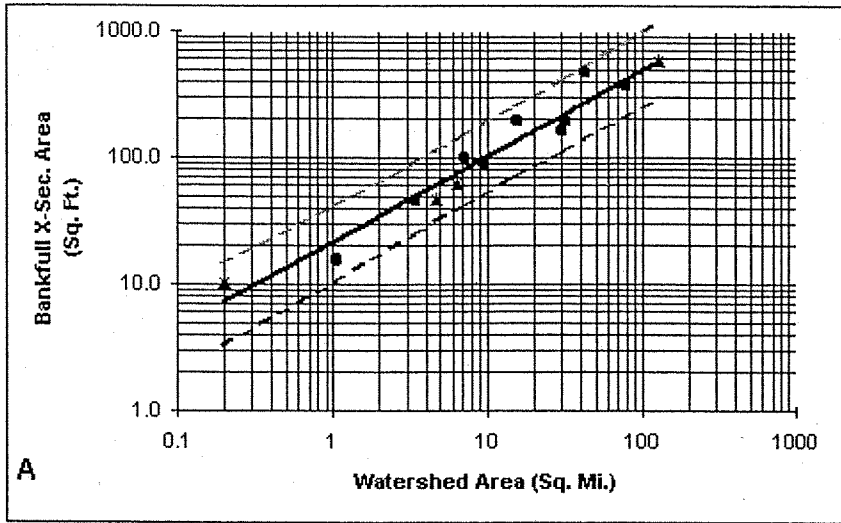
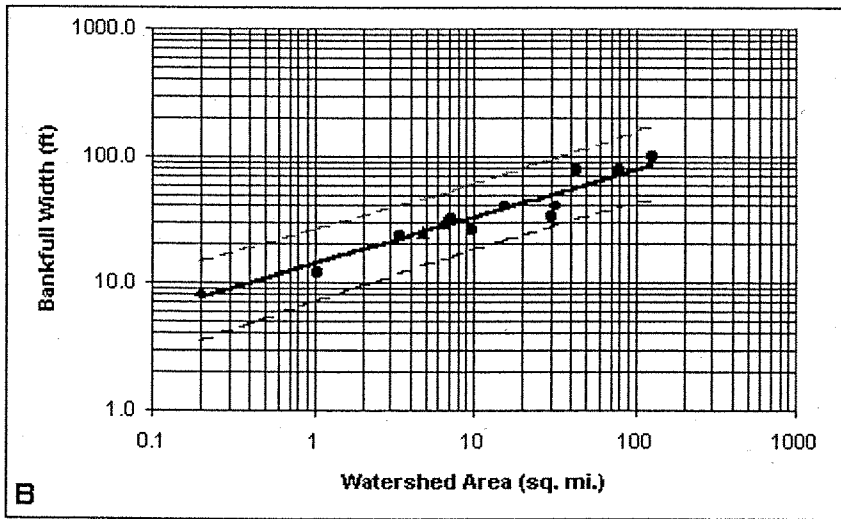
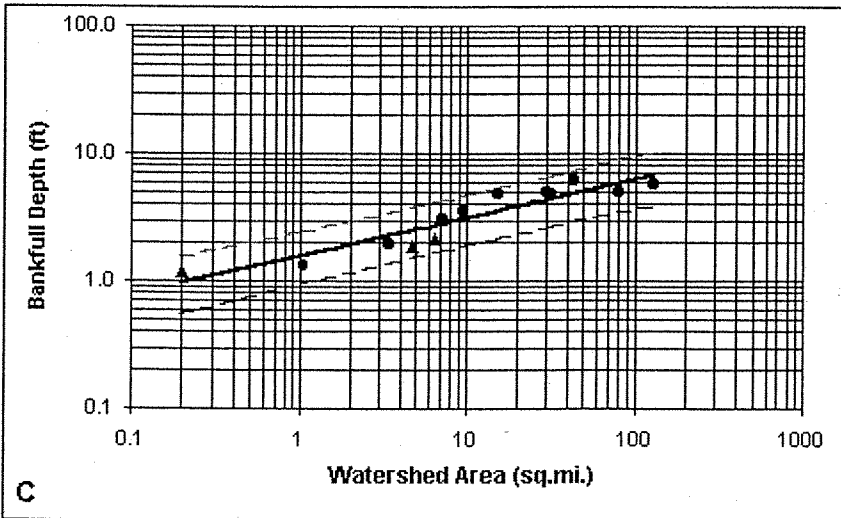
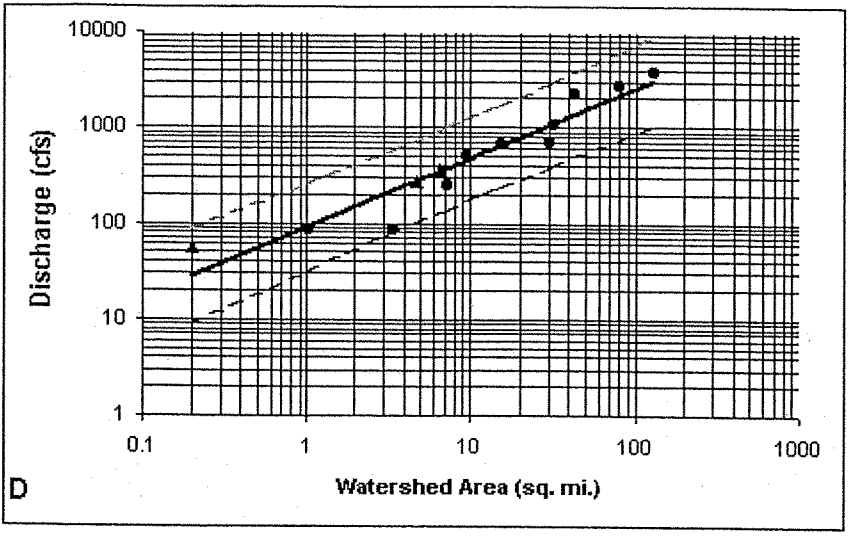
Bankfull hydraulic geometry relationships for rural Piedmont North Carolina Streams. The four graphs represent: a) cross sectional area, b) width, c) depth, and d) discharge. The circles represent gage stations and the triangles represent ungaged streams. The outside dashed lines are the 95% confidence intervals for all the data points.

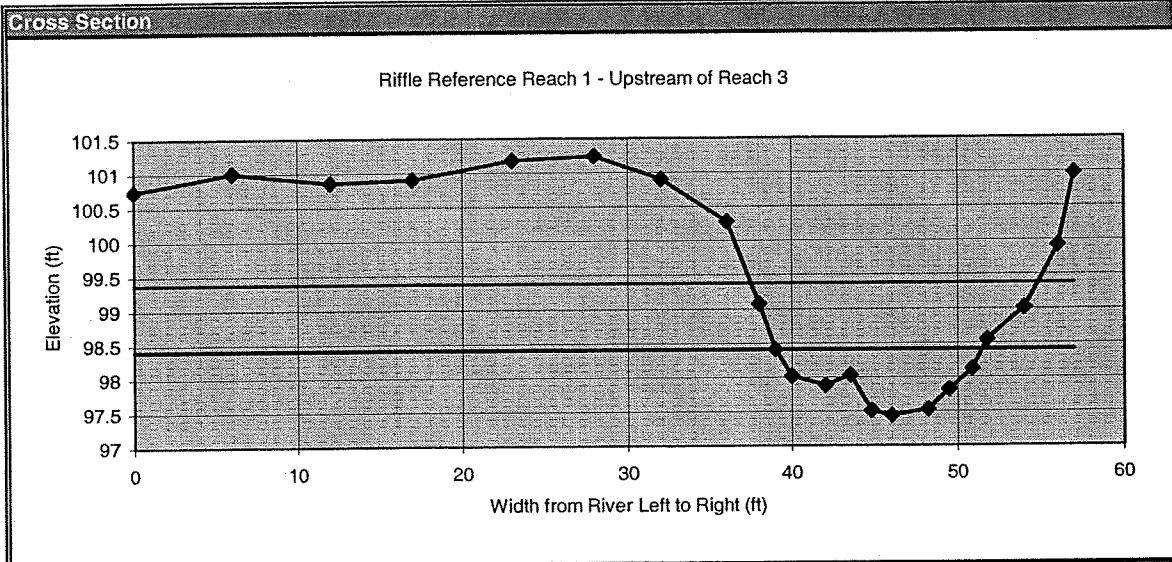
Purlear Creek
Upstream Reference Reach - Cross Section

section:
Riffle
Reference Reach 1 - Upstream of Reach 3
Purlear Creek, Yadkin River Basin

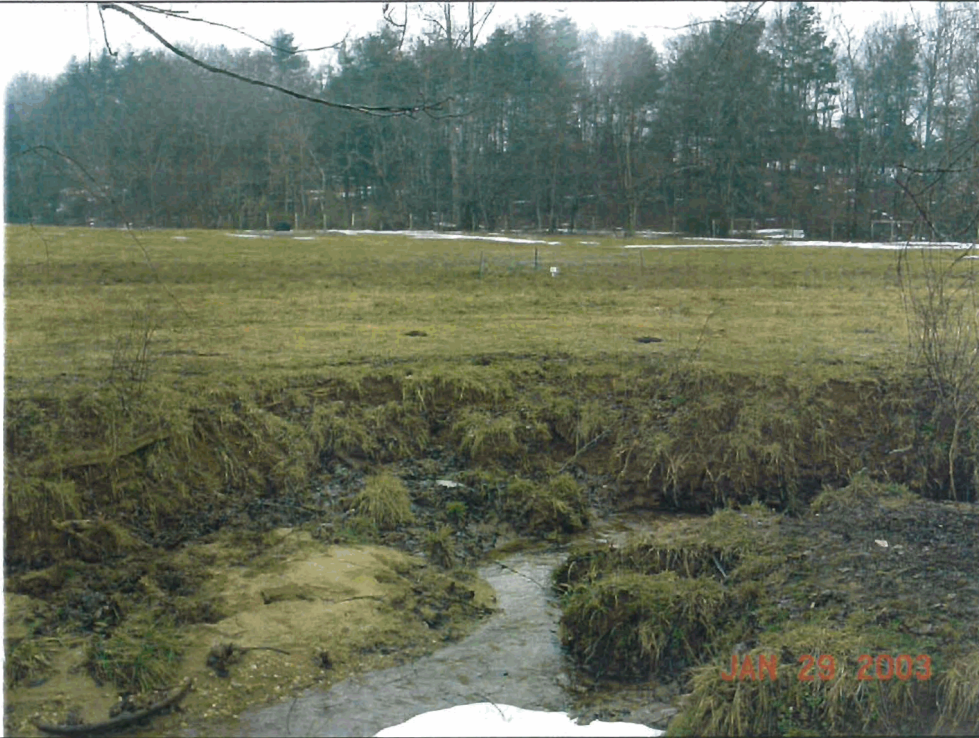
Photo 3: Downstream view of reach 4-(RDS-W2 in background). note downcutting and eroding banks

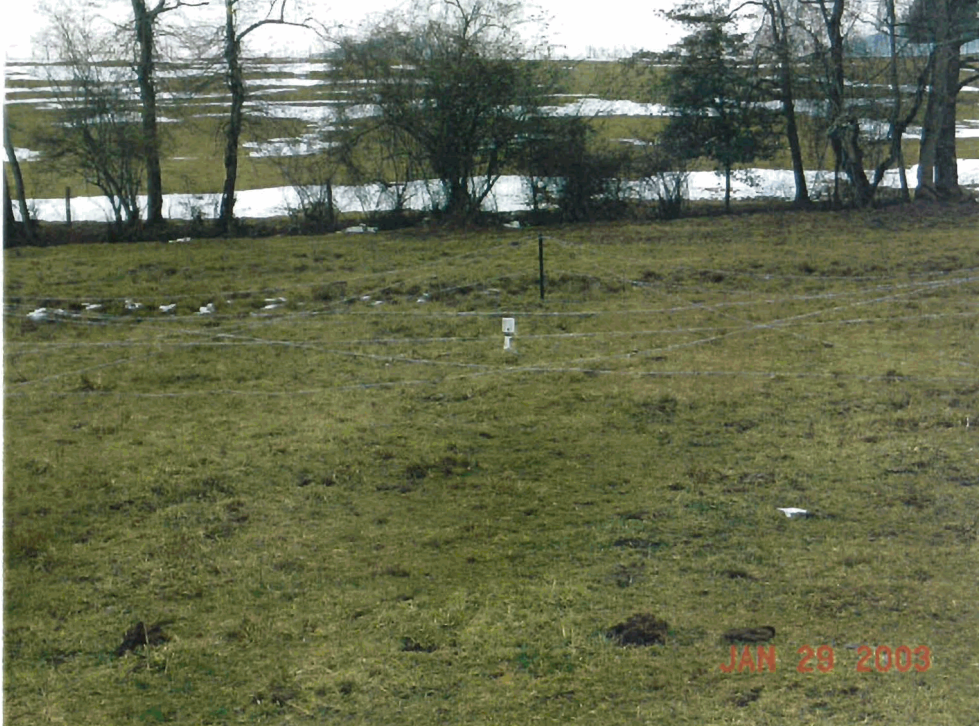
Photo 4: View of RDS-W1 monitoring location. Note straightened stream with minimal buffer in background.

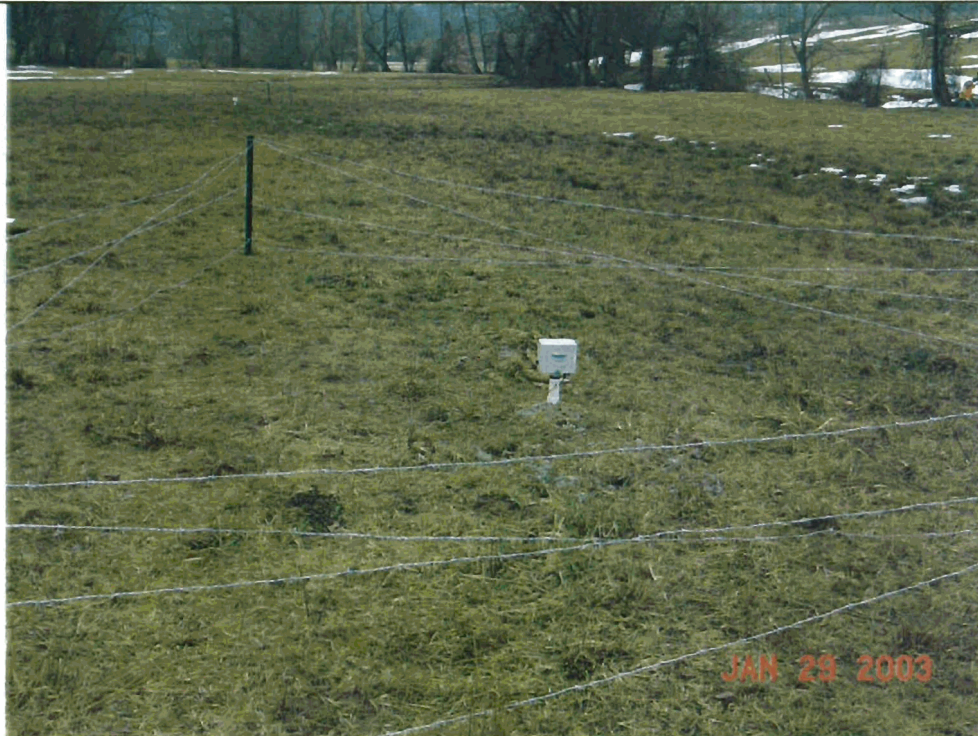
Photo 7: Wetland monitoring stations (RDS-W1 in foreground, RDS-W2 in background) adjacent to reach 4

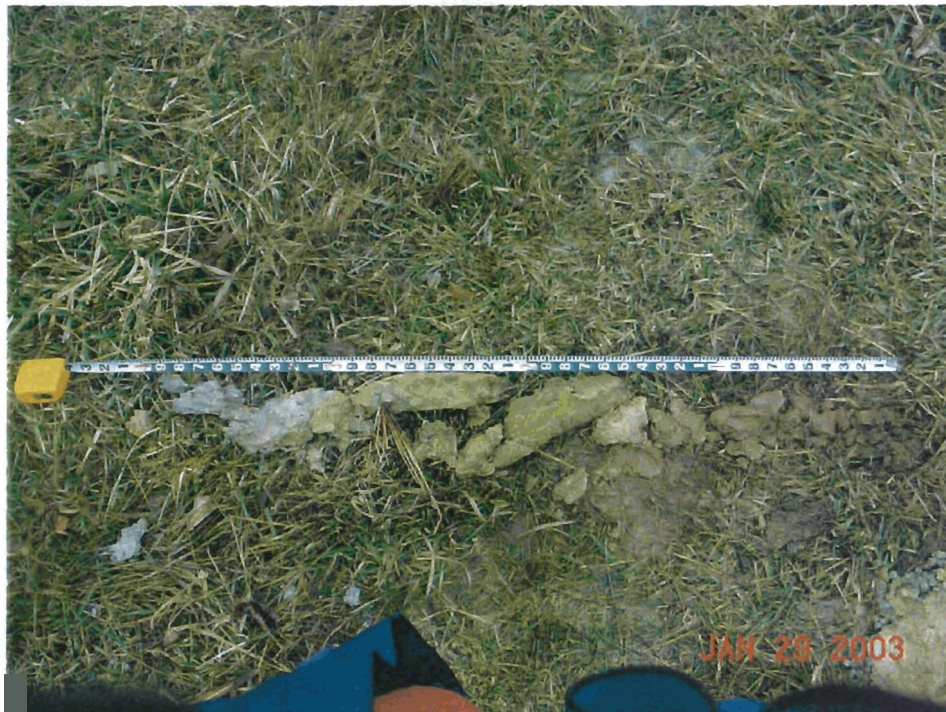
Photo 8: Soil profile (hydric) at the RDS-W2 monitoring location.

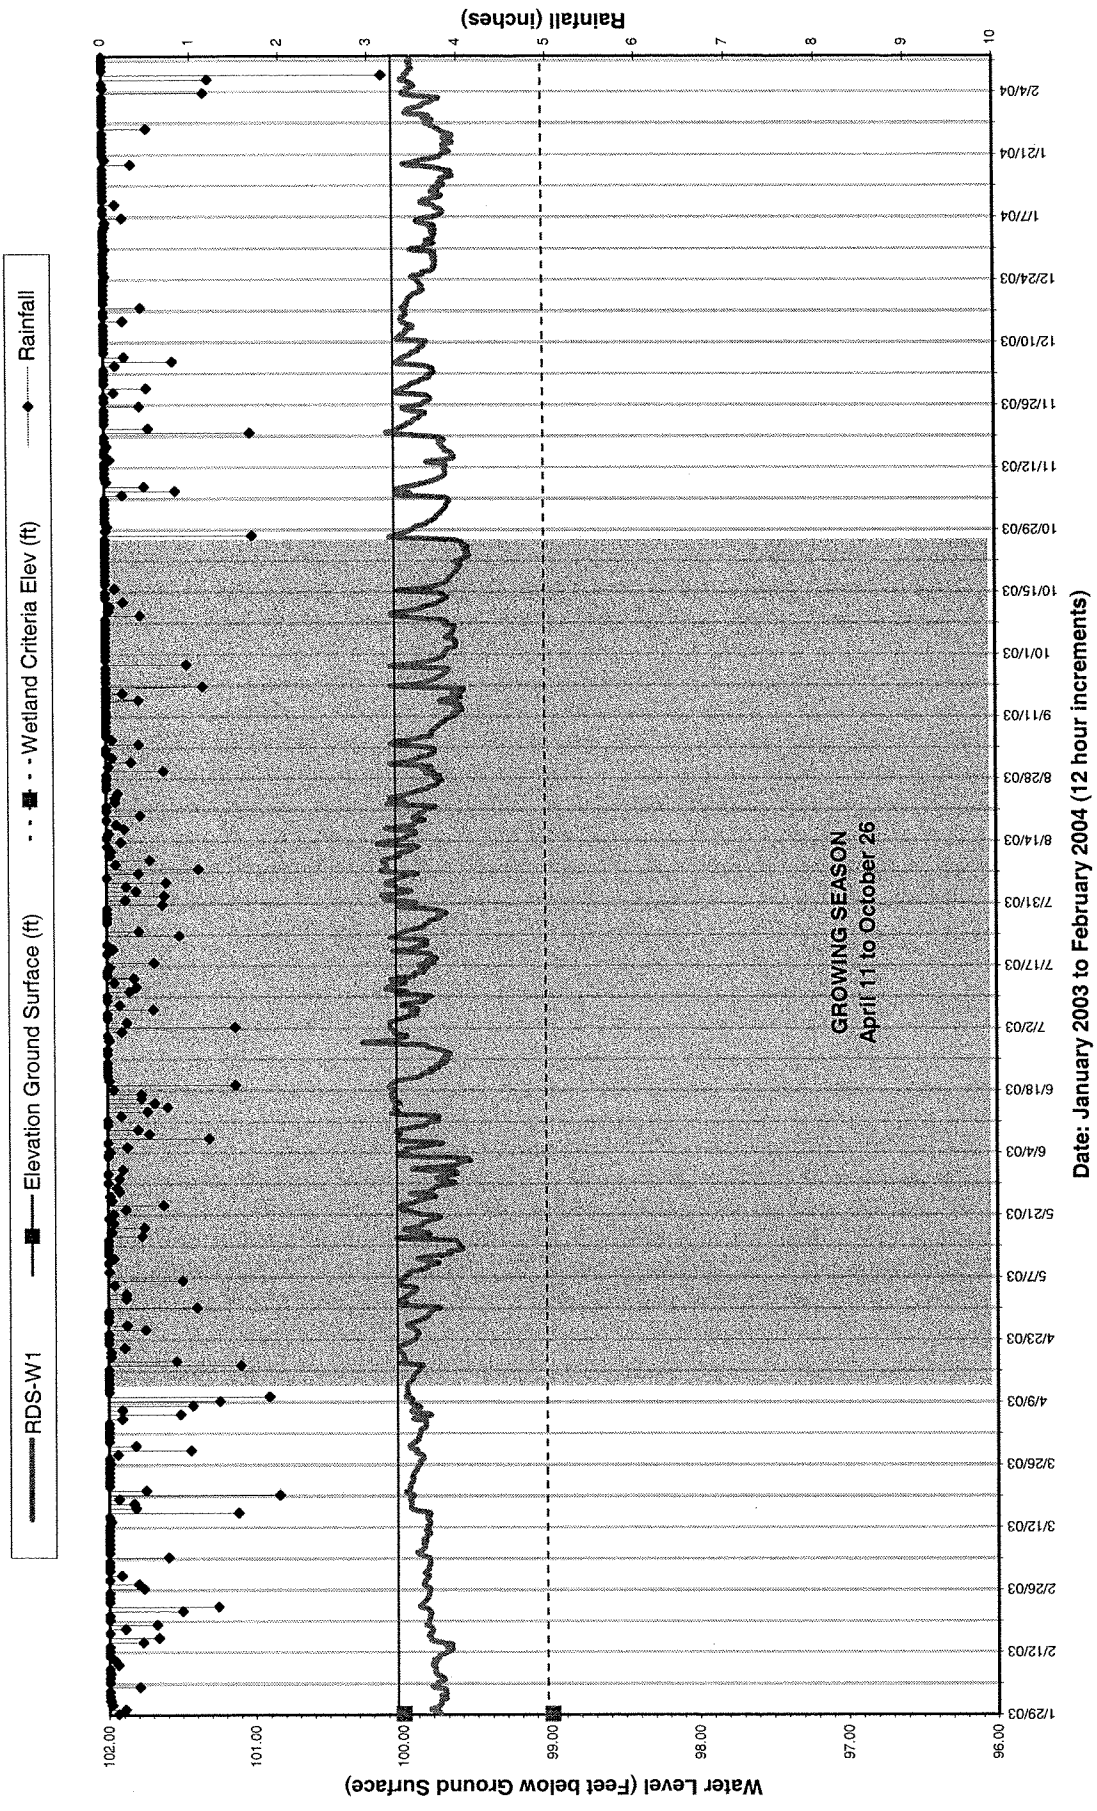
Purlear Creek Wetland Restoration Monitoring Gage

Date: January 2003 to February 2004 (12 hour increments)

GROWING SEASON
April 11 to October 26

The first success criterion for hydrology is determined as achieving inundation and/or saturation within the upper 12 inches of the soil, for consecutive days totaling 12.5% of the growing season. According to the Wilkes County Soil Survey, the growing season is determined as April 11 to October 26 (dates of 28° F in 5 of 10 years, approximating frost-free days). The 1987 Corps of Engineers Wetland Delineation Manual states that areas irregularly inundated or saturated for 5 to 12.5 percent of the growing season generally support wetland hydrology. Therefore, success criteria for hydrology of the wetland restoration will be to achieve 25 consecutive days (12.5%) of saturation in the upper 12 inches of soil,.

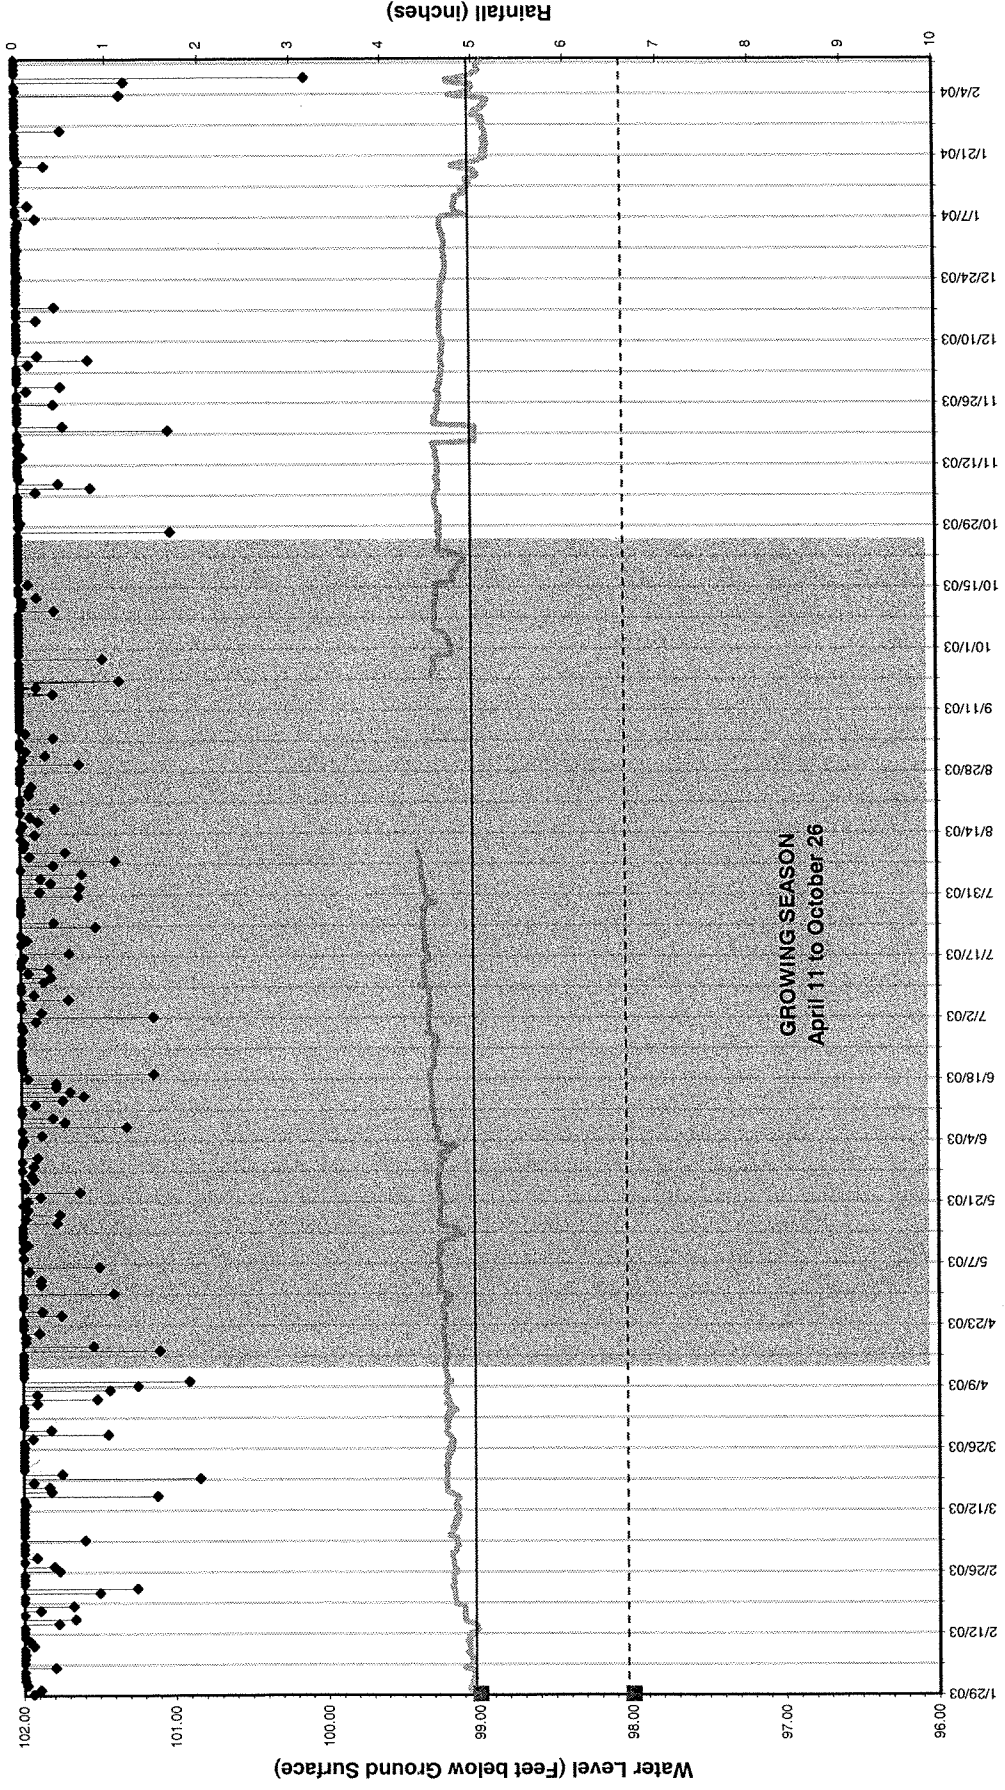
Purlear Creek Wetland Restoration Monitoring Gage

Date: January 2003 to February 2004 (12 hour increments)
