Purlear Creek - Phase II Stream Restoration Annual Monitoring Report

Monitoring Year: 2006

NCEEP Project Number: 010559701

Prepared by: Biological & Agricultural Engineering, North Carolina State University
Campus Box 7625
Raleigh, NC 27695

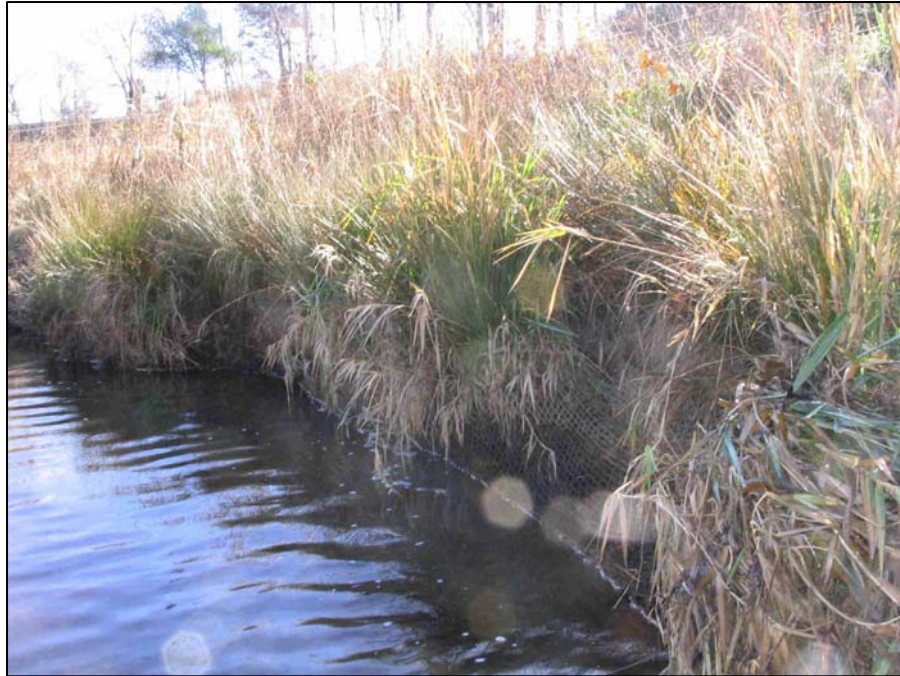
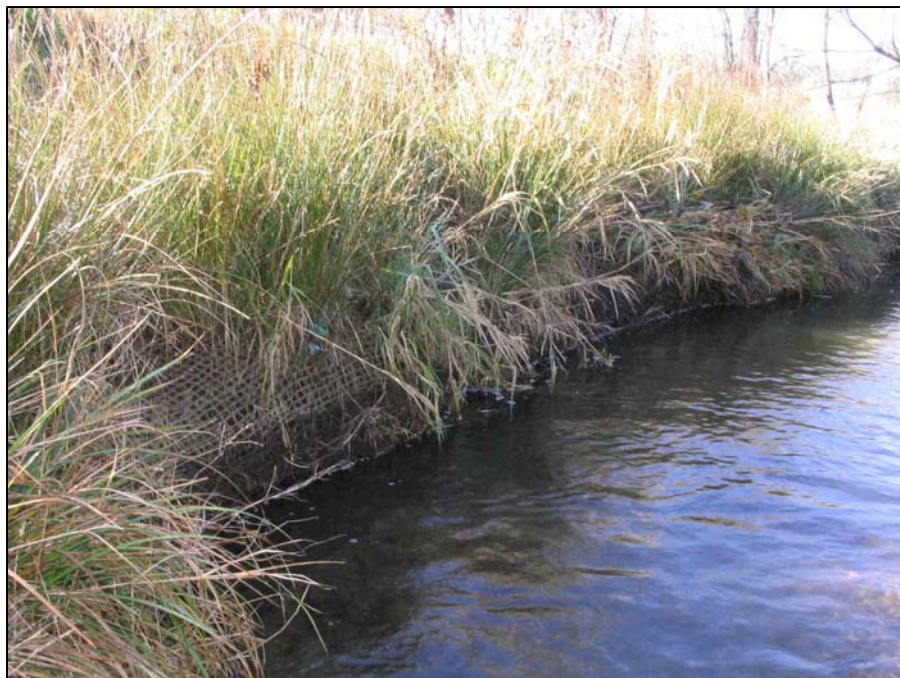
IP1. Reach 1 – Station 5+75 Eroding Bank (Oct. 5, 2007)
(top photo looking upstream, bottom photo looking downstream)

Two areas concern exist on Reach 4. The first is erosion along the outside meander at station 5+75. This area should be monitored to see if further degradation occurs. The second is concentrated flow piping through the buffer at station 9+80. Excess nutrients are bypassing the buffer in this location. The area outside of the buffer should be fenced and the swale cutting through the buffer should be turned into a level spreader to repair this location. Reach 1 has no areas of instability although the upper 300 feet is silting in fairly heavily. The channel will likely adjust to this sediment load over the next few years as vegetation and the channel matures.

Table X. Stream Problem Areas Purlear Creek Phase II / Project ID 010559701					
Feature Issue	Reach	Station numbers	Description	Suspected Cause	Photo number
Bank scour/erosion	1	5+60 to 6+20	Erosion around outside meander	Tight meander and lack of deep rooting vegetation	SP01
	--	--	--	--	--
Piping through Buffer	1	9+75	Nutrient laden water piping through buffer	Wet Seep and heavy cattle usage	SP02
	-			--	--

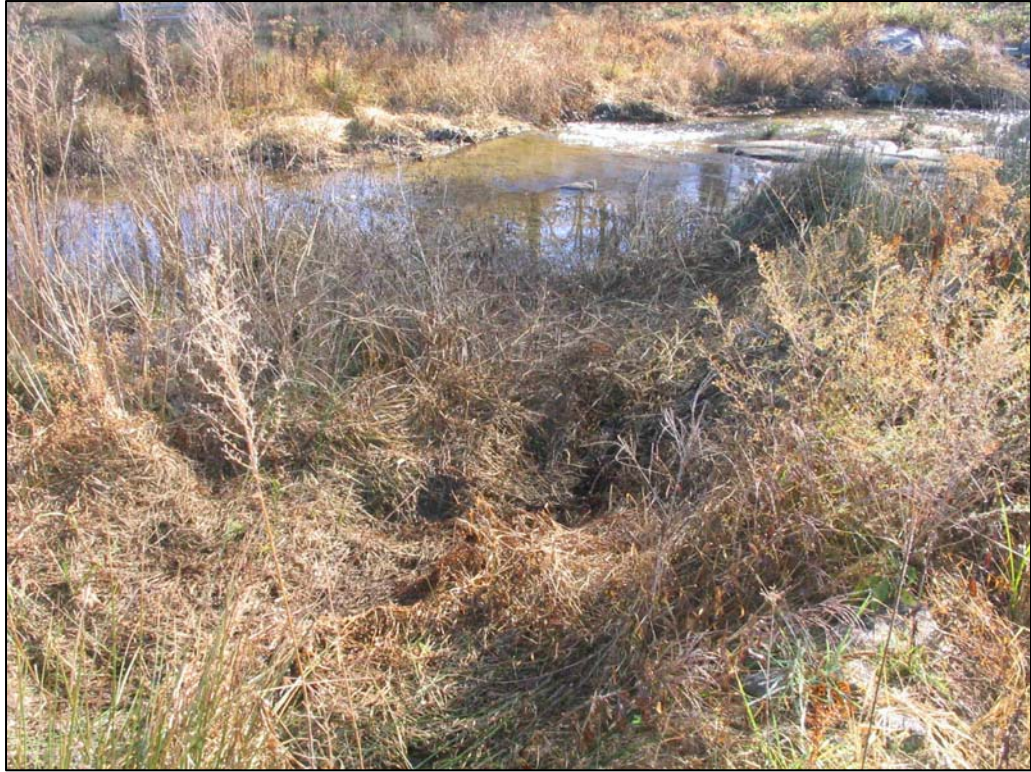
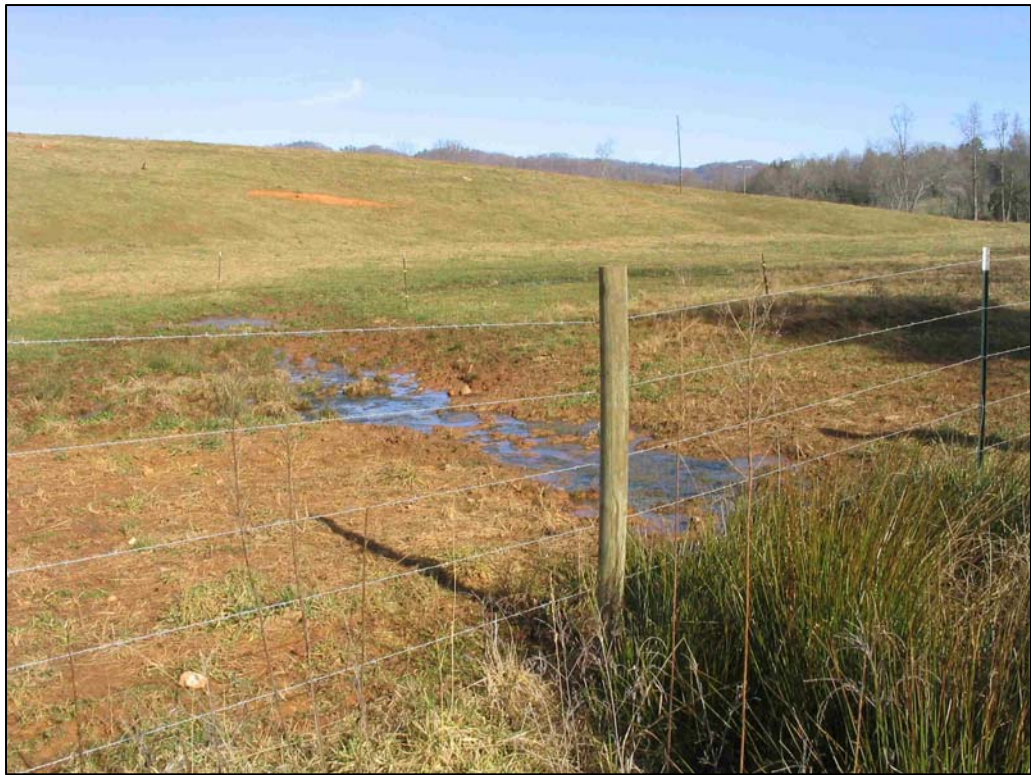
IP2. Reach 1 – Station 9+80 – Concentrated flow into and through the buffer. (Oct. 5, 2007) (top photo – gully through buffer. Bottom photo – seep from field)

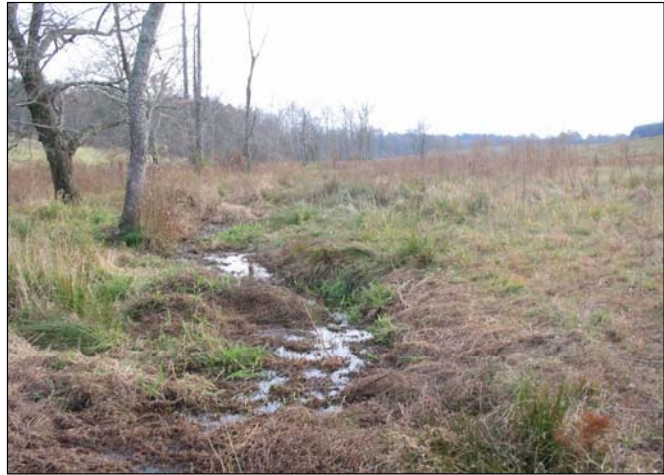
Photo of Cross-Section #1 - Looking Downstream

As-Built	2006
Area	7.31	6.7
Width	17.5	11.1
Mean Depth	0.4	0.6
Max Depth	1.3	1.3
w/d ratio	41.8	18.3
FPW	72	72
ER (greater than)	4.1	6.5
Stream Type	C	C

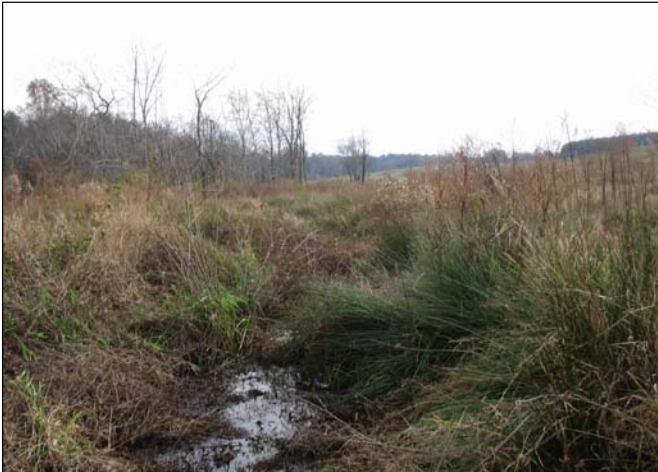
Photo of Cross-Section #2 - Looking Downstream

As-Built	2006
Area	4.9	4.2
Width	6.2	9.4
Mean Depth	0.8	0.4
Max Depth	1.1	1.0

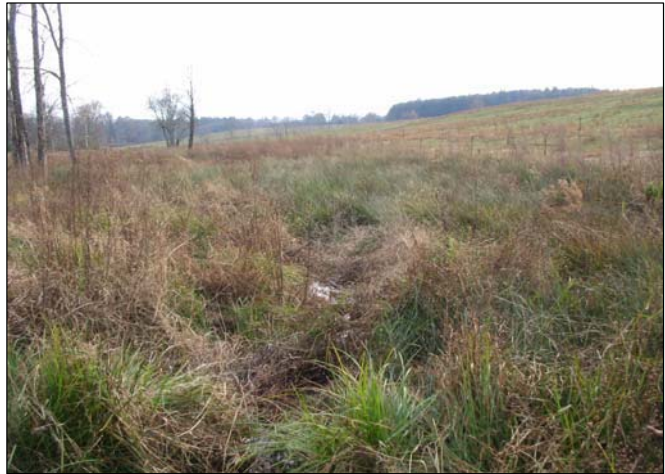
Photo of Cross-Section #3 - Looking Downstream

As-Built	2006
Area	4.93	4.8
Width	10.3	7.8
Mean Depth	0.5	0.6
Max Depth	1.5	1.4
w/d ratio	21.5	12.9
FPW	72	72
ER (greater than)	7.0	9.2
Stream Type	C	C

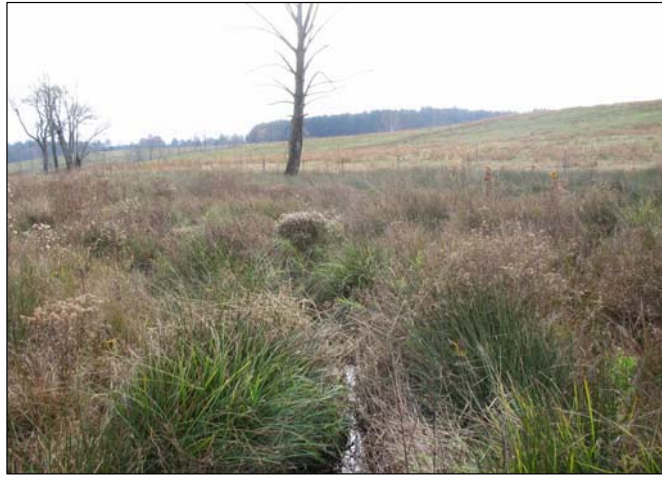
Photo of Cross-Section #4 - Looking Downstream

As-Built	2006
Area	12.1	14.4
Width	11.3	17.2
Mean Depth	1.1	0.8
Max Depth	2.2	2.5

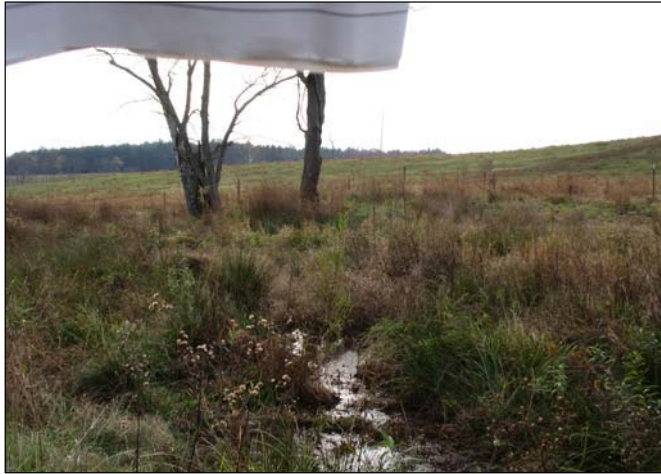
Photo of Cross-Section #5 - Looking Downstream

As-Built	2006
Area	5.1	7.0
Width	10.1	9.9
Mean Depth	0.5	0.7
Max Depth	0.9	1.4
w/d ratio	20.0	14.0
FPW	46	46
ER (greater than)	4.5	4.6
Stream Type	C	C

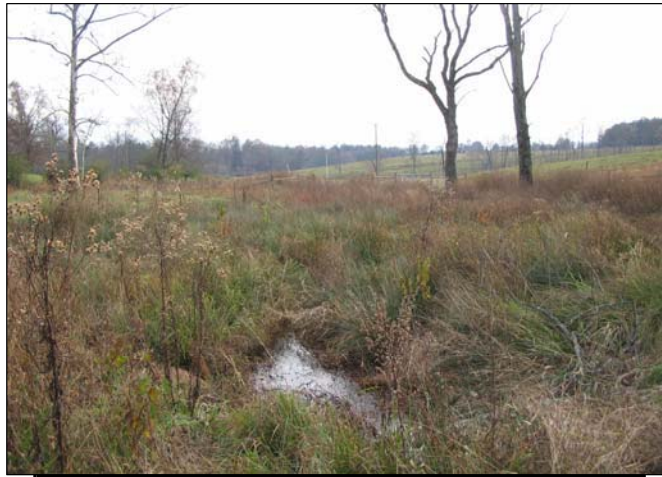
Photo of Cross-Section #6 - Looking Downstream

As-Built	2006
Area	6.1	7.9
Width	8.4	8.0
Mean Depth	0.7	1.0
Max Depth	1.3	1.7

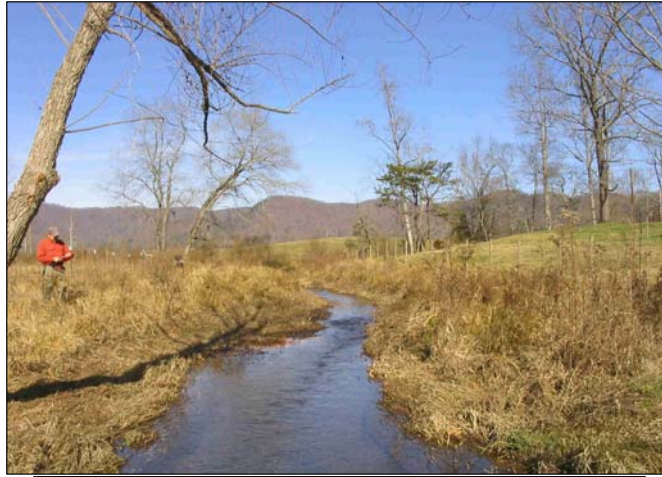
Photo of Cross-Section #7 - Looking Downstream

As-Built	2006
Area	25.2	23.1
Width	25.2	20.4
Mean Depth	1.0	1.1
Max Depth	1.9	1.9
w/d ratio	25.1	18.0
FPW	50	50
ER (greater than)	2.0	2.4
Stream Type	C	C

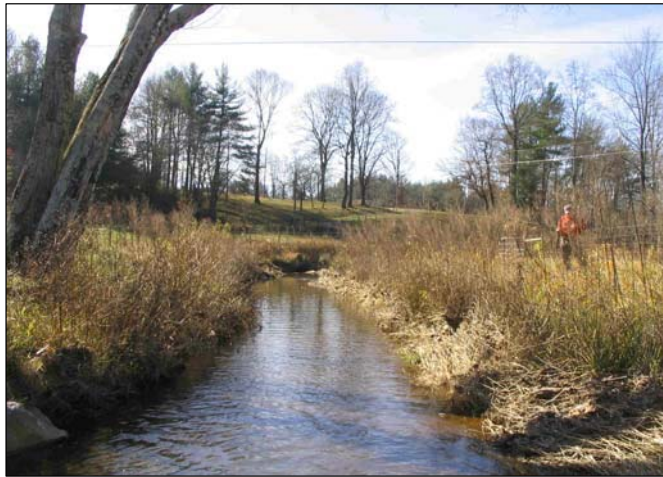
Photo of Cross-Section #8 - Looking Downstream

As-Built	2006
Area	44.21	54.8
Width	35.4	31.3
Mean Depth	1.2	1.8
Max Depth	3.4	3.5
w/d ratio	28.3	17.9
FPW	98	98
ER (greater than)	2.8	3.1
Stream Type	C	C

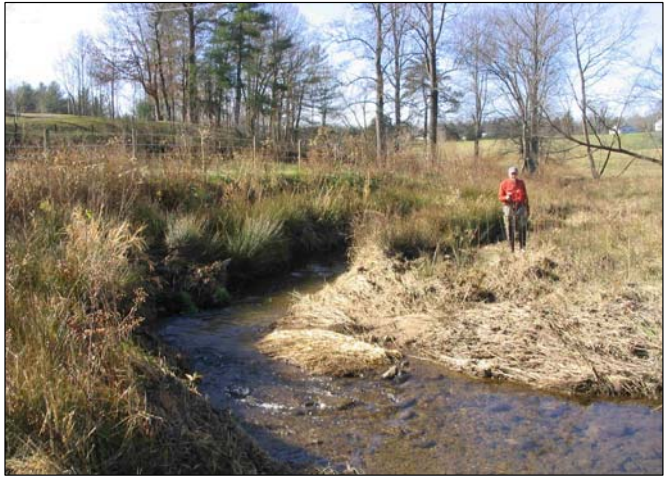
Photo of Cross-Section #9 - Looking Downstream

As-Built	2006
Area	33.8	31.5
Width	29.2	28.8
Mean Depth	1.2	1.1
Max Depth	3.4	3.2

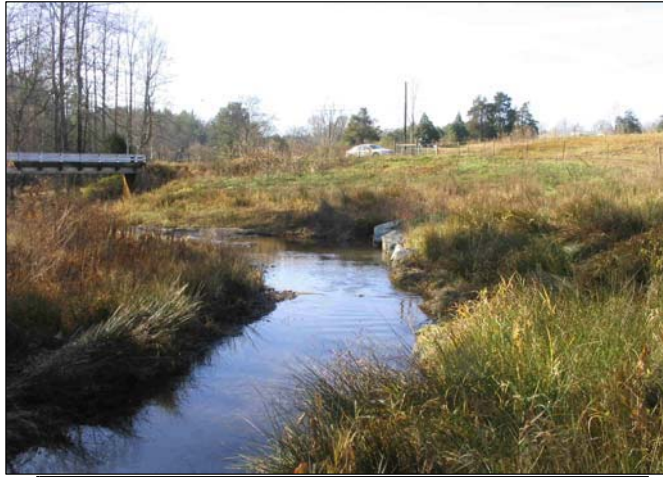
Photo of Cross-Section #10 - Looking Downstream

As-Built	2006
Area	40.0	42.4
Width	28.3	34.5
Mean Depth	1.4	1.2
Max Depth	2.9	3.0

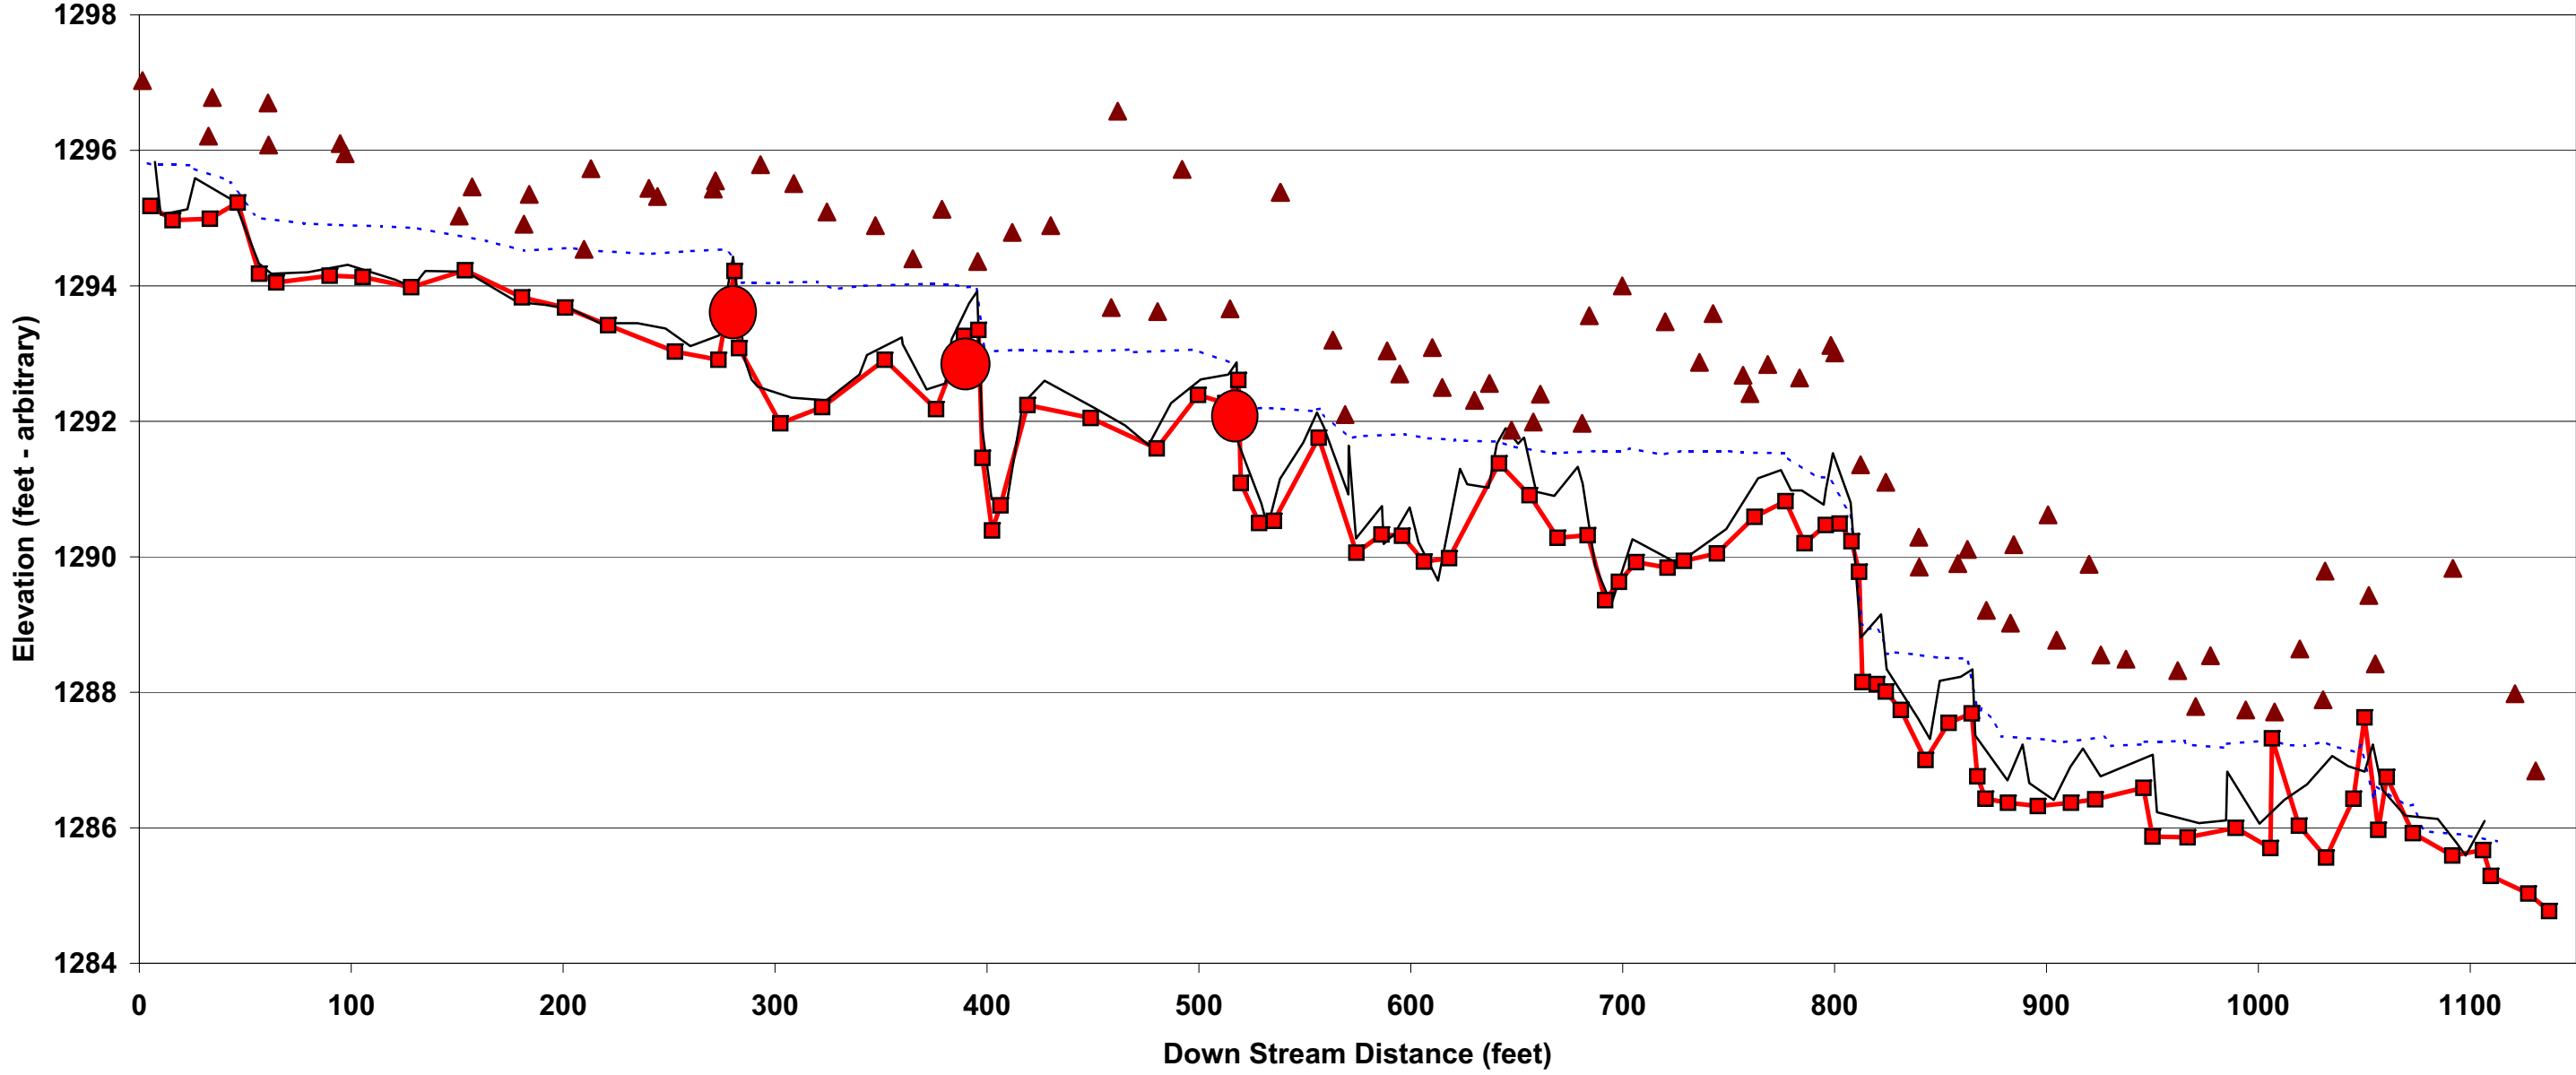
**Purlear Phase 2
Longitudinal Profile
2006 - Reach 4
Main Channel**

The channel profile is similar to the as-built survey condition, with the majority of bedform features maintaining their locations and depths. Channel cross sections show some adjustment as a result of heavy sediment loads entering the channel from upstream. As the restored channel and vegetation matures, the channel should adjust to this sediment load. Channel thalweg is being maintained in the proper location and banks show no signs of degrading.

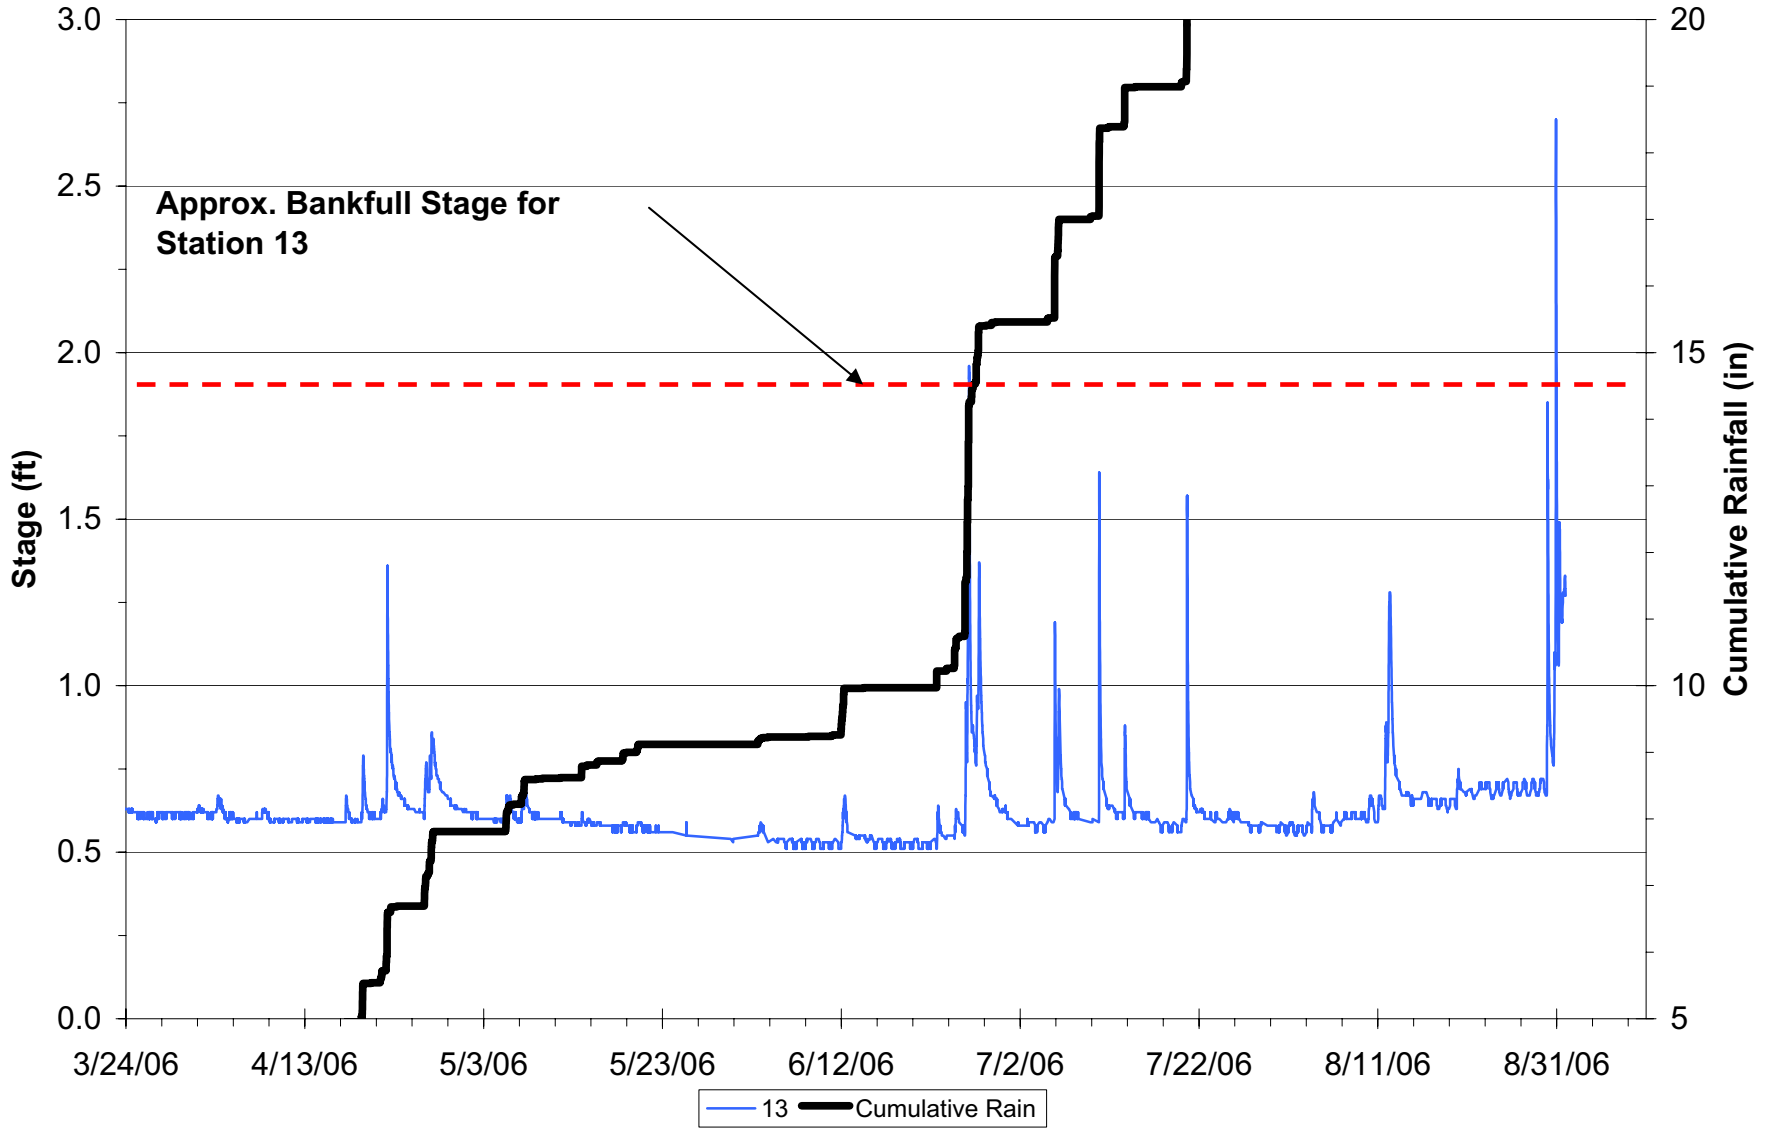
2006 Stage Data for Purlear Creek Phase 2

Vegetation is performing excellent on both reaches. The wetlands appear to be exceeding minimal conditions for hydrology but both groundwater wells have failed to function. New wells should be installed this winter.
