Purlear Creek - Phase II Stream Restoration Annual Monitoring Report

Monitoring Year: 2008

NCEEP Project Number: 010559701

PURLEAR CREEK - PHASE II STREAM RESTORATION 2008 MONITORING REPORT

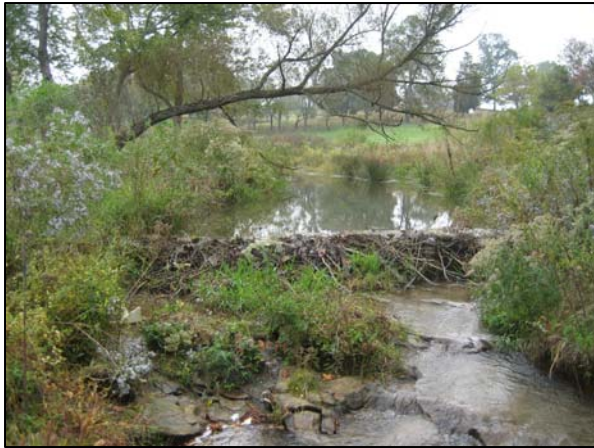
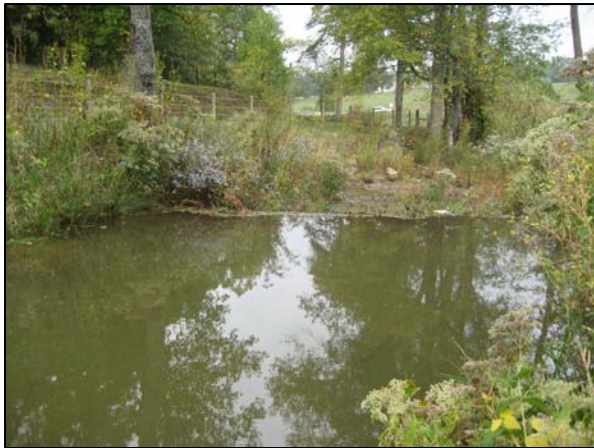
One problem area was identified in Reach 1. Problem area 3 (PA 3) consists of a beaver dam on Reach 1 that was first observed in 2007. The beaver dam was still intact during the July 2008 survey and October 2008 photographs. The beaver dam is backing up water, obstructing flow, and trapping sediment upstream of the dam. It is recommended that the beaver dam be removed so the stream can flow as intended.

PA3. Reach 1 – Station 7+69 – Beaver dam

The problem area Table B1, plan sheet and photographs can be found in Appendix B. Two problem areas were identified in the 2006 monitoring report in Reach 1. Problem area 1 and problem area 2 from previous monitoring reports appeared to stabilize in 2008. Both areas shall continue to be monitored in subsequent monitoring events. Problem area 3 (PA 3) consists of a beaver dam on Reach 1 that was first observed in 2007. The beaver dam was still intact during the July 2008 survey and October 2008 photographs. The beaver dam is backing up water, obstructing flow, and trapping sediment upstream of the dam. It is recommended that the beaver dam be removed so the stream can flow as intended.

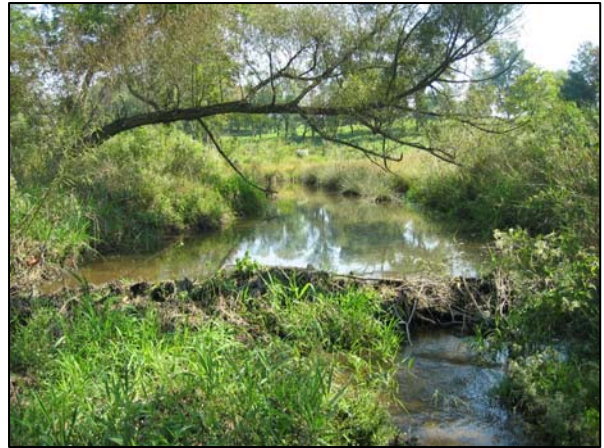
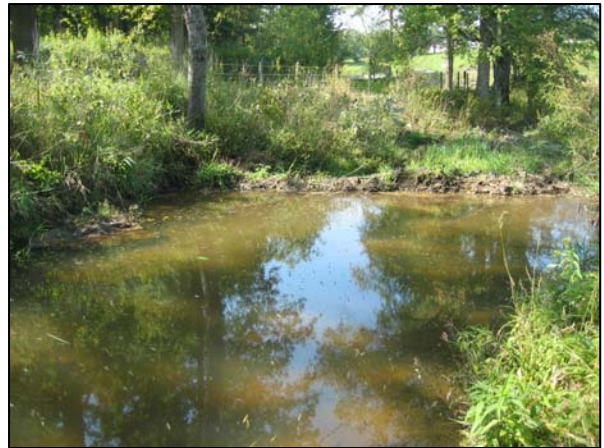
Feature Issue	Reach	Station numbers	Description	Suspected Cause	Photo number
Beaver dam	1	7+69	Beaver dam backing up water and impeding flow	Beaver activity	PA03
	-			--	--
Cattle Intrusion	4	Throughout	Cattle observed within the fenced in buffer	Inadequate fencing	PA04
	-			--	--

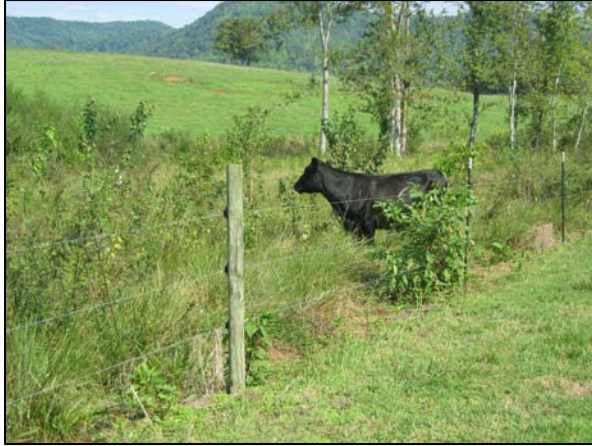
One problem area (PA4) was noted in Reach 4. Cows were observed within the fenced buffer on two separate occasions during the 2008 monitoring period. Cows in the buffer area can have a negative impact on water quality, streambank stability, and riparian vegetation.

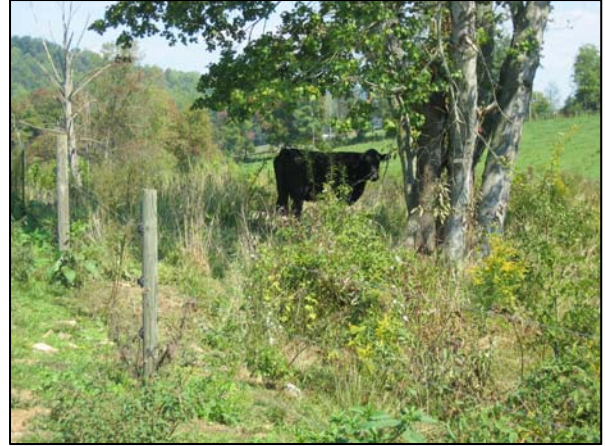
**PA4. Reach 4 – Throughout – Cattle observed in fenced
buffer**

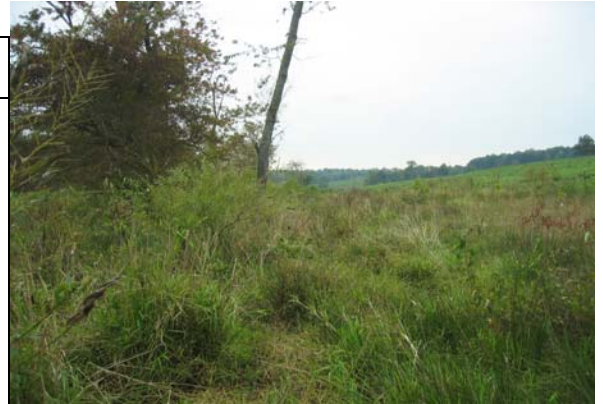
Photo of Cross-Section #1 - Looking Downstream

As-Built	2006	2007	2008
Area	7.31	6.7		3.8
Width	17.5	11.1		17.3
Mean Depth	0.4	0.6		0.2
Max Depth	1.3	1.3		0.5
wid ratio	41.8	18.3		78.8
FPW	72	72		72
ER (greater than)	4.1	6.5		4.2
Stream Type	C	C		C

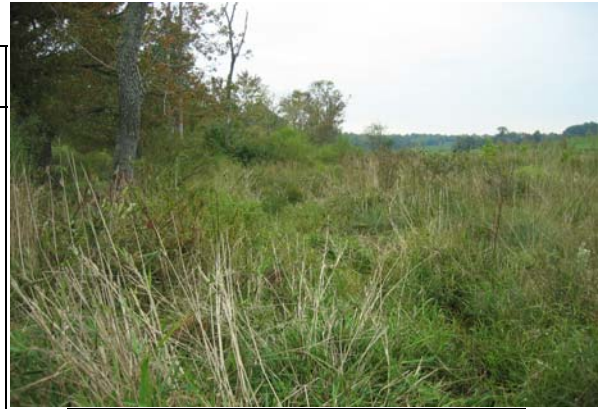
Photo of Cross-Section #2 - Looking Downstream

As-Built	2006	2007	2008
Area	4.9	4.2	5.9	2.7
Width	6.2	9.4	10.8	7.5
Mean Depth	0.8	0.4	0.6	0.4
Max Depth	1.1	1.0	0.9	1.1

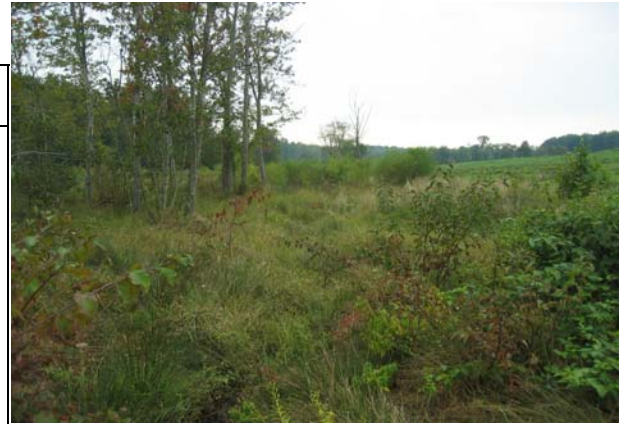
Photo of Cross-Section #3 - Looking Downstream

As-Built	2006	2007	2008
Area	4.93	4.8	4.3	3.2
Width	10.3	7.8	7.3	9.0
Mean Depth	0.5	0.6	0.6	0.4
Max Depth	1.5	1.4	1.4	0.9
Wid ratio	21.5	12.9	12.3	25.3
FPW	72	72	72	72
ER (greater than)	7.0	9.2	9.9	8.0
Stream Type	C	C	C	C

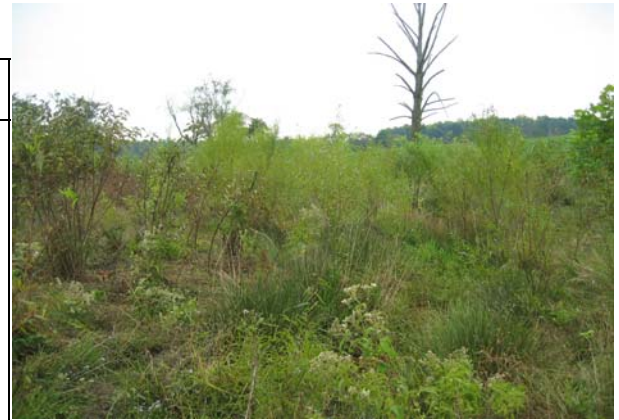
Photo of Cross-Section #4 - Looking Downstream

As-Built	2006	2007	2008
Area	12.1	14.2	13.3	13.6
Width	11.3	13.7	10.3	13.2
Mean Depth	1.1	1.0	1.3	1.0
Max Depth	2.2	2.5	2.6	2.5

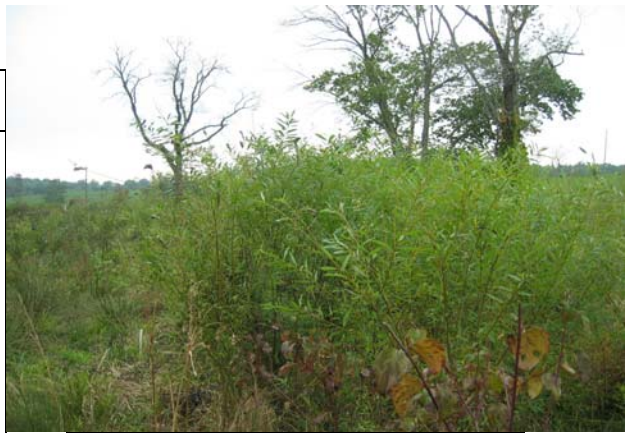
Photo of Cross-Section #5 - Looking Downstream

As-Built	2006	2007	2008
Area	5.1	7.0	6.2	5.6
Width	10.1	9.9	8.8	10.1
Mean Depth	0.5	0.7	0.7	0.6
Max Depth	0.9	1.4	1.3	1.2
w/d ratio	20.0	14.0	12.5	18.2
FPW	46	46	46	46
ER (greater than)	4.5	4.6	5.2	4.6
Stream Type	C	C	C	C

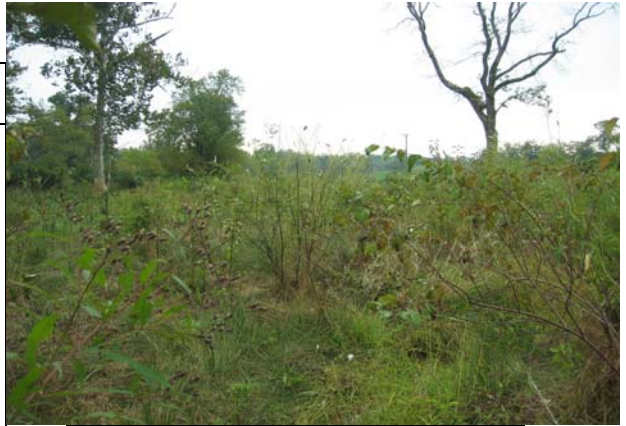
Photo of Cross-Section #6 - Looking Downstream

As-Built	2006	2007	2008
Area	6.1	7.9	8.2	7.0
Width	8.4	8.0	10.9	9.8
Mean Depth	0.7	1.0	0.8	0.7
Max Depth	1.3	1.7	1.9	1.9

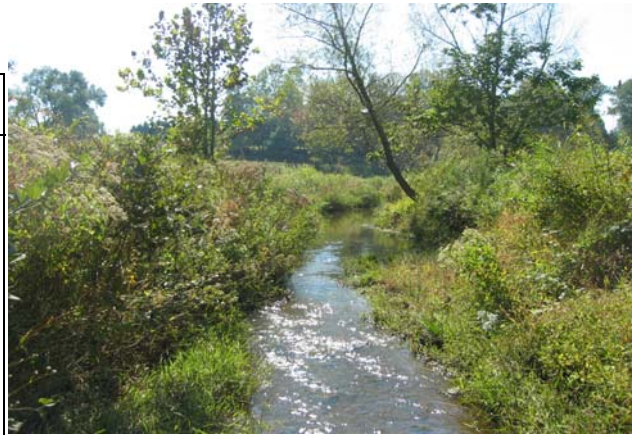
Photo of Cross-Section #7 - Looking Downstream

As-Built	2006	2007	2008
Area	49.9	50.7	46.9	47.1
Width	35.2	42.3	40.0	39.3
Mean Depth	1.4	1.2	1.2	1.2
Max Depth	2.7	2.7	2.7	2.7
w/d ratio	24.9	35.2	34.2	32.8
FPW	100	100	100	100
ER (greater than)	2.8	2.4	2.5	2.5
Stream Type	C	C	C	C

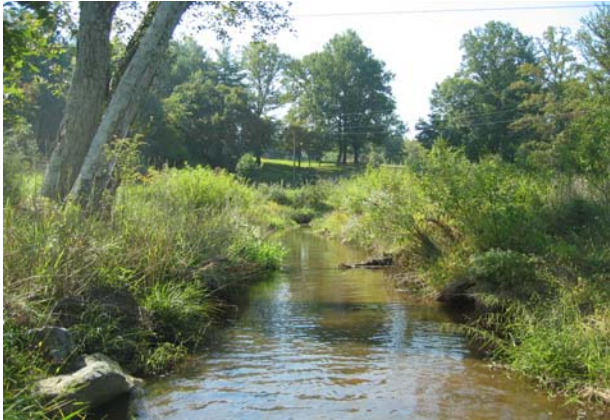
Photo of Cross-Section #8 - Looking Downstream

As-Built	2006	2007	2008
Area	48.59	54.8	57.9	50.6
Width	23.7	31.3	30.2	28.8
Mean Depth	2.0	1.8	1.9	1.8
Max Depth	3.4	3.5	3.5	3.5
wid ratio	111.6	17.9	15.7	16.4
FPW	98	98	98	98
ER (greater than)	4.1	3.1	3.2	3.4
Stream Type	C	C	C	C

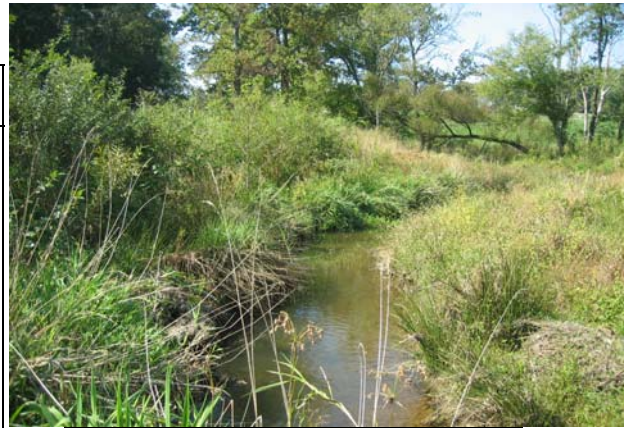
Photo of Cross-Section #9 - Looking Downstream

As-Built	2006	2007	2008
Area	33.8	31.5	28.6	30.2
Width	29.2	28.8	29.3	28.6
Mean Depth	1.2	1.1	1.0	1.1
Max Depth	3.4	3.2	3.4	3.3

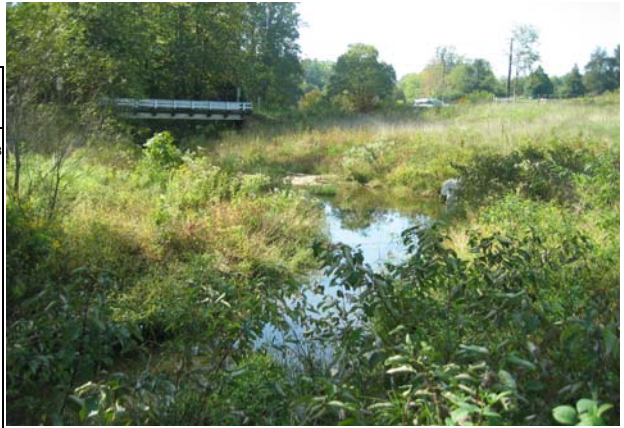
Photo of Cross-Section #10 - Looking Downstream

As-Built	2006	2007	2008
Area	40.0	42.4	45.2	46.1
Width	28.3	34.5	30.0	29.4
Mean Depth	1.4	1.2	1.5	1.6
Max Depth	2.9	3.0	3.1	3.1

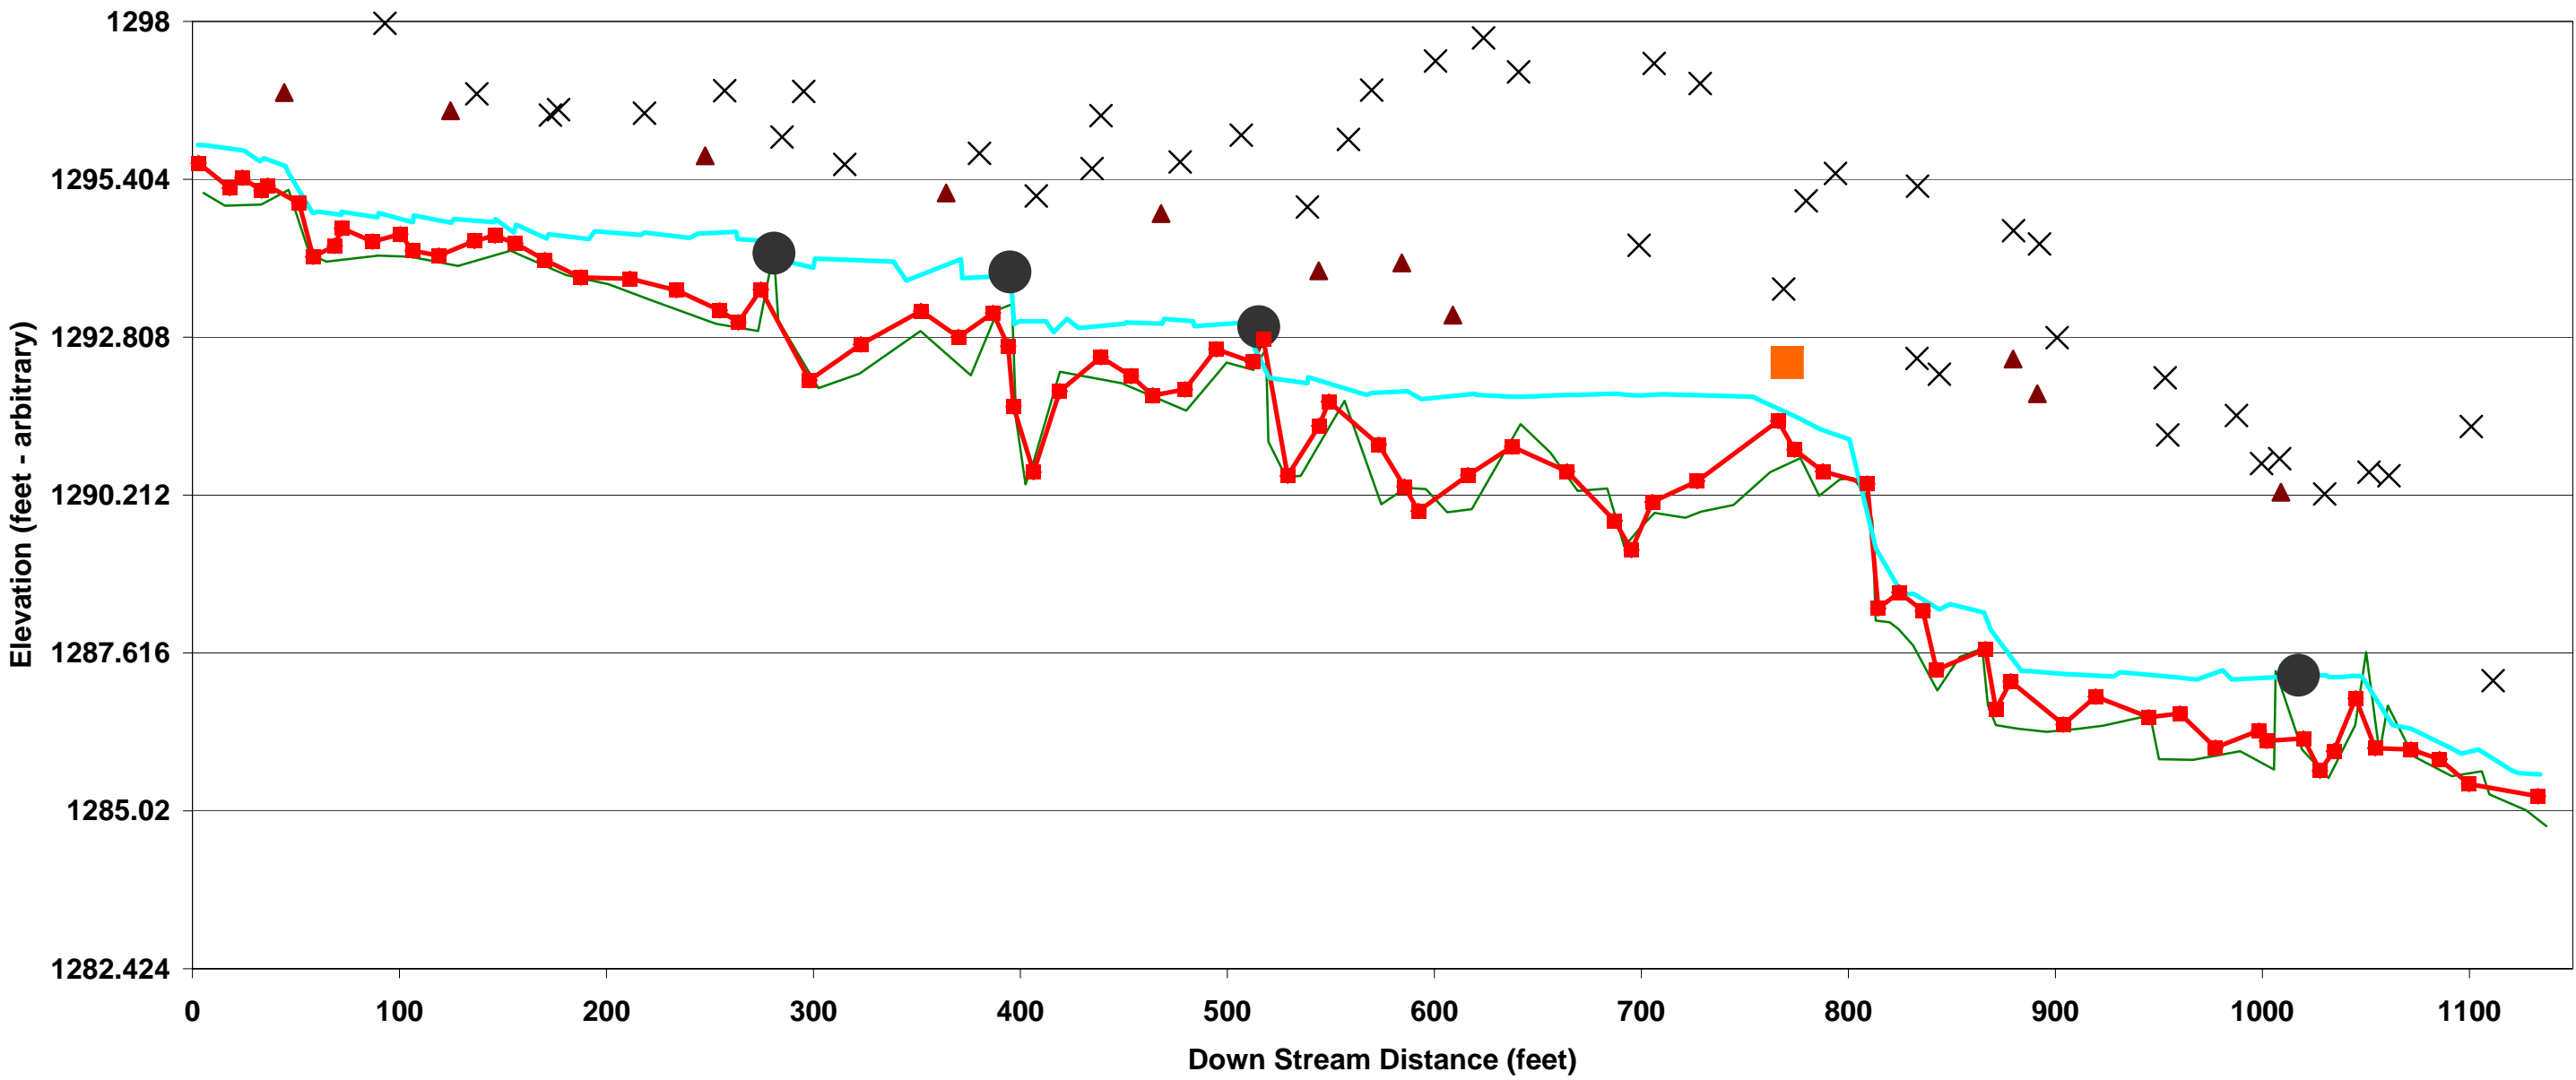
The channel profile did not change significantly from the as built condition with the exception of some aggradation along the upstream portion of Reach 4 and just upstream of a beaverdam in Reach 1. The aggradation observed in Reach 4 was likely caused by excess sediment from upstream sources. This aggradation is illustrated in the longitudinal profile and cross sections 1, 2, and 3 in Appendix B of this report. The cross sectional areas and dimensions of the remaining cross sections were comparable to the as built conditions. All of the permanent cross sections appear to be stable.

**Purlear Phase II
Longitudinal Profile
2008 - Reach 1
Main Channel
Survey: 7/17/08**

— 2006 Thalweg ■ 2008 Beaverdam ● Rock Vane —■ 2008 Thalweg — 2008 Water × 2008 TOB ▲ 2008 Bankfull

The channel profile is similar to the as-built survey condition, with bedform features maintaining their locations and depths. The only exception is the area just upstream of the beaver dam where

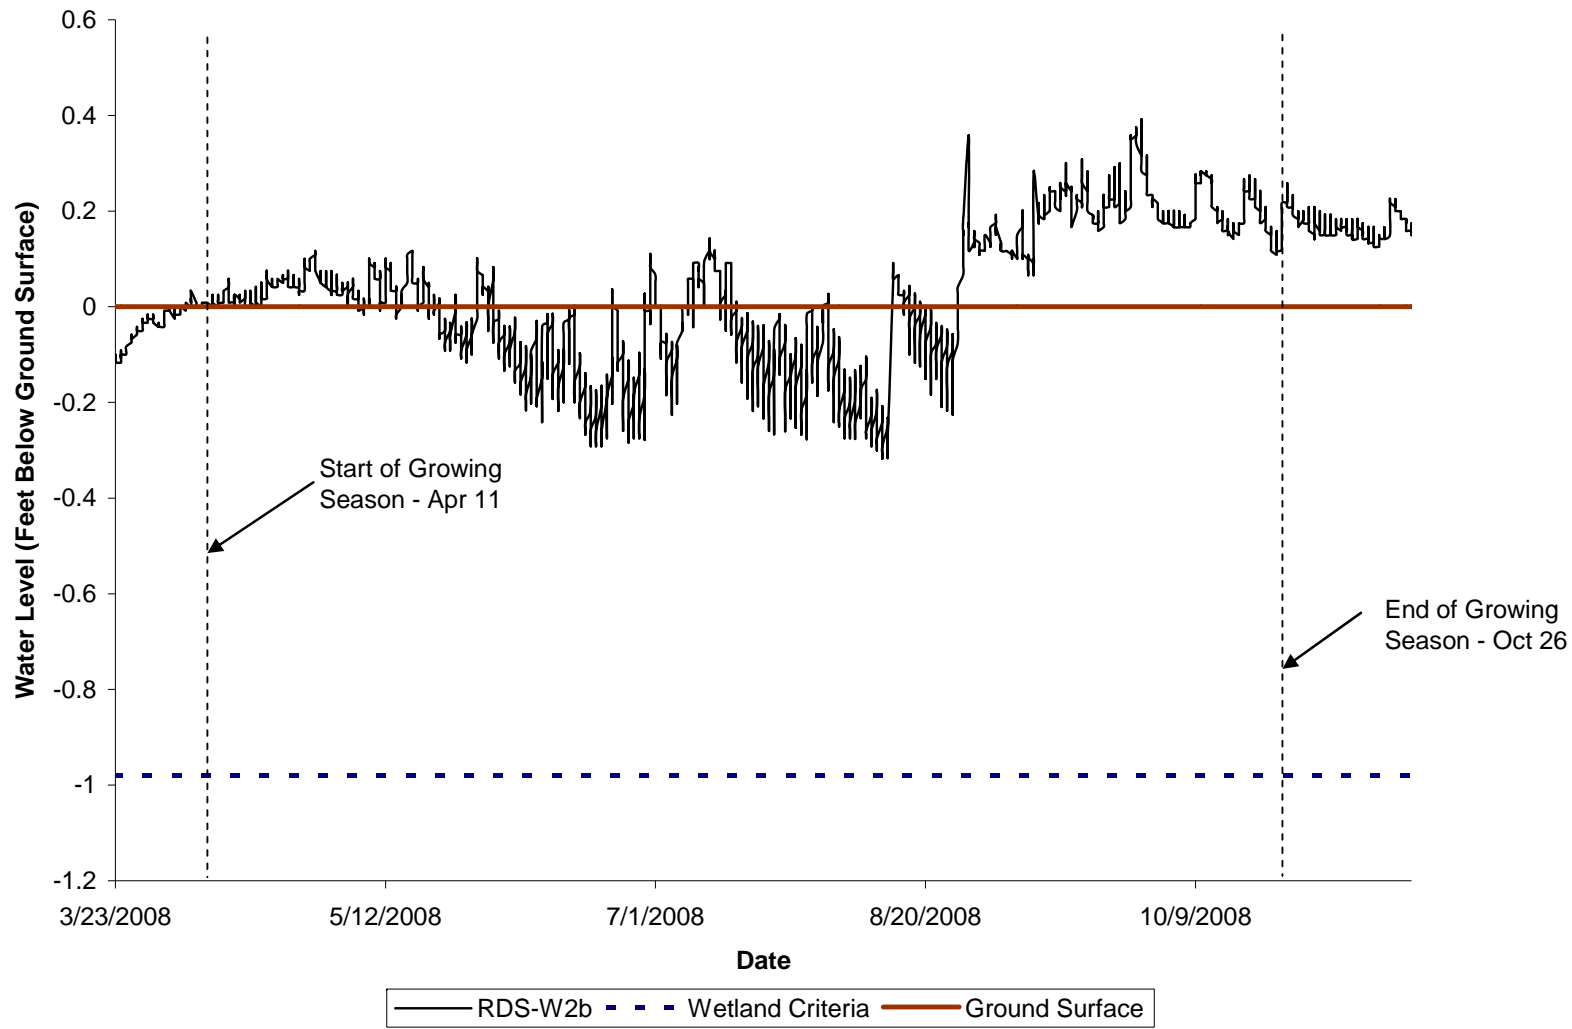
Monitoring Well RDS-W2b

The restored wetland along Reach 4 exceeded minimal conditions for hydrology and vegetation survival during the 2008 monitoring period.
