**As-Built Baseline Monitoring Report**

**RES Randleman Group A  
Riparian Buffer Mitigation Project**

**DMS Project # 100046 (Contract # 7427)**

**May 2019**

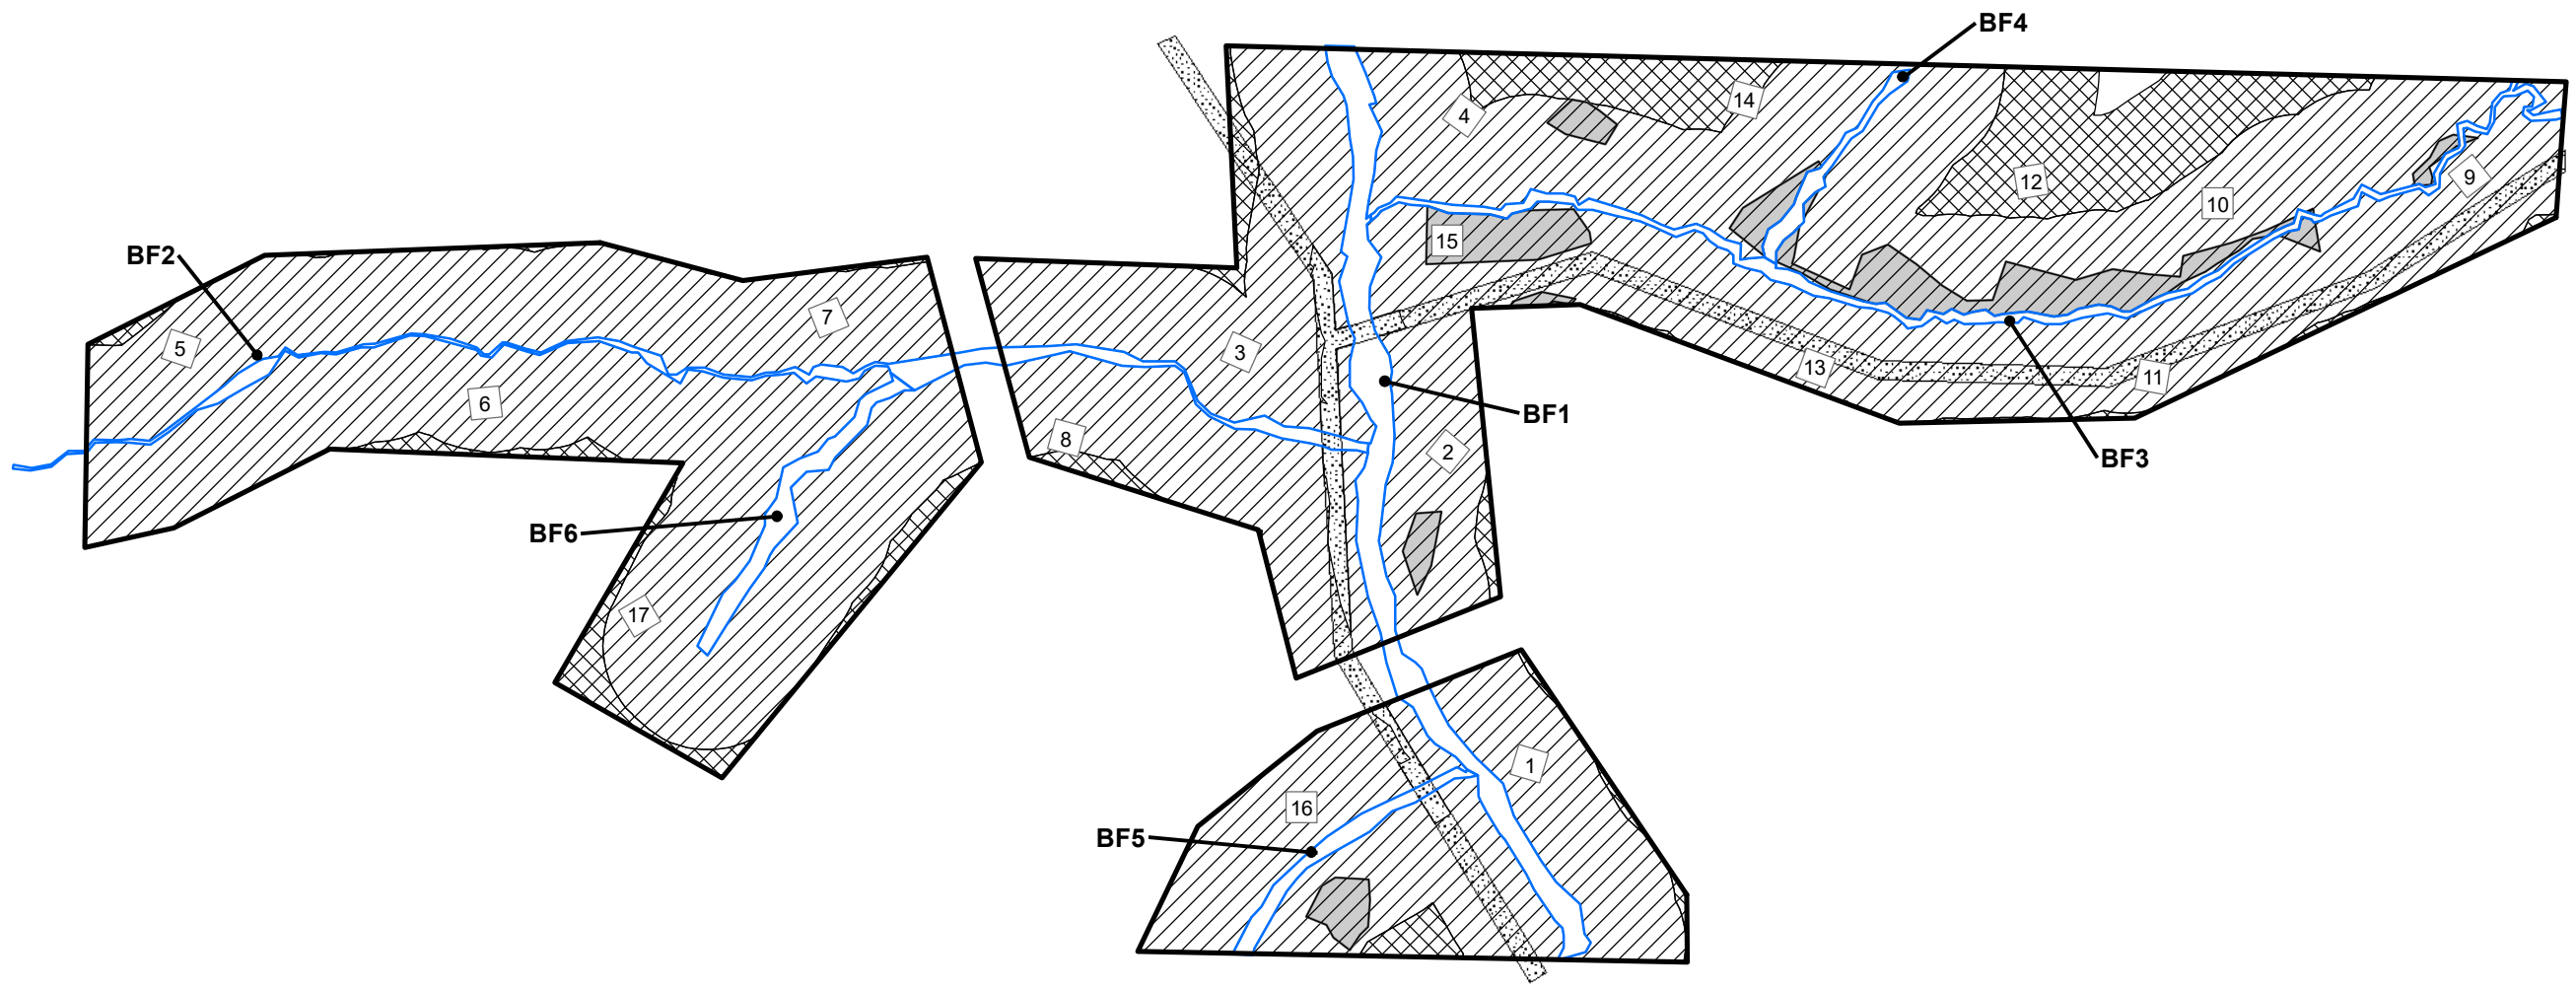
**Figure 3a**  
**As-Built Map**  
**RES Randleman Group A**  
**Pequod Site**  
**Randolph County, NC**

- Conservation Easement
- Top of Bank
- Vegetation Plot
- Restoration, 0-100
- Restoration, 101-200
- Enhancement, 0-100
- Enhancement, 101-200
- Sewer Easement
- Sewer Easement (Zone 1)

Sealed Conservation Easement Boundaries were provided by GC Mapping, PLLC (FIRM # P-1311, GUY V. COOKE, PLS, L-4596), dated 10/11/18. Top of bank linework is based on field measurements also performed by GC Mapping, PLLC dated 10/11/18.

**Figure 3a** – Please correct spelling error in map legend (Sewer Easement spelled incorrectly).  
[Done.](#)

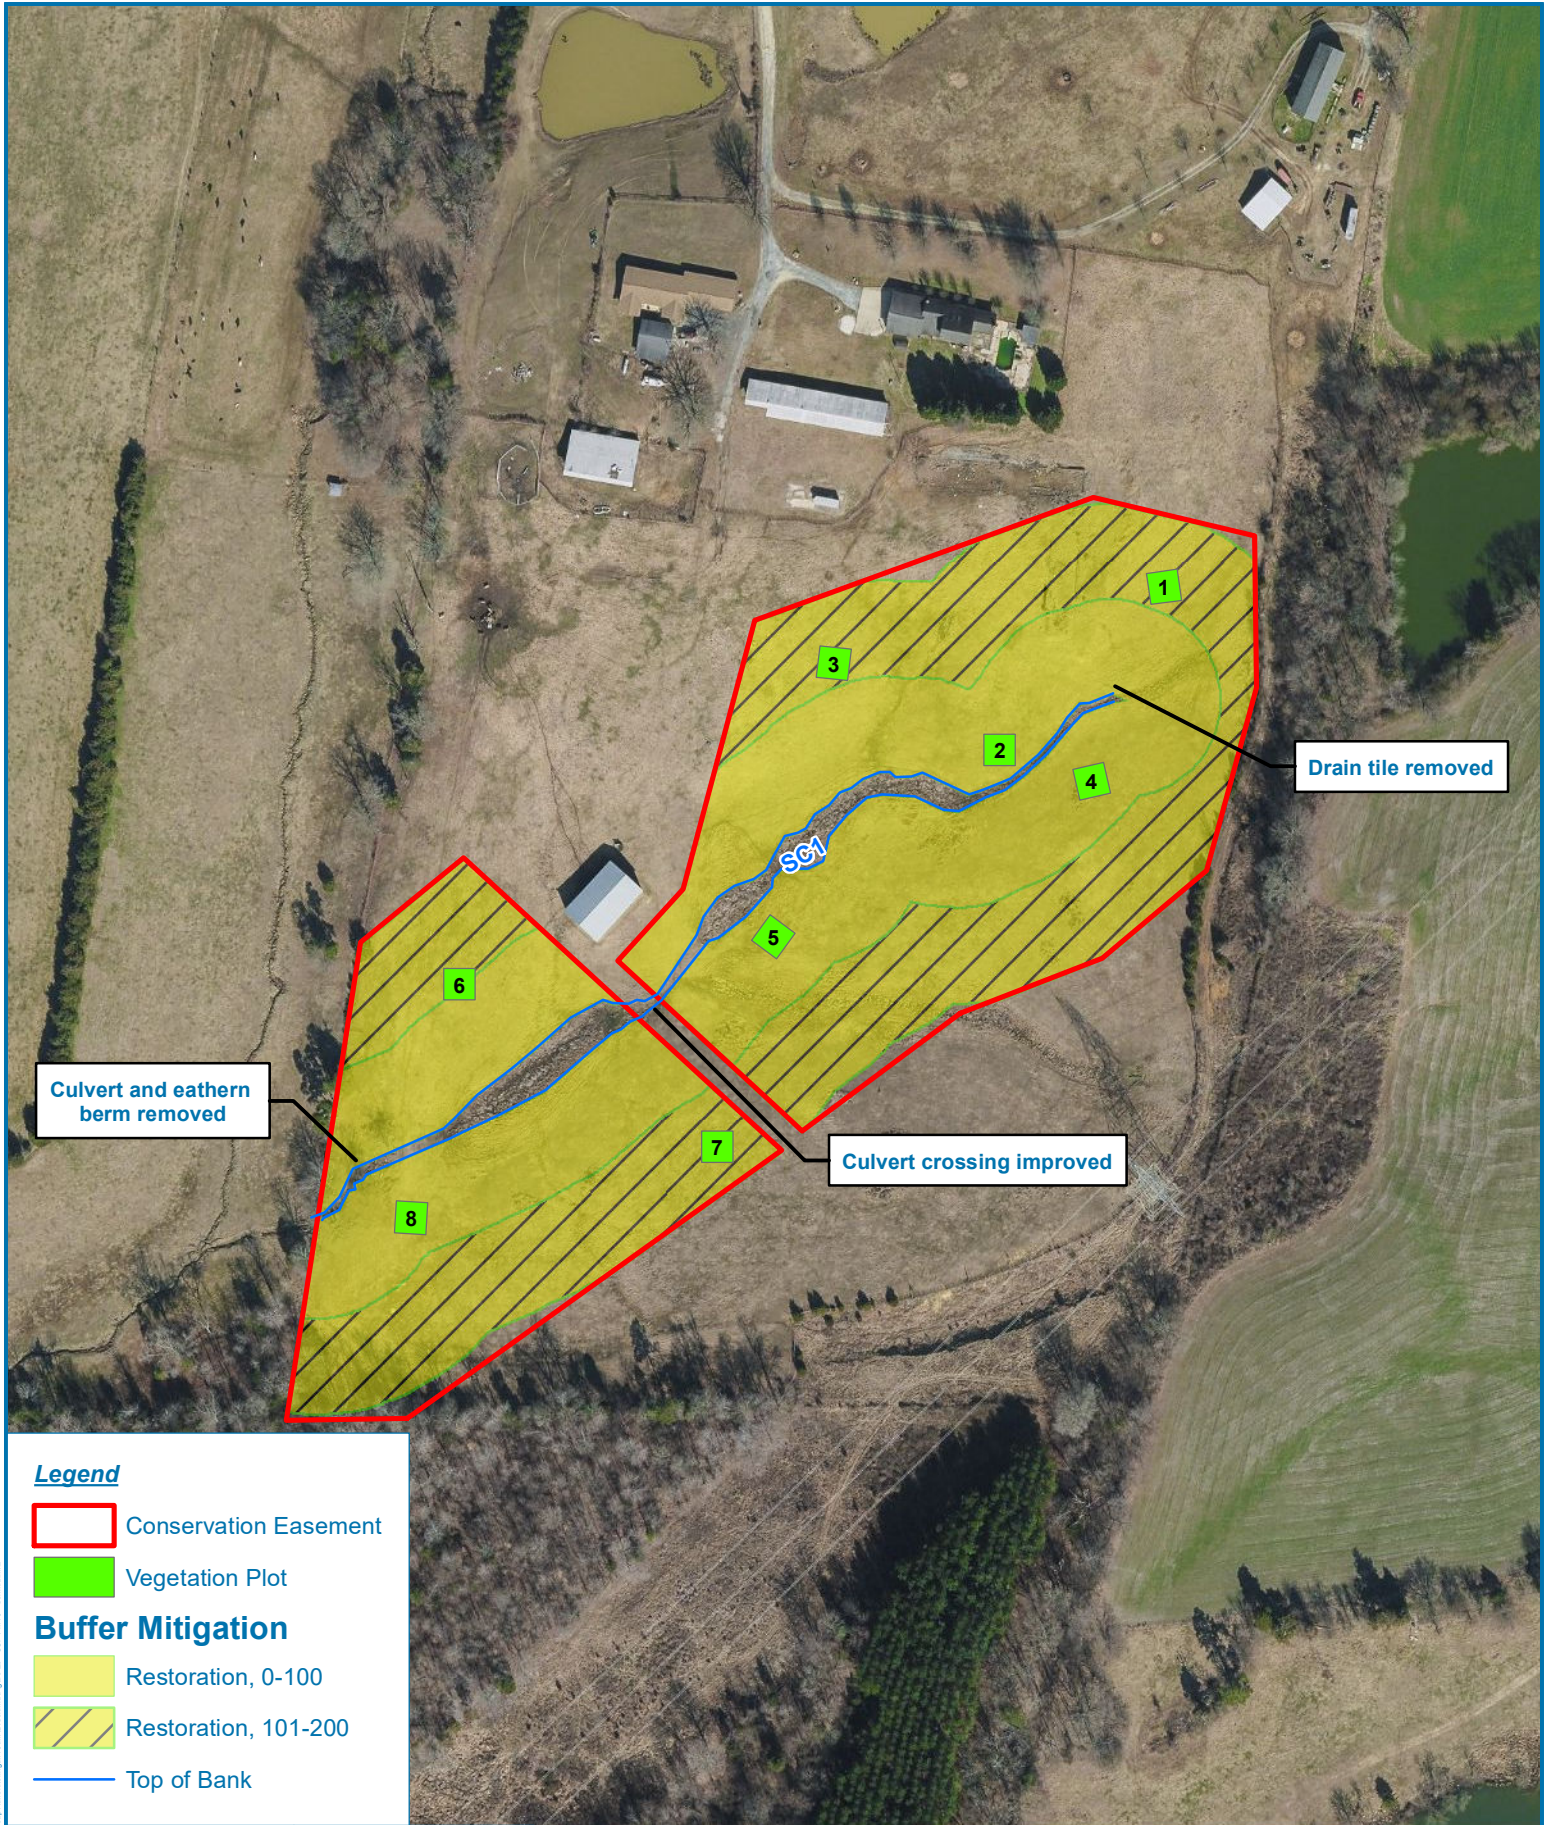
**Figure 2b - Current Conditions Plan View**

- Conservation Easement
- Vegetation Plot
- Buffer Mitigation**
- Restoration, 0-100
- Restoration, 101-200
- Top of Bank

Sealed Conservation Easement Boundaries were provided by Ascension Land Surveying, PC (FIRM # C-4288, CHRISTOPHER L. COLE L-5008), dated 11/20/18. Top of bank linework is based on field measurements also performed by Ascension Land Surveying, PC dated 11/20/18.

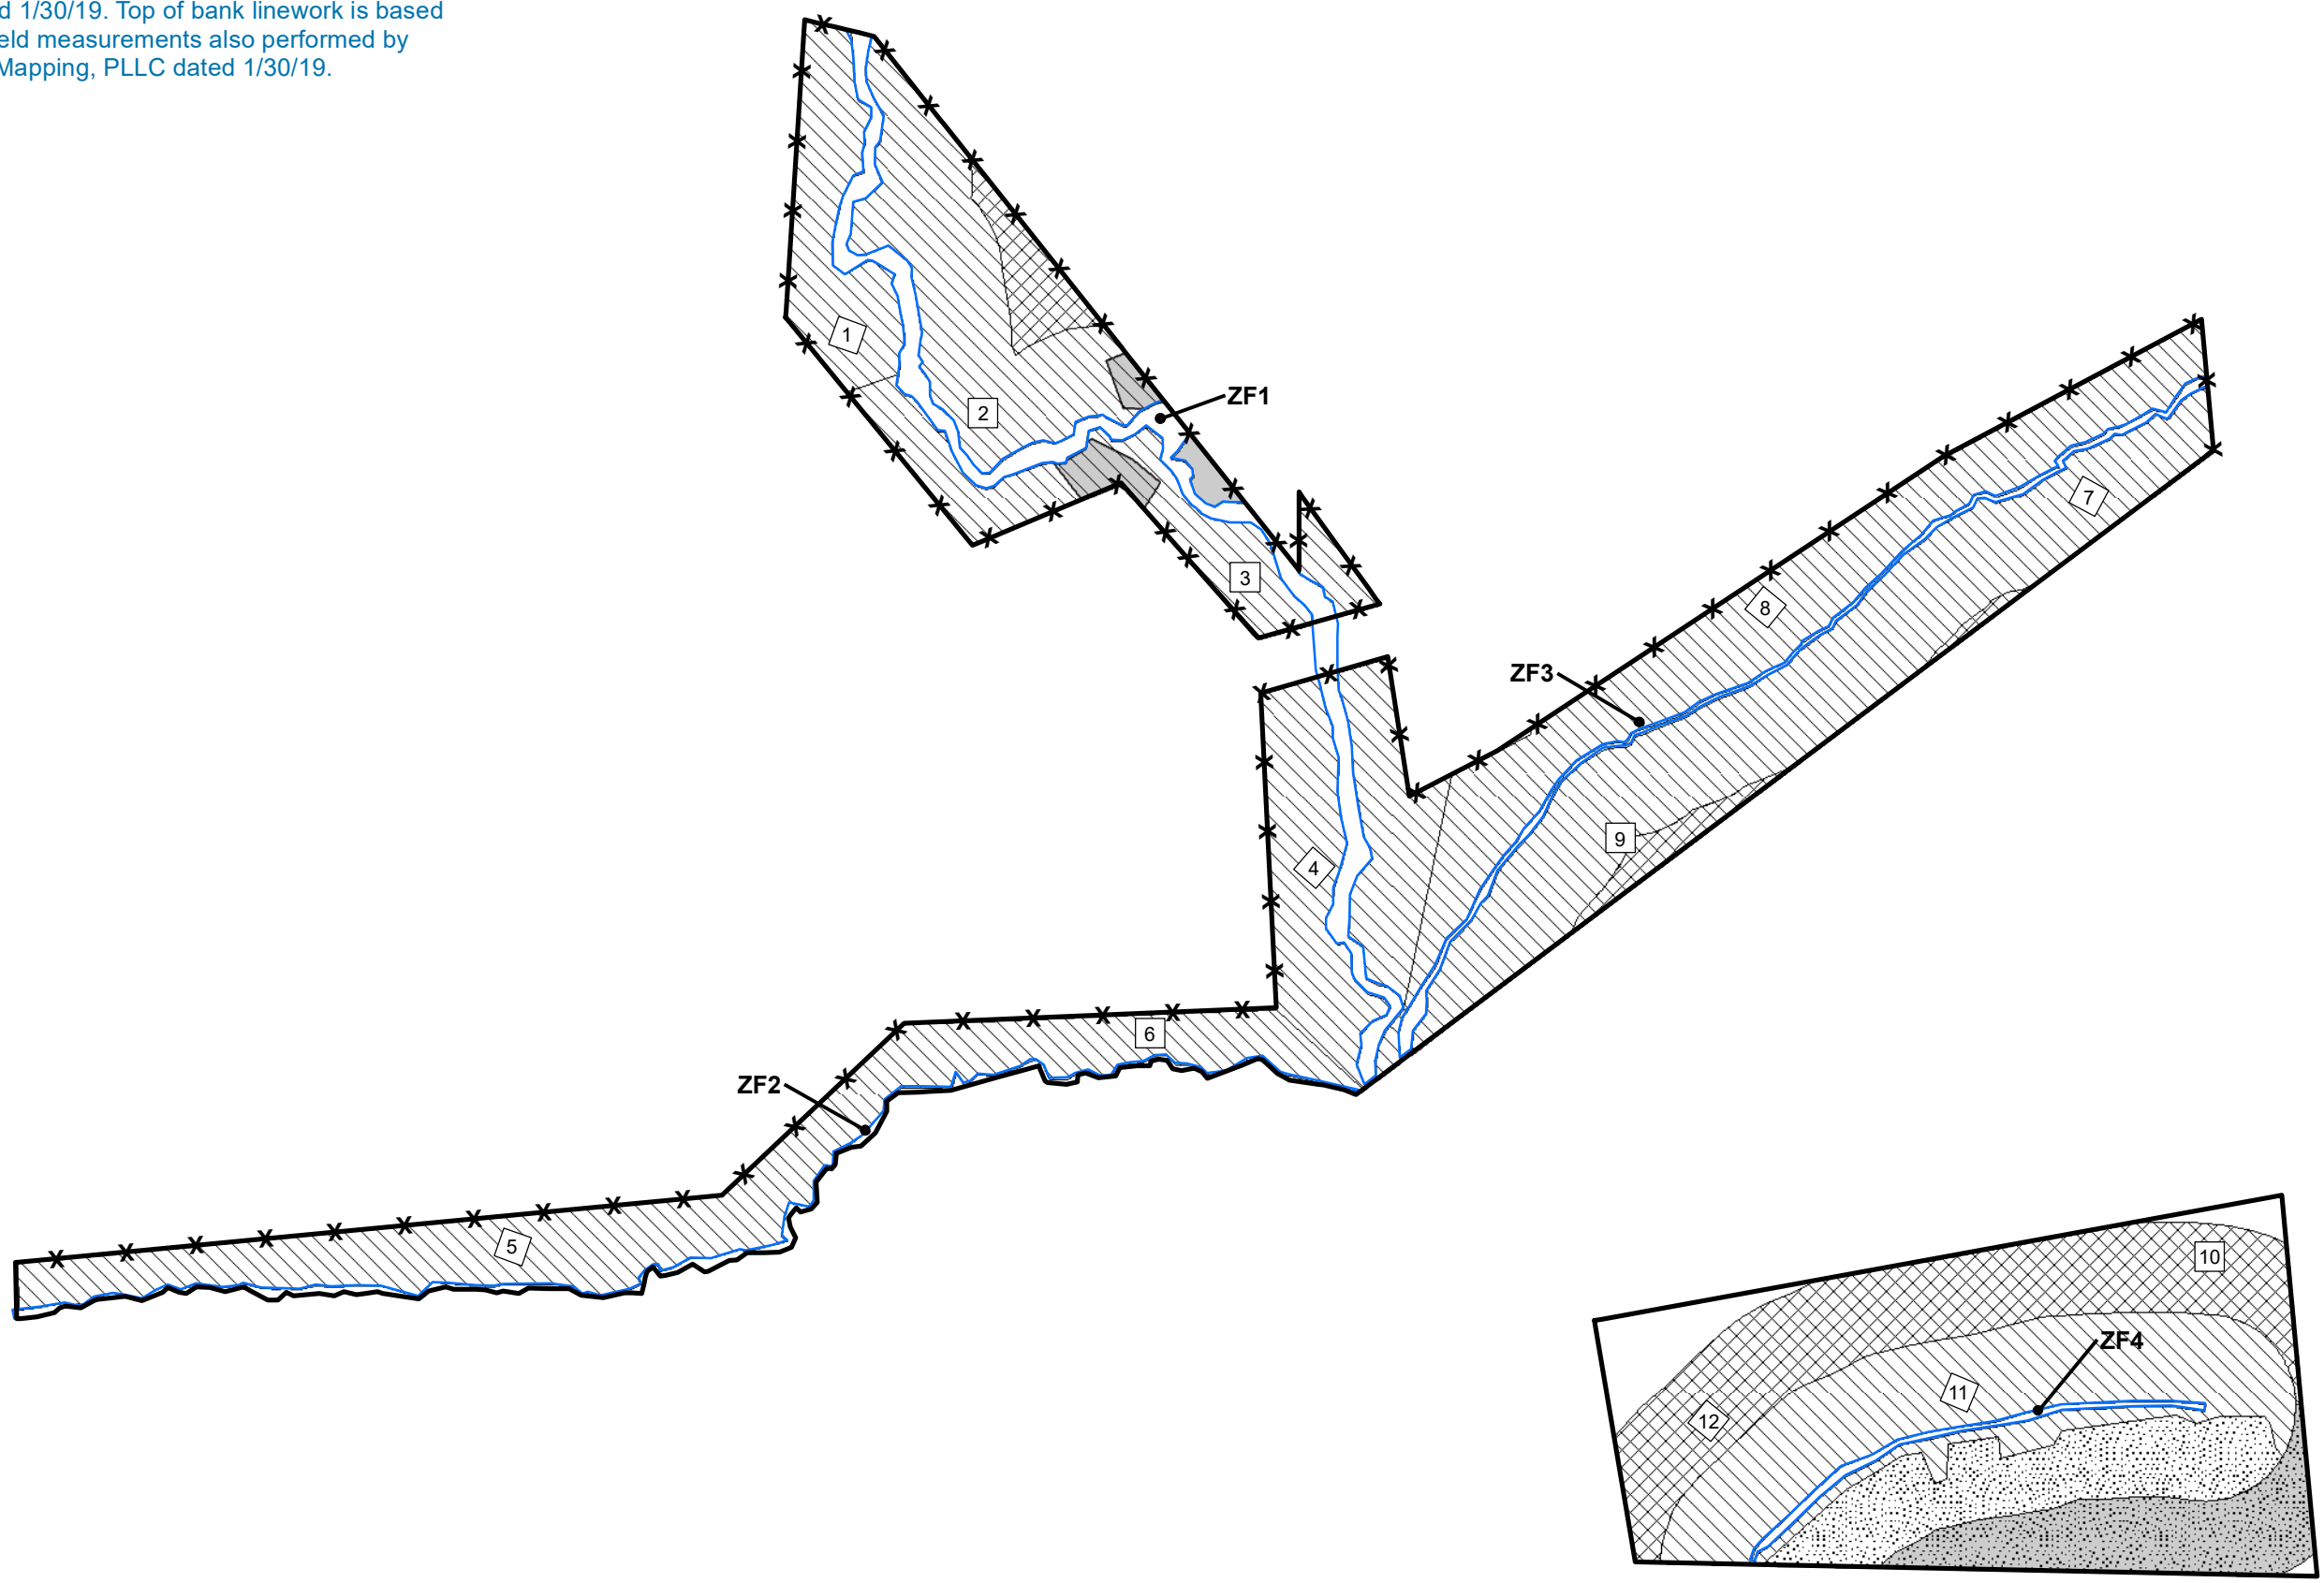
- Conservation Easement
- Vegetation Plot
- Top of Bank
- Buffer Mitigation**
- Restoration, <30
- Restoration, 0-100
- Restoration, 101-200
- Enhancement, 0-100
- Preservation, 0-100
- Preservation, 101-200
- Installed Fence

**CCPVs** – Please add fencing to all CCPVs and As-built maps where it was installed.  
[New fencing was only installed at Sunbeam. The CCPV and As-built map have been updated.](#)
