# Reeds Creek Wetland Restoration Project

Contract #: D05016-3  
County: Iredell  
Cataloging Unit: Catawba 03050101  
Monitoring Firm POC: Mid-Atlantic Mitigation, LLC  
Rich Mogensen (704) 782-4133  
Environmental Services, Inc.  
Paul Petitgout (704) 523-7225  
Prepared For: EEP Project Manager, Guy Pearce

## Year 2 Monitoring Report - October 2008

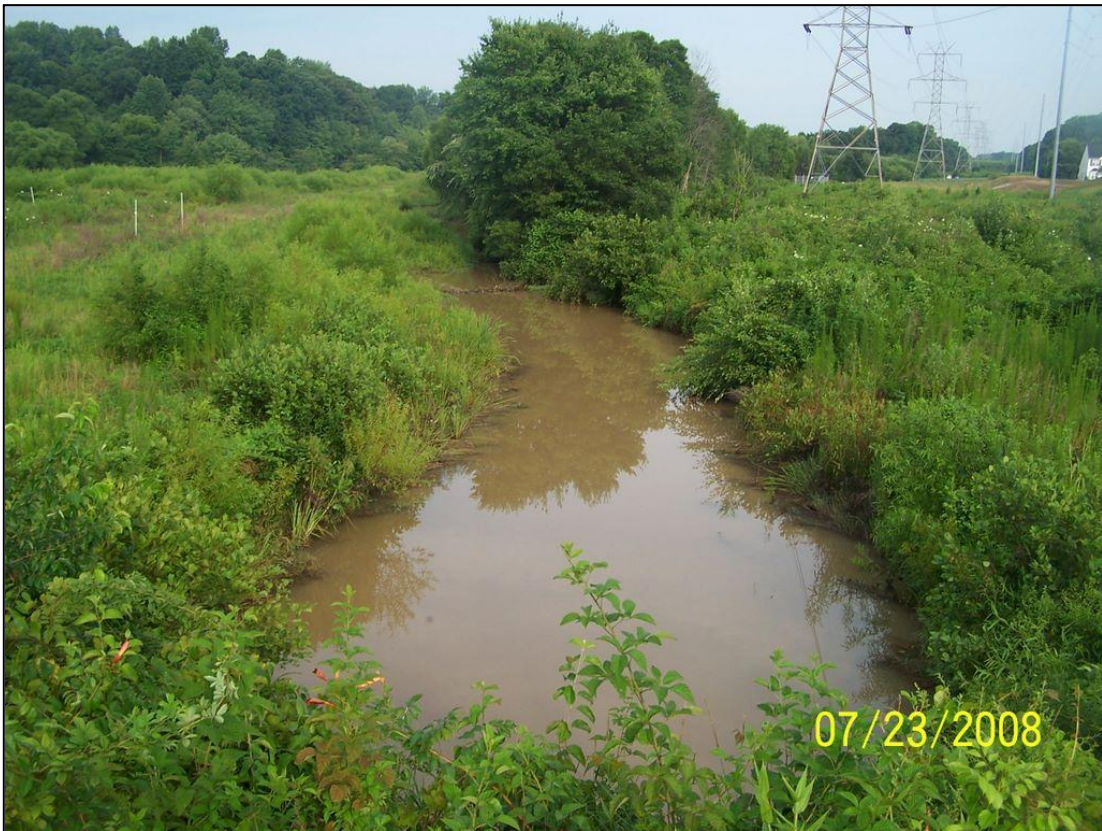
Photo Point 6 – Facing W (Overview from HWY 21 bridge)

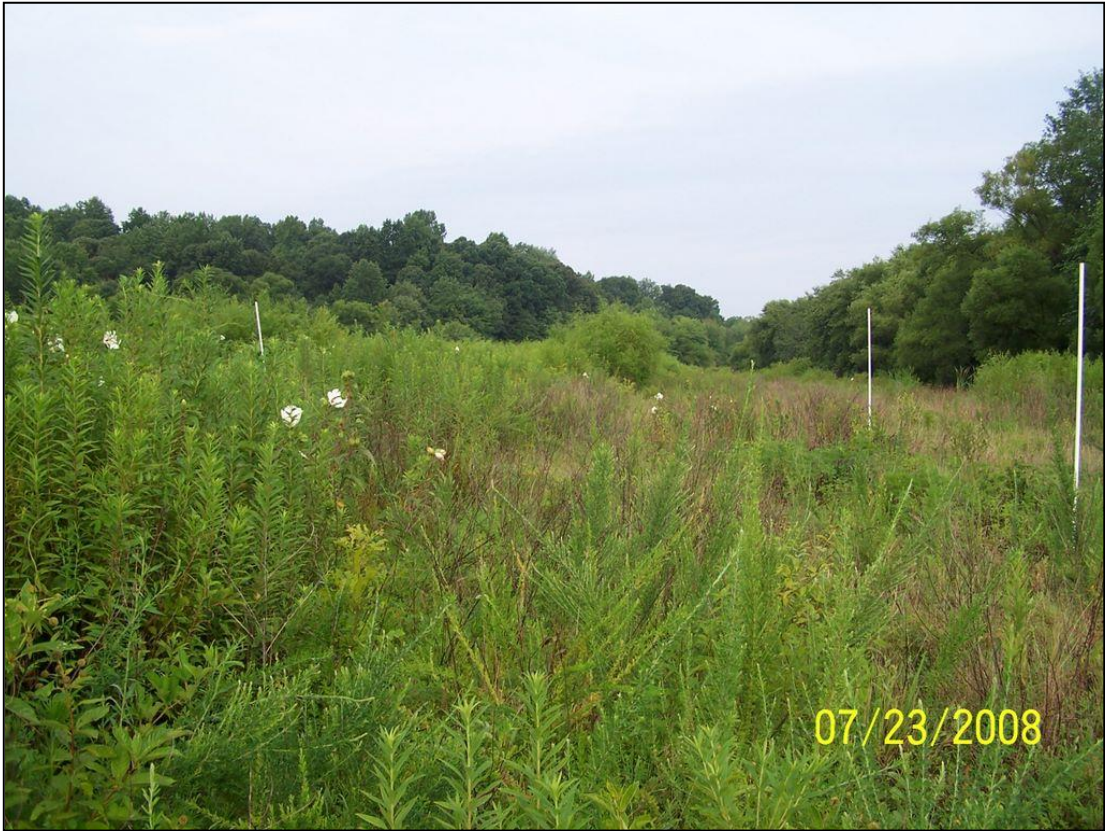
Vegetation Plot A – Facing W

The herbaceous cover plant community was monitored in a 1 m by 1 m square at one corner of each plot. Each herbaceous quadrant showed at least 75% cover and were actually at or close to 100%.

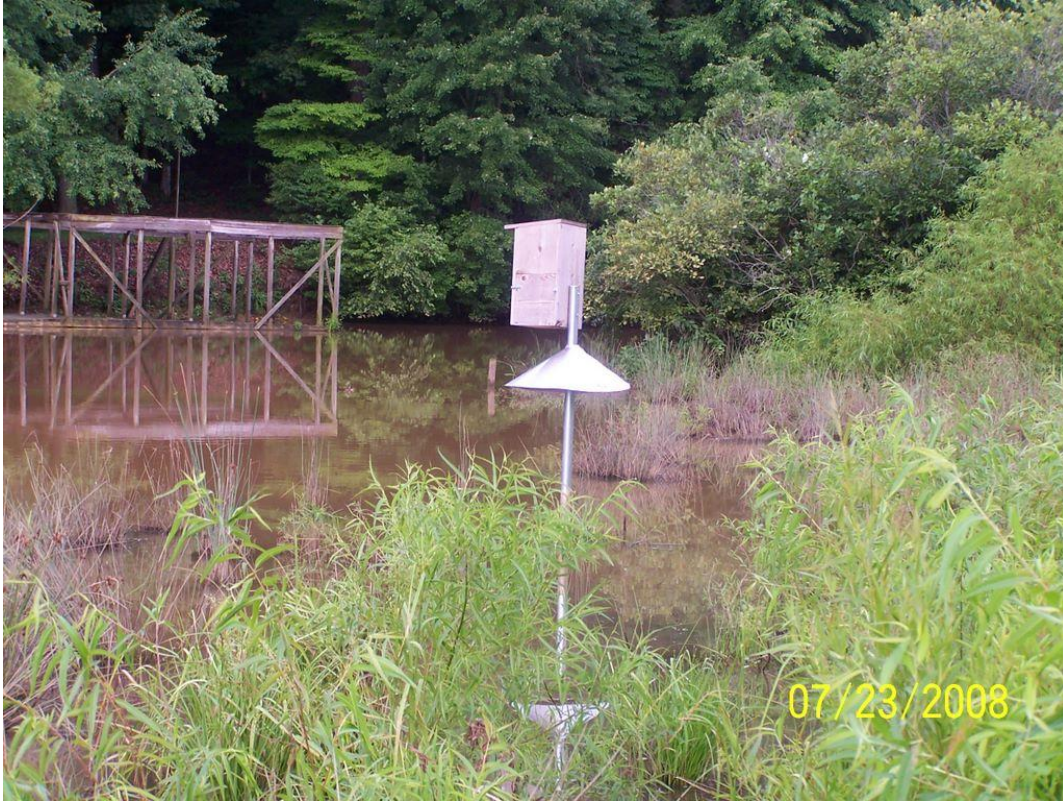
Wood Duck Box Installed by LNWC

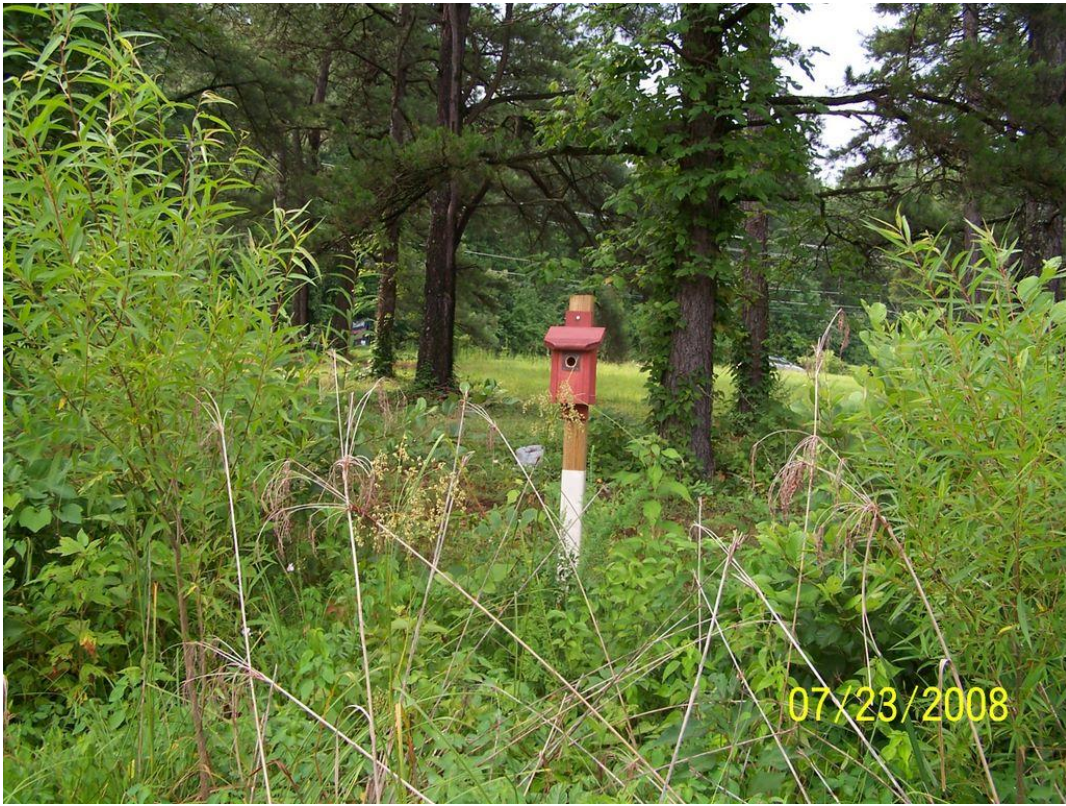
Warbler Nesting Box Installed by LNWC
