1.0 EXECUTIVE SUMMARY/PROJECT ABSTRACT

The goals and objectives of the Reeds Creek Wetland Restoration Project (Reeds Project) are to restore the hydrologic functions, the native vegetation of the degraded and drained wetlands, flood retention and water quality functions within the Reeds Creek watershed of the Catawba River Basin (HUC 03050101).

3.2.2 Photo Reference Points

SHEET	1	REID'S CREEK WETLAND RESTORATION SITE	AS-BUILT CONTOURS COMPARED TO PRE-CONSTRUCTION CONTOURS	DATE	4/17/07
	OF			2	APPROVED BY
JOB NO.		CAD FILE PATH		CHECKED BY	
06028		R:\Joe Horton & Assoc.		ARMSTRONG Glen, PC	
		SURVEYED BY		APPROVED BY

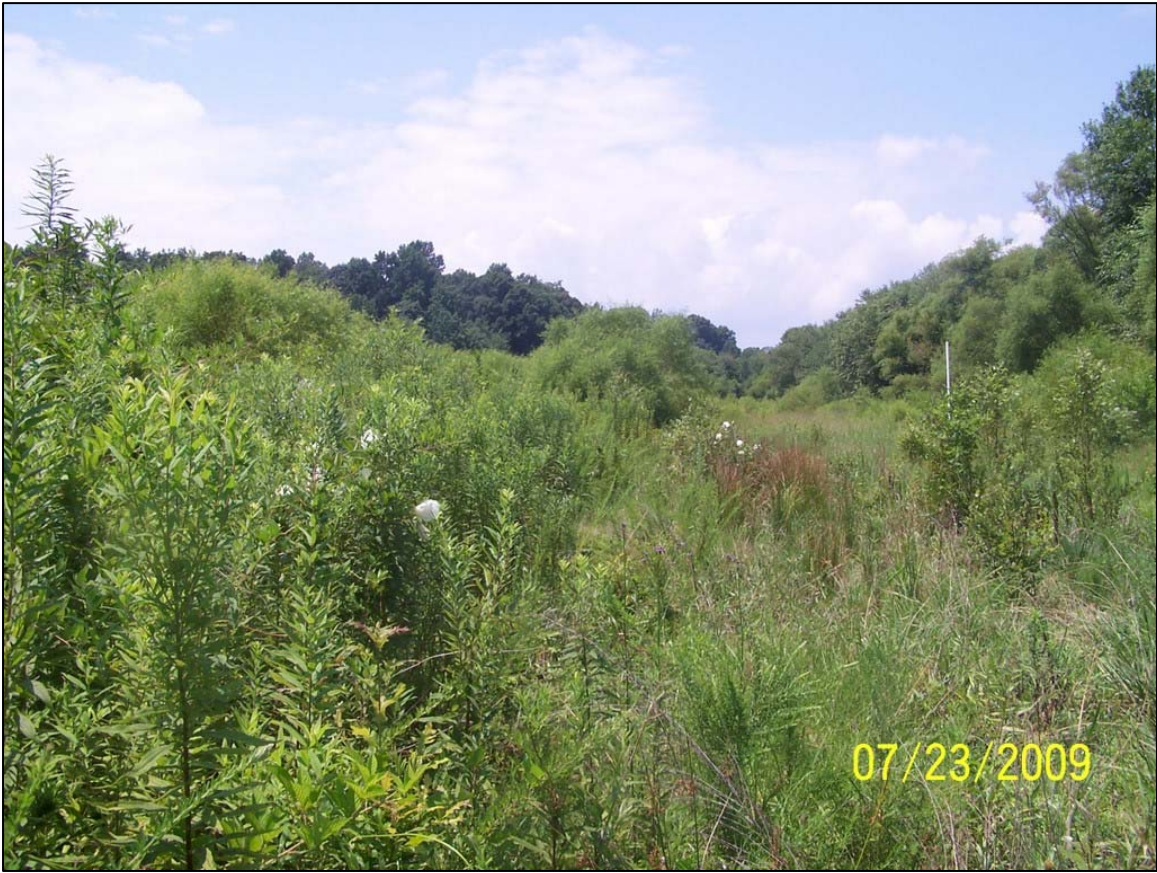
Vegetation Plot A

Plot A

Total 960
w/ vols. 1280

Herbaceous Cover:

100%

soft rush Juncus effusus
deertounge grass Panicum clandestinum
swamp rose mallow Hibiscus moscheutos

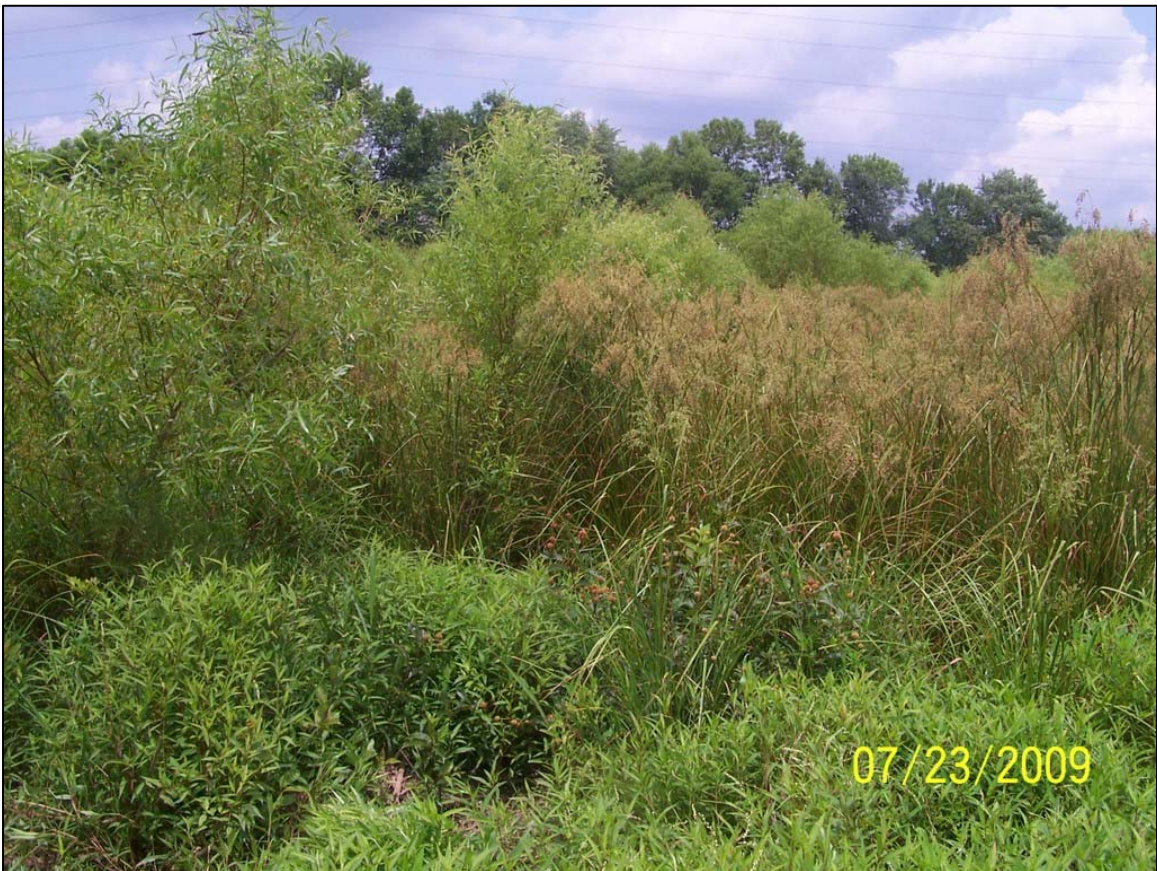
Vegetation Plot B

Plot B

Total 1040

w/ vols. 2600

Plot B is 60% Black Willow

Herbaceous Cover:

100%
