Reeds Creek Wetland Restoration Project

Contract #: D05016-3
County: Iredell
Cataloging Unit: Catawba 03050101
Monitoring Firm POC: Mid-Atlantic Mitigation, LLC
Christine Cook (704) 782-4133 x 101
Prepared For: EEP Project Manager, Guy Pearce

Year 4 Monitoring Report - July 2010

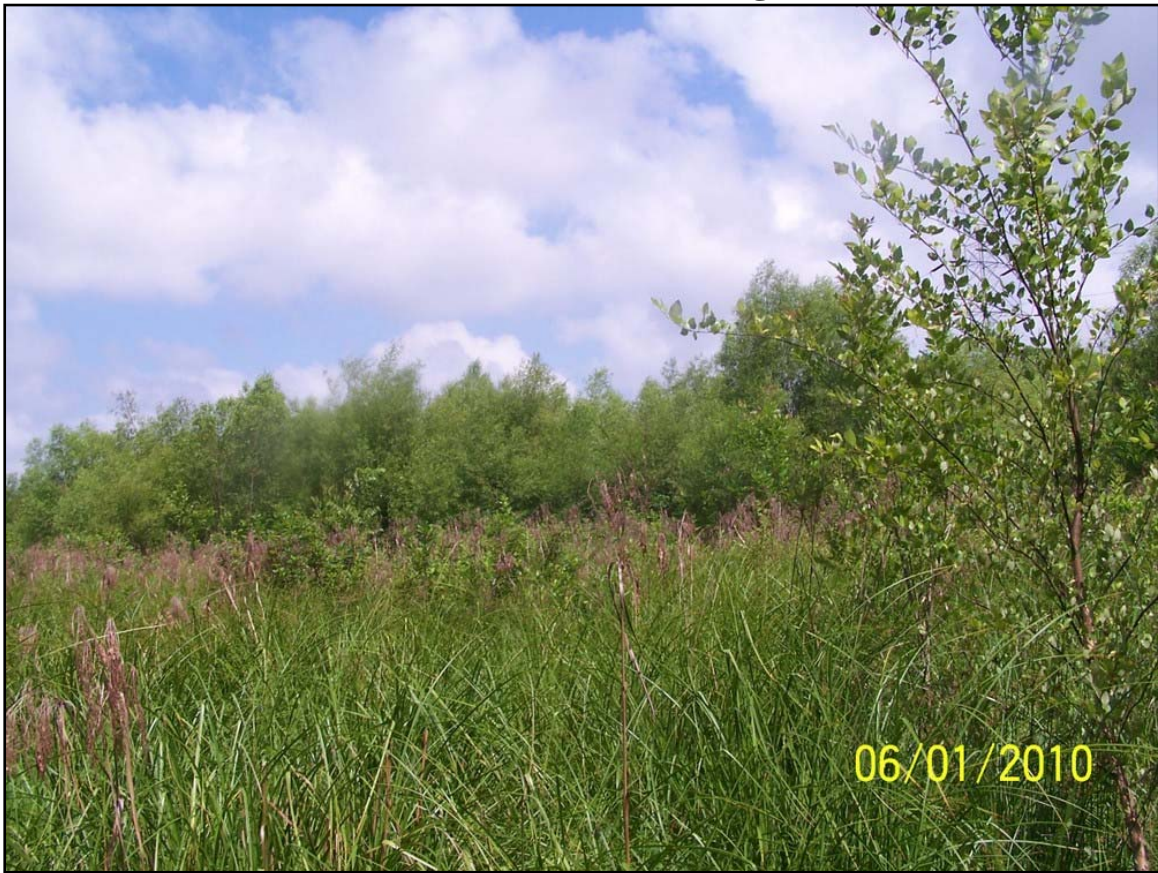
Photo Point 1

There are eight permanent photo reference points located throughout the Reeds Project included in this monitoring report. Two of the photo reference points are located in the southwest corner of each vegetation plot. All the Photographs will help to illustrate the health of the planted vegetation and the surface water hydrology (e.g. standing water). The Photo Log is located in Appendix A.

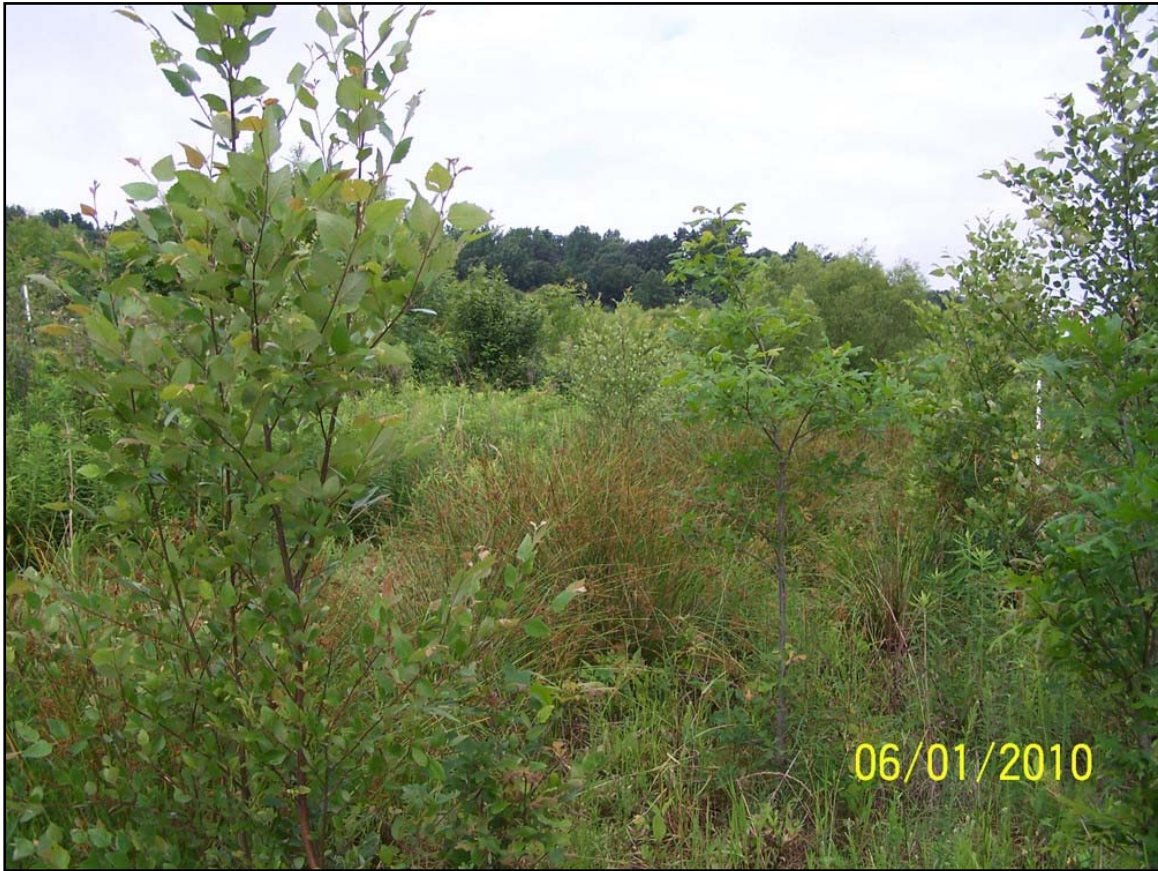
Vegetation Plot A

Plot A: 6/1/2010

Shrubs	
<i>Cephalanthus occidentalis</i> Vols	7
<i>Cornus amomum</i>	7
Totals	14
Trees	
<i>Betula nigra</i>	4
<i>Fraxinus pennsylvanica</i>	10
<i>Liriodendron tulipifera</i>	0
<i>Quercus lyrata</i>	2
<i>Quercus michauxii</i>	2
<i>Quercus pagodifolia</i>	6
<i>Quercus phellos</i>	1
<i>Salix nigra</i>	1
<i>Ulmus Sp. Vol</i>	1
Totals	21
Woody Stems Total:	28
Total w/ Vols.	41
Stems Per Acre	1120
Stems Per Acre w/vols.	1640

Herbaceous Cover:

100%

Invasives:

None noted

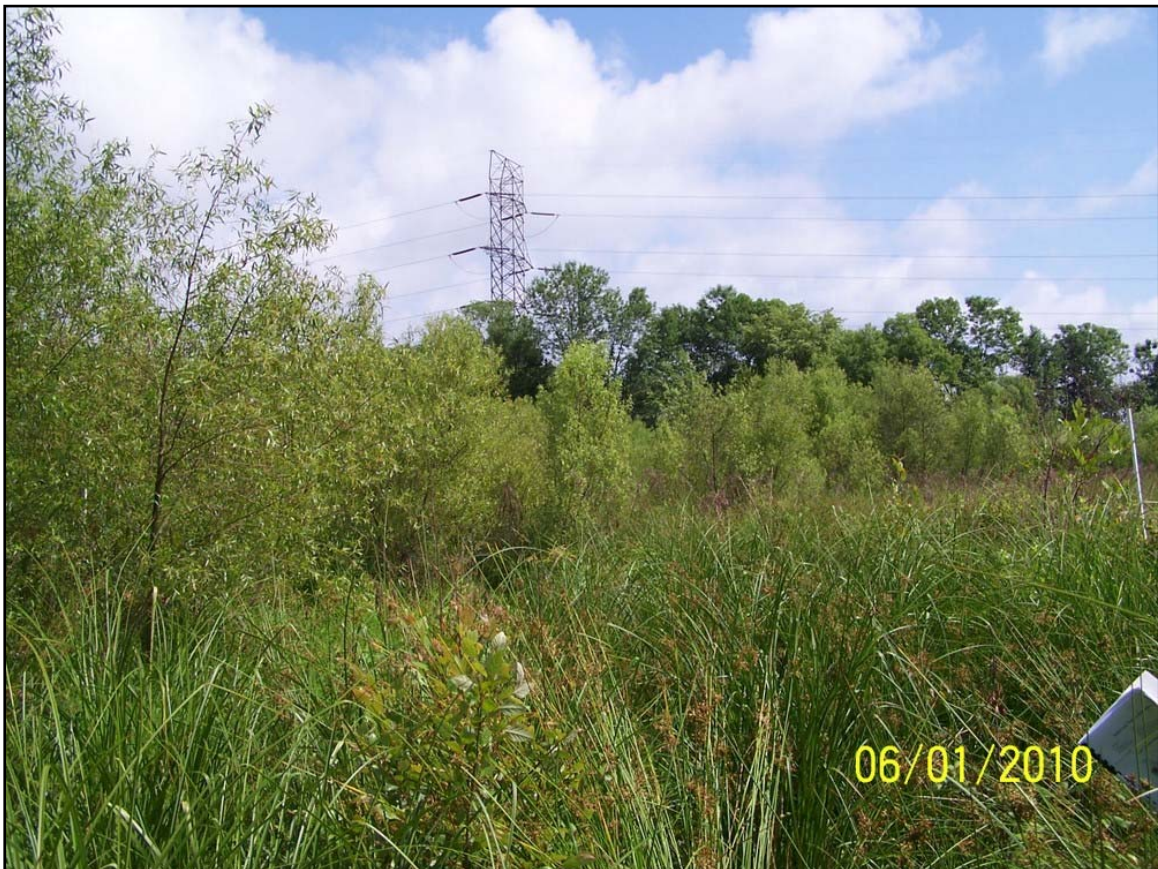
Vegetation Plot B

Plot B: 6/1/2010

Plot B is 42% Black Willow

Black Willows were thinned this winter

Black Willows create overstory

Oaks, SD, and BB are thriving in the understory

Herbaceous Cover:

100%
