Year 4 Monitoring Report

**RES Randleman Group A
Riparian Buffer Mitigation Project**

DMS Project # 100046 (Contract # 7427)

Randolph County, North Carolina
Cape Fear River Basin HUC 03030003

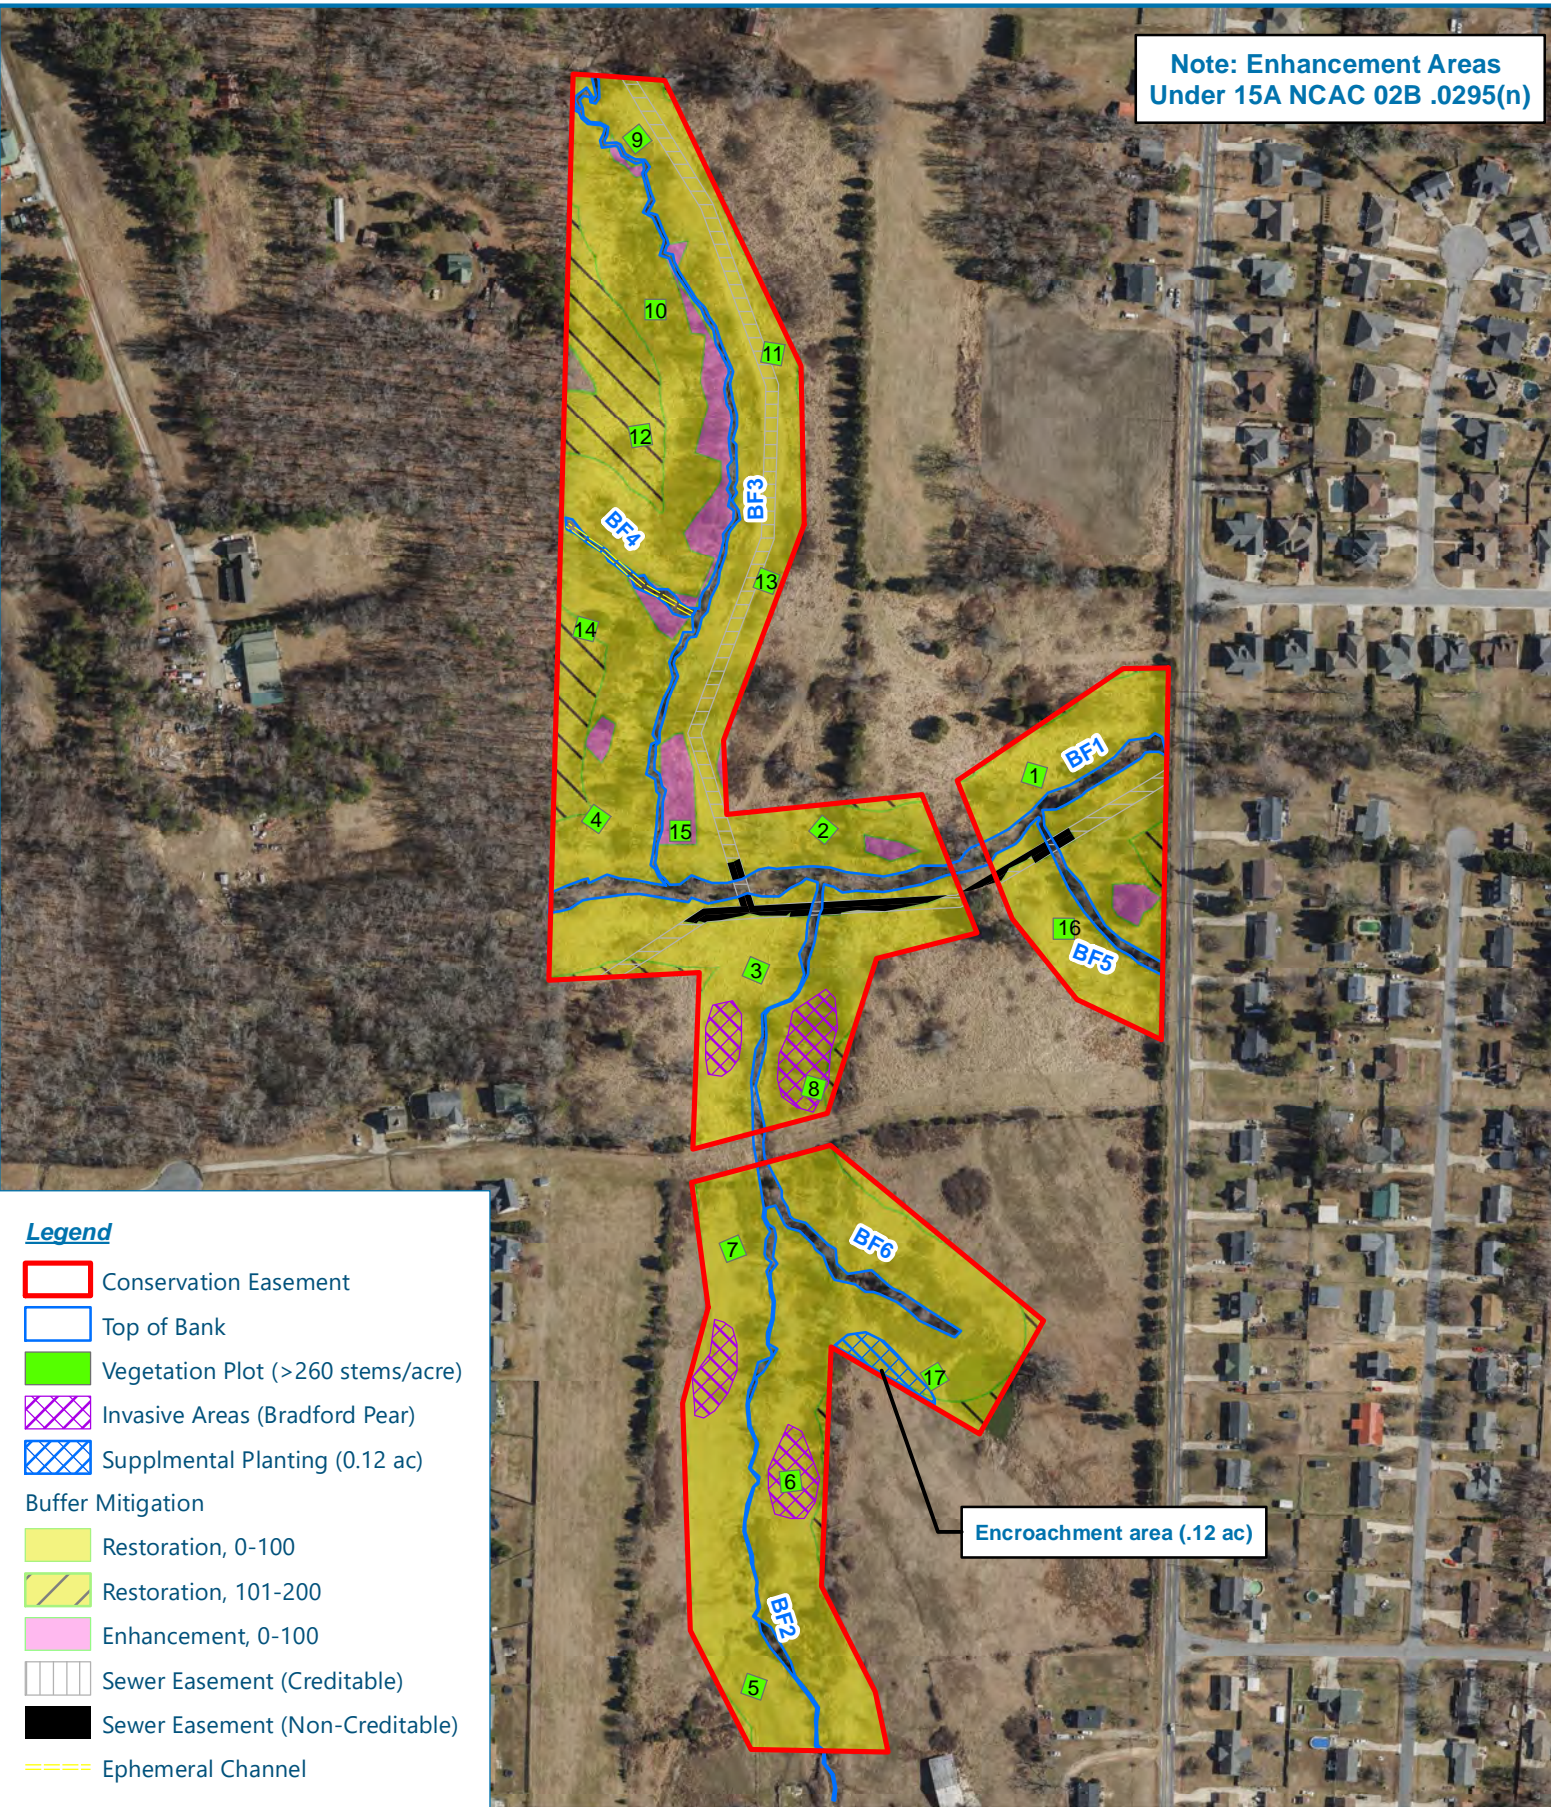
Figure 2a. Current Conditions Plan View
 RES Randleman Group A -
 Pequod Mitigation Site (MY4 2022)
 Randolph County, North Carolina

Agricultural encroachment was observed at Pequod in June 2022. The encroachment area was planted with corn and is approximately 0.12 acres. The encroachment area was replanted on December 6, 2022 with 40 three-gallon trees that included Sycamore, Water oak, Northern red oak, and River birch species. Also, driving paths to the adjacent sewer easement were observed within the conservation easement during MY4. RES contacted the City of Archdale and met with them onsite to determine appropriate paths to access the sewer easement. RES cleared two paths outside of the conservation easement that allows access the sewer easement. Additional easement signage and horse tape was installed to prevent future encroachment in these areas. This instance of encroachment will no longer be an issue.
