RESTORATION PLAN

RICH FORK MITIGATION SITE

Davidson County, North Carolina

August 2002

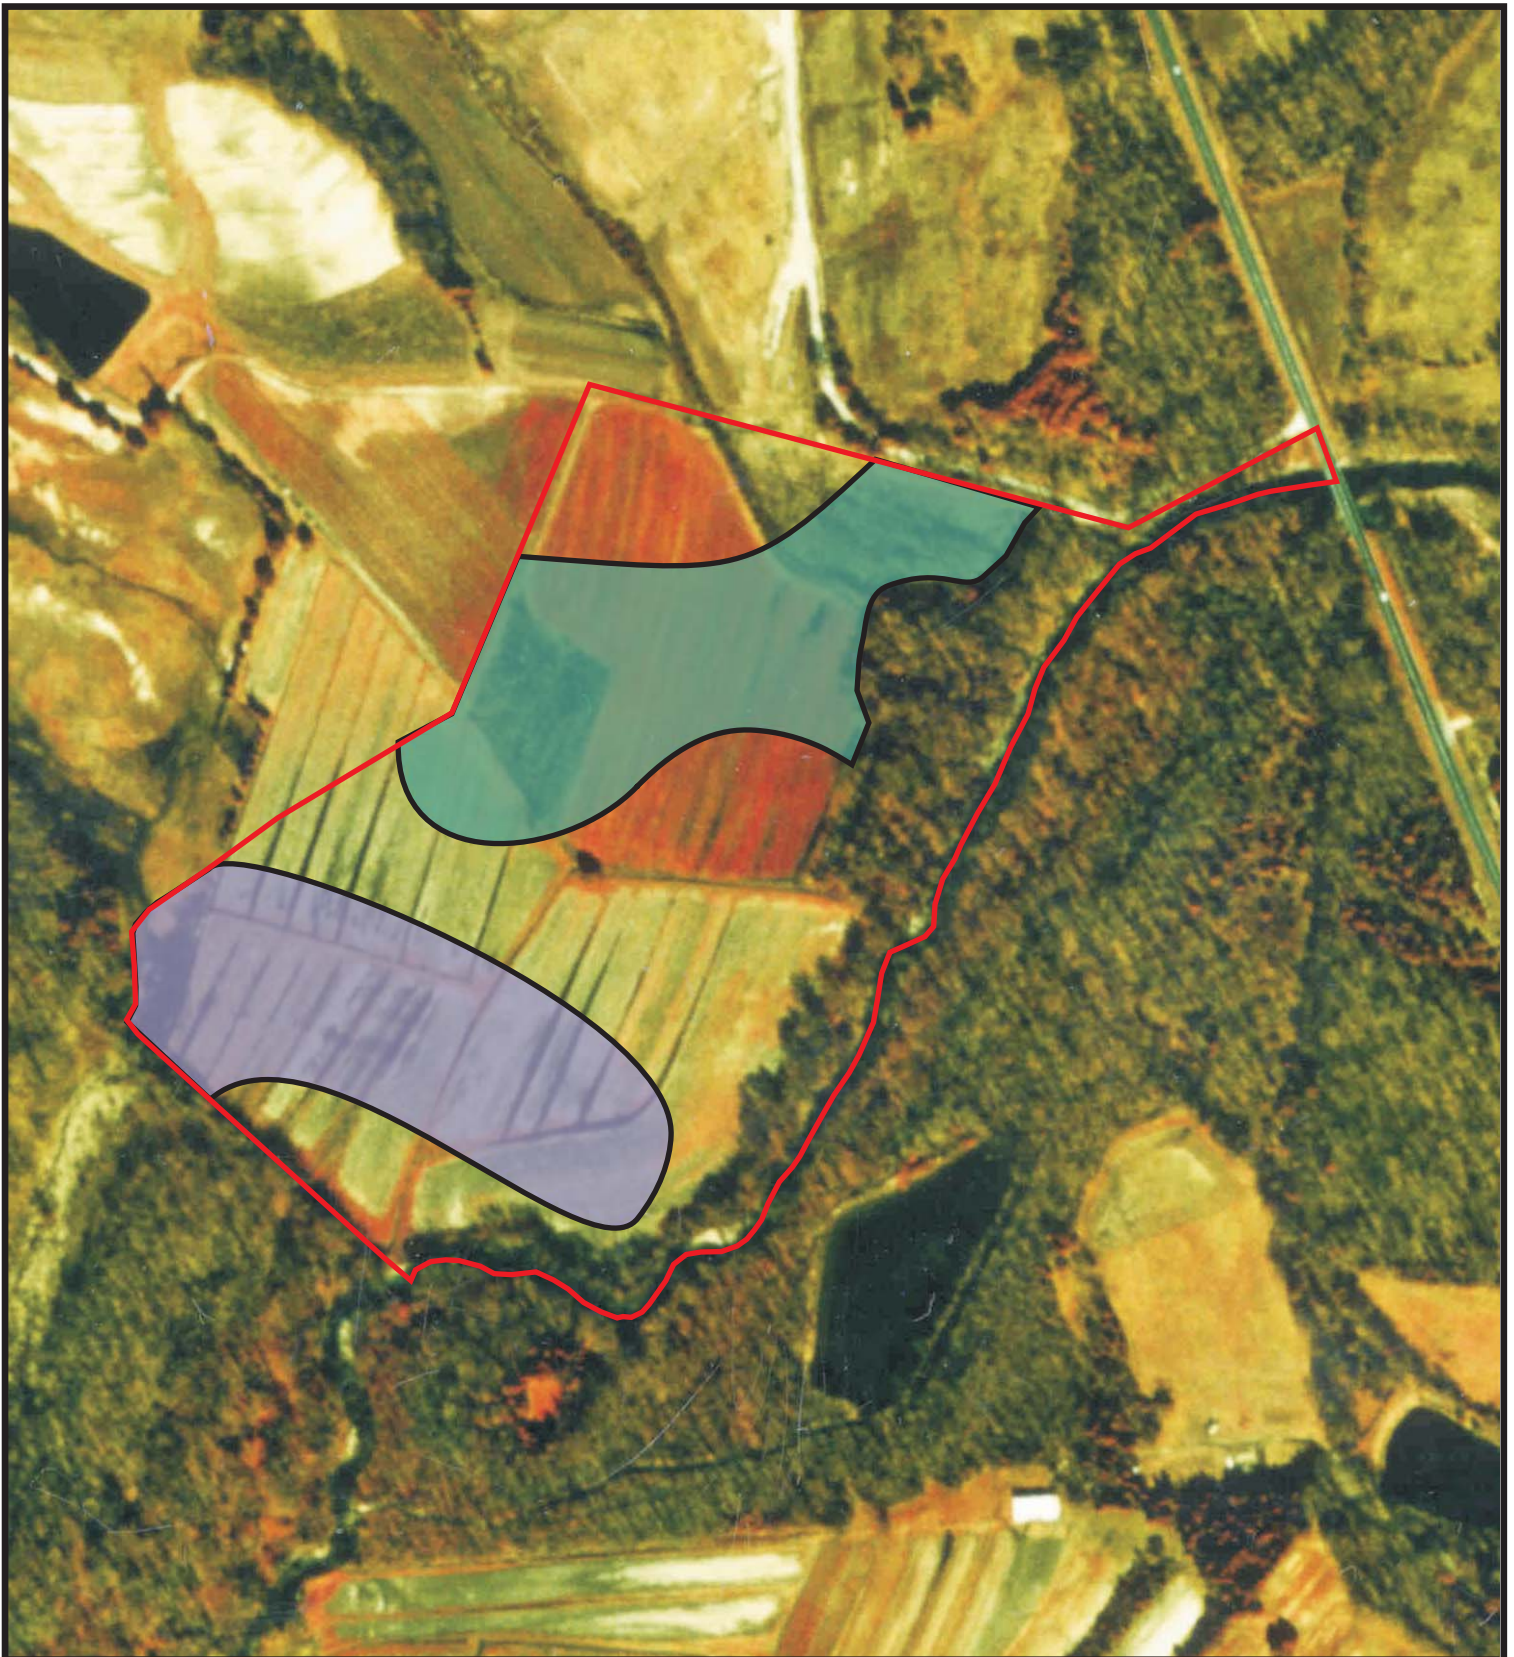
Figure 6: Depleted Soils

SOME INDICATORS OF REDUCING CONDITIONS
IN THE UPPER 12"

The redoximorphic feature evaluation was conducted by establishing nine transects over the site, running perpendicular to the existing drainage ditch network. Soil borings were performed along the transect lines at approximately 300-foot (90-meter) intervals (Figure 5 and Appendix D). This process was complicated by the disturbed nature of the agricultural fields which have homogenized the horizons in the upper 12-18 inches of soil by plowing. Repetitive plowing and mixing of crop residues into the soil, along with the artificial drainage, has affected and altered the hydric features (soil color and mottling) normally found in the upper soil horizons in an undisturbed, natural site. This evaluation identified 24 borings that exhibited redoximorphic features (i.e. mottling and concretions), within 12-14" (the plow layer zone) of the surface (Figure 6).

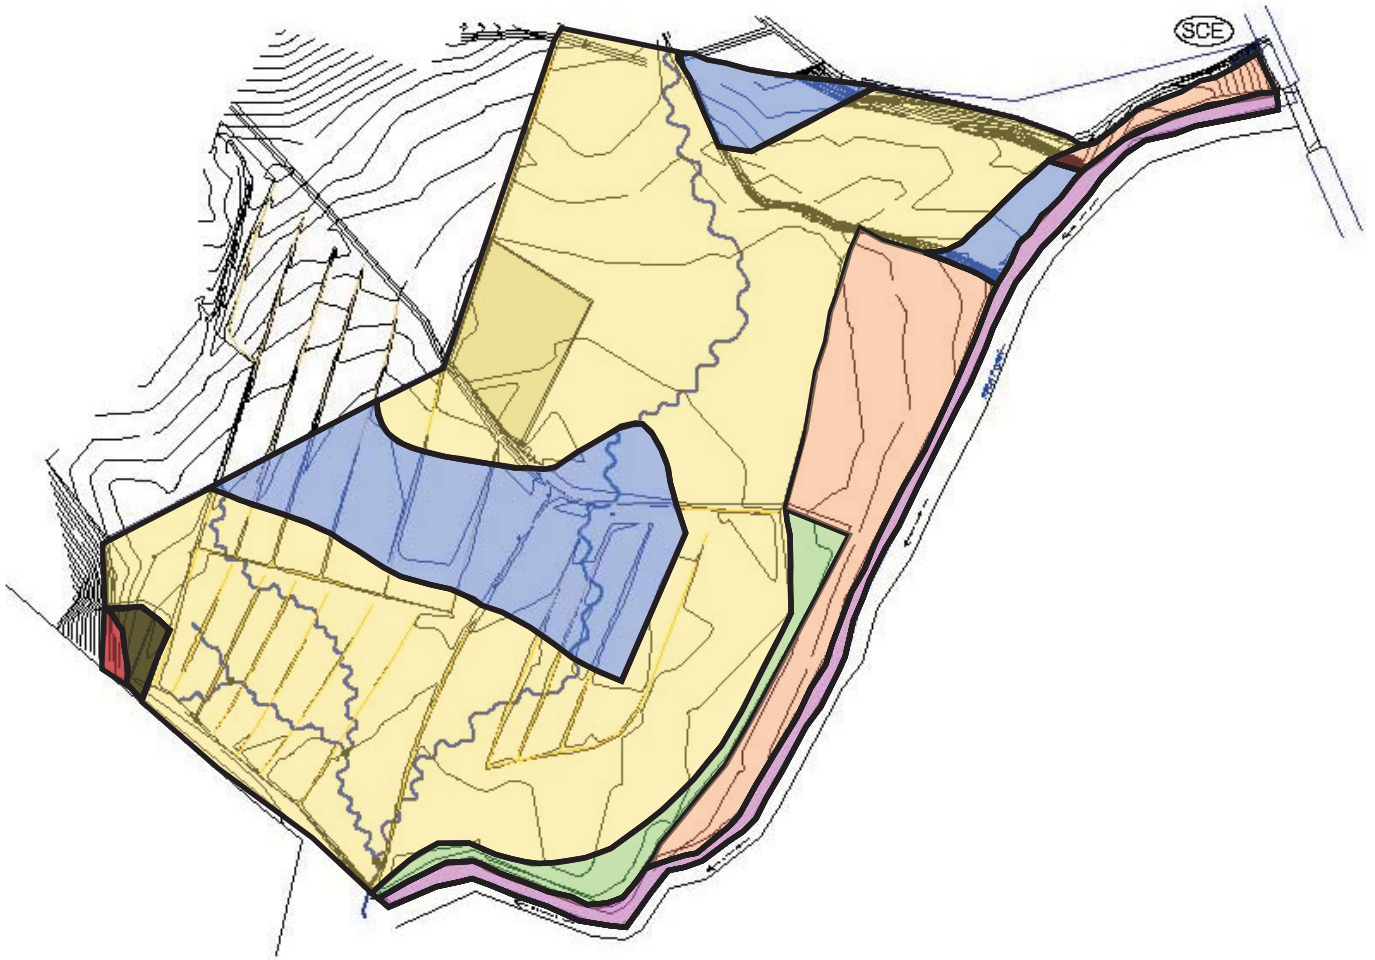
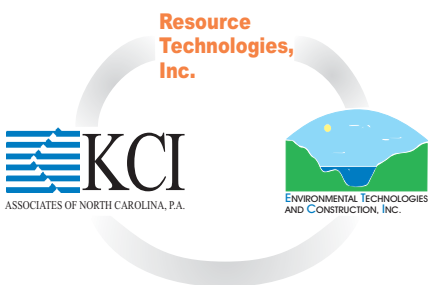
Rich Fork Mitigation Site Figure 11: Restoration Type, Extents, and Distribution

WETLAND COMMUNITIES

UPLAND COMMUNITIES

- LEVEE FOREST RESTORATION
- LEVEE FOREST PRESERVATION

The Rich Fork Mitigation Site will focus on re-establishing the historic bottomland hardwood communities and associated stream network. At present, the site exhibits the effects of hydrologic modifications that prevent the attainment of jurisdictional hydrology, by limiting the number of consecutive days in which saturation occurs within 12” of the grounds surface. However, approximately 70% of the site has indicators of reducing conditions in the upper 12” of the soil profile. Given the extent of human induced alterations to the vegetative communities and hydrology (through draining and ditching), the restoration plan focuses on re-establishing hydrology and vegetation in order to restore the functions and values of a bottomland hardwood community. The restoration types and extents that will be available are found in Table 4 and Figure 11.

COMMUNITY TYPE	Restoration	Creation	Enhancement	Preservation
Piedmont Bottomland Hardwood Forest	17.1 ac.	3.9 ac.	0	0
Low Elevation Seep	0	0	0.31 ac.	0.18 ac.
Piedmont Levee Forest	.62 ac.	0	0	4.1 ac.
Stream	3,386 lf	N/A	0	1,972 lf
