RICH FORK(BODENHEIMER)
STREAM/WETLAND RESTORATION
DAVIDSON COUNTY
2005 REPORT

Activities in 2005 reflect the second year of monitoring following construction. Included in this report are analyses of both hydrologic and vegetation monitoring results, as well as local climate conditions throughout the growing season. Monitoring activities included sampling vegetation survivability at six locations, monitoring ground water elevations at six locations and documenting general site conditions at six permanent photo documentation points within the wetland restoration area.

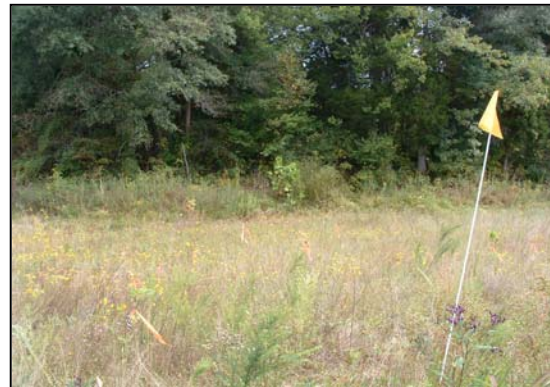
2nd Year Monitoring

Species	Percent of Total
Swamp Chestnut Oak (<i>Quercus michauxii</i>)	67%
Yellow Poplar (<i>Liriodendron tulipifera</i>)	22%
Green Ash (<i>Fraxinus pennsylvanica</i>)	11%

$$\text{Total Number of Trees } \underline{18} \quad / \quad 0.025 \text{ acres} \quad = \quad \underline{720} \quad \text{trees / acre}$$

$$\text{Total Number of Trees } \underline{18} \quad / \quad 18 \text{ trees} \quad \times \quad 100 \quad = \quad \underline{100} \quad \% \text{ survivability}$$

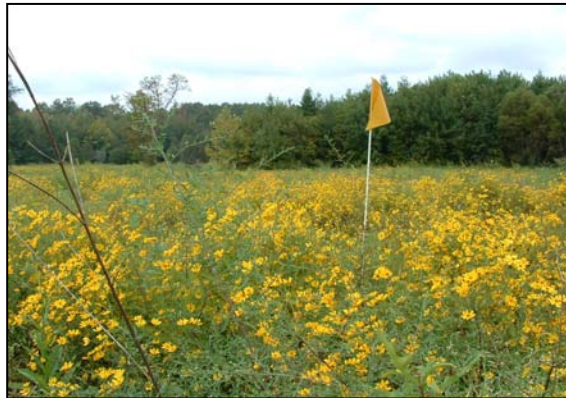
**2nd Year
Monitoring**

Species	Percent of Total
Swamp Chestnut Oak (<i>Quercus michauxii</i>)	13%
Cherrybark Oak (<i>Quercus falcata</i>)	40%
Laurel Oak (<i>Quercus laurifolia</i>)	47%

$$\frac{\text{Total Number of Trees } \mathbf{15}}{\text{0.025 acres}} = \mathbf{600} \text{ trees / acre}$$

$$\frac{\text{Total Number of Trees } \mathbf{15}}{\mathbf{15} \text{ trees}} \times 100 = \mathbf{100} \% \text{ survivability}$$

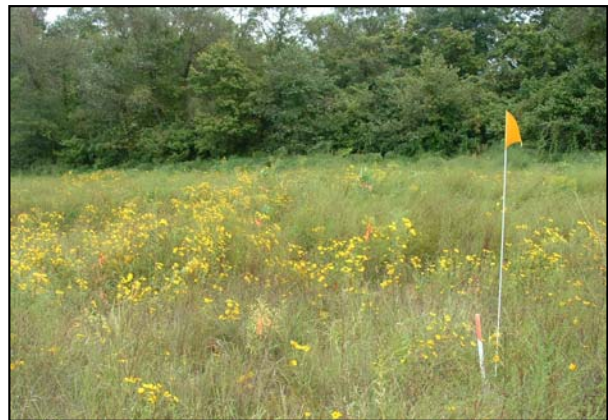
**2nd Year
Monitoring**

Species	Percent of Total
Swamp Chestnut Oak (<i>Quercus michauxii</i>)	13%
Willow Oak (<i>Quercus phellos</i>)	44%
Green Ash (<i>Fraxinus pennsylvanica</i>)	38%
Laurel Oak (<i>Quercus laurifolia</i>)	6%

Total Number of Trees 16 / 0.025 acres = 640 trees / acre

Total Number of Trees 16 / 16 trees X 100 = 100 % survivability

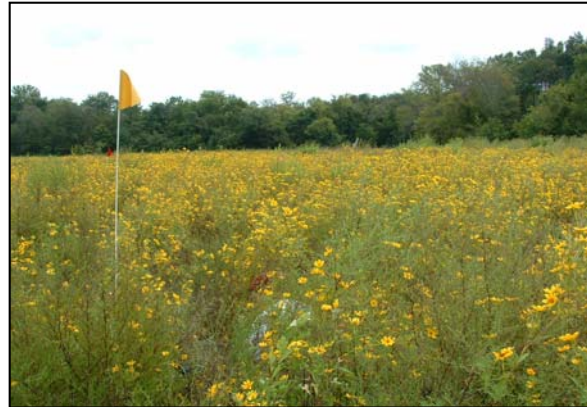
**2nd Year
Monitoring**

Species	Percent of Total
Swamp Chestnut Oak (<i>Quercus michauxii</i>)	18%
Green Ash (<i>Fraxinus pennsylvanica</i>)	24%
Cherrybark Oak (<i>Quercus falcata</i>)	12%
Swamp Black Gum (<i>Nyssa sylvatica</i>)	0%
Silky Dogwood (<i>Cornus amomum</i>)	6%
Black Willow (<i>Salix nigra</i>)	12%
Yellow Poplar (<i>Liriodendron tulipifera</i>)	12%
Laurel Oak (<i>Quercus laurifolia</i>)	18%

$$\text{Total Number of Trees } \underline{17} \quad / \quad 0.025 \text{ acres} \quad = \quad \underline{680} \quad \text{trees / acre}$$

$$\text{Total Number of Trees } \underline{17} \quad / \quad 18 \text{ trees} \quad \times \quad 100 \quad = \quad \underline{94.4} \quad \% \text{ survivability}$$

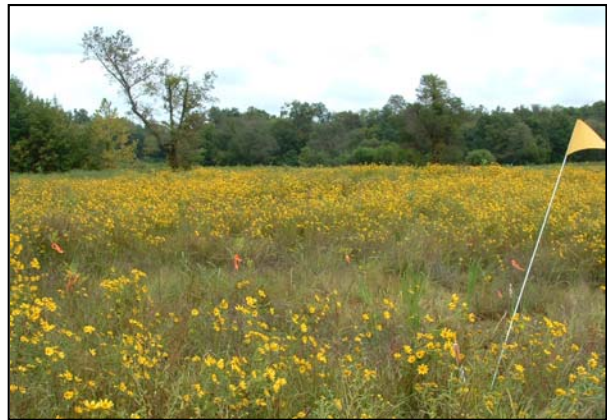
**2nd Year
Monitoring**

Species	Percent of Total
Swamp Chestnut Oak (<i>Quercus michauxii</i>)	8
Green Ash (<i>Fraxinus pennsylvanica</i>)	92

Total Number of Trees 13 / 0.025 acres = 520 trees / acre

Total Number of Trees 13 / 13 trees x 100 = 100 % survivability

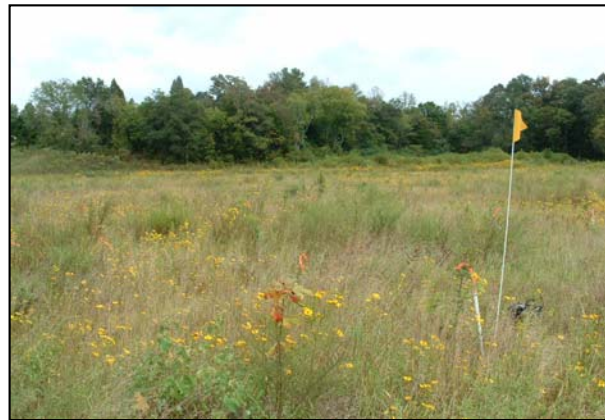
**2nd Year
Monitoring**

Species	Percent of Total
Swamp Chestnut Oak (<i>Quercus michauxii</i>)	58
Green Ash (<i>Fraxinus pennsylvanica</i>)	17
Yellow Poplar (<i>Liriodendron tulipifera</i>)	8
Willow Oak (<i>Quercus phellos</i>)	17

Total Number of Trees 12 / 0.025 acres = 480 trees / acre

Total Number of Trees 12 / 12 trees X 100 = 100 % survivability

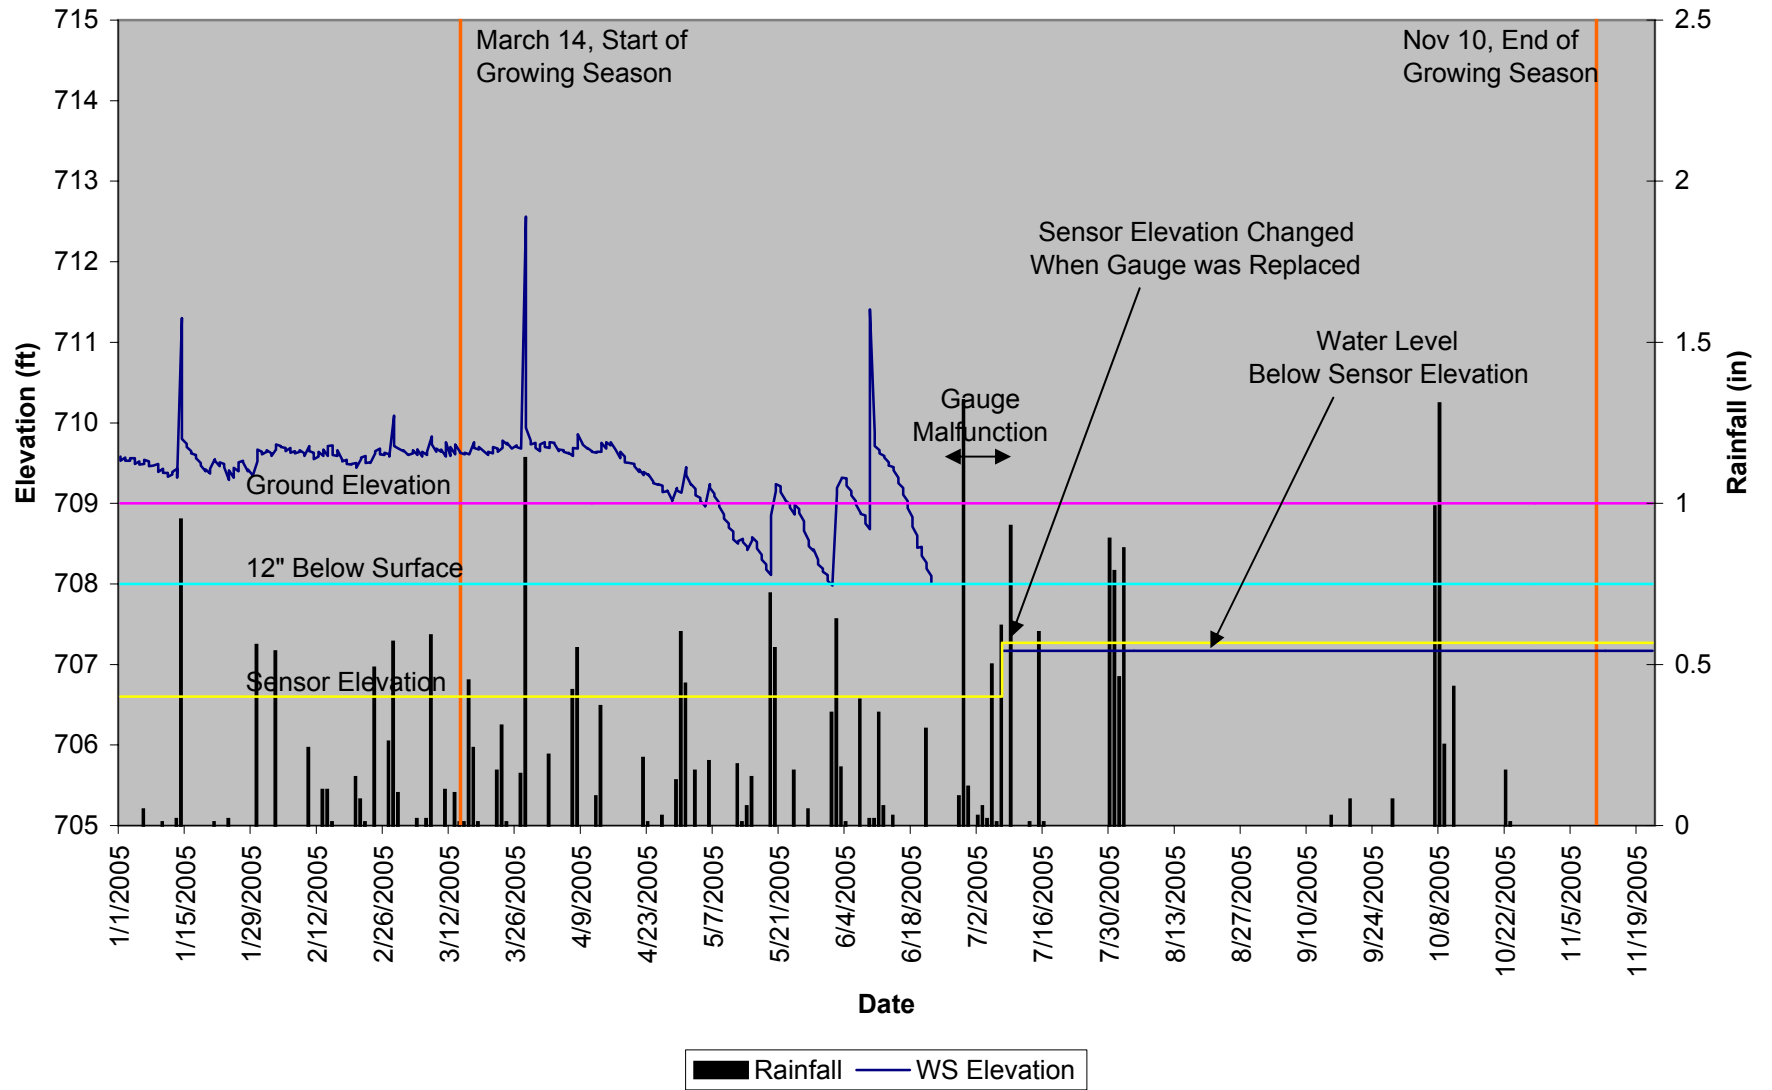
Rich Fork-Reference

1.2 Hydrology Wetland hydrology was monitored through the entire 2005 growing season with groundwater gauges (Appendix B). The result of this monitoring indicated that the water table is within 12 inches of the soil surface for greater than 12.5 % of the growing season at all six monitoring gauges (Table 2). In addition the site gauges closely mimic the hydroperiod of the reference wetland.

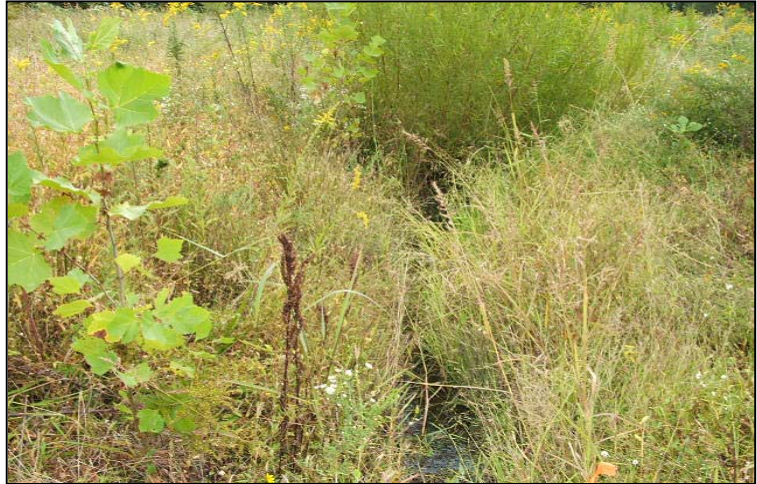
View of mainstem upstream planform section looking downstream

SUMMARY DATA	
Stream Segment Length:	160.00
Distance Between Survey Points:	134.00
Distance Between Stations:	2.00
Sinuosity:	1.19
Mean Radius of Curvature:	13.45
Belt Width:	18.70

Very little water in stream at time of survey.

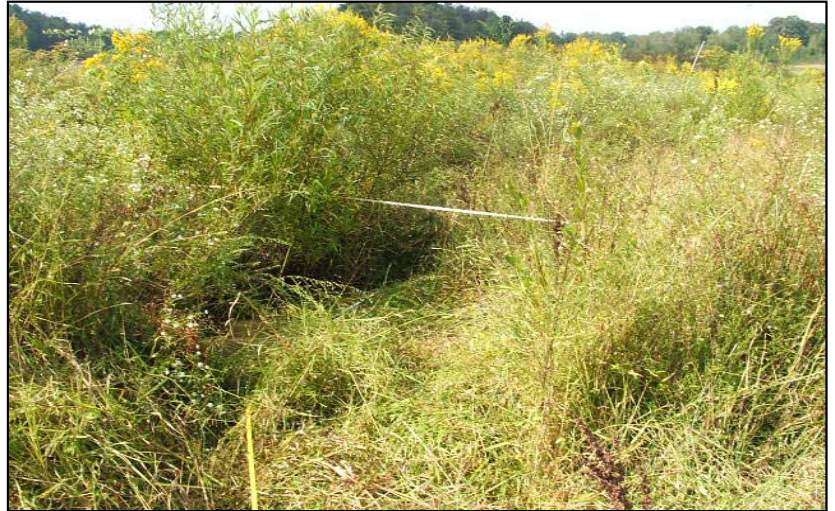
Yadkin River Basin, Rich Fork, Main XS 1 (Pool)

View of mainstem cross-section #1 looking upstream

SUMMARY DATA	
Bankfull Elevation:	696.60
Bankfull Cross-Sectional Area:	6.25
Bankfull Width:	16.52
Flood Prone Area Elevation:	697.79
Flood Prone Width:	240.00
Max Depth at Bankfull:	1.19
Mean Depth at Bankfull:	0.38
W / D Ratio:	43.7
Entrenchment Ratio:	14.53
Bank Height Ratio:	0.91
Slope (ft/ft):	0.004
Discharge (cfs)	10

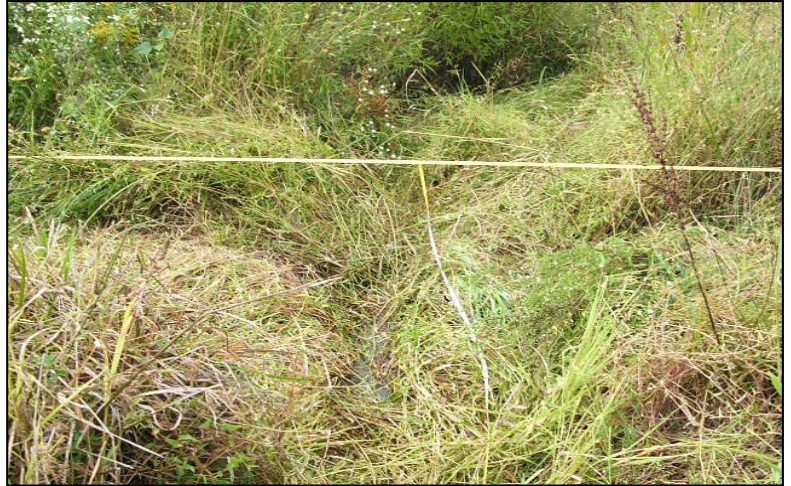
View of mainstem cross-section #2 looking upstream

SUMMARY DATA	
Bankfull Elevation:	696.24
Bankfull Cross-Sectional Area:	1.90
Bankfull Width:	6.00
Flood Prone Area Elevation:	696.88
Flood Prone Width:	240.00
Max Depth at Bankfull:	0.64
Mean Depth at Bankfull:	0.32
W / D Ratio:	19.0
Entrenchment Ratio:	40.00
Bank Height Ratio:	1.00
Slope (ft/ft):	0.004
Discharge (cfs)	3

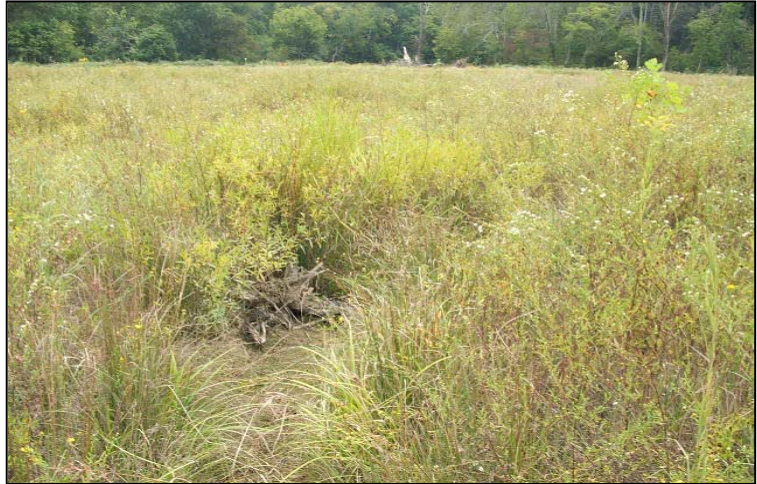
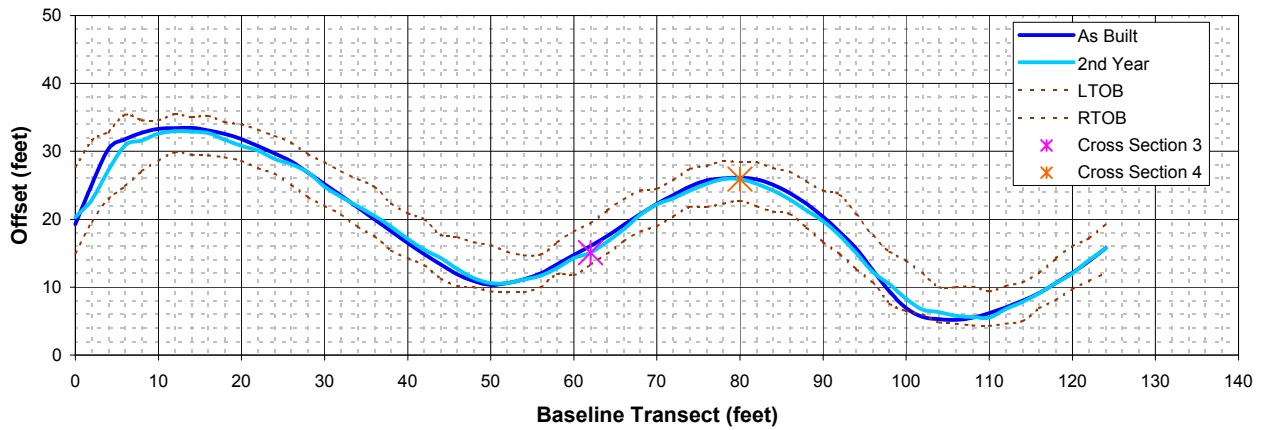
View of mainstem downstream planform section looking downstream

SUMMARY DATA	
Stream Segment Length:	149.00
Distance Between Survey Points:	124.00
Distance Between Stations:	2.00
Sinuosity:	1.20
Mean Radius of Curvature:	14.86
Belt Width:	27.50

No water in stream at time of survey.

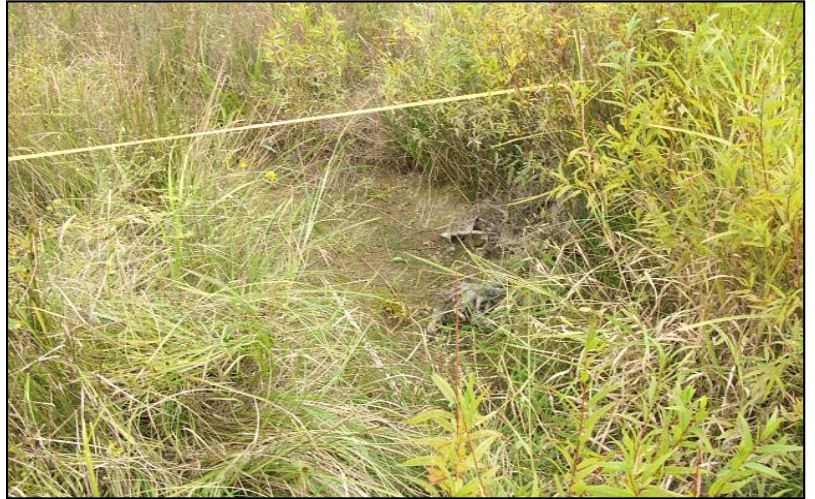
View of mainstem cross-section #3 looking upstream

SUMMARY DATA	
Bankfull Elevation:	696.35
Bankfull Cross-Sectional Area:	5.21
Bankfull Width:	14.07
Flood Prone Area Elevation:	697.74
Flood Prone Width:	180.00
Max Depth at Bankfull:	1.39
Mean Depth at Bankfull:	0.37
W / D Ratio:	38.0
Entrenchment Ratio:	12.79
Bank Height Ratio:	0.95
Slope (ft/ft):	0.005
Discharge (cfs)	9

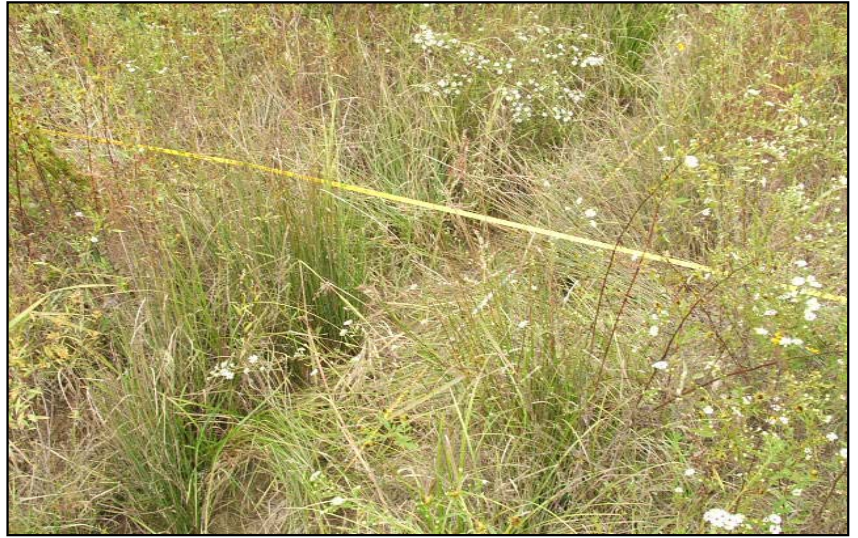
Yadkin River Basin, Rich Fork, Main XS 4 (Riffle)

View of mainstem cross-section #4 looking upstream

SUMMARY DATA	
Bankfull Elevation:	696.56
Bankfull Cross-Sectional Area:	3.99
Bankfull Width:	13.87
Flood Prone Area Elevation:	697.59
Flood Prone Width:	130.00
Max Depth at Bankfull:	1.03
Mean Depth at Bankfull:	0.29
W / D Ratio:	48.2
Entrenchment Ratio:	9.37
Bank Height Ratio:	0.78
Slope (ft/ft):	0.005
Discharge (cfs)	6

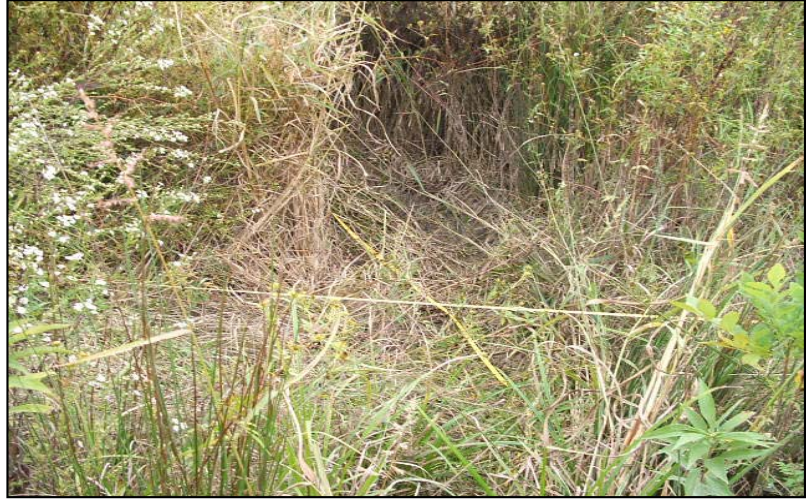
Yadkin River Basin, Rich Fork, Trib XS 1 (Pool)

View of tributary cross-section #1 looking upstream

SUMMARY DATA	
Bankfull Elevation:	696.19
Bankfull Cross-Sectional Area:	2.69
Bankfull Width:	13.64
Flood Prone Area Elevation:	696.93
Flood Prone Width:	180.00
Max Depth at Bankfull:	0.74
Mean Depth at Bankfull:	0.20
W / D Ratio:	69.3
Entrenchment Ratio:	13.19
Bank Height Ratio:	1.00
Slope (ft/ft):	0.006
Discharge (cfs)	3

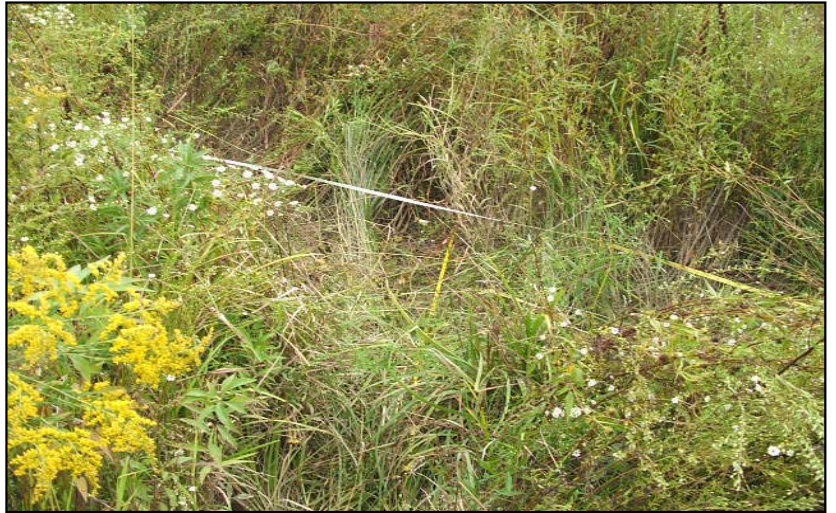
View of tributary cross-section #2 looking upstream

SUMMARY DATA	
Bankfull Elevation:	696.22
Bankfull Cross-Sectional Area:	0.94
Bankfull Width:	6.04
Flood Prone Area Elevation:	696.62
Flood Prone Width:	240.00
Max Depth at Bankfull:	0.40
Mean Depth at Bankfull:	0.16
W / D Ratio:	38.8
Entrenchment Ratio:	39.75
Bank Height Ratio:	1.00
Slope (ft/ft):	0.006
Discharge (cfs)	1

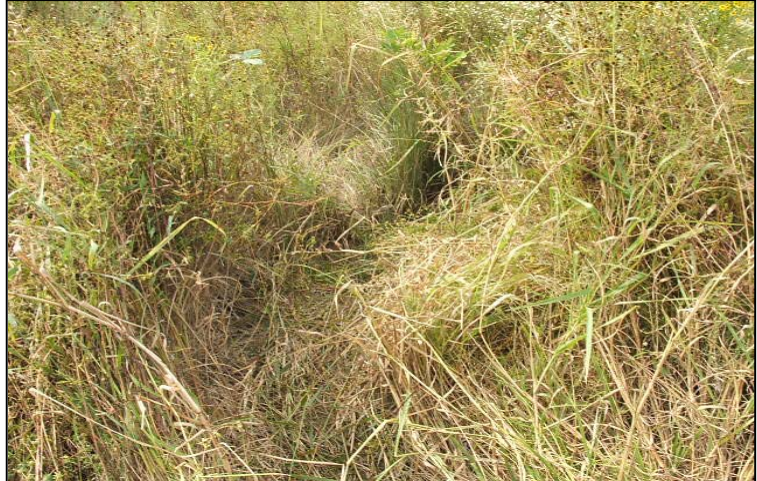
View of tributary upstream planform section looking downstream

SUMMARY DATA	
Stream Segment Length:	112.00
Distance Between Survey Points:	90.00
Distance Between Stations:	2.00
Sinuosity:	1.24
Mean Radius of Curvature:	8.71
Belt Width:	18.50

No water in stream at time of survey.

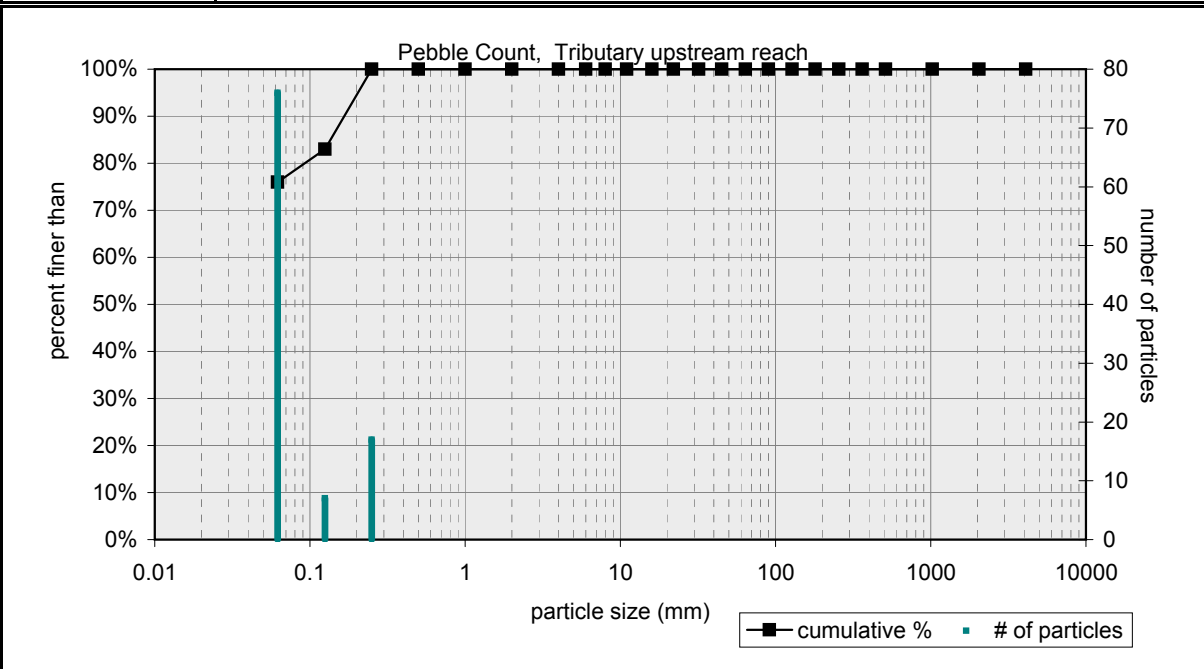
Pebble Count,	
Tributary upstream reach	
Rich Fork Creek	
High Point, NC	
Note: 9/29/2005

Pebble Count of Channel Reach			
Material	Size Range (mm)		Count
silt/clay	0	0.062	76
very fine sand	0.062	0.13	7
fine sand	0.13	0.25	17
medium sand	0.25	0.5	
coarse sand	0.5	1	
very coarse sand	1	2	
very fine gravel	2	4	
fine gravel	4	6	
fine gravel	6	8	
medium gravel	8	11	
medium gravel	11	16	
coarse gravel	16	22	
coarse gravel	22	32	
very coarse gravel	32	45	
very coarse gravel	45	64	
small cobble	64	90	
medium cobble	90	128	
large cobble	128	180	
very large cobble	180	256	
small boulder	256	362	
small boulder	362	512	
medium boulder	512	1024	
large boulder	1024	2048	
very large boulder	2048	4096	
total particle count:			100
bedrock			
clay hardpan			
detritus/wood			
artificial			
total count:			100

based on sediment particles only	size percent less than (mm)						particle size distribution gradation		
	D16	D35	D50	D65	D84	D95	geo mean	std dev	
	0.062	0.06	0.1	0	0	0	1.6	0.1	1.4
based on total count	percent by substrate type								
	silt/clay	sand	gravel	cobble	boulder	bedrock	hardpan	wood/det	artificial
	76%	24%	0%	0%	0%	0%	0%	0%	0%

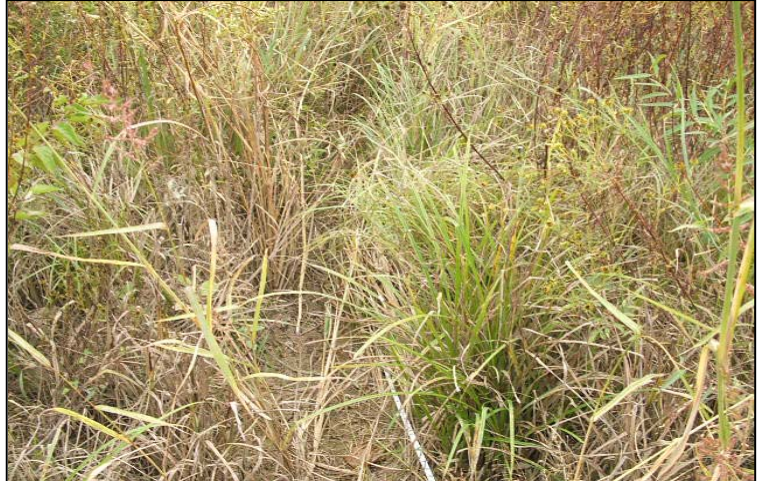
View of tributary downstream planform section looking downstream

SUMMARY DATA	
Stream Segment Length:	127.00
Distance Between Survey Points:	94.00
Distance Between Stations:	2.00
Sinuosity:	1.35
Mean Radius of Curvature:	7.63
Belt Width:	23.60

No water in stream at time of survey.

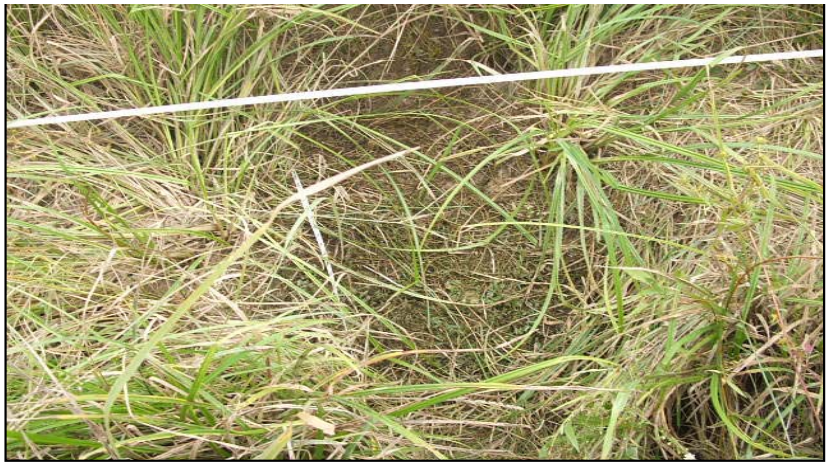
Yadkin River Basin, Rich Fork, Trib XS 3 (Pool)

SUMMARY DATA	
Bankfull Elevation:	695.77
Bankfull Cross-Sectional Area:	1.57
Bankfull Width:	6.05
Flood Prone Area Elevation:	696.38
Flood Prone Width:	240.00
Max Depth at Bankfull:	0.61
Mean Depth at Bankfull:	0.26
W / D Ratio:	23.3
Entrenchment Ratio:	39.69
Bank Height Ratio:	0.80
Slope (ft/ft):	0.006
Discharge (cfs)	2

View of tributary cross-section #3 looking upstream

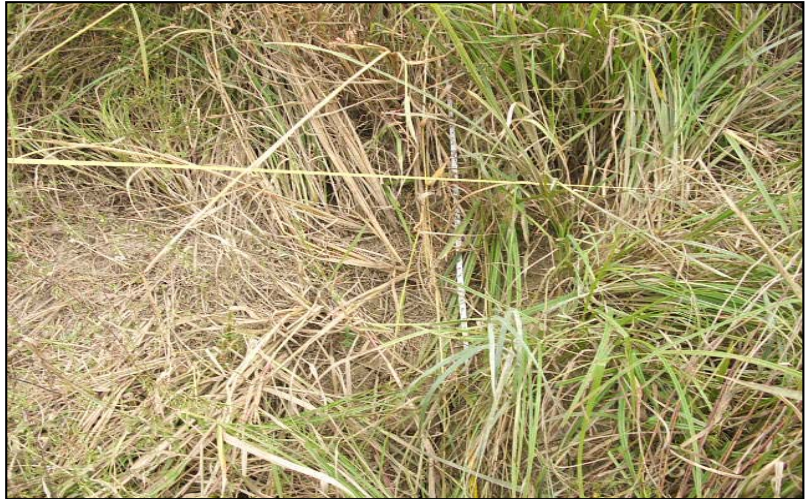
View of tributary cross-section #4 looking upstream

SUMMARY DATA	
Bankfull Elevation:	695.85
Bankfull Cross-Sectional Area:	0.93
Bankfull Width:	6.50
Flood Prone Area Elevation:	696.33
Flood Prone Width:	240.00
Max Depth at Bankfull:	0.48
Mean Depth at Bankfull:	0.14
W / D Ratio:	45.6
Entrenchment Ratio:	36.92
Bank Height Ratio:	0.92
Slope (ft/ft):	0.006
Discharge (cfs)	1

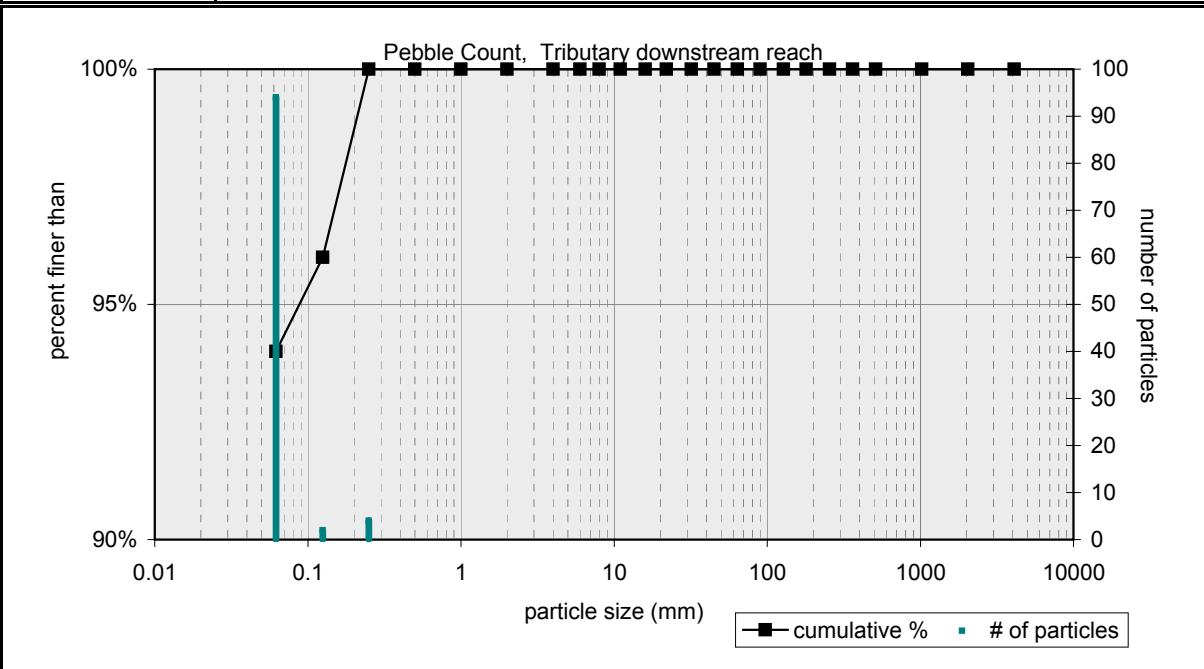
Pebble Count,	
Tributary downstream reach	
Rich Fork Creek	
High Point, NC	
Note:	9/30/2005

Pebble Count of Channel Reach			
Material	Size Range (mm)		Count
silt/clay	0	0.062	94
very fine sand	0.062	0.13	2
fine sand	0.13	0.25	4
medium sand	0.25	0.5	
coarse sand	0.5	1	
very coarse sand	1	2	
very fine gravel	2	4	
fine gravel	4	6	
fine gravel	6	8	
medium gravel	8	11	
medium gravel	11	16	
coarse gravel	16	22	
coarse gravel	22	32	
very coarse gravel	32	45	
very coarse gravel	45	64	
small cobble	64	90	
medium cobble	90	128	
large cobble	128	180	
very large cobble	180	256	
small boulder	256	362	
small boulder	362	512	
medium boulder	512	1024	
large boulder	1024	2048	
very large boulder	2048	4096	
total particle count:			100
bedrock			
clay hardpan			
detritus/wood			
artificial			
total count:			100

based on sediment particles only	size percent less than (mm)						particle size distribution gradation		
	D16	D35	D50	D65	D84	D95	geo mean	std dev	
	0.062	0.06	0.1	0	0	0	1.0	0.1	1.0
based on total count	percent by substrate type								
	silt/clay	sand	gravel	cobble	boulder	bedrock	hardpan	wood/det	artificial
	94%	6%	0%	0%	0%	0%	0%	0%	0%

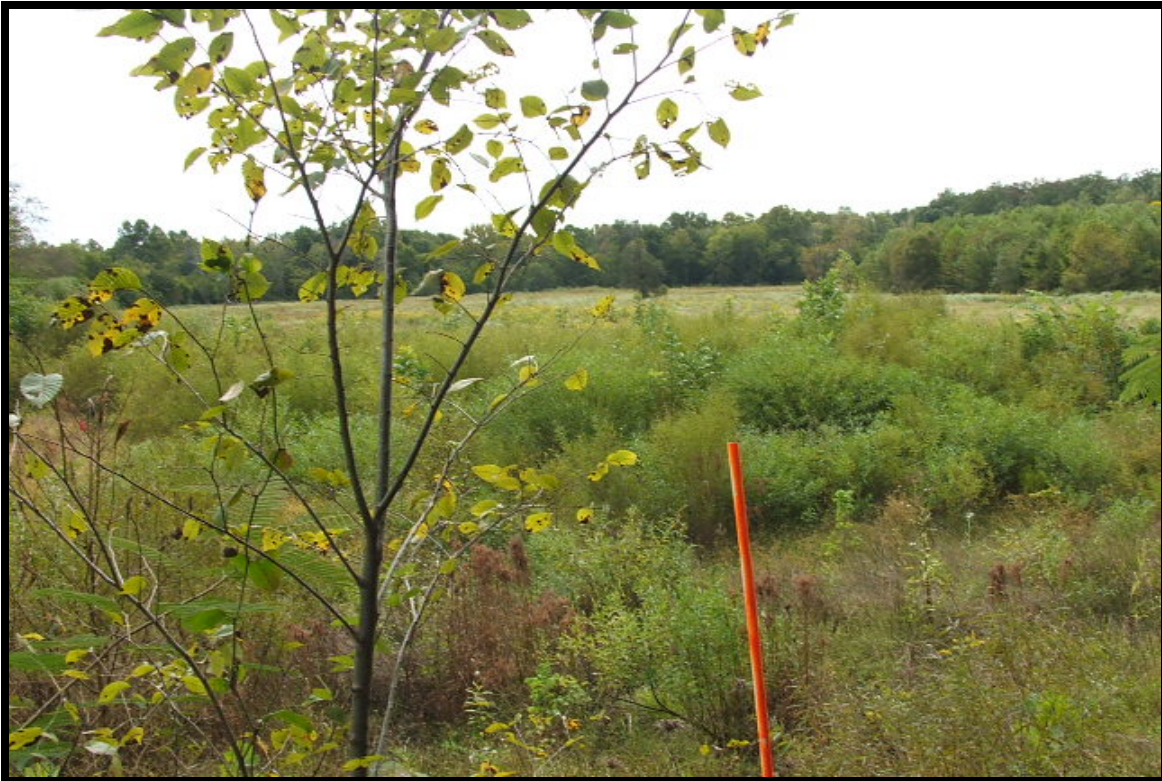
Photo Location 1: View looking toward large cedar and restored channel at confluence with Rich Fork Creek

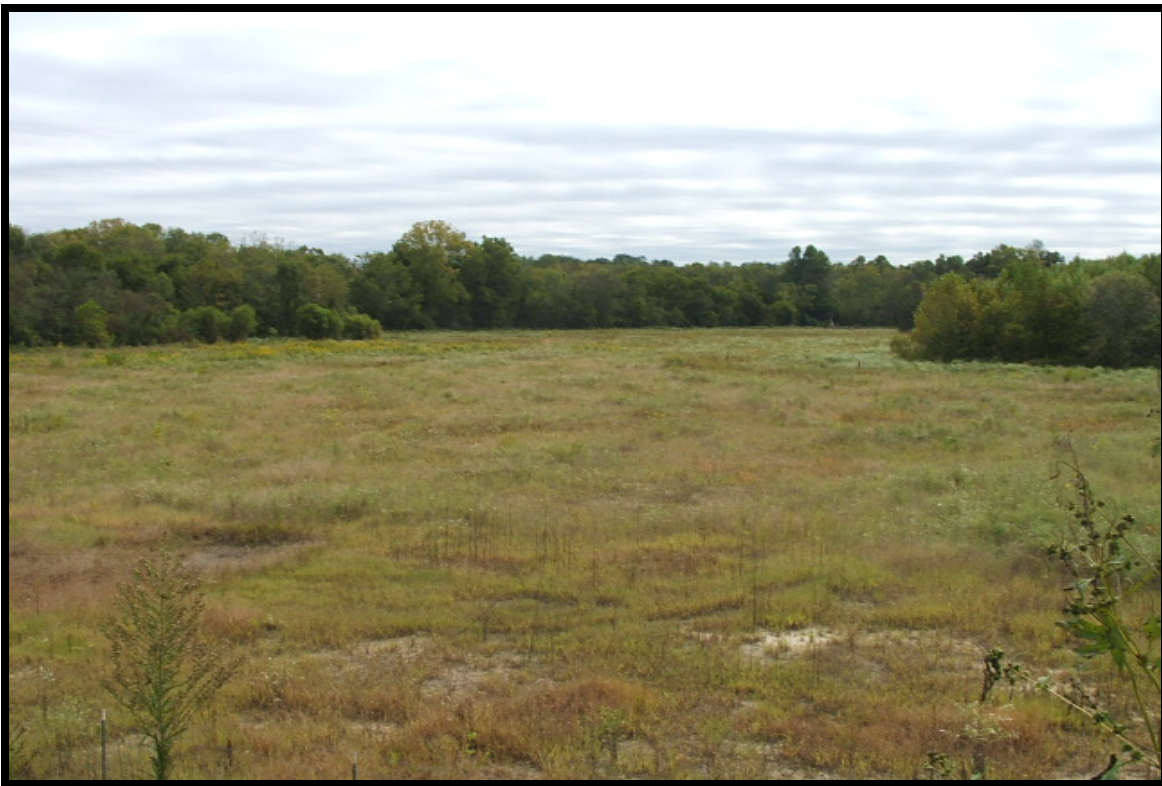
Photo Location 2, Photo 1: View looking toward large cedar and vegetation monitoring plot #6.

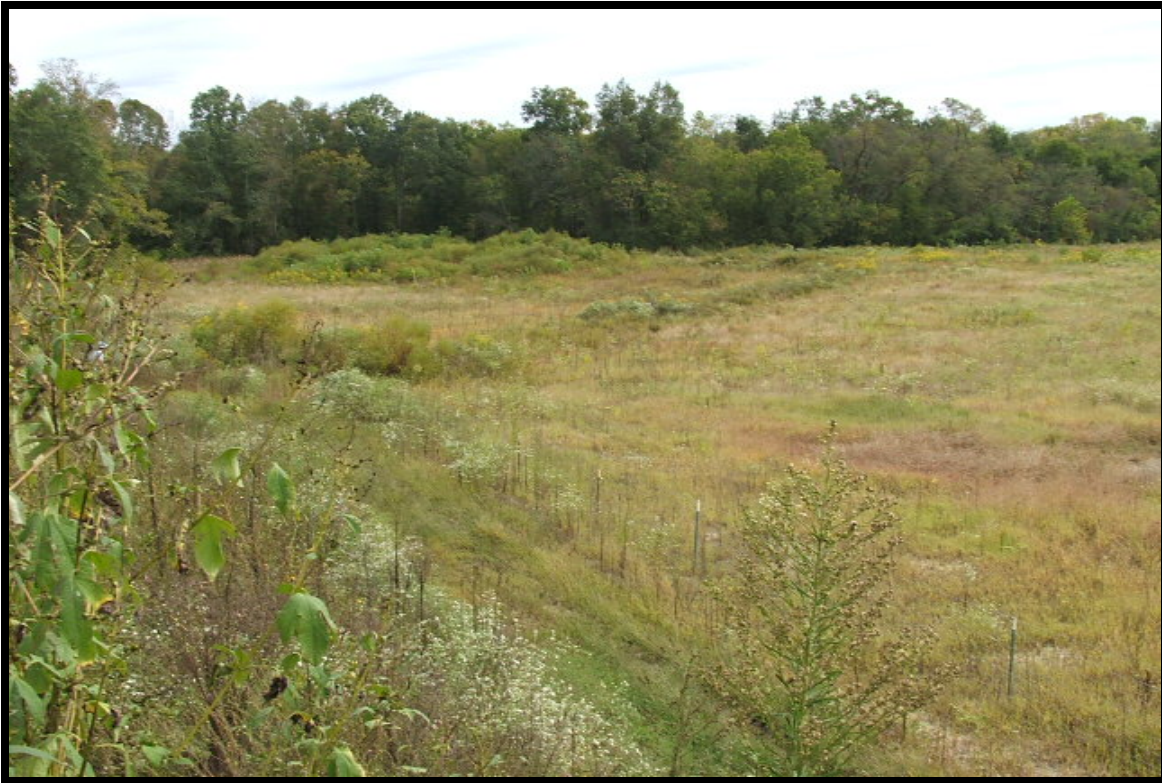
Photo Location 2, Photo 2: View looking toward vegetation-monitoring plot #1 identified by a yellow flag in left center of the photo.

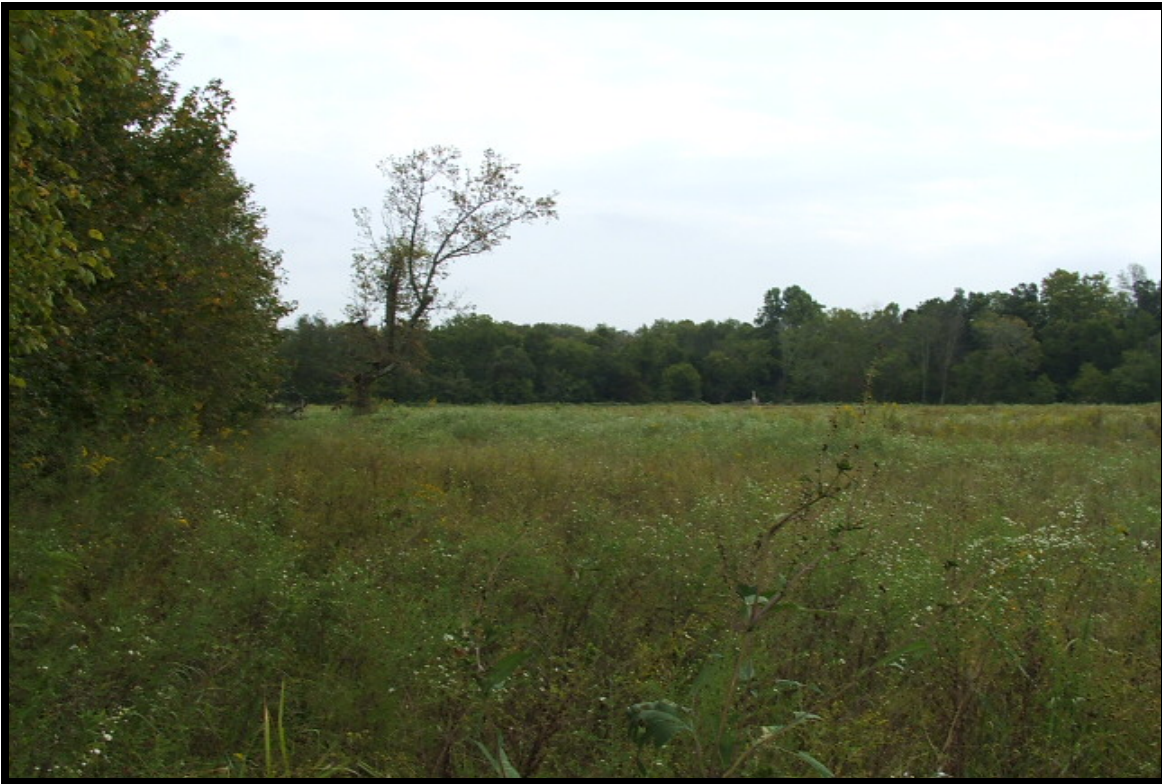
Photo Location 3: View looking east along the wetland preservation area.

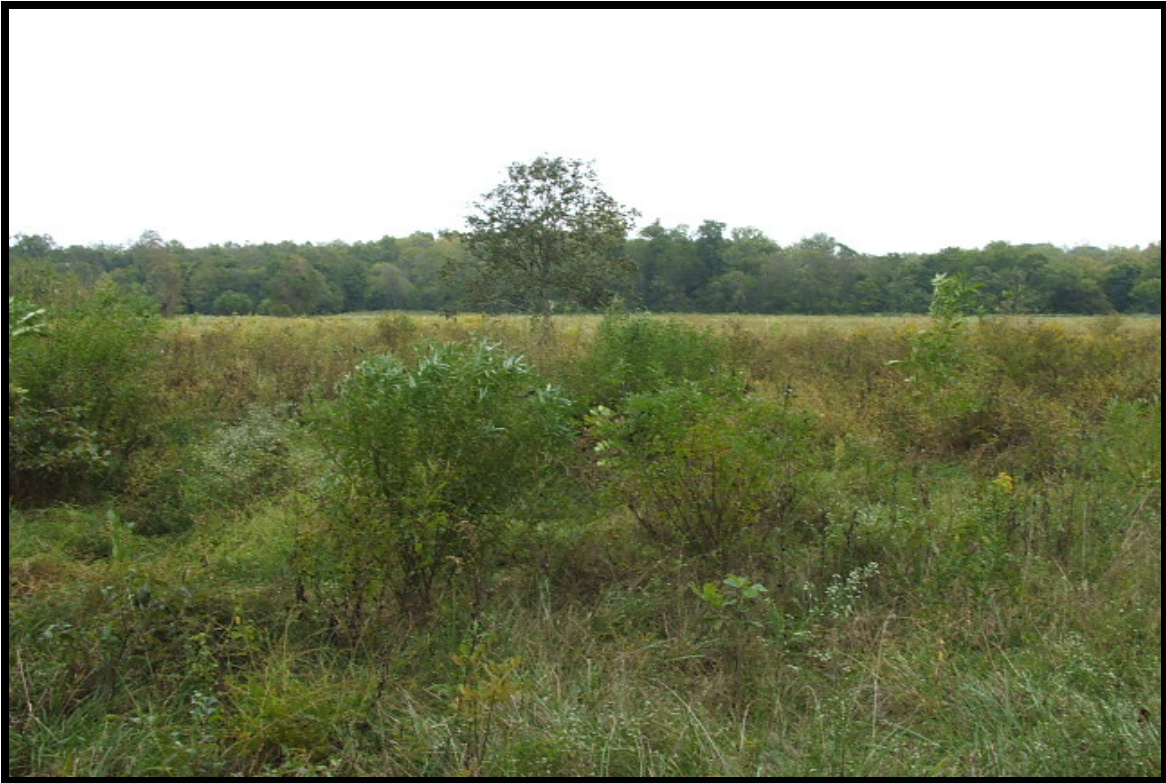
Photo Location 4: View looking east with large cedar shown in the upper left corner of the photo.

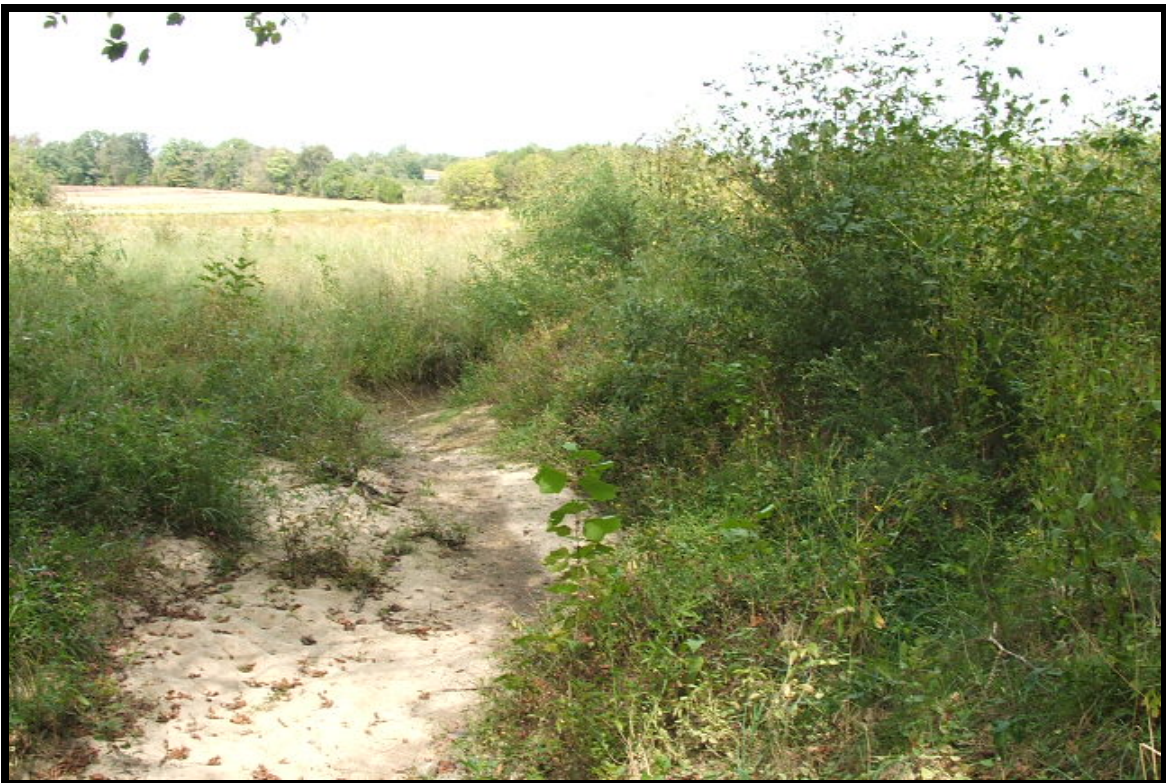
Photo Location 5: View looking north toward tree line of wetland preservation area.

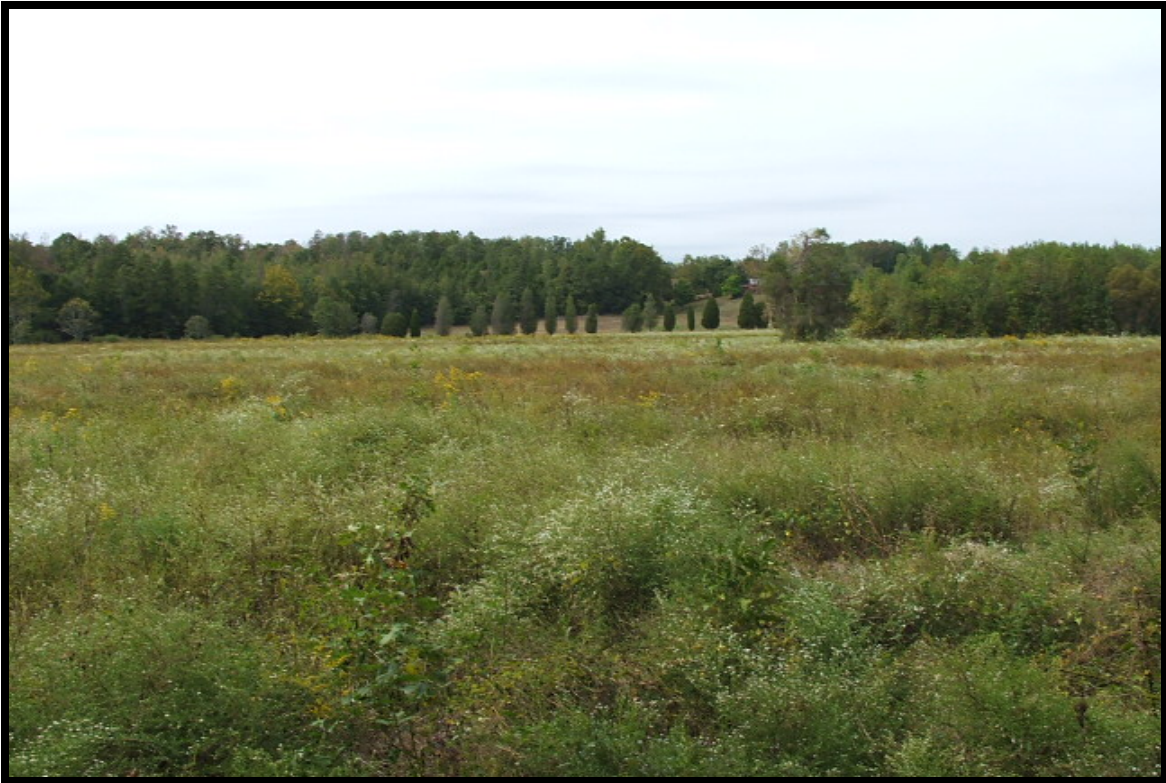
Photo Location 6, Photo 1: View looking west toward large cedar.

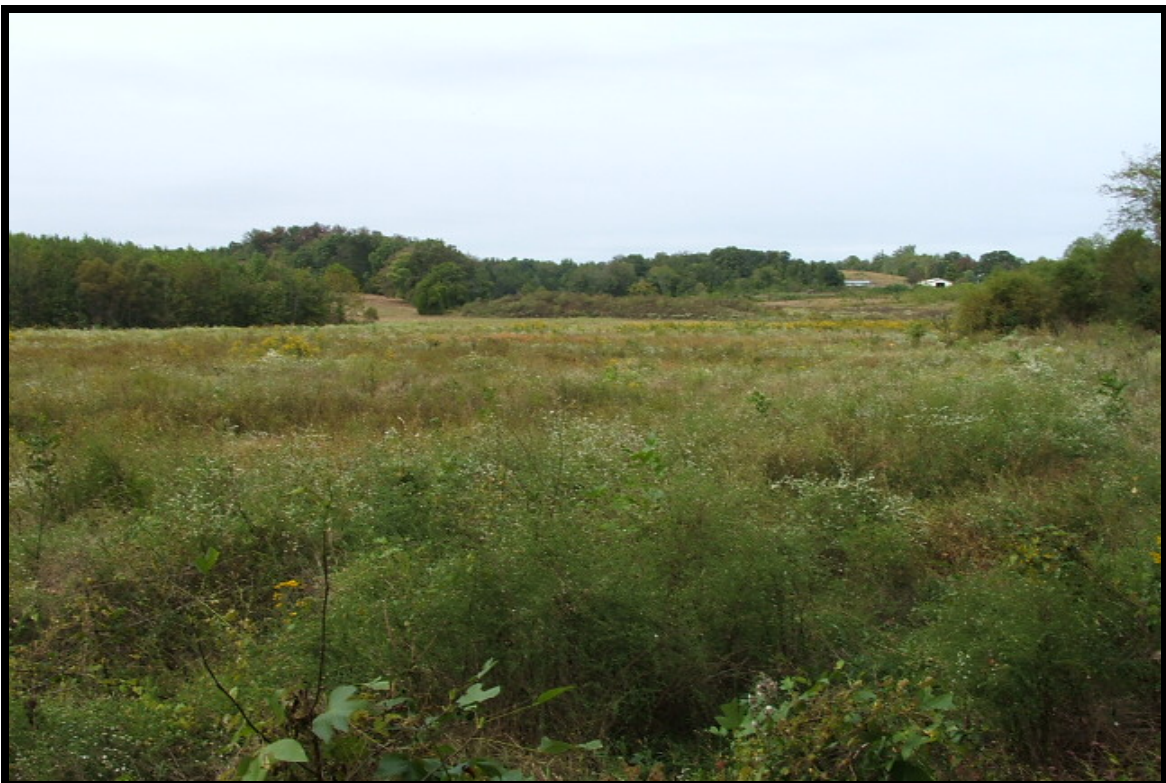
Photo Location 6, Photo 2: View looking from Rich Fork toward photo point #2 at the spoil pile.
