RICH FORK(BODENHEIMER)
STREAM/WETLAND RESTORATION
YEAR 3 MONITORING REPORT
DECEMBER 2006

FULL DELIVERY PROJECT

EXECUTIVE SUMMARY

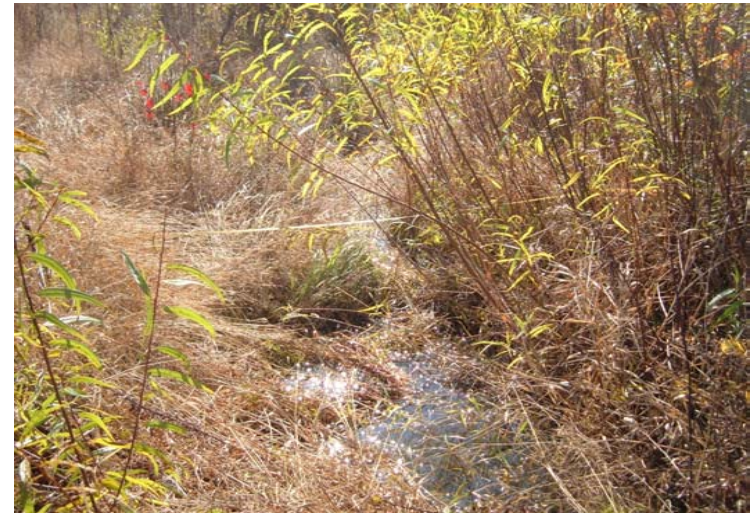
River Basin:	Yadkin
Watershed:	Rich Fork, MY03
XS ID	Main XS 1, Pool
Date:	11/1/2006
Field Crew:	A. Spiller & K. Knight

SUMMARY DATA	
Bankfull Elevation:	696.6
Bankfull Cross-Sectional Area:	6.2
Bankfull Width:	17.0
Flood Prone Area Elevation:	697.4
Flood Prone Width:	50.0
Max Depth at Bankfull:	1.2
Mean Depth at Bankfull:	0.4
W / D Ratio:	46.5
Entrenchment Ratio:	2.9
Bank Height Ratio:	1.0

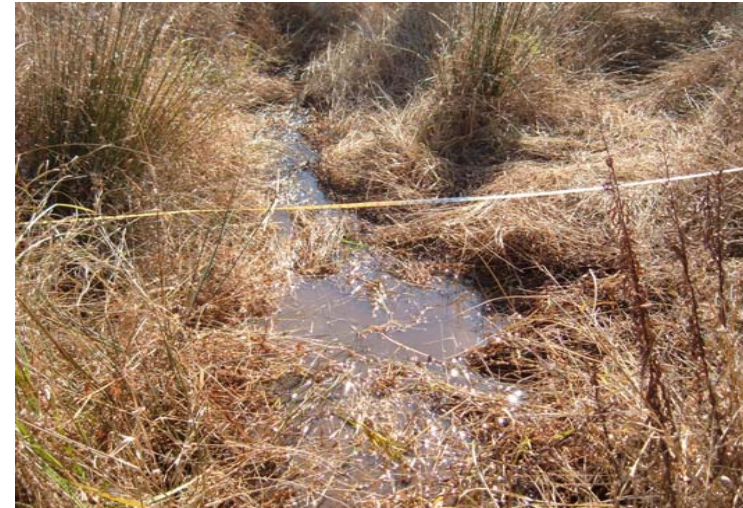
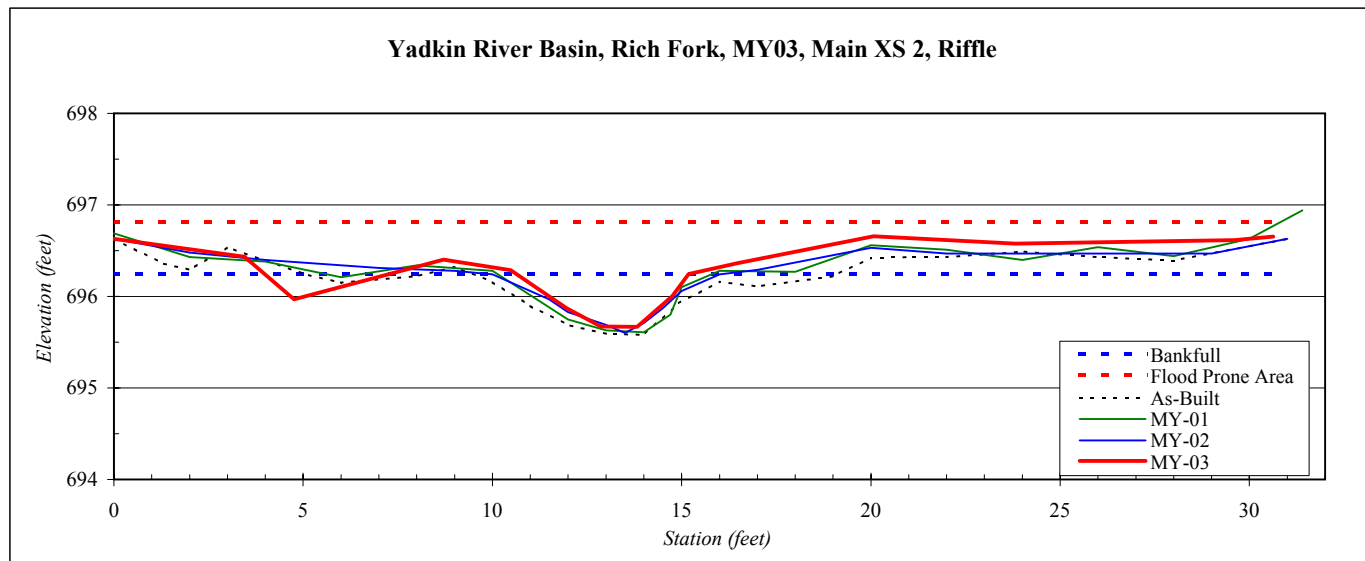
River Basin:	Yadkin
Watershed:	Rich Fork, MY03
XS ID	Main XS 2, Riffle
Date:	11/1/2006
Field Crew:	A. Spiller & K. Knight

SUMMARY DATA	
Bankfull Elevation:	696.24
Bankfull Cross-Sectional Area:	1.6
Bankfull Width:	4.9
Flood Prone Area Elevation:	696.81
Flood Prone Width:	35.0
Max Depth at Bankfull:	0.6
Mean Depth at Bankfull:	0.3
W / D Ratio:	19.6
Entrenchment Ratio:	7.1
Bank Height Ratio:	1.0

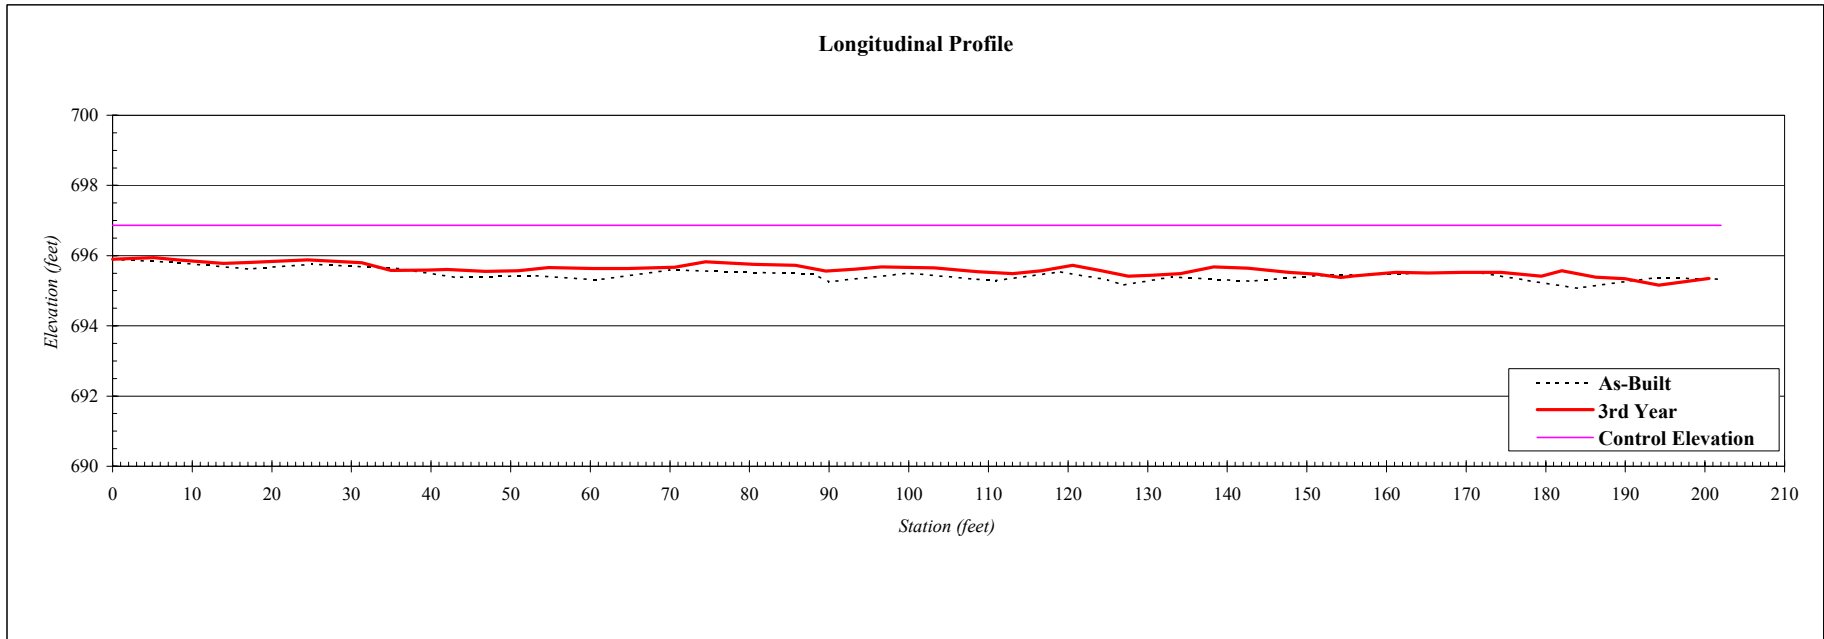
River Basin:	Yadkin
Watershed:	Rich Fork Creek
Reach:	Mainstem
Profile ID:	Upstream
Date:	11/1/2006
Field Crew:	A. Spiller & K. Knight
Control Elevation:	696.86

Average Slope:	0.003
As-Built Avg. Depth:	1.42
3rd Year Avg. Depth:	1.26

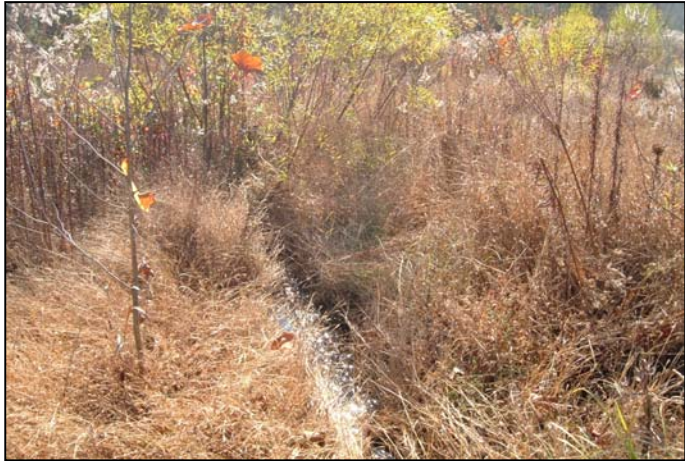
River Basin:	Yadkin
Watershed:	Rich Fork
Planform ID	Main Up
Date:	11/1/2006
Field Crew:	AS, KK

SUMMARY DATA	
Stream Segment Length:	160
Distance Between Survey Points:	134
Distance Between Stations:	2
Sinuosity:	1.2
Mean Radius of Curvature:	13.8
Belt Width:	18.9

View of mainstem upstream planform section looking downstream

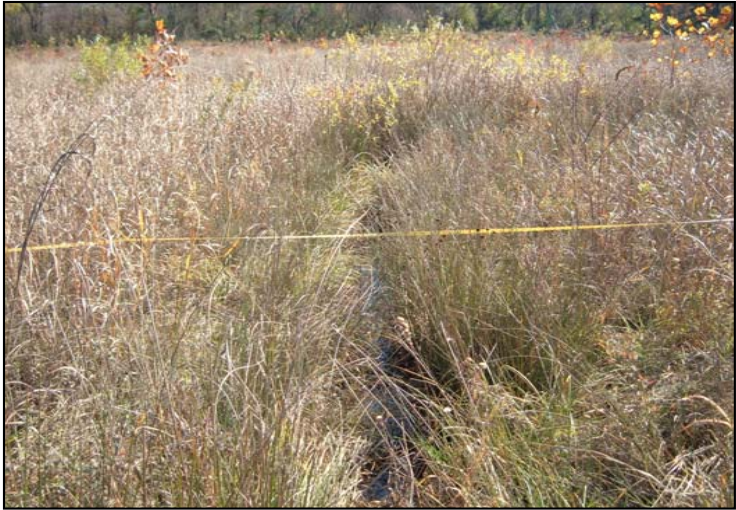
River Basin:	Yadkin
Watershed:	Rich Fork, MY03
XS ID	Main XS 3, Pool
Date:	11/1/2006
Field Crew:	A. Spiller & K. Knight

SUMMARY DATA	
Bankfull Elevation:	696.35
Bankfull Cross-Sectional Area:	2.9
Bankfull Width:	5.9
Flood Prone Area Elevation:	697.15
Flood Prone Width:	40.0
Max Depth at Bankfull:	0.9
Mean Depth at Bankfull:	0.5
W / D Ratio:	12.0
Entrenchment Ratio:	6.8
Bank Height Ratio:	1.0

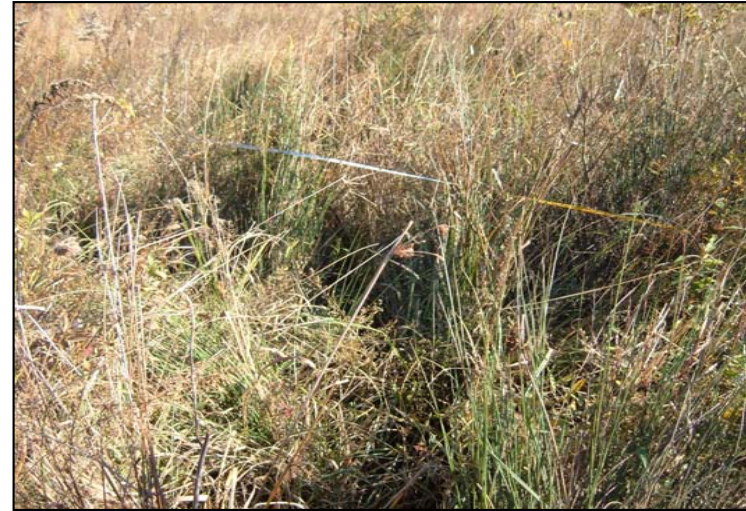
River Basin:	Yadkin
Watershed:	Rich Fork, MY03
XS ID	Trib XS 1, Pool
Date:	11/1/2006
Field Crew:	A. Spiller & K. Knight

SUMMARY DATA	
Bankfull Elevation:	696.19
Bankfull Cross-Sectional Area:	1.2
Bankfull Width:	10.8
Flood Prone Area Elevation:	697.0
Flood Prone Width:	30.0
Max Depth at Bankfull:	0.4
Mean Depth at Bankfull:	0.1
W / D Ratio:	10.9
Entrenchment Ratio:	2.8
Bank Height Ratio:	1.0

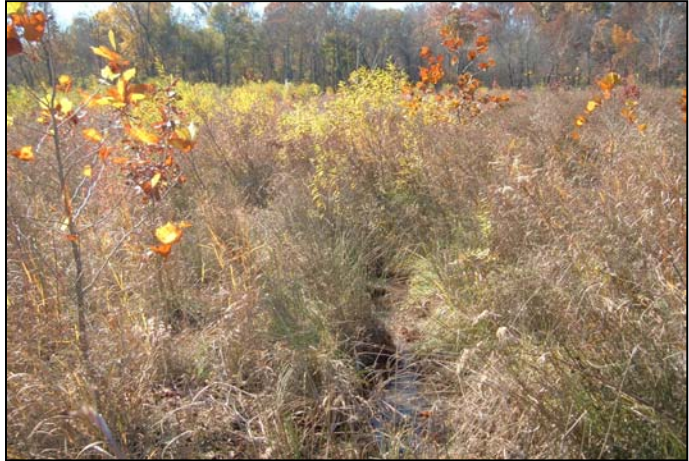
River Basin:	Yadkin
Watershed:	Rich Fork
Planform ID	Main Dwn
Date:	11/1/2006
Field Crew:	AS, KK

View of mainstem downstream planform section looking downstream

SUMMARY DATA	
Stream Segment Length:	151
Distance Between Survey Points:	124
Distance Between Stations:	2
Sinuosity:	1.2
Mean Radius of Curvature:	11.8
Belt Width:	26.9

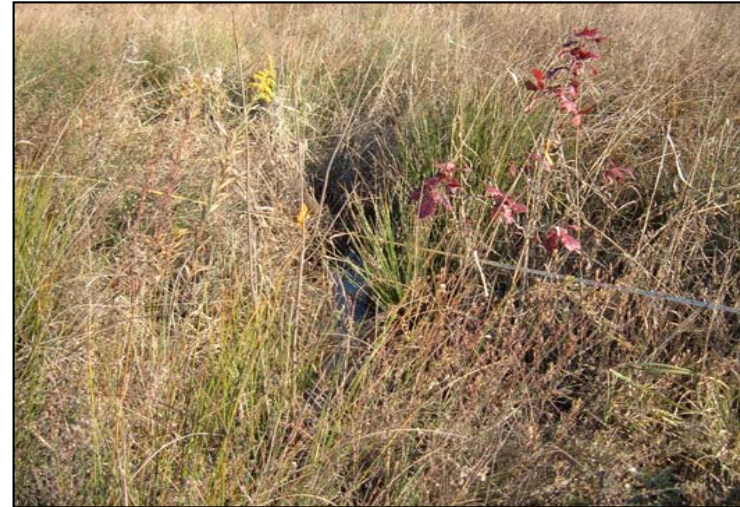
River Basin:	Yadkin
Watershed:	Rich Fork, MY03
XS ID	Trib XS 2, Riffle
Date:	11/1/2006
Field Crew:	A. Spiller & K. Knight

SUMMARY DATA	
Bankfull Elevation:	696.22
Bankfull Cross-Sectional Area:	1.5
Bankfull Width:	7.1
Flood Prone Area Elevation:	696.8
Flood Prone Width:	25.0
Max Depth at Bankfull:	0.6
Mean Depth at Bankfull:	0.2
W / D Ratio:	34.7
Entrenchment Ratio:	3.5
Bank Height Ratio:	1.0

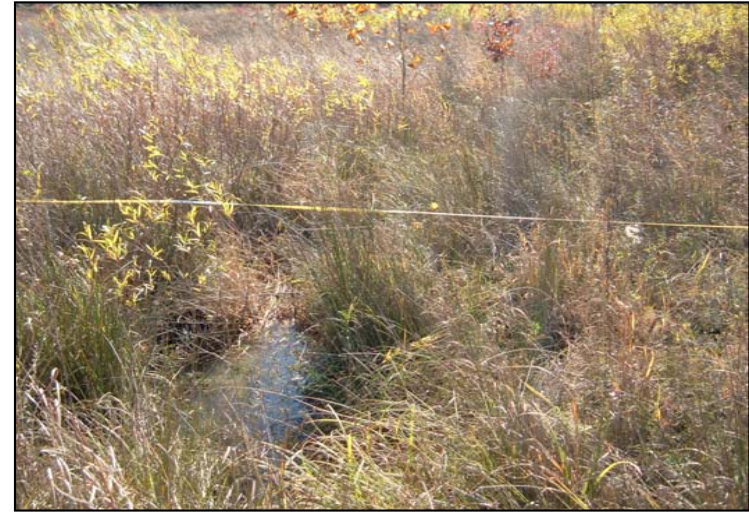
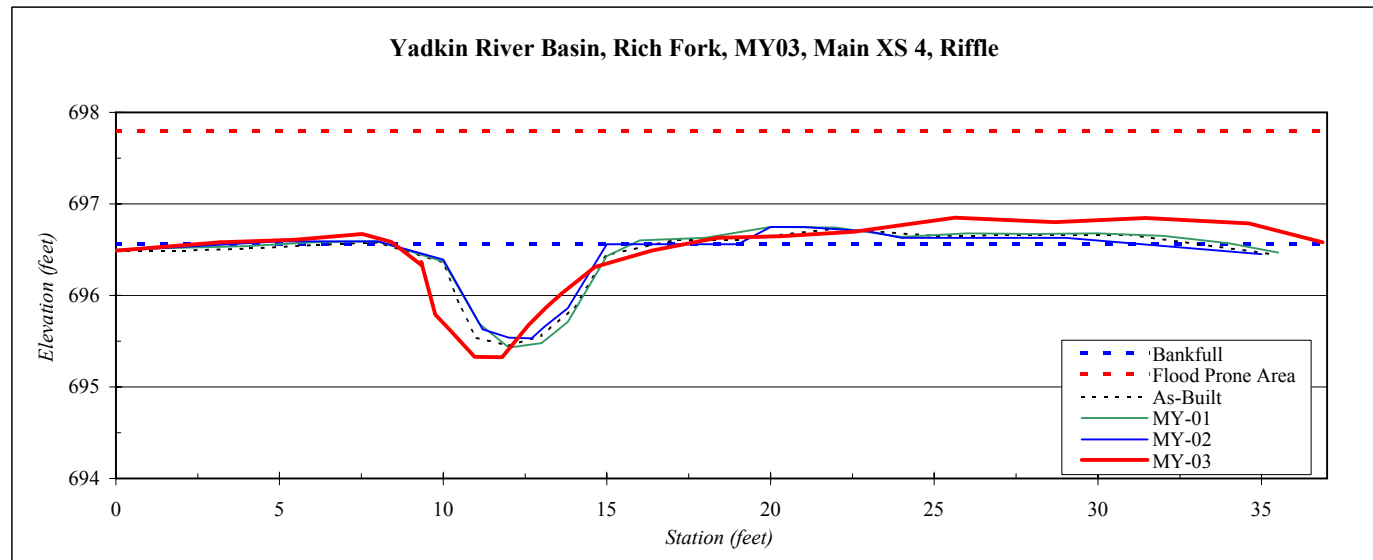
River Basin:	Yadkin
Watershed:	Rich Fork, MY03
XS ID	Main XS 4, Riffle
Date:	11/1/2006
Field Crew:	A. Spiller & K. Knight

SUMMARY DATA	
Bankfull Elevation:	696.56
Bankfull Cross-Sectional Area:	5.2
Bankfull Width:	12.0
Flood Prone Area Elevation:	697.8
Flood Prone Width:	50.0
Max Depth at Bankfull:	1.2
Mean Depth at Bankfull:	0.4
W / D Ratio:	27.9
Entrenchment Ratio:	4.2
Bank Height Ratio:	1.0

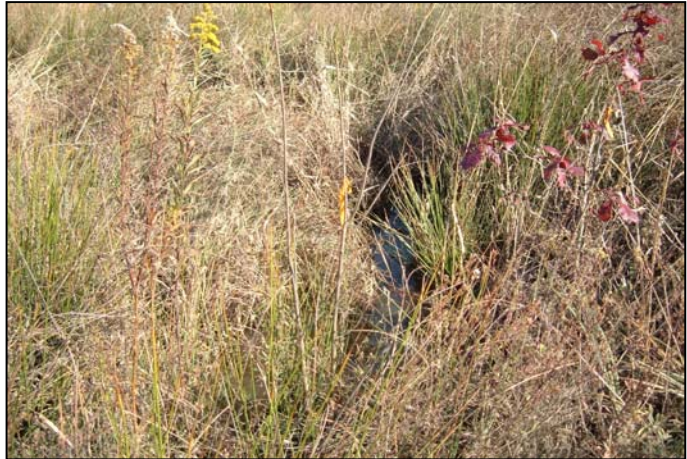
River Basin:	Yadkin
Watershed:	Rich Fork
Planform ID	Trib Up
Date:	11/1/2006
Field Crew:	AS, KK

SUMMARY DATA	
Stream Segment Length:	107
Distance Between Survey Points:	88
Distance Between Stations:	2
Sinuosity:	1.2
Mean Radius of Curvature:	7.0
Belt Width:	17.6

View of tributary upstream planform section looking downstream

Due to blockage in tributary near the confluence with the mainstem, backwatered conditions existed in the tributary

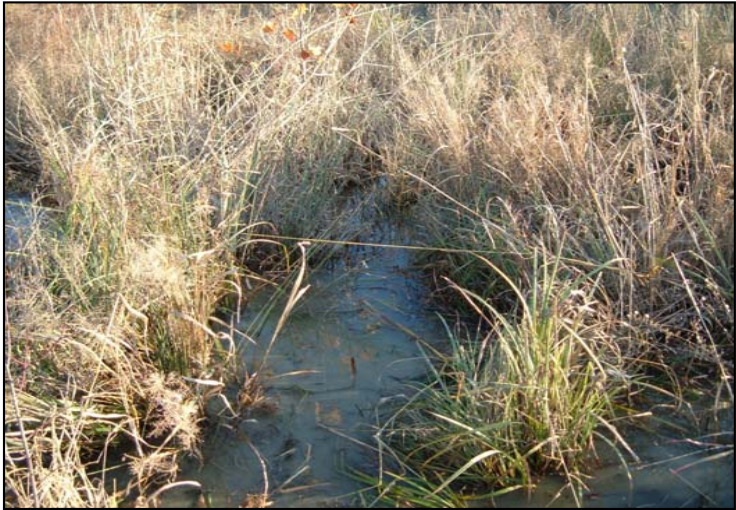
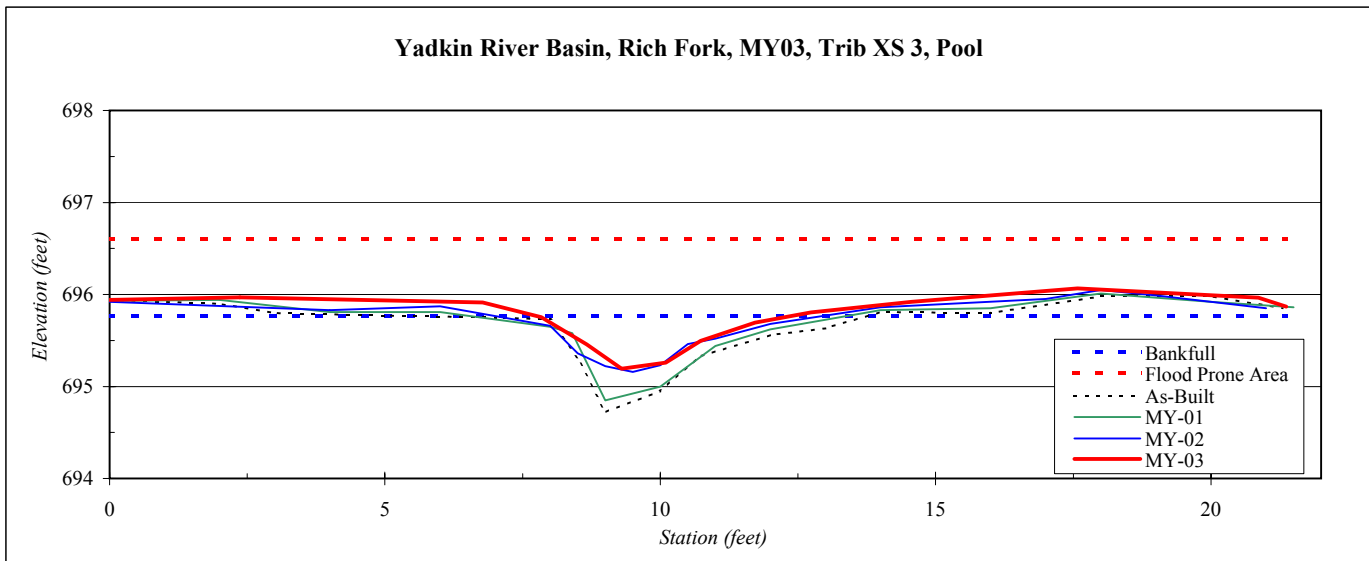
River Basin:	Yadkin
Watershed:	Rich Fork, MY03
XS ID	Trib XS 3, Pool
Date:	11/1/2006
Field Crew:	A. Spiller & K. Knight

SUMMARY DATA	
Bankfull Elevation:	695.77
Bankfull Cross-Sectional Area:	1.3
Bankfull Width:	4.7
Flood Prone Area Elevation:	696.6
Flood Prone Width:	23.0
Max Depth at Bankfull:	0.6
Mean Depth at Bankfull:	0.3
W / D Ratio:	17.0
Entrenchment Ratio:	4.9
Bank Height Ratio:	1.0

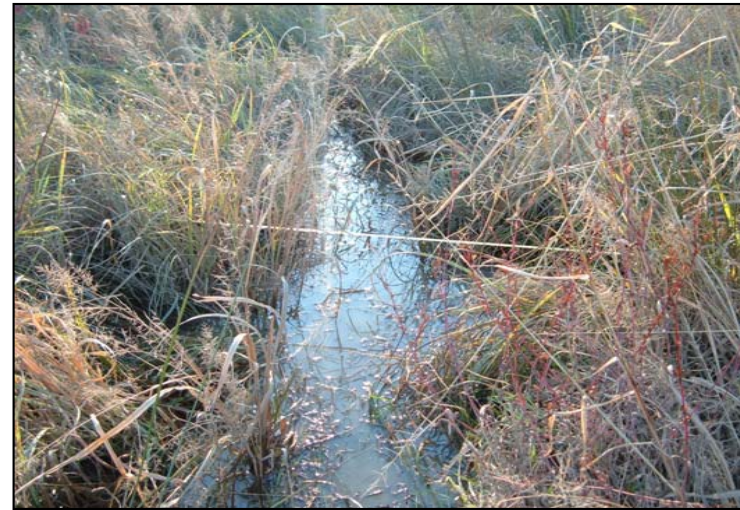
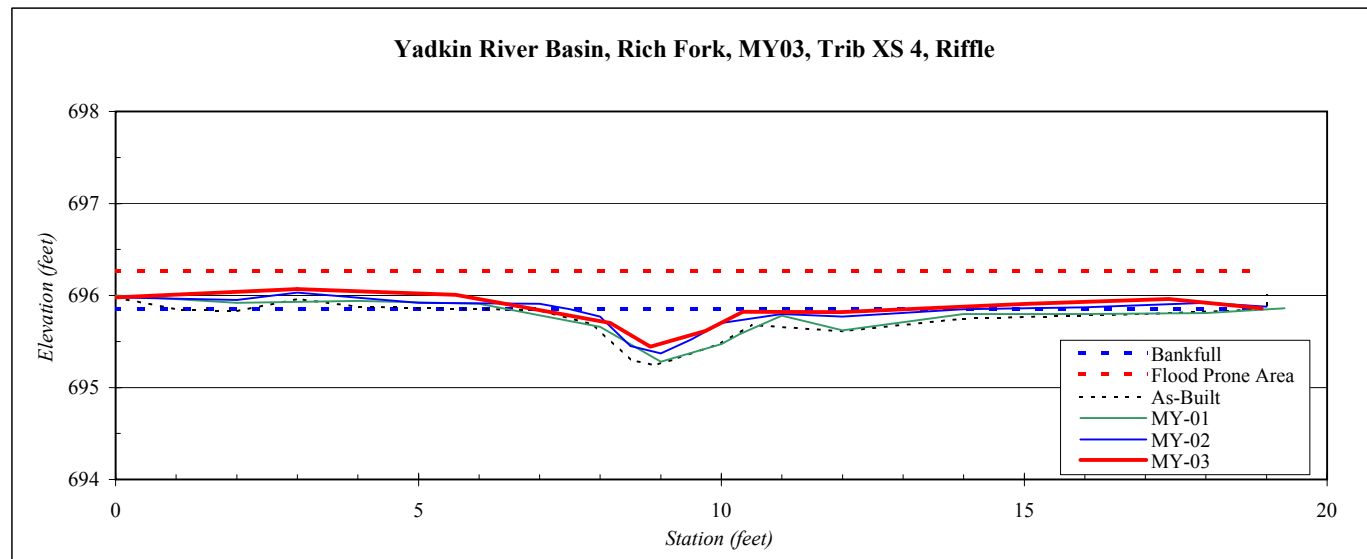
River Basin:	Yadkin
Watershed:	Rich Fork, MY03
XS ID	Trib XS 4, Riffle
Date:	11/1/2006
Field Crew:	A. Spiller & K. Knight

SUMMARY DATA	
Bankfull Elevation:	695.85
Bankfull Cross-Sectional Area:	0.7
Bankfull Width:	6.1
Flood Prone Area Elevation:	696.26
Flood Prone Width:	20.0
Max Depth at Bankfull:	0.4
Mean Depth at Bankfull:	0.1
W / D Ratio:	52.0
Entrenchment Ratio:	3.3
Bank Height Ratio:	1.0

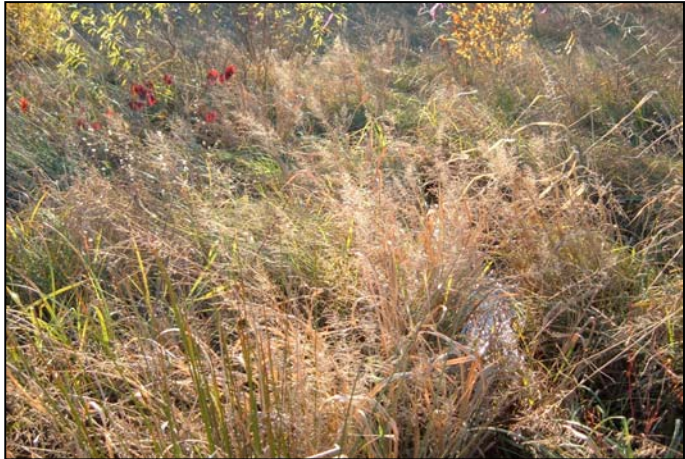
River Basin:	Yadkin
Watershed:	Rich Fork
Planform ID	Trib Dwn
Date:	11/1/2006
Field Crew:	AS, KK

SUMMARY DATA	
Stream Segment Length:	123
Distance Between Survey Points:	92
Distance Between Stations:	2
Sinuosity:	1.3
Mean Radius of Curvature:	7.0
Belt Width:	23.7

View of tributary downstream planform section looking downstream

Due to blockage in tributary near the confluence with the mainstem, backwatered conditions existed in the tributary

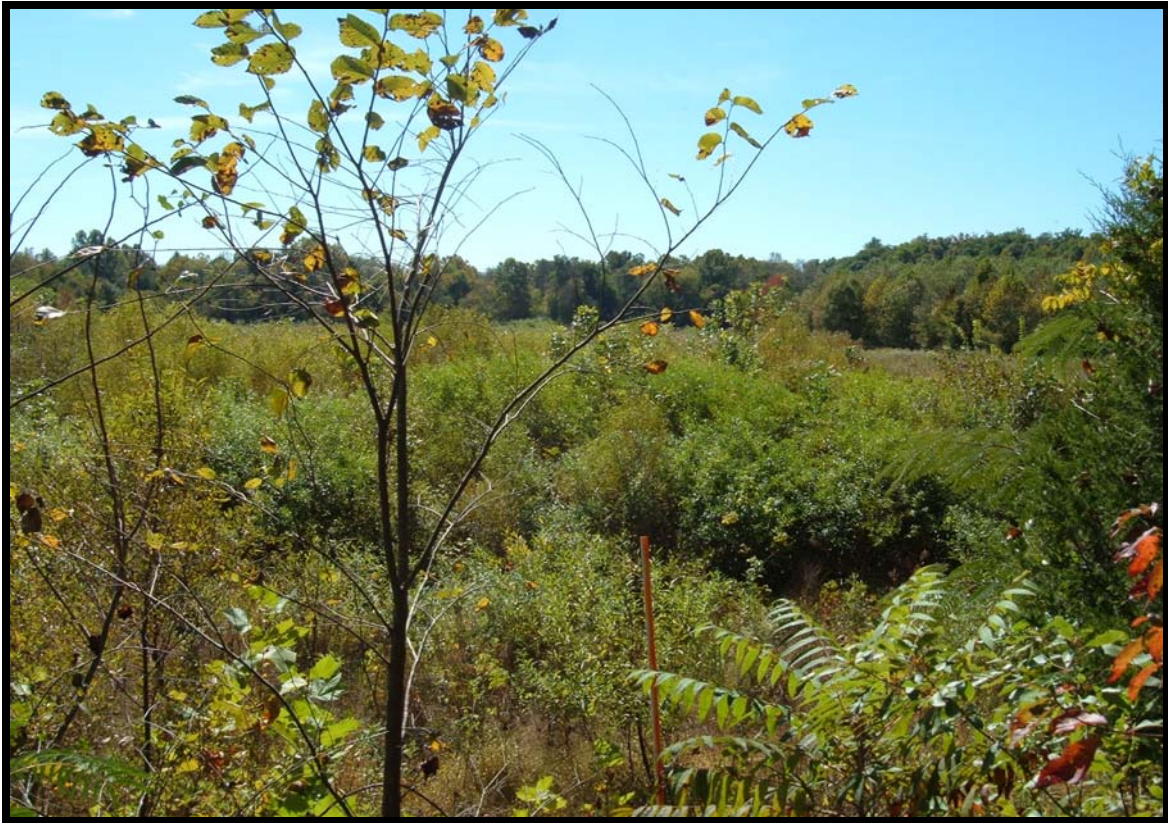
Photo Location 1: View looking toward large cedar and restored channel at confluence with Rich Fork Creek

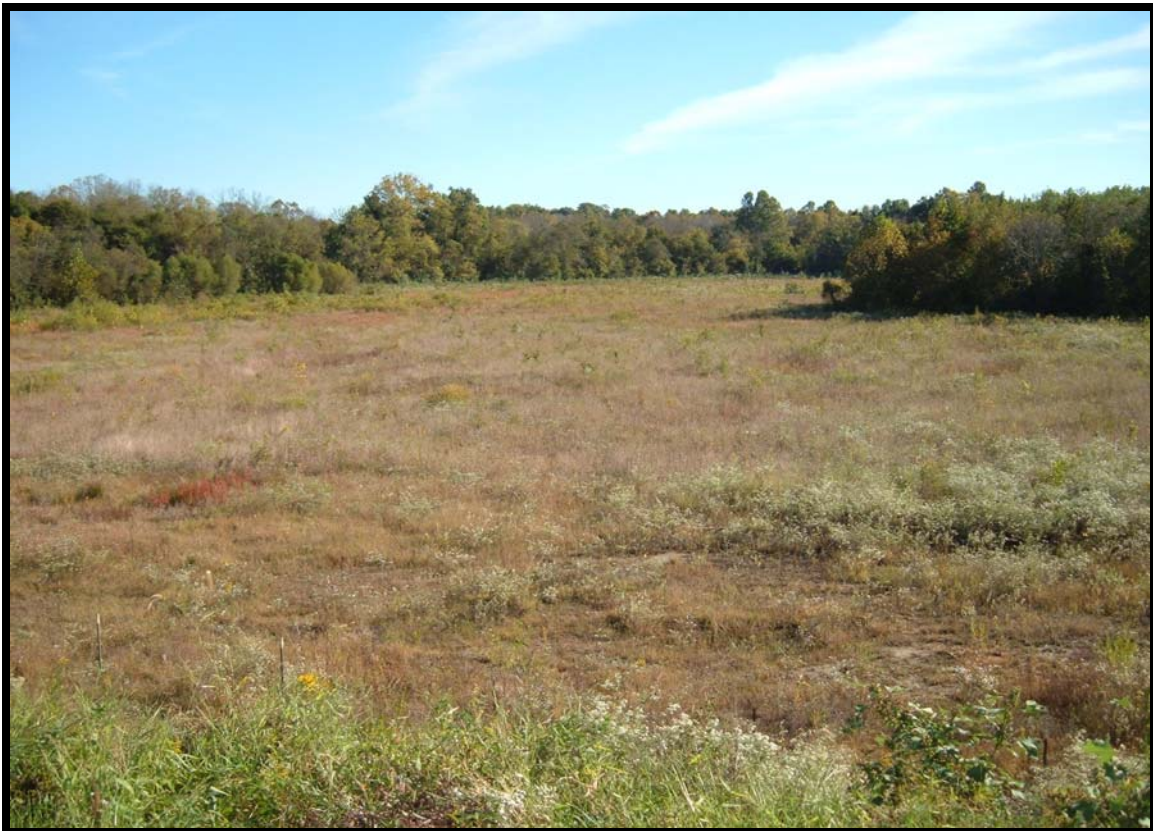
Photo Location 2, Photo 1: View looking toward large cedar and vegetation monitoring plot #6.

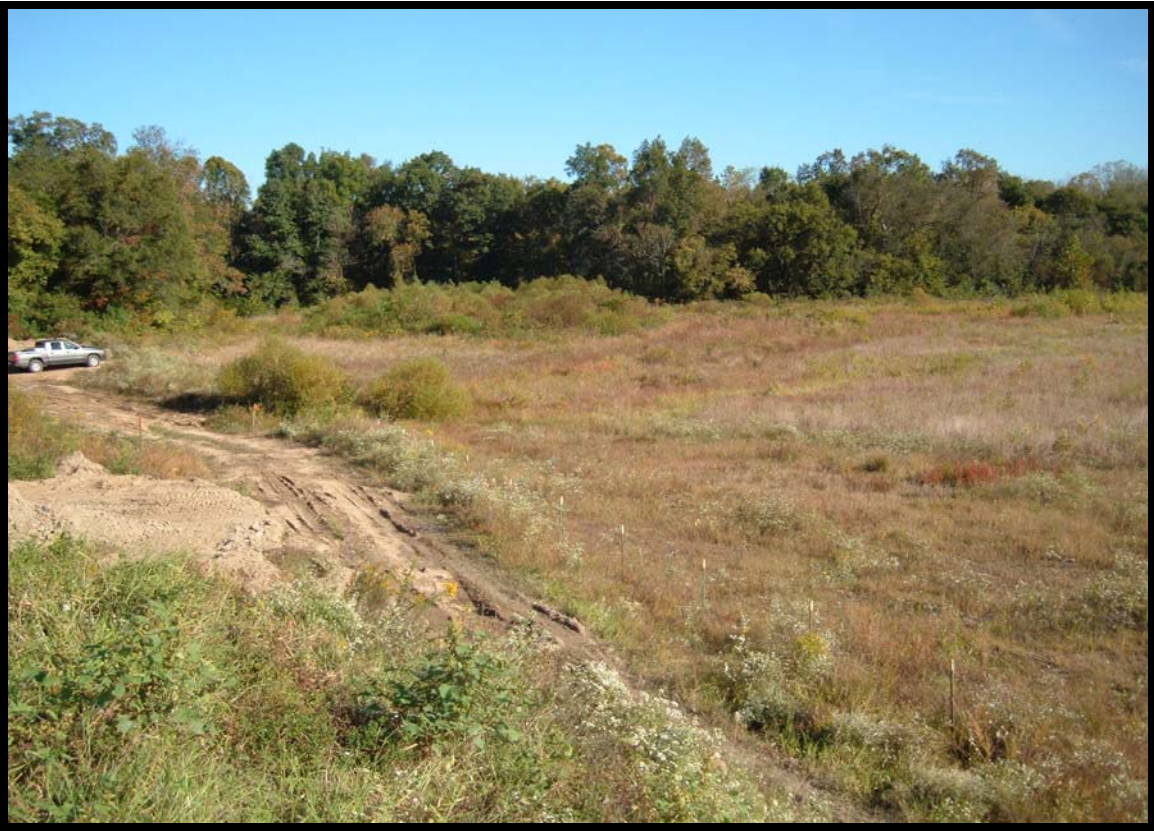
Photo Location 2, Photo 2: View looking toward vegetation-monitoring plot #1

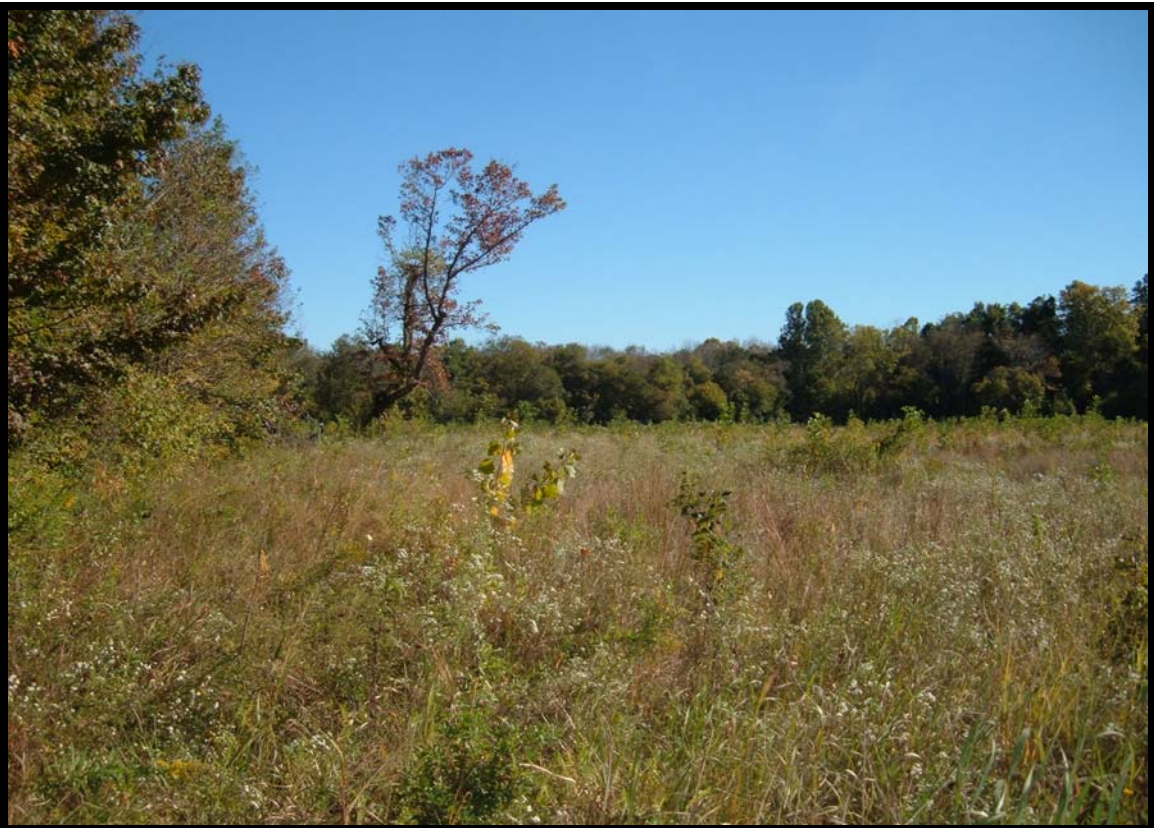
Photo Location 3: View looking east along the wetland preservation area.

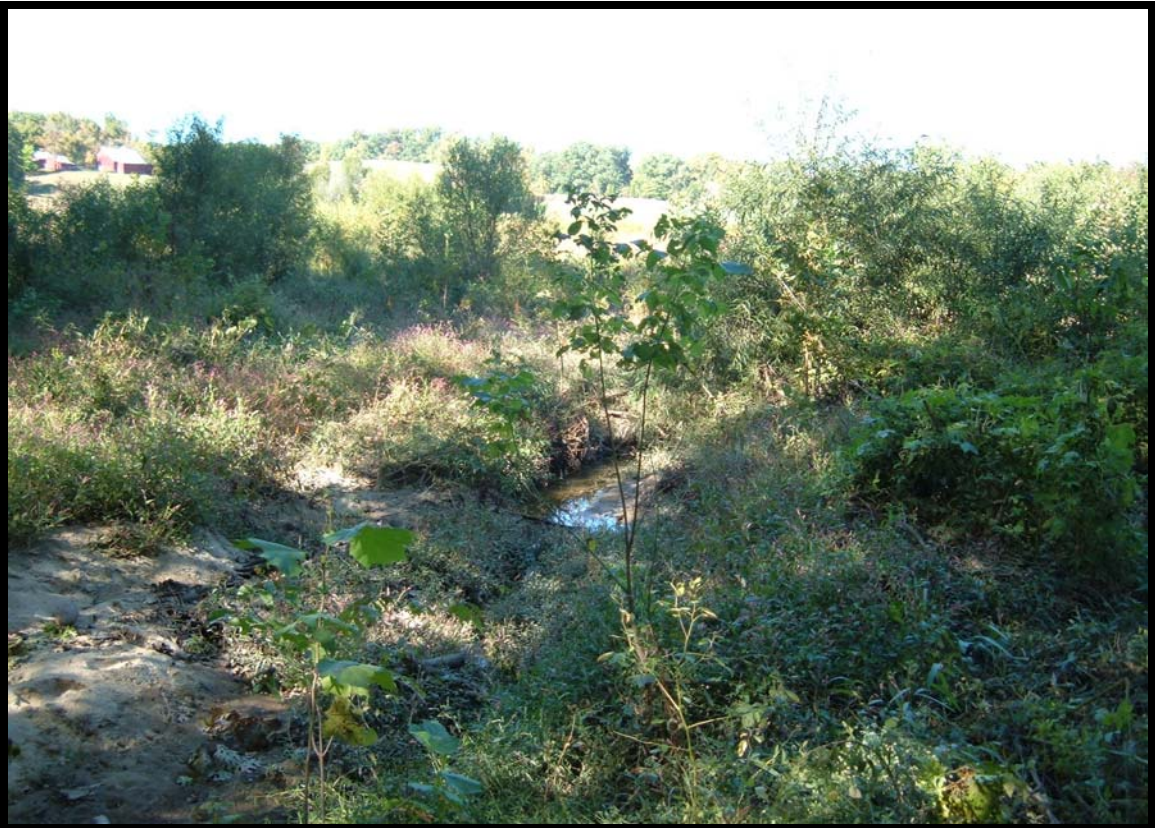
Photo Location 5: View looking north toward tree line of wetland preservation area.

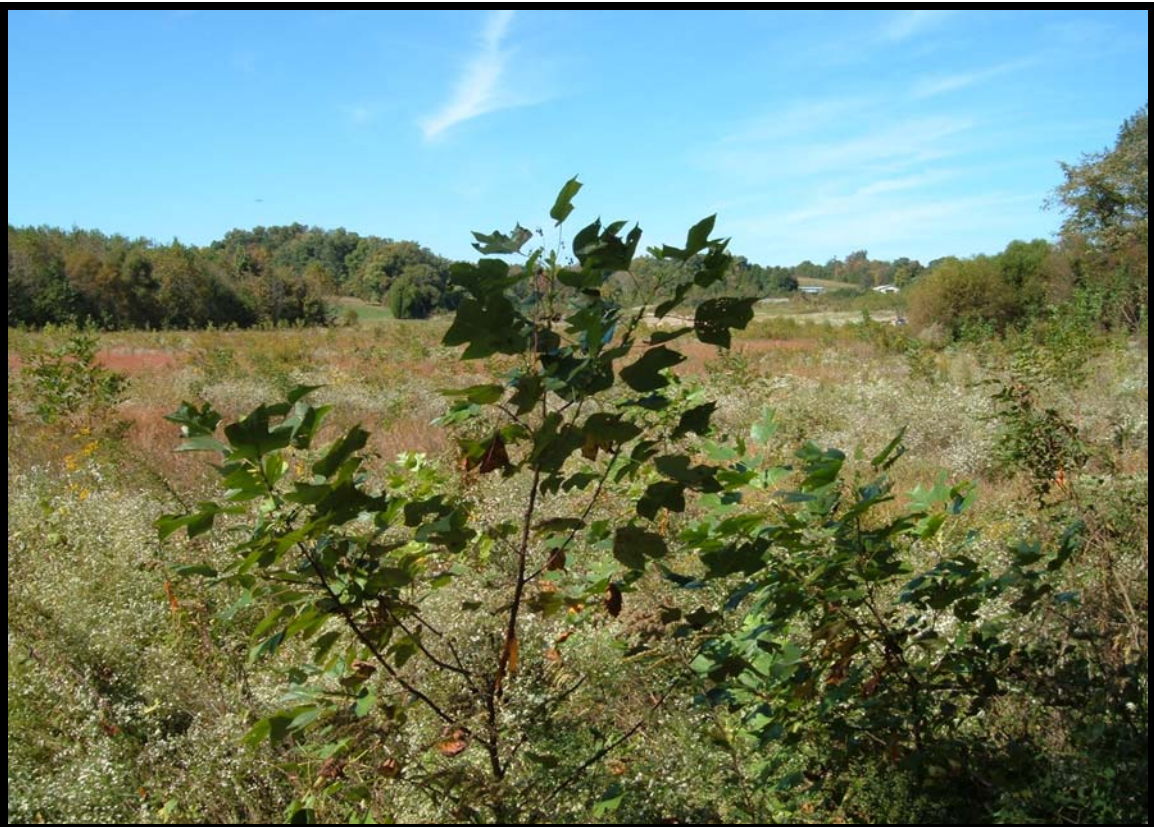
Photo Location 6, Photo 2: View looking from Rich Fork toward photo point #2 at the spoil pile.
