Monitoring Report
Year 4
Rich Fork Mitigation Site
Davidson County, North Carolina

Yadkin 03040103
Contract #R-9999WM

November 2007

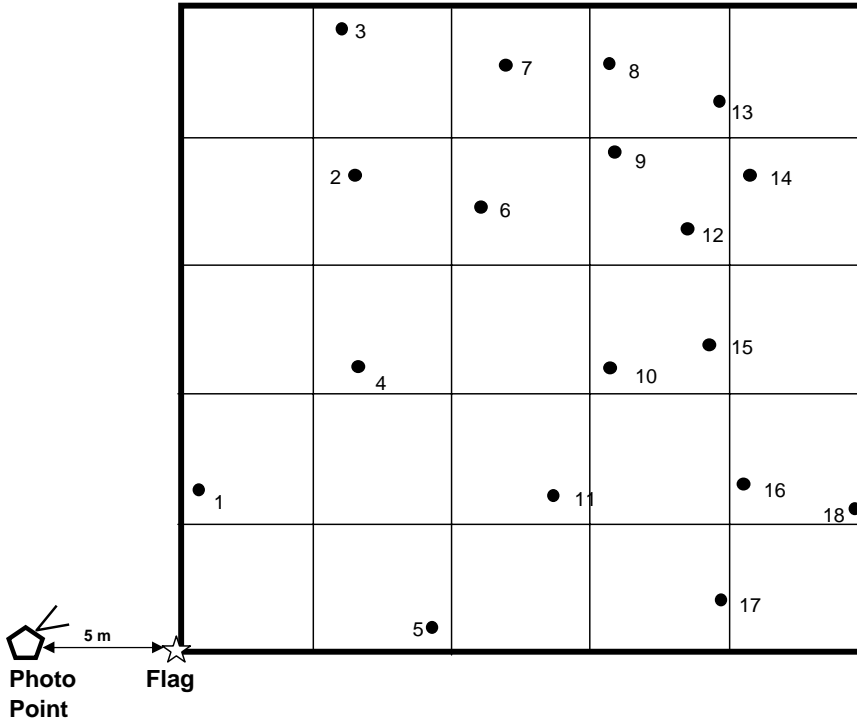
Plot Map

Site: Rich Fork Plot: 1 Date: 7/5/2007

Notes - Tree heights smaller than previous years reflect die back in tops of trees.
 - Plot map updated annually to more accurately reflect tree locations.

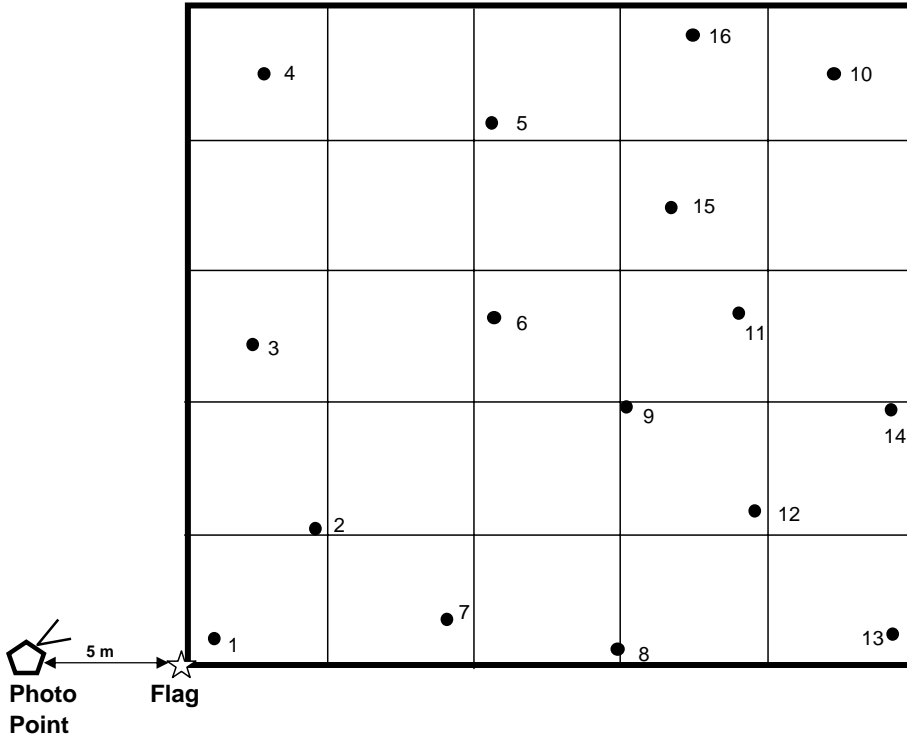
Plot Map

Site: Rich Fork Plot: 2 Date: 7/5/2007

Notes - Tree heights smaller than previous years reflect die back in tops of trees.
 - Plot map updated annually to more accurately reflect tree locations.

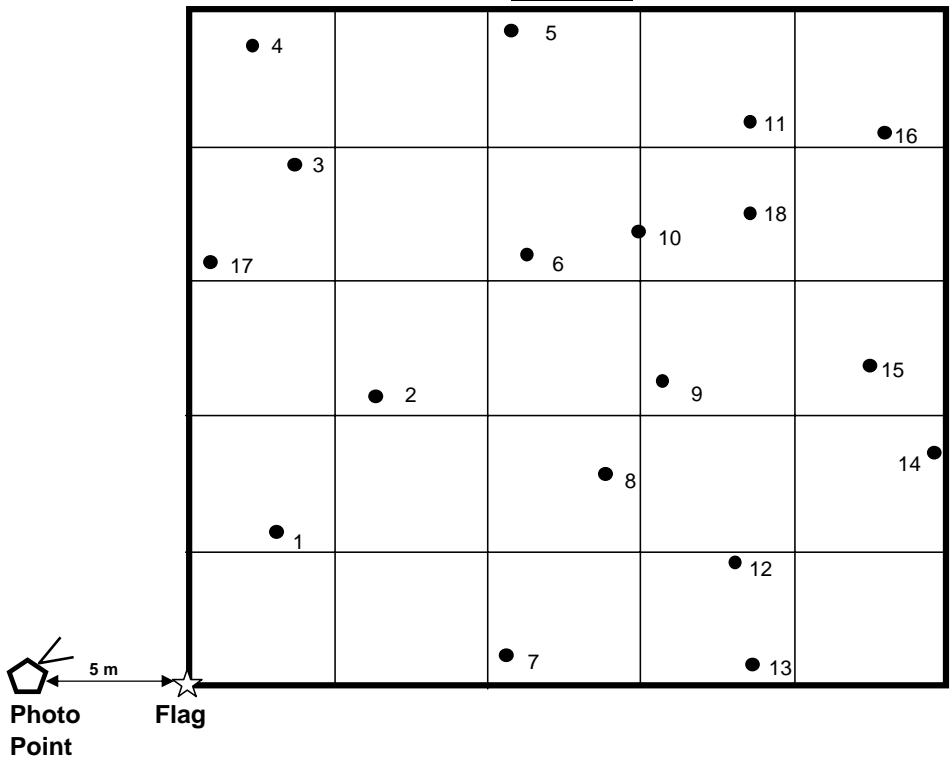
Plot Map

Site: Rich Fork Plot: 3 Date: 7/5/2007

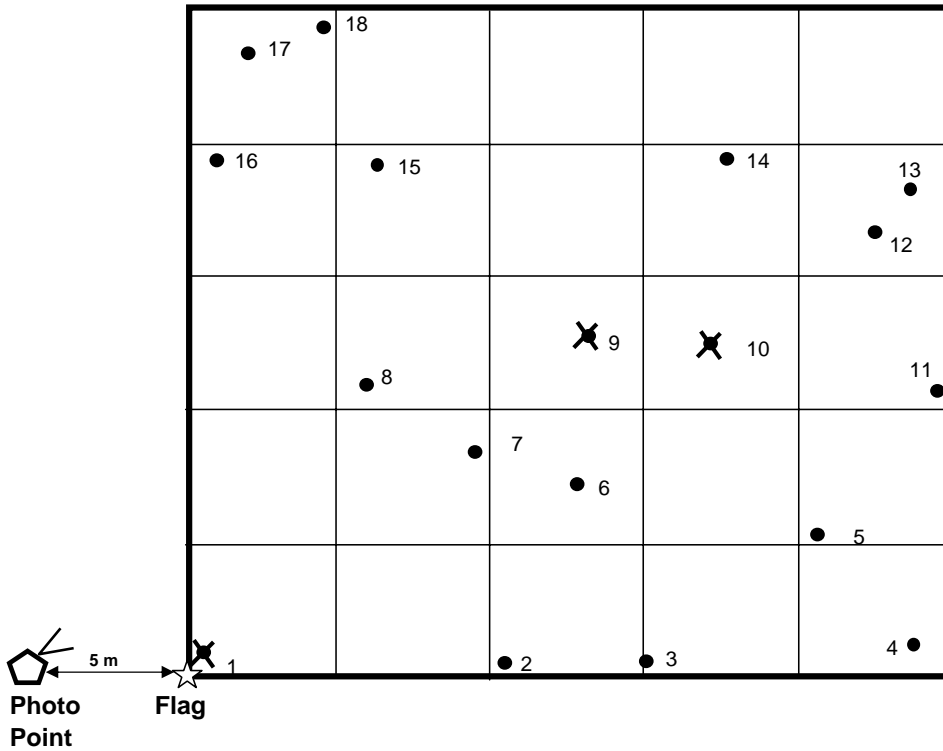
Plot Map

Site: Rich Fork Plot: 4 Date: 7/5/2007

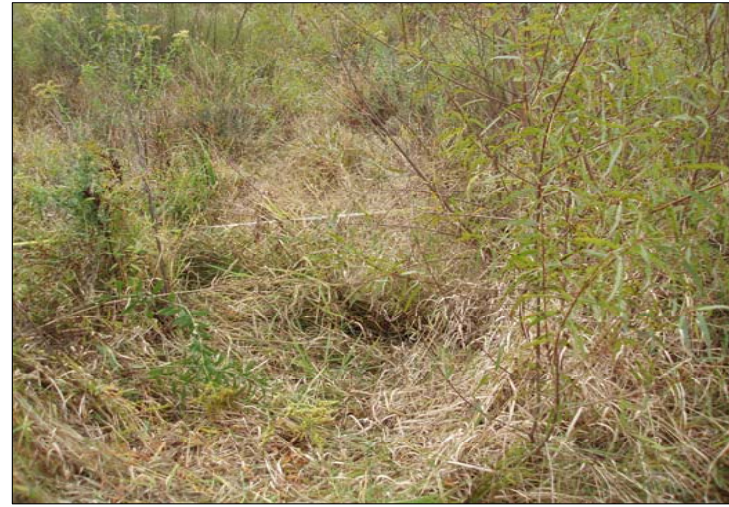
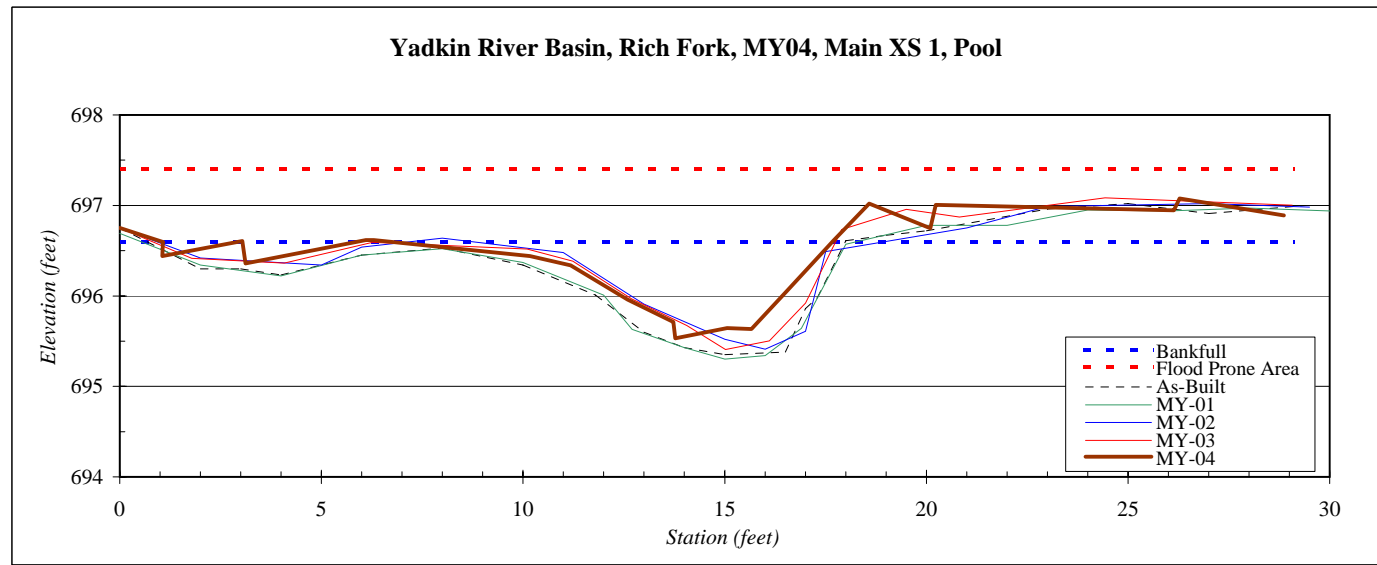
River Basin:	Yadkin
Watershed:	Rich Fork, MY04
XS ID	Main XS 1, Pool
Date:	10/22/2007
Field Crew:	B. Roberts, T. King

SUMMARY DATA	
Bankfull Elevation:	696.6
Bankfull Cross-Sectional Area:	5.4
Bankfull Width:	15.7
Flood Prone Area Elevation:	697.4
Flood Prone Width:	>50
Max Depth at Bankfull:	1.1
Mean Depth at Bankfull:	0.3
W / D Ratio:	46.0
Entrenchment Ratio:	>3
Bank Height Ratio:	1.1

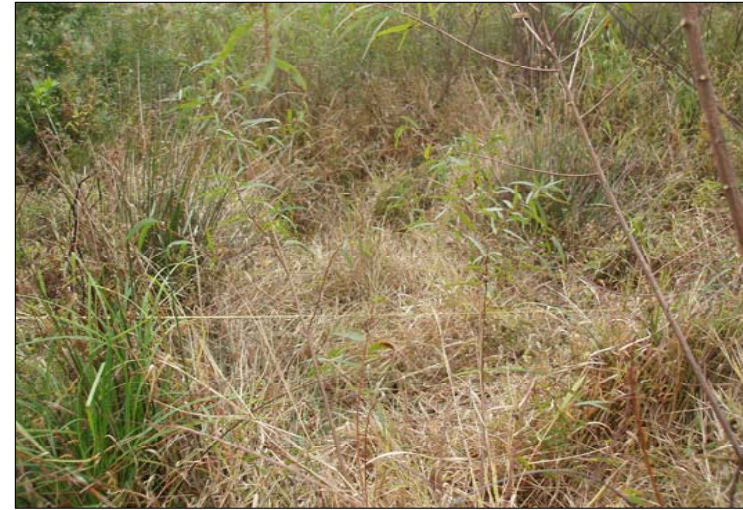
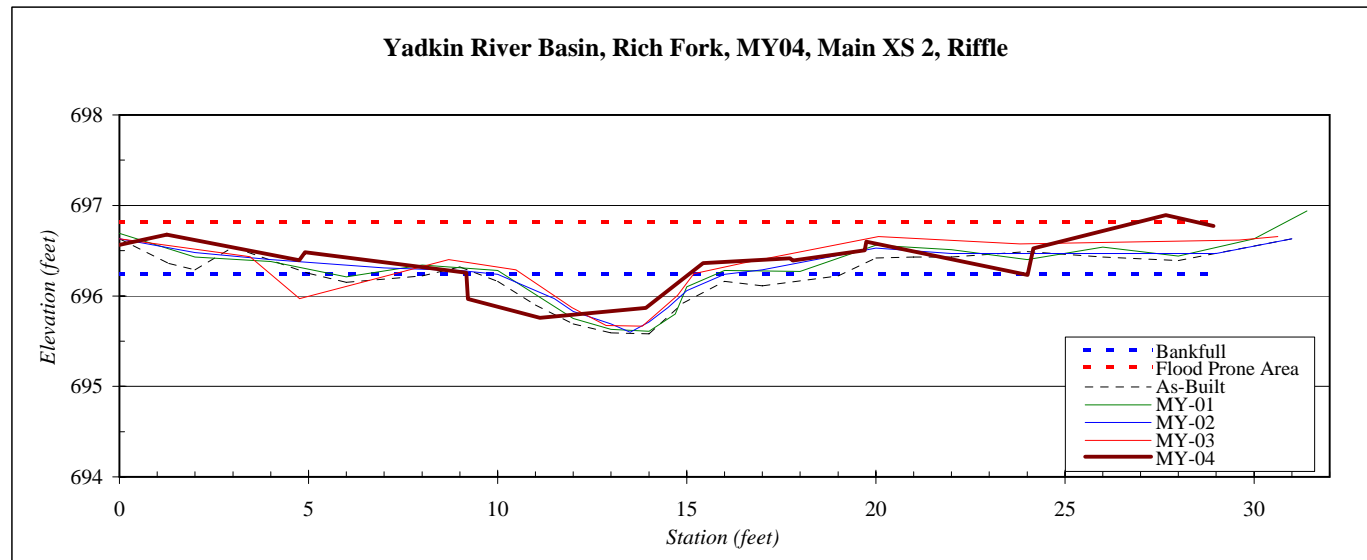
River Basin:	Yadkin
Watershed:	Rich Fork, MY04
XS ID	Main XS 2, Riffle
Date:	10/22/2007
Field Crew:	B. Roberts, T. King

SUMMARY DATA	
Bankfull Elevation:	696.24
Bankfull Cross-Sectional Area:	2.1
Bankfull Width:	6.0
Flood Prone Area Elevation:	696.81
Flood Prone Width:	>35
Max Depth at Bankfull:	0.5
Mean Depth at Bankfull:	0.4
W / D Ratio:	16.0
Entrenchment Ratio:	16.8
Bank Height Ratio:	1.0

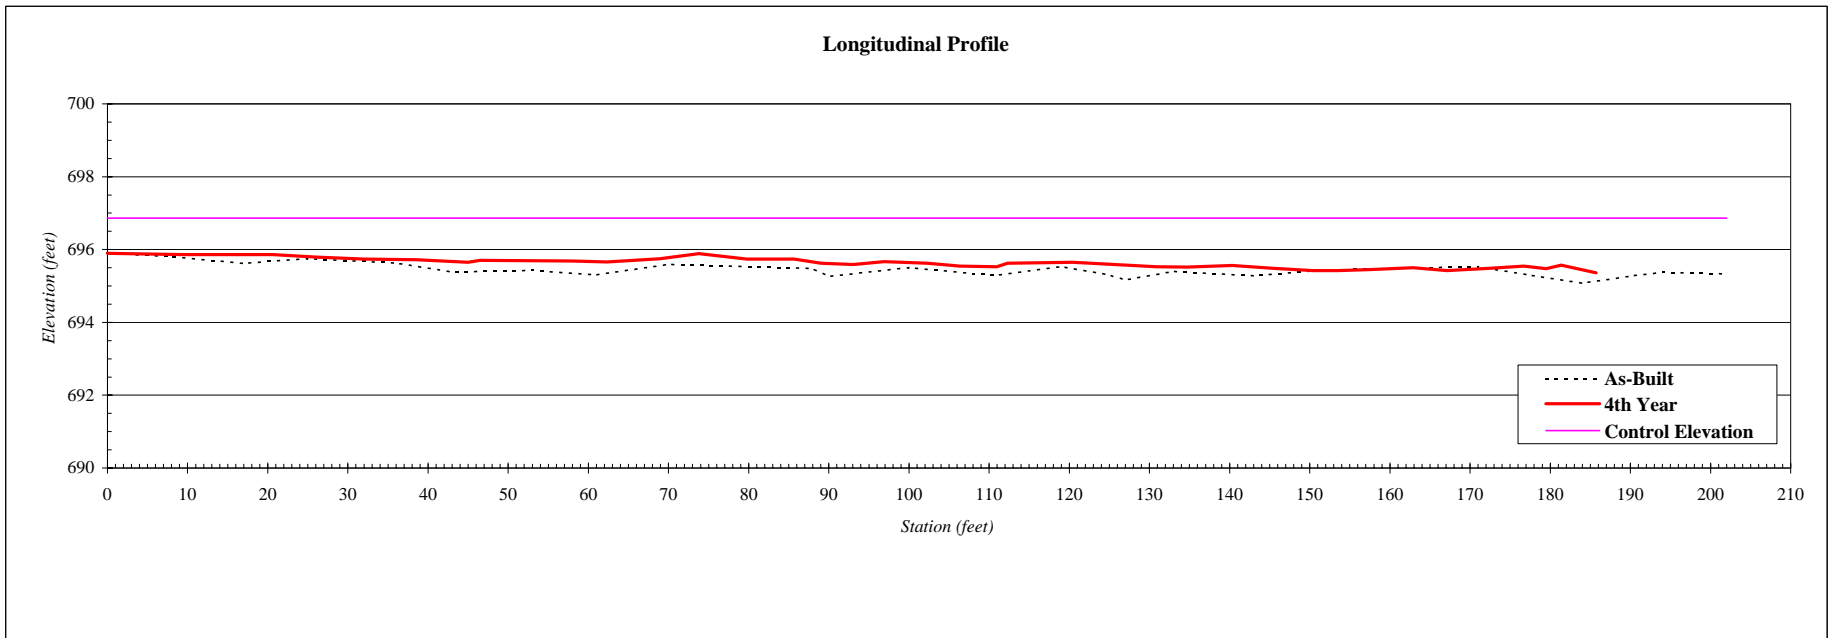
River Basin:	Yadkin
Watershed:	Rich Fork Creek
Reach:	Mainstem
Profile ID:	Upstream
Date:	10/22/2007
Field Crew:	B. Roberts, T. King
Control Elevation:	696.86

Average Slope:	0.003
As-Built Avg. Depth:	1.42
4th Year Avg. Depth:	1.23

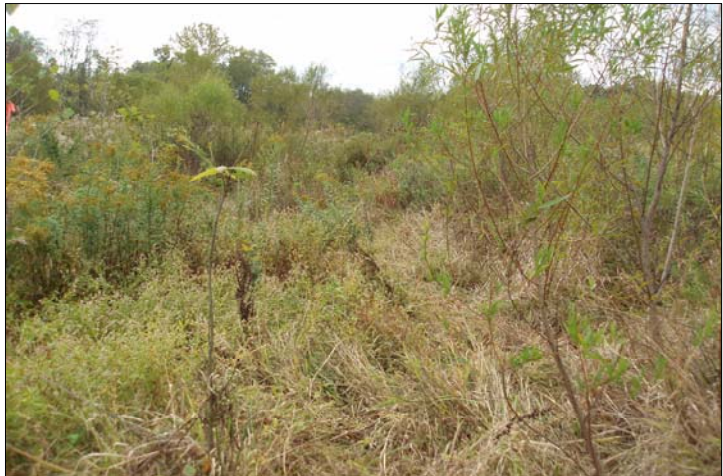
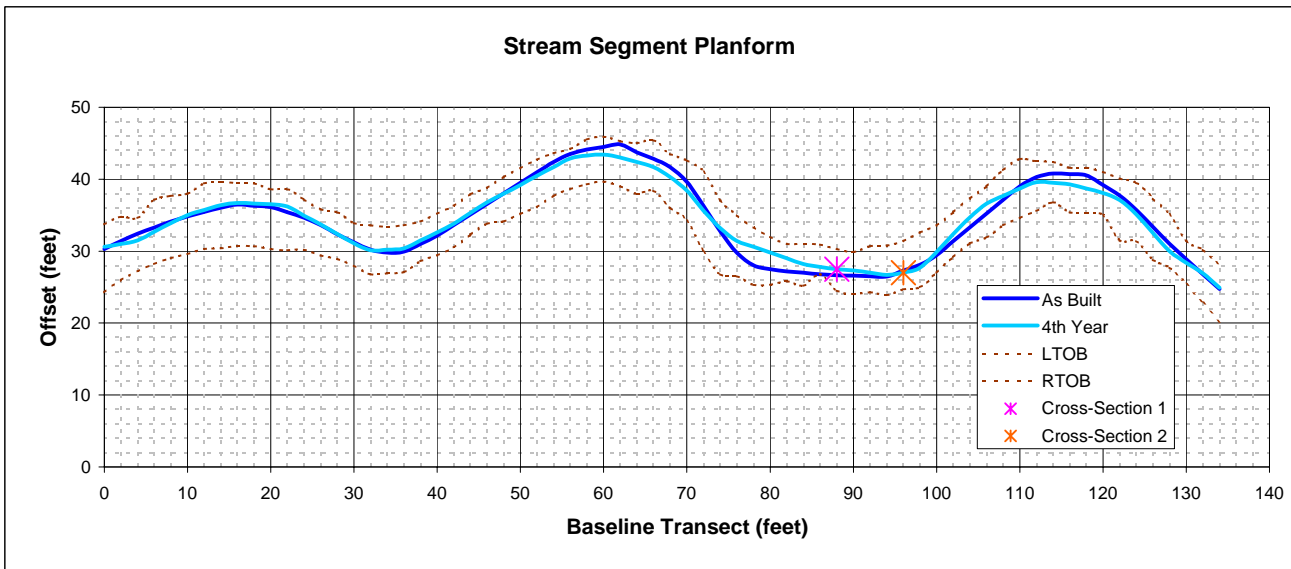
River Basin:	Yadkin
Watershed:	Rich Fork
Planform ID	Main Up
Date:	10/22/2007
Field Crew:	BR, TK

View of mainstem upstream planform looking downstream

SUMMARY DATA	
Stream Segment Length:	160
Distance Between Survey Points:	134
Distance Between Stations:	2
Sinuosity:	1.2
Mean Radius of Curvature:	13.8
Belt Width:	18.5

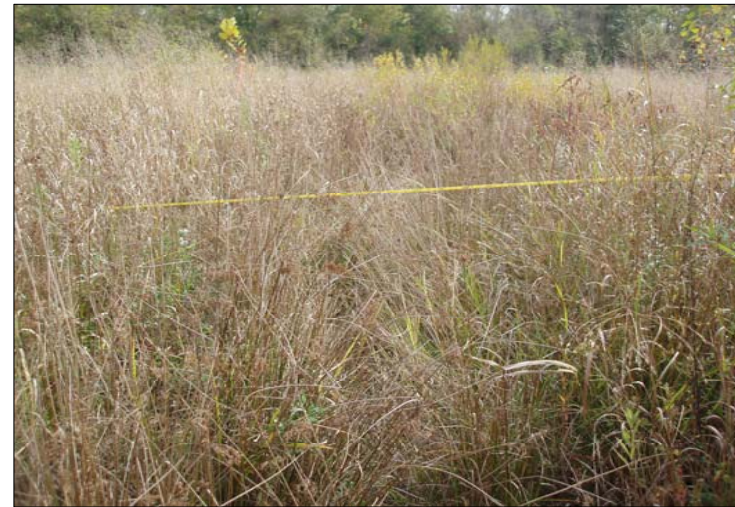
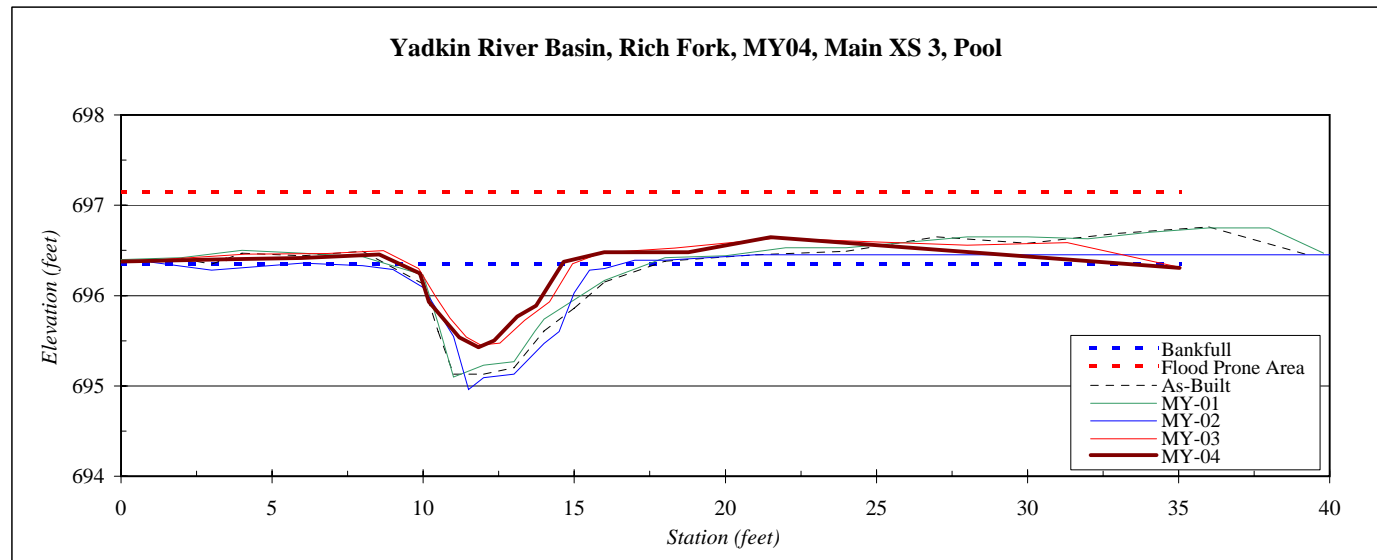
River Basin:	Yadkin
Watershed:	Rich Fork, MY04
XS ID	Main XS 3, Pool
Date:	10/22/2007
Field Crew:	B. Roberts, T. King

SUMMARY DATA	
Bankfull Elevation:	696.35
Bankfull Cross-Sectional Area:	2.8
Bankfull Width:	5.4
Flood Prone Area Elevation:	697.15
Flood Prone Width:	>40
Max Depth at Bankfull:	0.9
Mean Depth at Bankfull:	0.5
W / D Ratio:	10.2
Entrenchment Ratio:	>7
Bank Height Ratio:	1.0

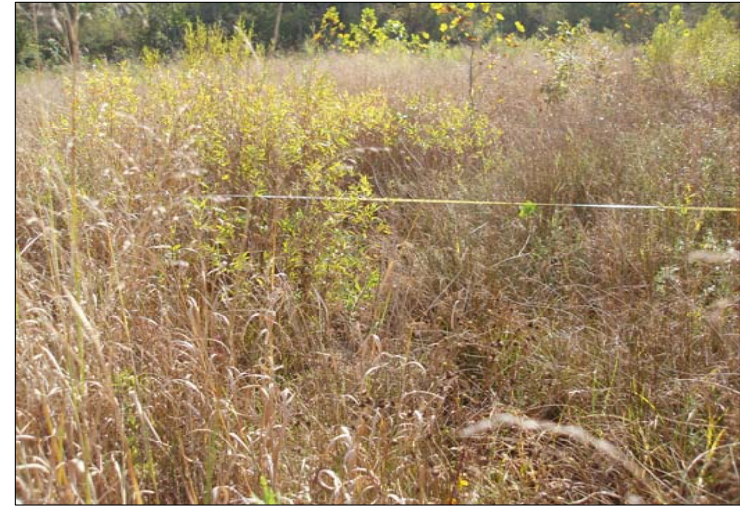
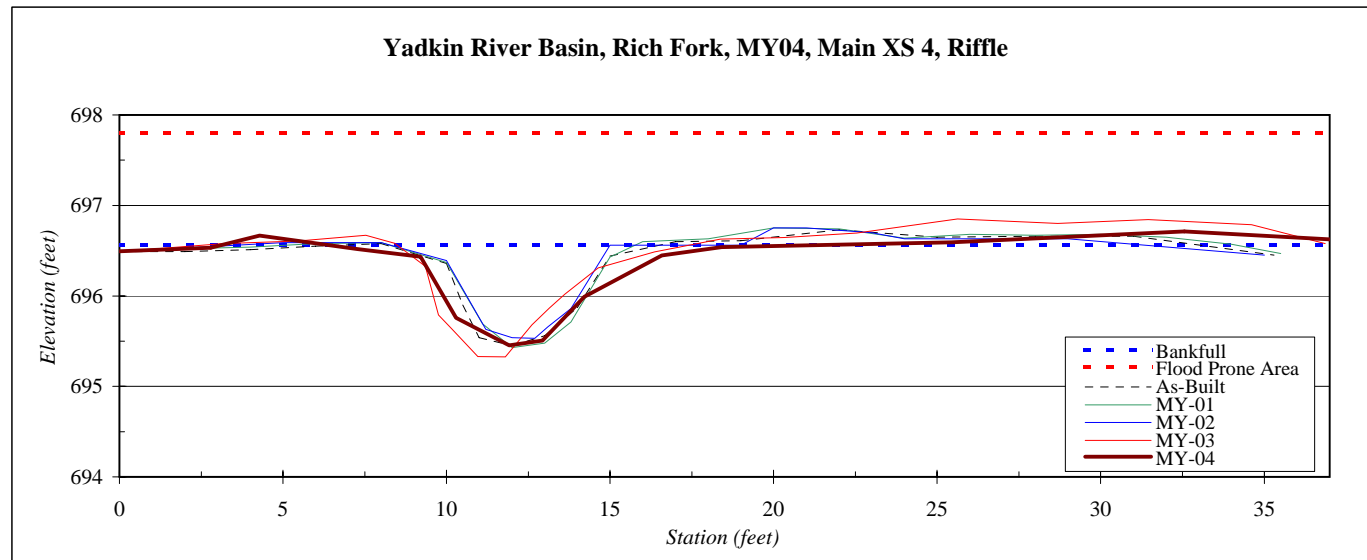
River Basin:	Yadkin
Watershed:	Rich Fork, MY04
XS ID	Main XS 4, Riffle
Date:	10/22/2007
Field Crew:	B. Roberts, T. King

SUMMARY DATA	
Bankfull Elevation:	696.56
Bankfull Cross-Sectional Area:	5.5
Bankfull Width:	17.7
Flood Prone Area Elevation:	697.8
Flood Prone Width:	>50
Max Depth at Bankfull:	1.1
Mean Depth at Bankfull:	0.3
W / D Ratio:	57.4
Entrenchment Ratio:	>3
Bank Height Ratio:	1.0

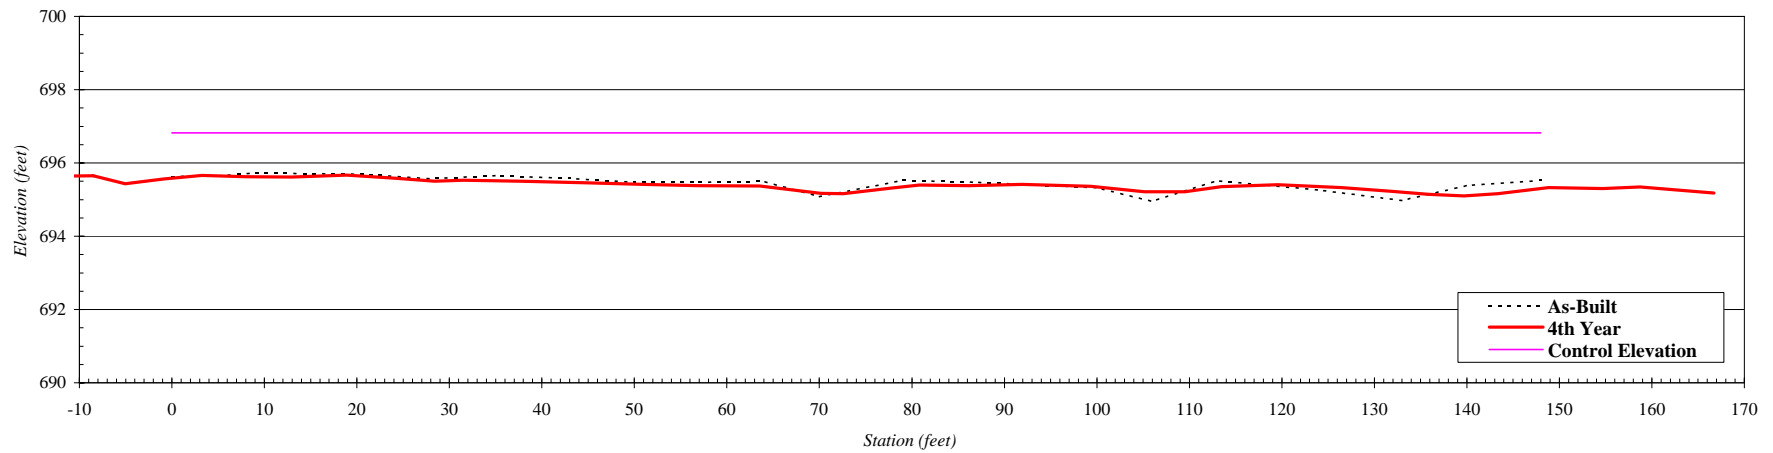
River Basin:	Yadkin
Watershed:	Rich Fork Creek
Reach:	Mainstem
Profile ID:	Downstream
Date:	10/22/2007
Field Crew:	B. Roberts, T. King
Control Elevation:	696.82

Average Slope:	0.003
As-Built Avg. Depth:	1.37
4th Year Avg. Depth:	1.43

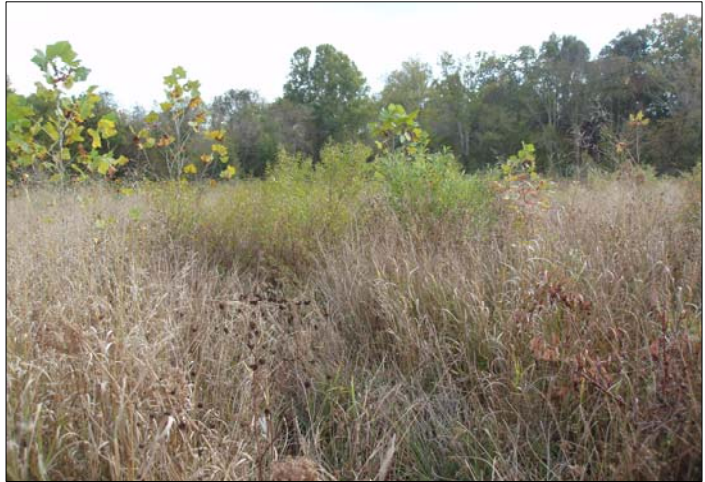
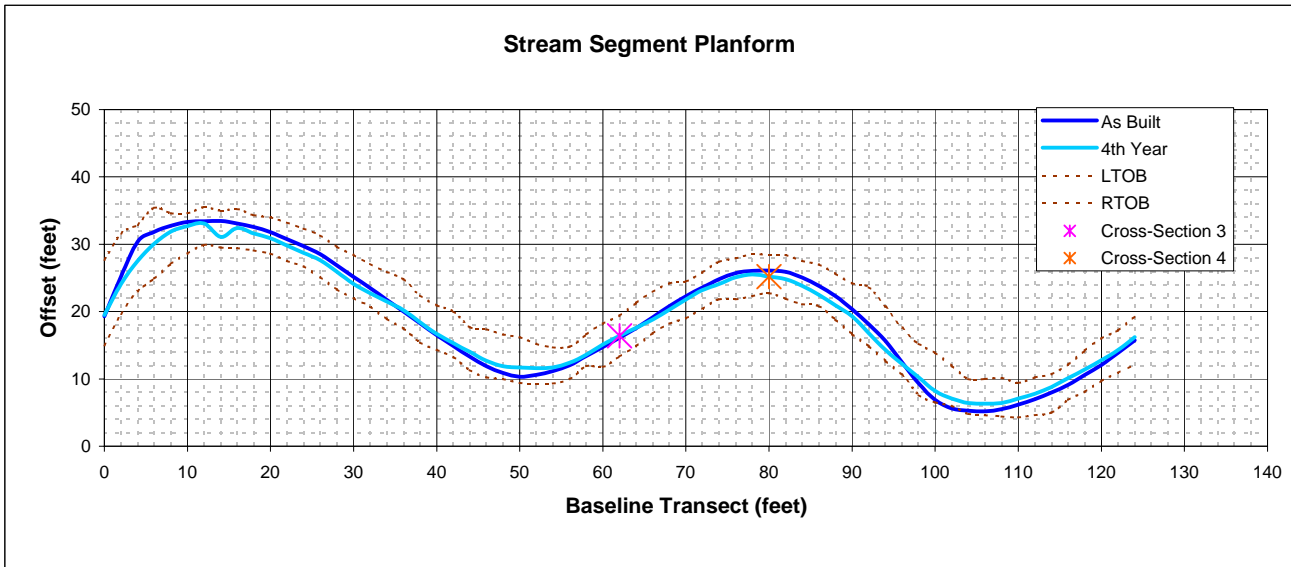
River Basin:	Yadkin
Watershed:	Rich Fork
Planform ID	Main Dwn
Date:	10/22/2007
Field Crew:	BR, TK

SUMMARY DATA	
Stream Segment Length:	151
Distance Between Survey Points:	124
Distance Between Stations:	2
Sinuosity:	1.2
Mean Radius of Curvature:	11.8
Belt Width:	26.8

Due to an extreme drought, there was no water in this section of main tributary

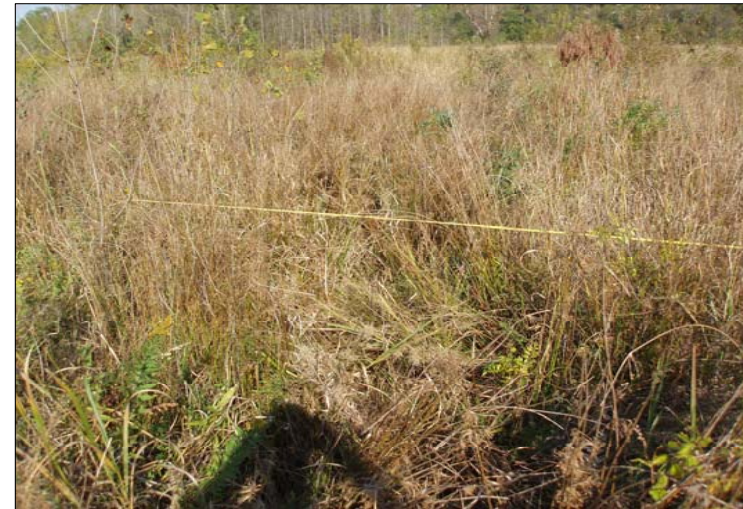
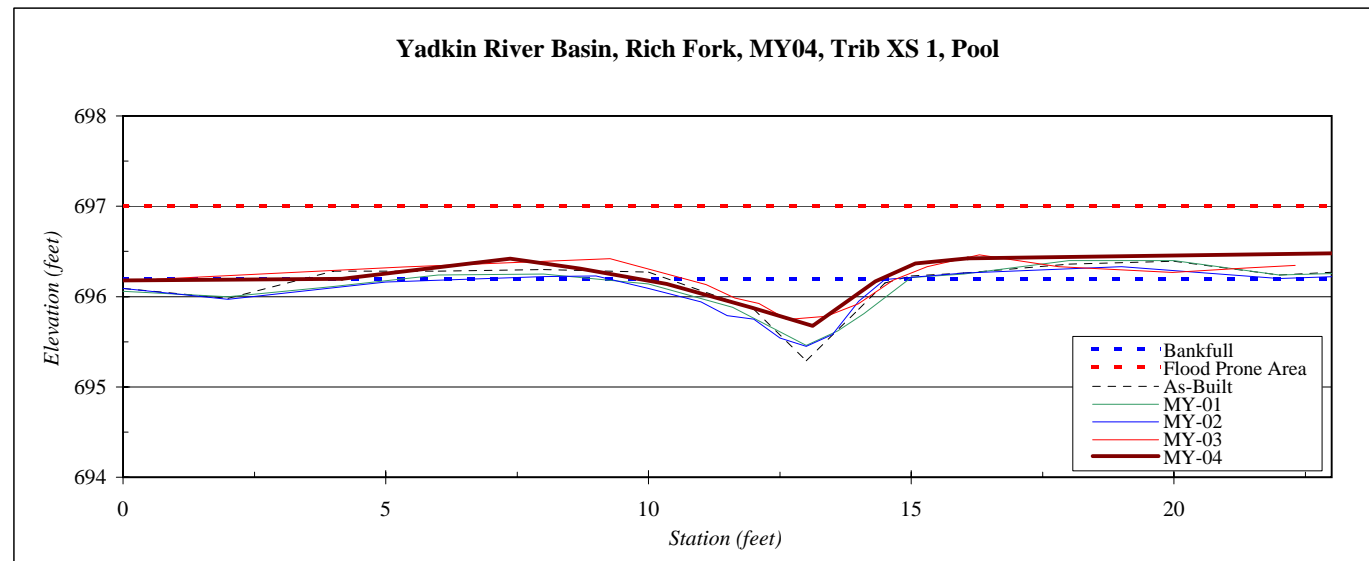
River Basin:	Yadkin
Watershed:	Rich Fork, MY04
XS ID	Trib XS 1, Pool
Date:	10/22/2007
Field Crew:	B. Roberts, T. King

SUMMARY DATA	
Bankfull Elevation:	696.19
Bankfull Cross-Sectional Area:	1.1
Bankfull Width:	4.5
Flood Prone Area Elevation:	697.0
Flood Prone Width:	>30
Max Depth at Bankfull:	0.5
Mean Depth at Bankfull:	0.2
W / D Ratio:	18.7
Entrenchment Ratio:	>6
Bank Height Ratio:	1.0

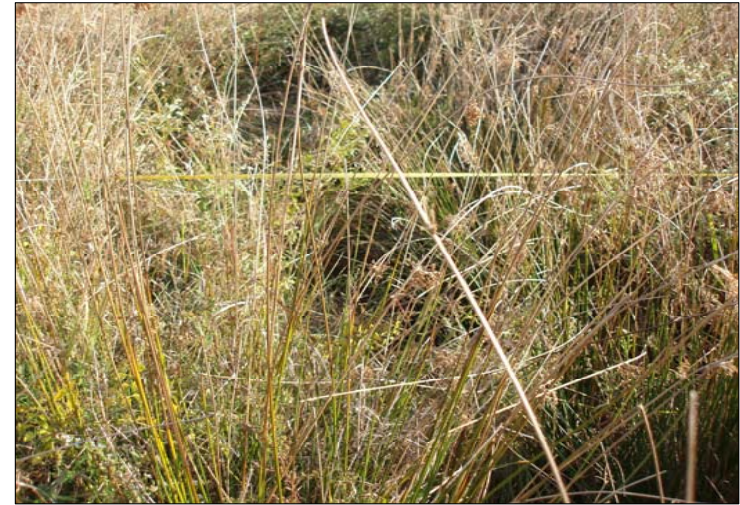
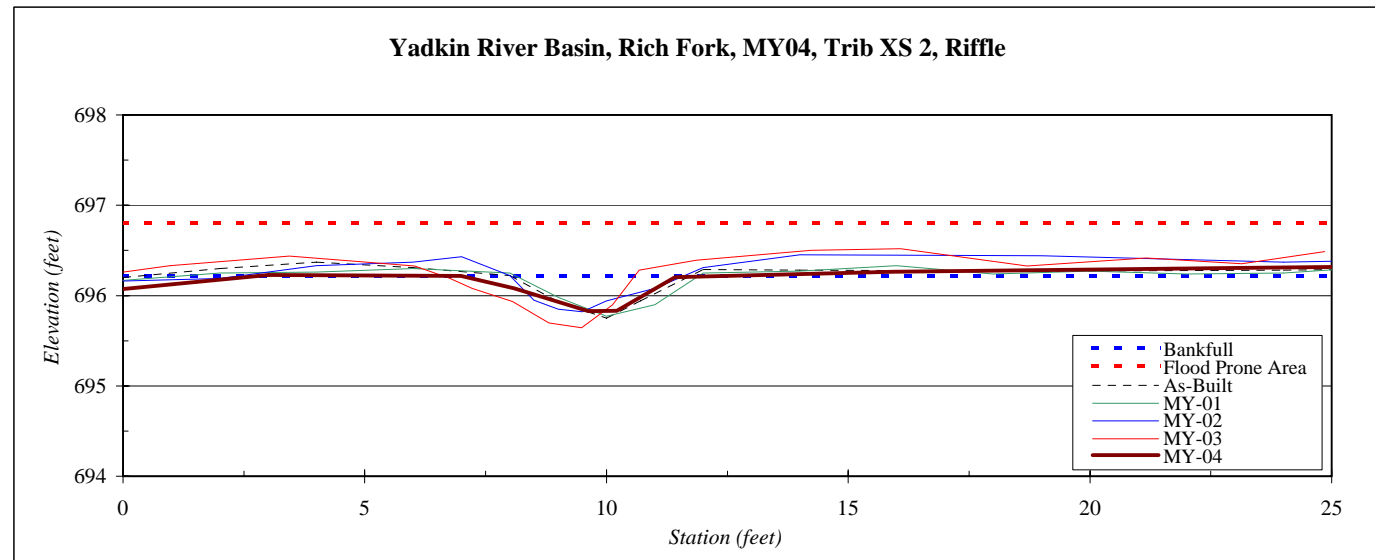
River Basin:	Yadkin
Watershed:	Rich Fork, MY04
XS ID	Trib XS 2, Riffle
Date:	10/22/2007
Field Crew:	B. Roberts, T. King

SUMMARY DATA	
Bankfull Elevation:	696.22
Bankfull Cross-Sectional Area:	1.2
Bankfull Width:	9.0
Flood Prone Area Elevation:	696.8
Flood Prone Width:	>25
Max Depth at Bankfull:	0.4
Mean Depth at Bankfull:	0.1
W / D Ratio:	69.6
Entrenchment Ratio:	>2
Bank Height Ratio:	1.0

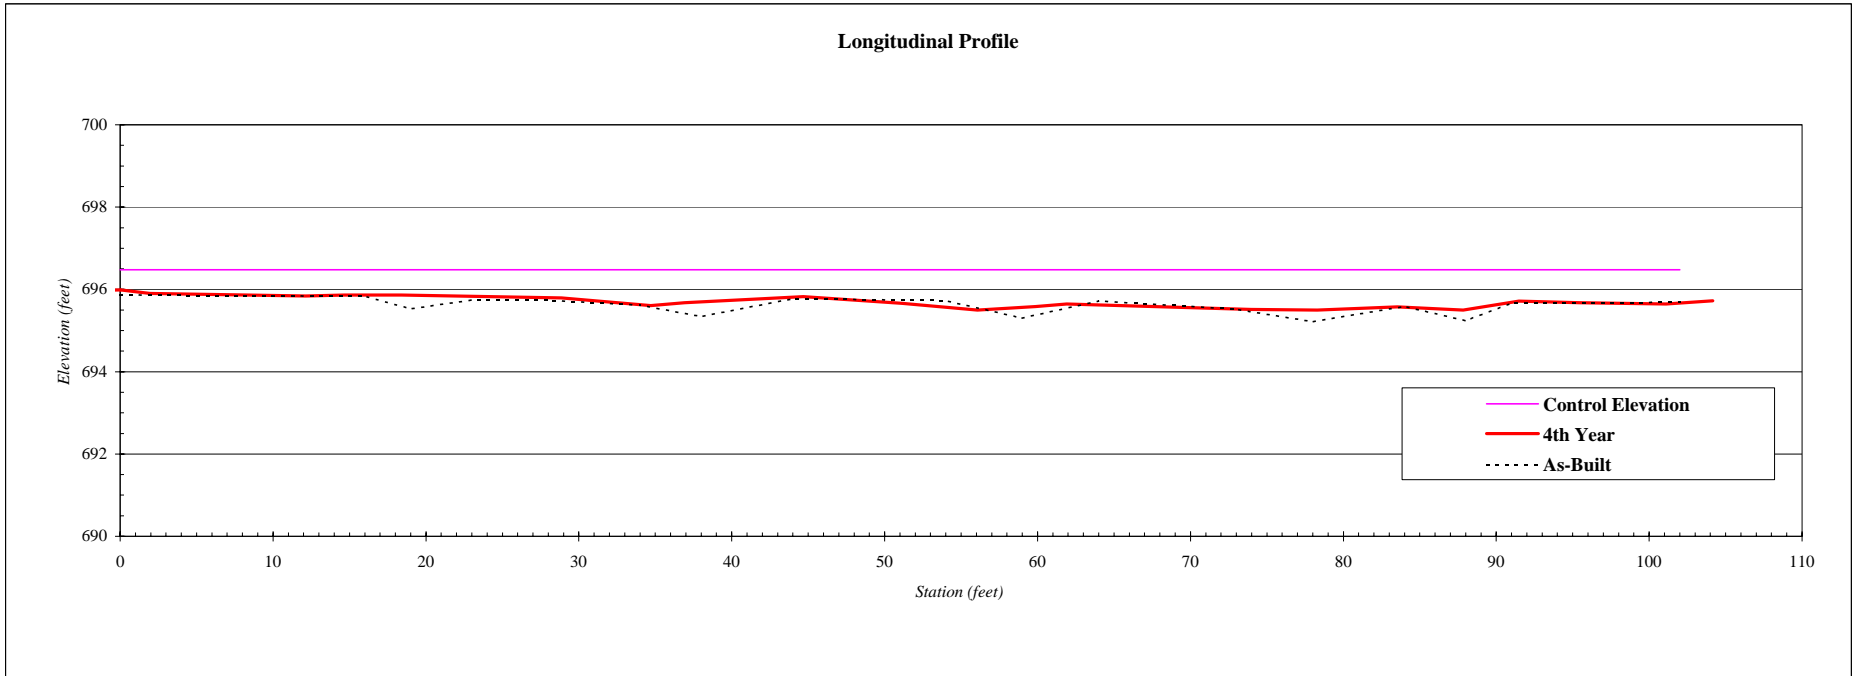
River Basin:	Yadkin
Watershed:	Rich Fork Creek
Reach:	Tributary
Profile ID:	Upstream
Date:	10/22/2007
Field Crew:	B. Roberts, T. King
Control Elevation:	696.48

Average Slope:	0.002
As-Built Avg. Depth:	0.87
4th Year Avg. Depth:	0.76

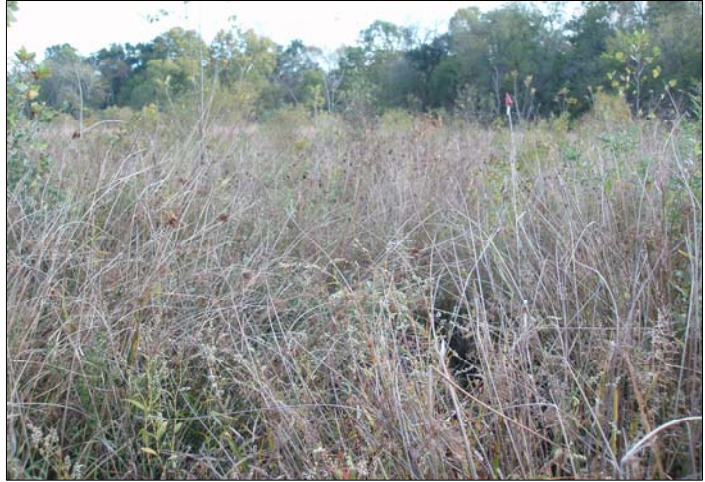
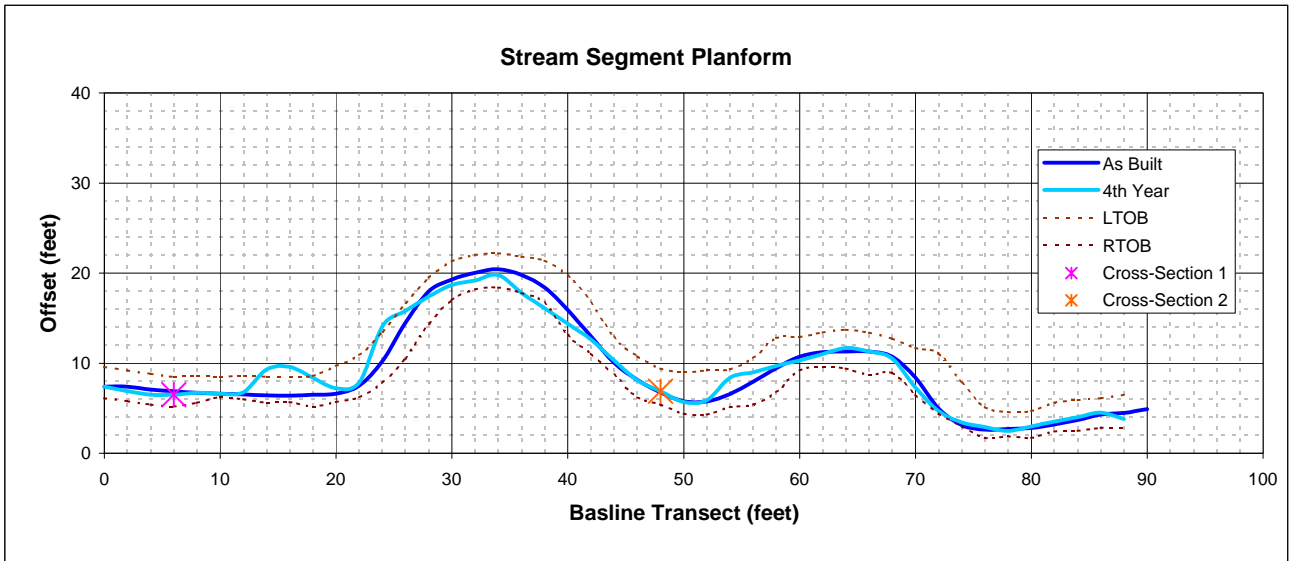
River Basin:	Yadkin
Watershed:	Rich Fork
Planform ID	Trib Up
Date:	10/22/2007
Field Crew:	BR, TK

SUMMARY DATA	
Stream Segment Length:	107
Distance Between Survey Points:	88
Distance Between Stations:	2
Sinuosity:	1.2
Mean Radius of Curvature:	7.0
Belt Width:	17.3

Due to an extreme drought, there was no water in the tributary

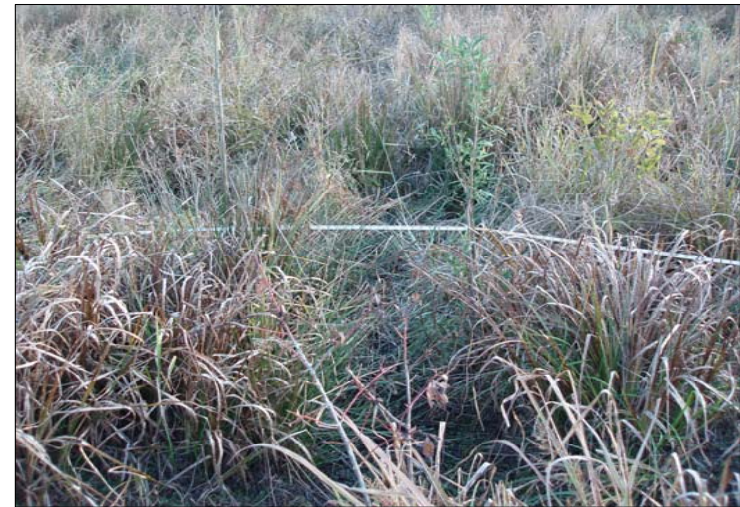
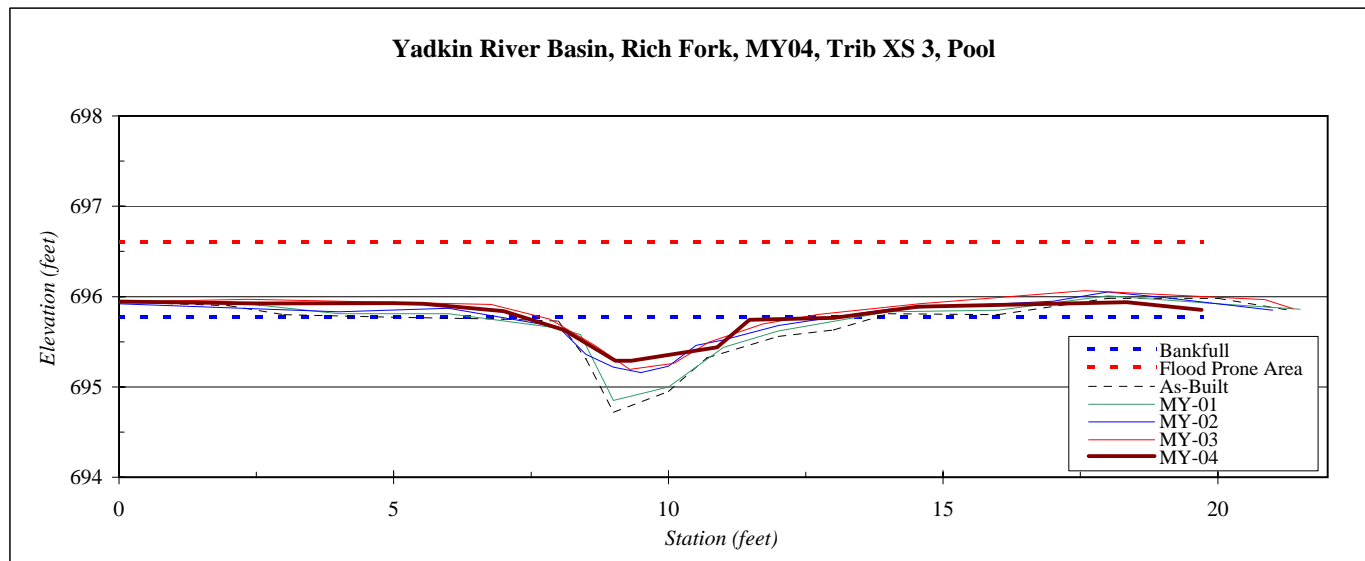
Yadkin River Basin, Rich Fork, MY04, Trib XS 3, Pool

SUMMARY DATA	
Bankfull Elevation:	695.77
Bankfull Cross-Sectional Area:	1.2
Bankfull Width:	5.7
Flood Prone Area Elevation:	696.6
Flood Prone Width:	>30
Max Depth at Bankfull:	0.5
Mean Depth at Bankfull:	0.2
W / D Ratio:	27.1
Entrenchment Ratio:	>6
Bank Height Ratio:	1.0

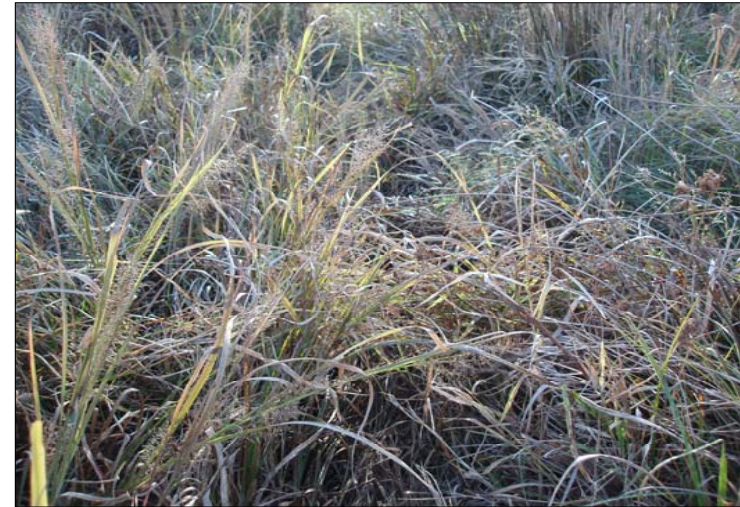
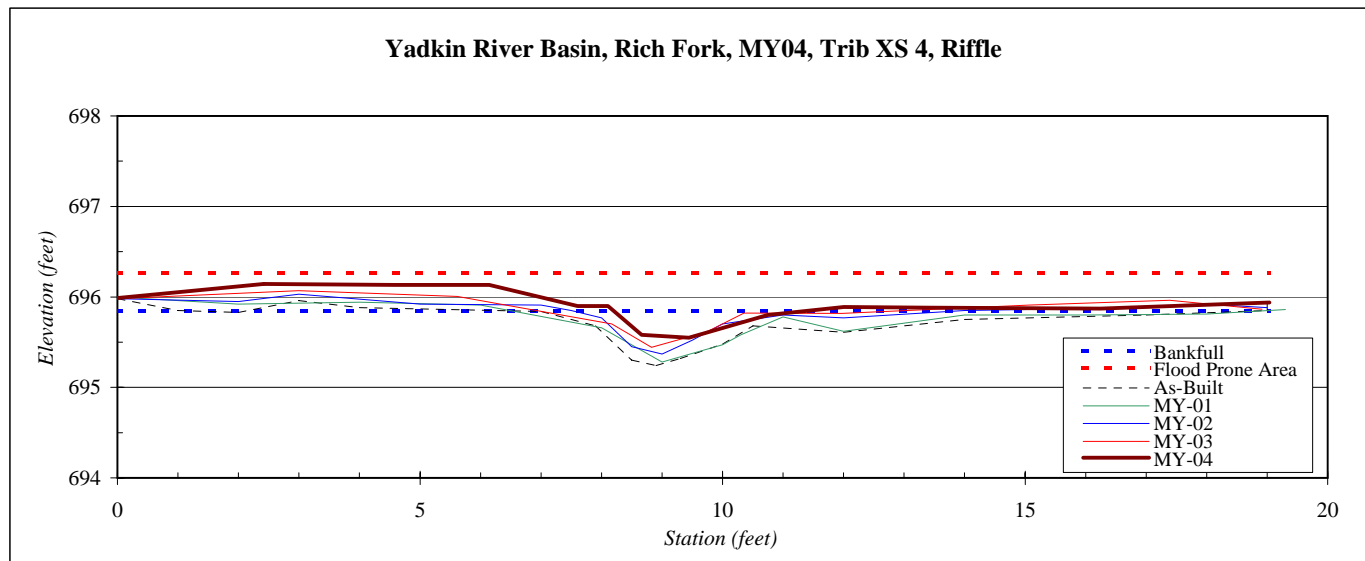
River Basin:	Yadkin
Watershed:	Rich Fork, MY04
XS ID	Trib XS 4, Riffle
Date:	10/22/2007
Field Crew:	B. Roberts, T. King

SUMMARY DATA	
Bankfull Elevation:	695.85
Bankfull Cross-Sectional Area:	0.5
Bankfull Width:	3.3
Flood Prone Area Elevation:	696.26
Flood Prone Width:	>20
Max Depth at Bankfull:	0.3
Mean Depth at Bankfull:	0.2
W / D Ratio:	19.9
Entrenchment Ratio:	>6
Bank Height Ratio:	1.0

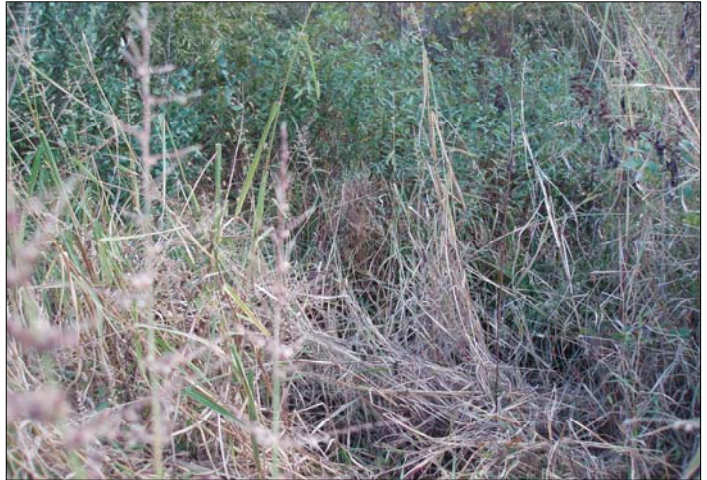
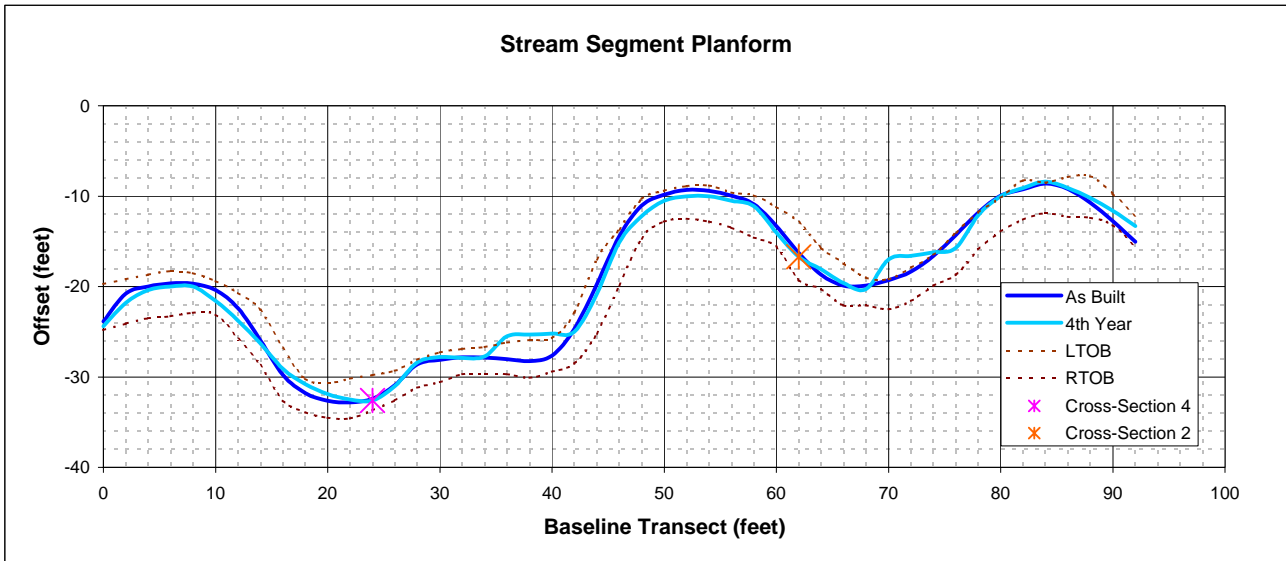
River Basin:	Yadkin
Watershed:	Rich Fork
Planform ID	Trib Dwn
Date:	10/22/2007
Field Crew:	BR, TK

Due to an extreme drought, there was no water in the tributary

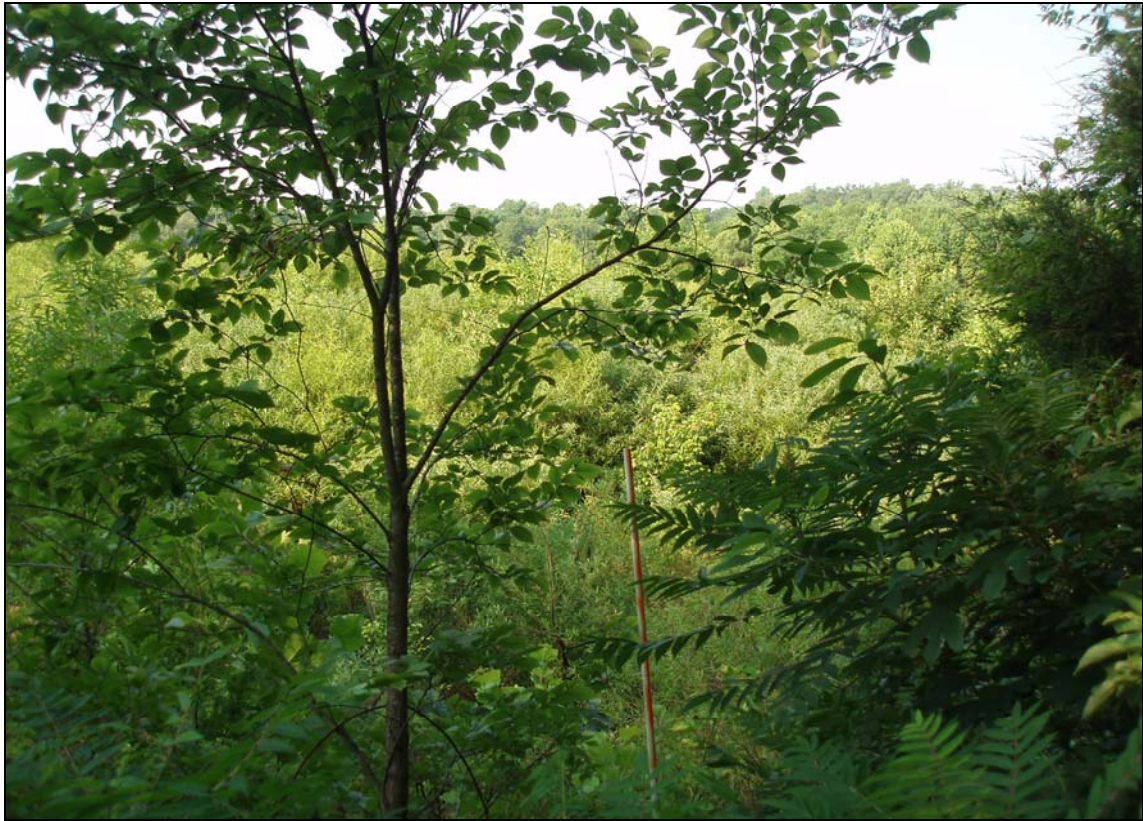
Photo Location 1: View looking toward large cedar and restored channel at confluence with Rich Fork Creek. 7/5/07 MY04

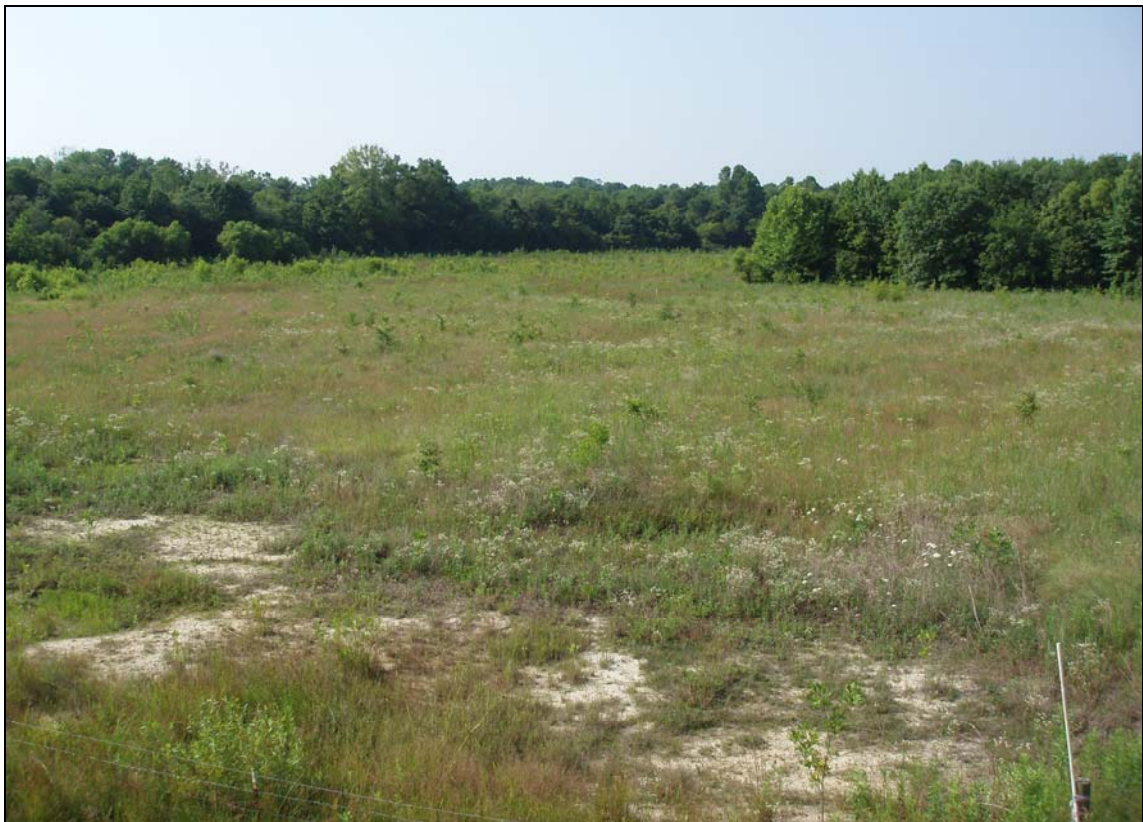
Photo Location 2, Photo 1: View looking toward large cedar and vegetation monitoring plot #6. 7/5/07 MY04
