Monitoring Report
Year 4
Rich Fork Mitigation Site
Davidson County, North Carolina

Yadkin 03040103
Contract #R-9999WM

November 2007

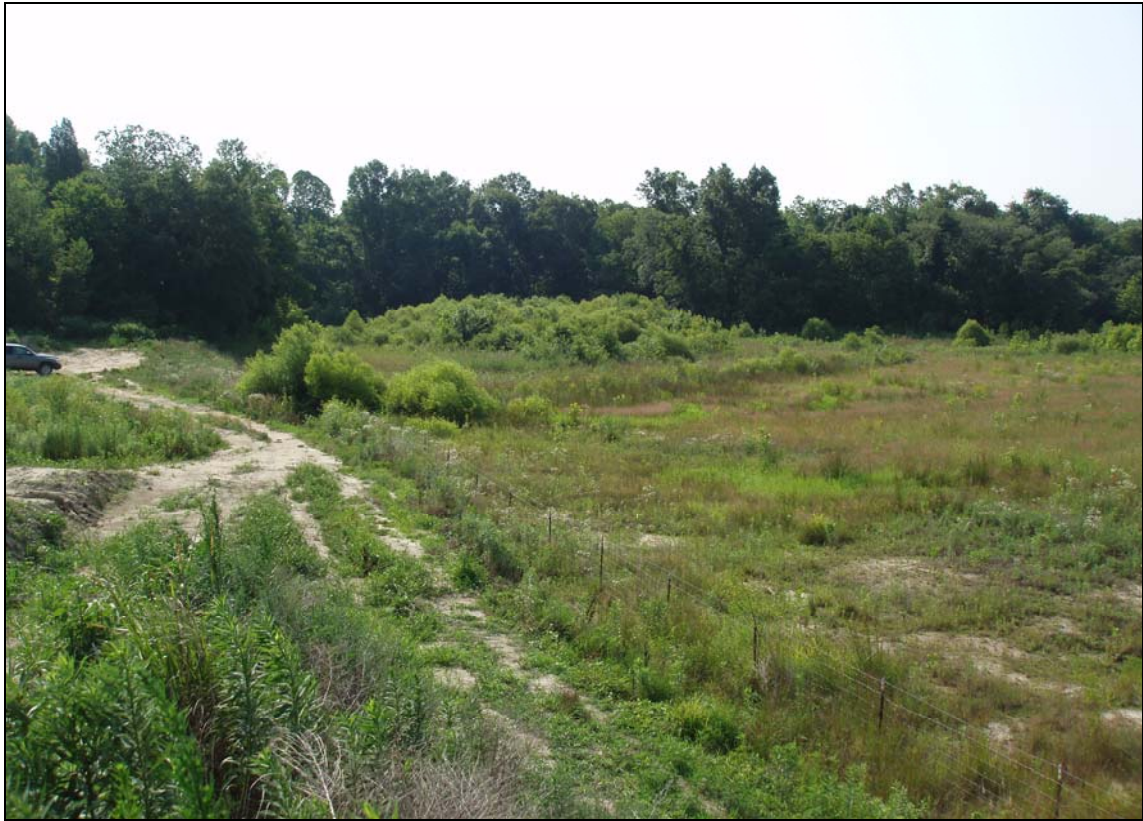
Photo Location 2, Photo 2: View looking toward vegetation monitoring plot #1. 7/5/07 MY04

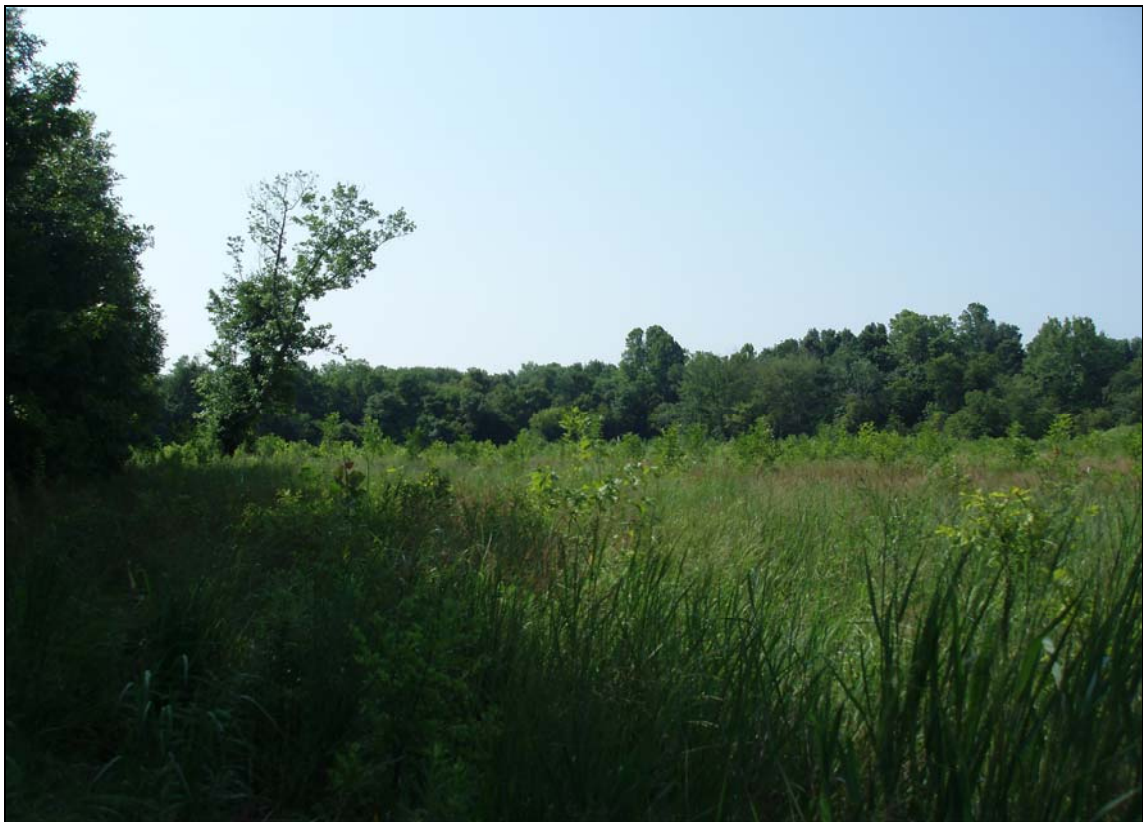
Photo Location 3: View looking east along the wetland preservation area. 7/5/07 MY04

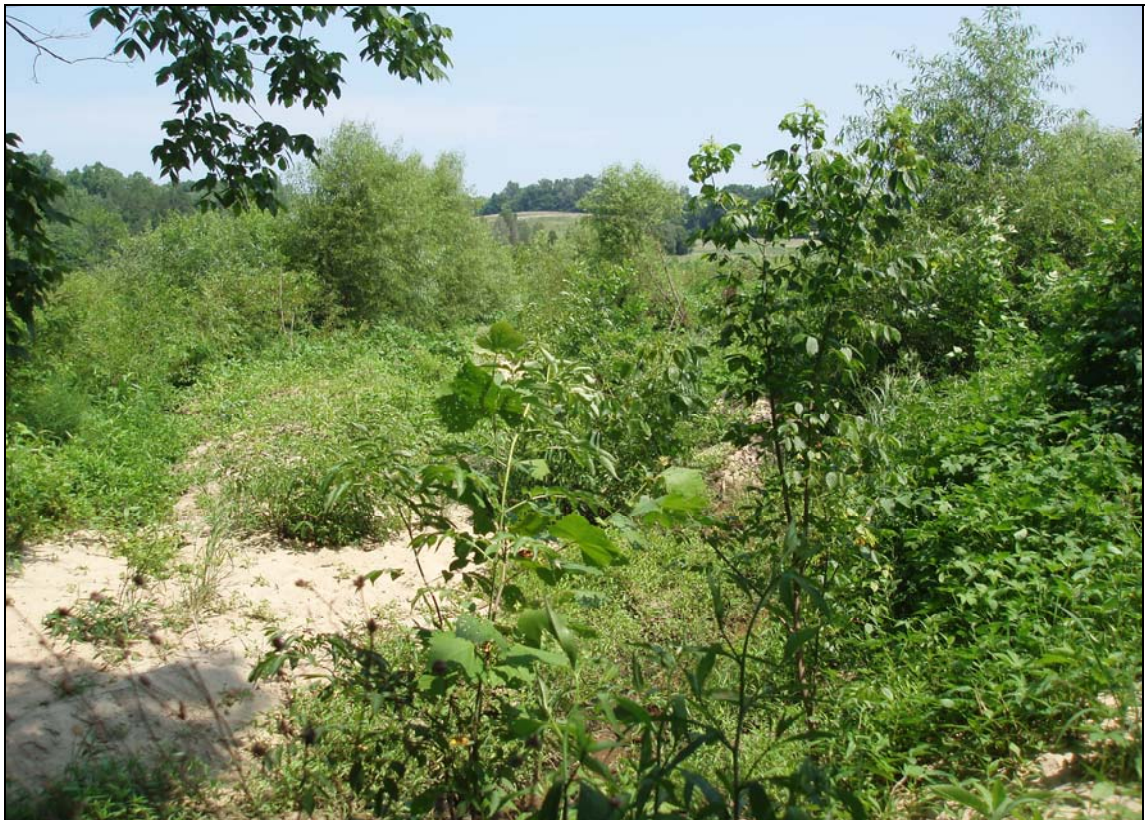
Photo Location 5: View looking north toward tree line of wetland preservation area. 7/5/07 MY04

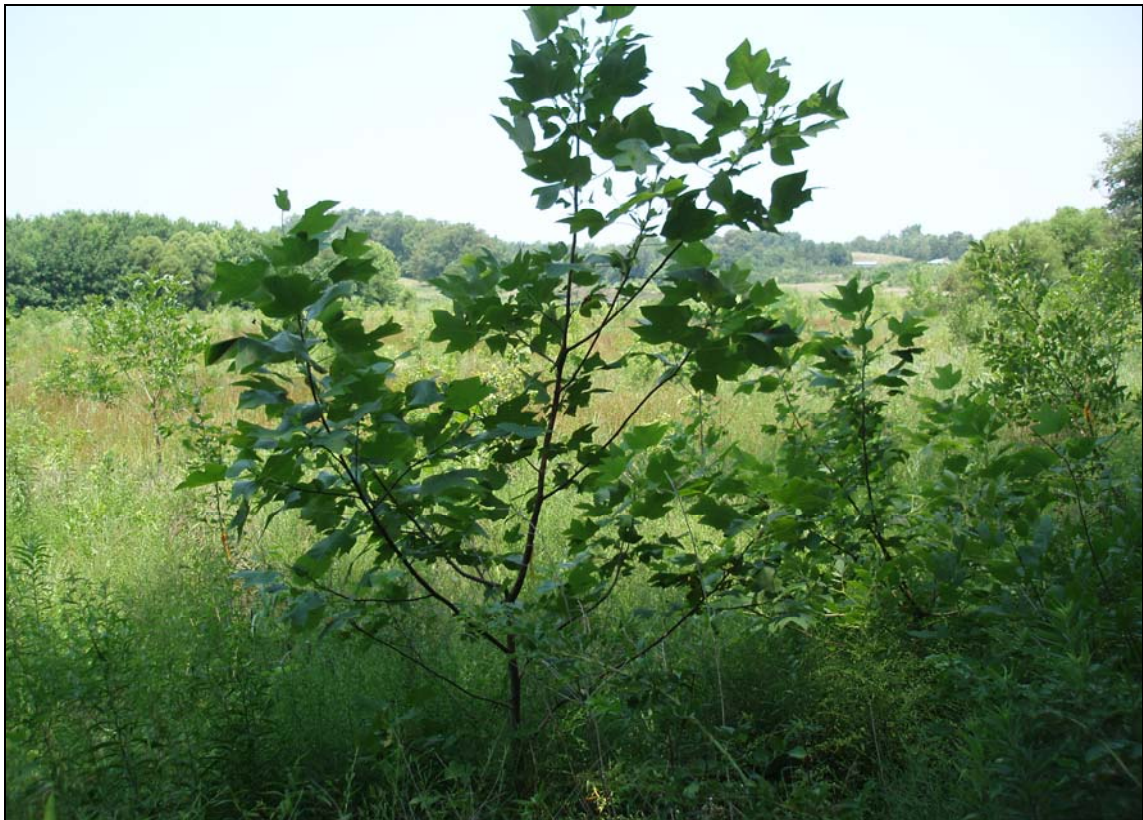
Photo Location 6, Photo 2: View looking from Rich Fork toward Photo Point #2 at the spoil pile. 7/5/07 MY04
