Monitoring Report
Year 5
Rich Fork Mitigation Site
Davidson County, North Carolina

Yadkin 03040103
Contract #R-9999WM

December 2008

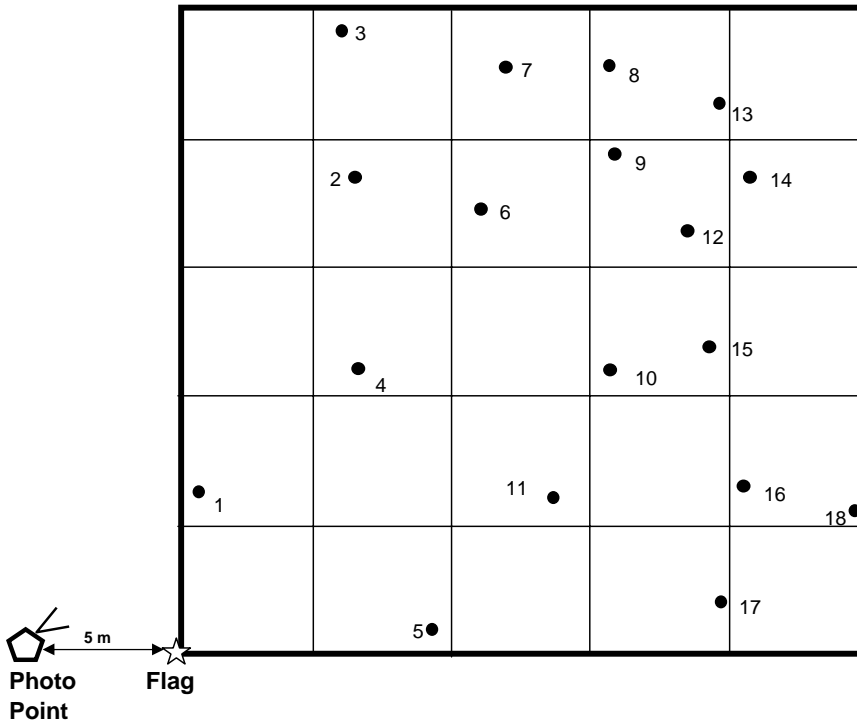
Plot Map

ID	Species	Height (m)	Collar Diameter (cm)	Comments (insect damage, disease, browsing)
1	Yellow Poplar (<i>Liriodendron tulipifera</i>)	0.61	1.3	top has died back
2	Yellow Poplar (<i>Liriodendron tulipifera</i>)	0.58	0.8	healthy
3	Swamp Chestnut Oak (<i>Quercus michauxii</i>)	0.77	1.0	healthy
4	Swamp Chestnut Oak (<i>Quercus michauxii</i>)	1.08	1.5	healthy
5	Swamp Chestnut Oak (<i>Quercus michauxii</i>)	1.15	1.4	healthy
6	Yellow Poplar (<i>Liriodendron tulipifera</i>)	0.61	1.2	healthy
7	Yellow Poplar (<i>Liriodendron tulipifera</i>)	0.51	0.8	healthy
8	Swamp Chestnut Oak (<i>Quercus michauxii</i>)	0.33	0.5	healthy
9	Swamp Chestnut Oak (<i>Quercus michauxii</i>)	0.52	0.8	healthy
10	Swamp Chestnut Oak (<i>Quercus michauxii</i>)	0.69	0.9	healthy
11	Green Ash (<i>Fraxinus pennsylvanica</i>)	2.06	2.3	healthy
12	Swamp Chestnut Oak (<i>Quercus michauxii</i>)	1.59	2.0	healthy
13	Swamp Chestnut Oak (<i>Quercus michauxii</i>)	0.45	0.6	top has died back

14	Swamp Chestnut Oak (<i>Quercus michauxii</i>)	0.80	0.9	healthy
15	Swamp Chestnut Oak (<i>Quercus michauxii</i>)	0.88	1.3	healthy
16	Swamp Chestnut Oak (<i>Quercus michauxii</i>)	0.98	0.8	healthy
17	Green Ash (<i>Fraxinus pennsylvanica</i>)	1.47	1.3	healthy
18	Swamp Chestnut Oak (<i>Quercus michauxii</i>)	0.58	2.1	top has died back

Notes - Tree heights smaller than previous years reflect that the top of certain trees have die back
 - Plot map updated annually to more accurately reflect tree locations.

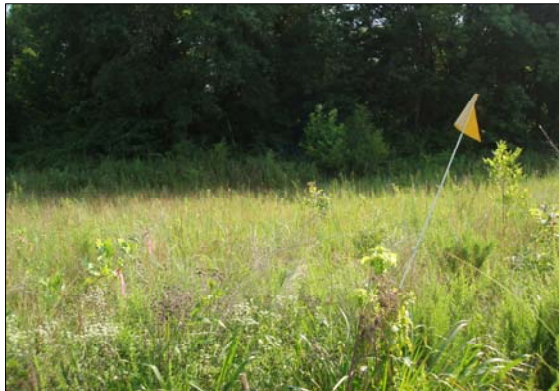
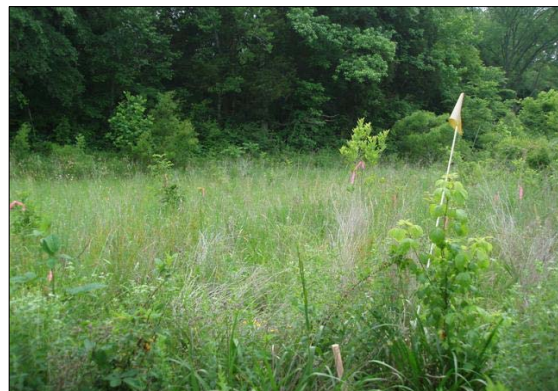
Note : Flag located N 38° E, 27' from monitoring well

Species	Percent of Total
Swamp Chestnut Oak (<i>Quercus michauxii</i>)	13%
Cherrybark Oak (<i>Quercus falcata</i>)	13%
Laurel Oak (<i>Quercus laurifolia</i>)	38%
Overcup Oak (<i>Quercus lyrata</i>)	38%

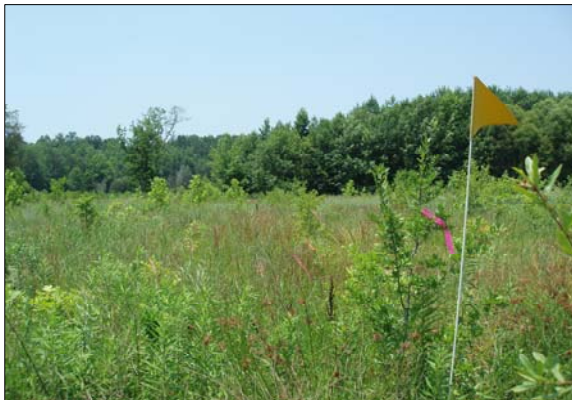
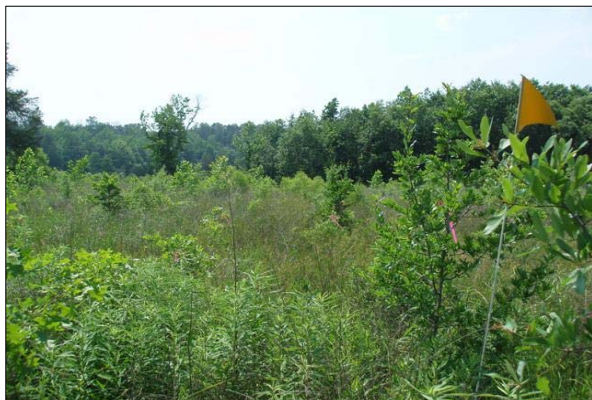
Note : Flag located W 270° N, 126' from monitoring well

Species	Percent of Total
Swamp Chestnut Oak (<i>Quercus michauxii</i>)	11%
Willow Oak (<i>Quercus phellos</i>)	50%
Green Ash (<i>Fraxinus pennsylvanica</i>)	33%
Laurel Oak (<i>Quercus laurifolia</i>)	6%

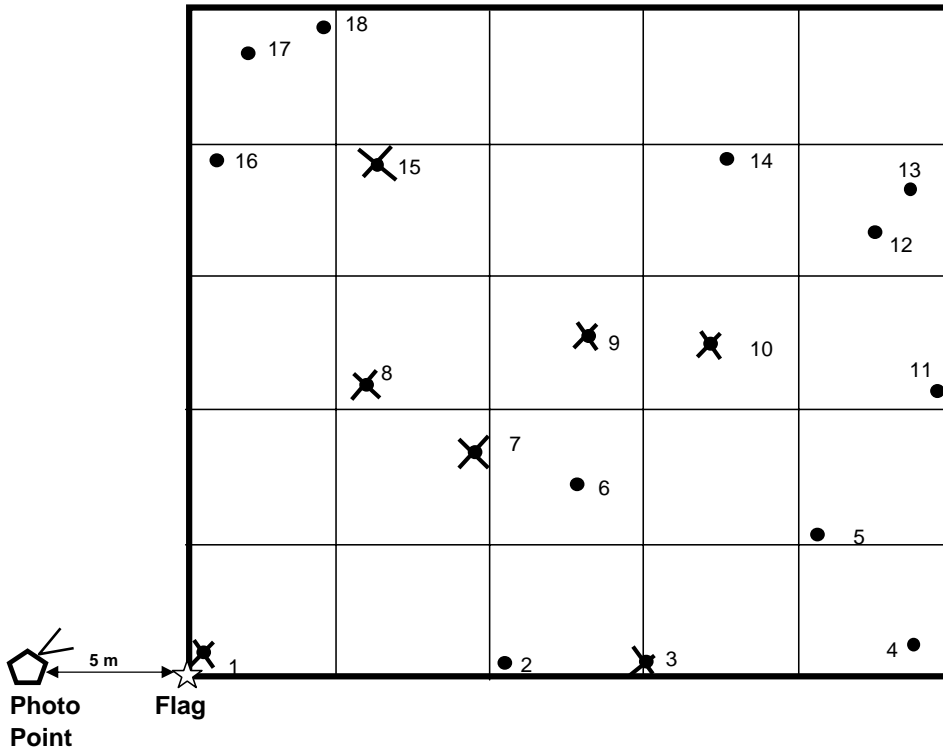
Plot Map

ID	Species	Height (m)	Collar Diameter (cm)	Comments (insect damage, disease, browsing)
1	Swamp Black Gum (<i>Nyssa sylvatica</i>)			dead
2	Laurel Oak (<i>Quercus laurifolia</i>)	1.16	1.0	sparse leaves
3	Laurel Oak (<i>Quercus laurifolia</i>)			dead
4	Black Willow (<i>Salix nigra</i>)	2.97	4.7	healthy
5	Swamp Chestnut Oak (<i>Quercus michauxii</i>)	1.28	1.2	healthy
6	Laurel Oak (<i>Quercus laurifolia</i>)	1.20	1.3	healthy
7	Swamp Chestnut Oak (<i>Quercus michauxii</i>)			dead (beaver)
8	Swamp Chestnut Oak (<i>Quercus michauxii</i>)			dead (beaver)
9	Yellow Poplar (<i>Liriodendron tulipifera</i>)			dead
10	Yellow Poplar (<i>Liriodendron tulipifera</i>)			dead
11	Overcup Oak (<i>Quercus lyrata</i>)	0.97	0.7	healthy
12	Silky Dogwood (<i>Cornus amomum</i>)	1.20	1.5	healthy multistem
13	Green Ash (<i>Fraxinus pennsylvanica</i>)	3.80	5.2	healthy
14	Green Ash (<i>Fraxinus pennsylvanica</i>)	1.20	3.5	beaver (resprout ~ 1ft from base)

15	Laurel Oak (<i>Quercus laurifolia</i>)			dead
16	Green Ash (<i>Fraxinus pennsylvanica</i>)	2.82	2.9	healthy
17	Black Willow (<i>Salix nigra</i>)	3.51	4.7	healthy
18	Green Ash (<i>Fraxinus pennsylvanica</i>)	2.48	3.2	healthy

Notes - Tree heights smaller than previous years reflect that the top of certain trees have die back
 - Plot map updated annually to more accurately reflect tree locations

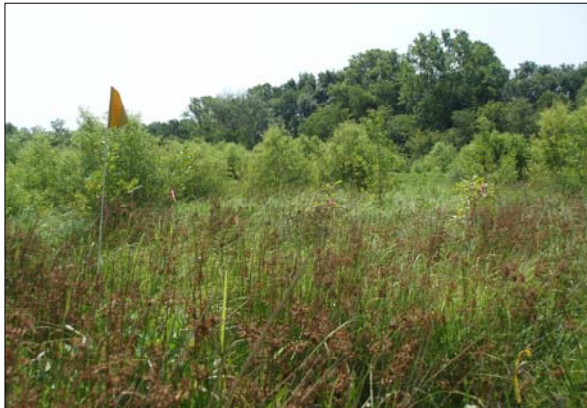
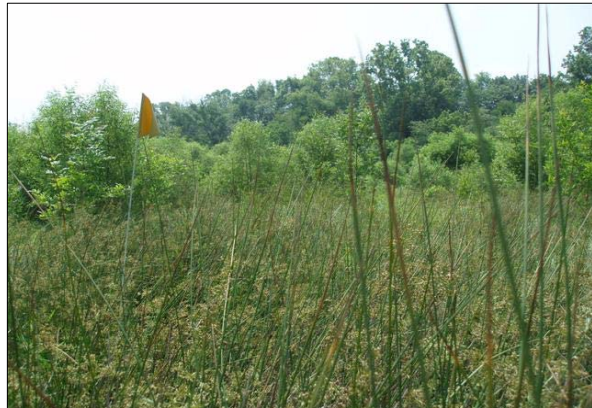
Note : Flag located E 158° S, 76' from monitoring well

Species	Percent of Total
Swamp Chestnut Oak (<i>Quercus michauxii</i>)	7%
Green Ash (<i>Fraxinus pennsylvanica</i>)	93%

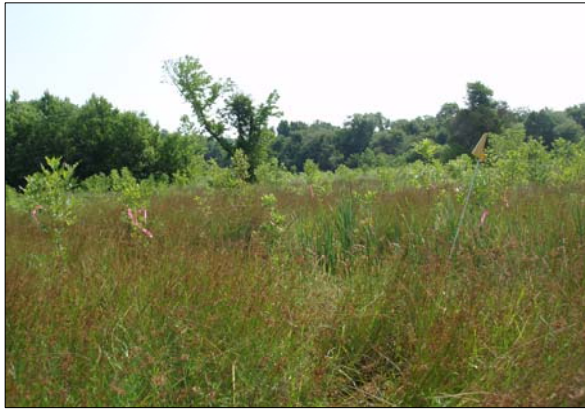
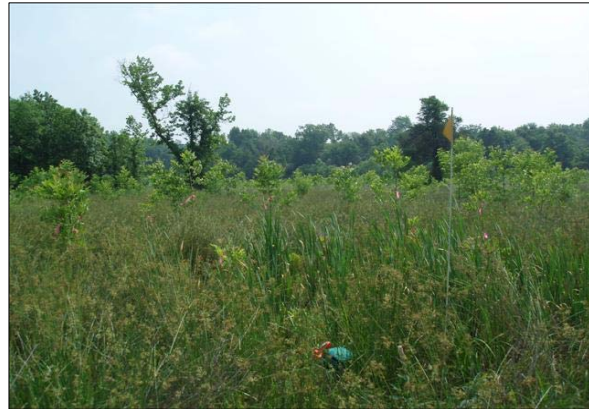
Note : Flag located N 38° E, 27' from monitoring well

Species	Percent of Total
Swamp Chestnut Oak (<i>Quercus michauxii</i>)	54%
Green Ash (<i>Fraxinus pennsylvanica</i>)	15%
Yellow Poplar (<i>Liriodendron tulipifera</i>)	8%
Willow Oak (<i>Quercus phellos</i>)	15%
Laurel Oak (<i>Quercus laurifolia</i>)	8%

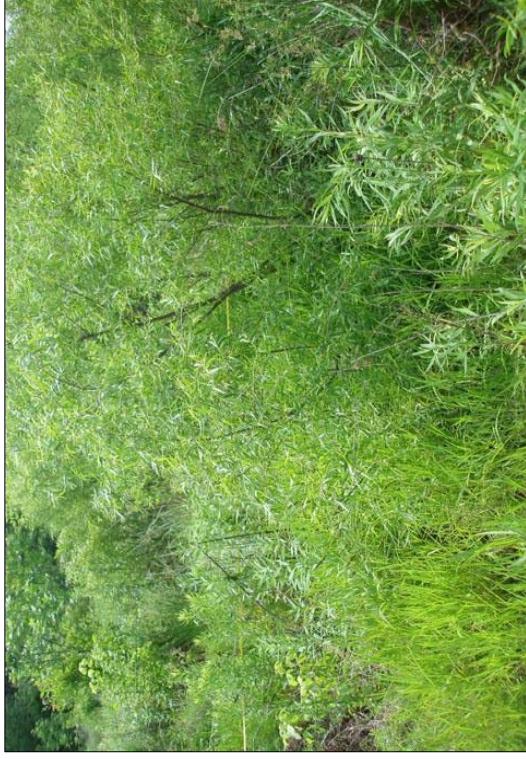
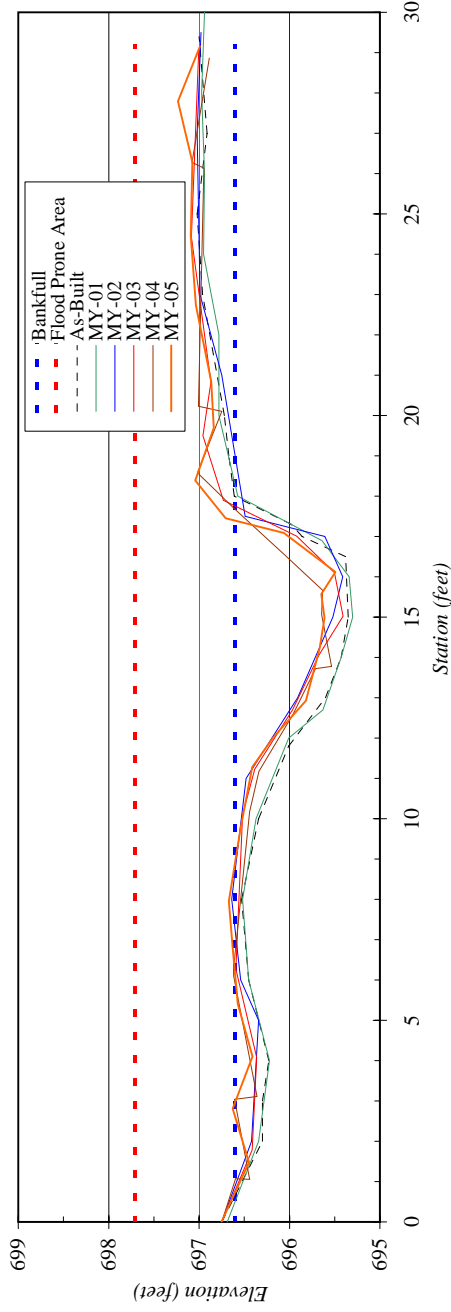
Yadkin River Basin, Rich Fork, MY05, Main XS 1, Pool

SUMMARY DATA	
Bankfull Elevation:	696.6
Bankfull Cross-Sectional Area:	4.8
Bankfull Width:	8.5
Flood Prone Area Elevation:	697.7
Flood Prone Width:	>30
Max Depth at Bankfull:	1.1
Mean Depth at Bankfull:	0.6
W / D Ratio:	15.1
Entrenchment Ratio:	>3
Bank Height Ratio:	1.0

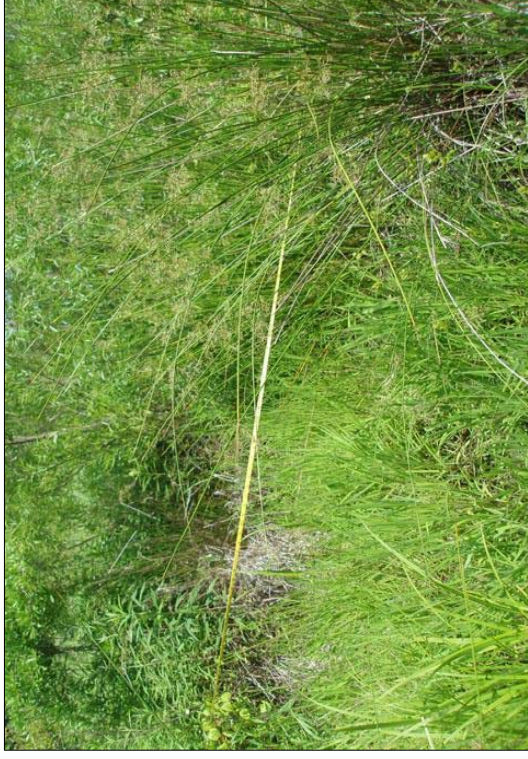
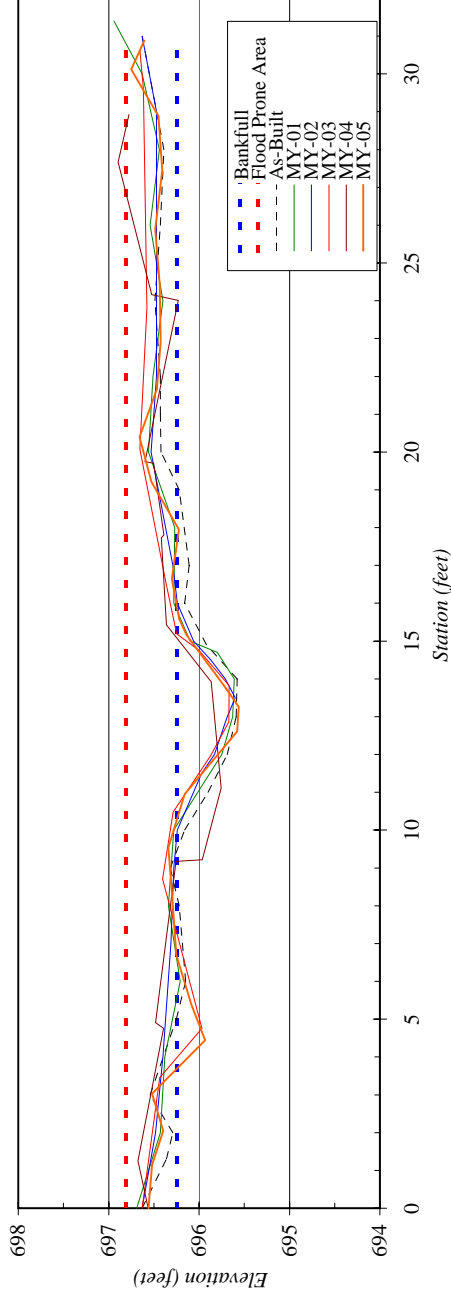
Yadkin River Basin, Rich Fork, MY05, Main XS 2, Riffle

SUMMARY DATA	
Bankfull Elevation:	696.24
Bankfull Cross-Sectional Area:	1.9
Bankfull Width:	5.9
Flood Prone Area Elevation:	696.81
Flood Prone Area Width:	>35
Max Depth at Bankfull:	0.7
Mean Depth at Bankfull:	0.3
W / D Ratio:	18.8
Entrenchment Ratio:	>6
Bank Height Ratio:	1.0

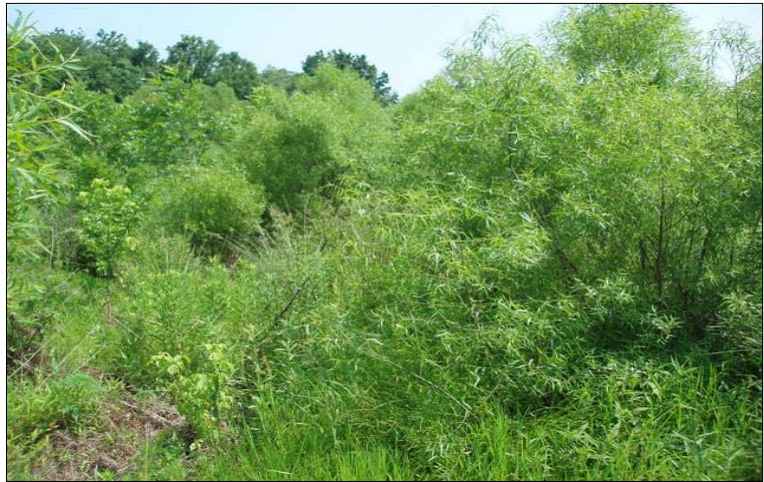
View of mainstem upstream planform looking downstream

SUMMARY DATA	
Stream Segment Length:	160
Distance Between Survey Points:	134
Distance Between Stations:	2
Sinuosity:	1.2
Mean Radius of Curvature:	13.8
Belt Width:	20.1

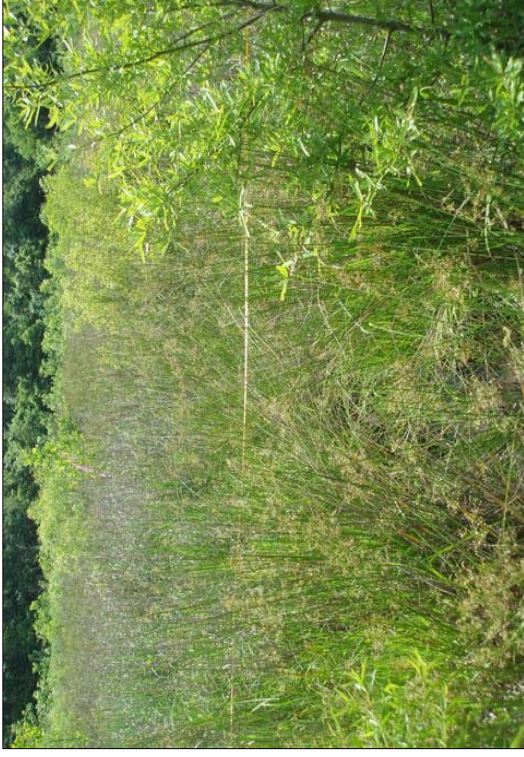
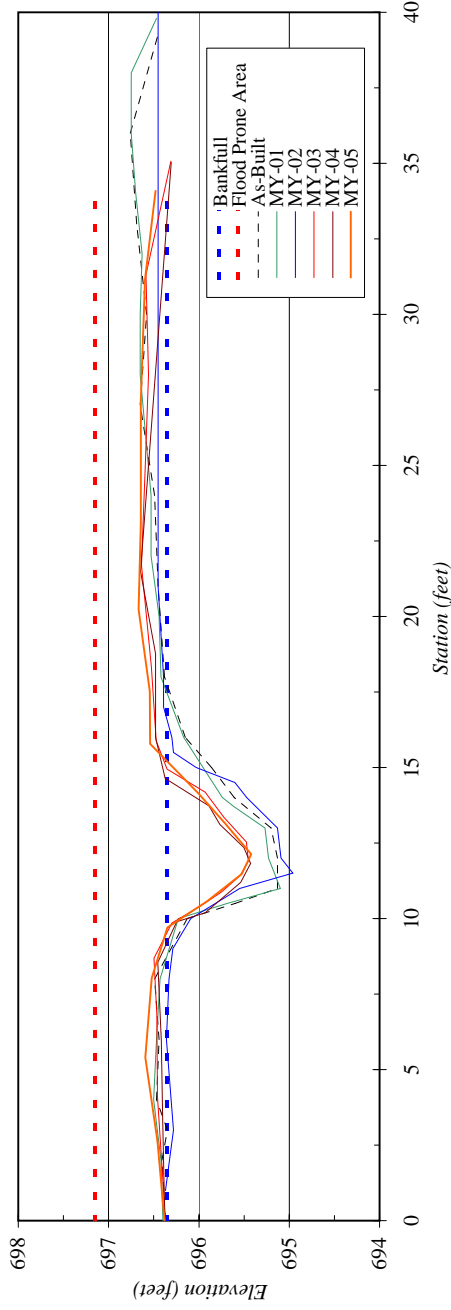
Yadkin River Basin, Rich Fork, MY05, Main XS 3, Pool

SUMMARY DATA	
Bankfull Elevation:	696.35
Bankfull Cross-Sectional Area:	2.8
Bankfull Width:	5.5
Flood Prone Area Elevation:	697.15
Flood Prone Width:	>40
Max Depth at Bankfull:	1.0
Mean Depth at Bankfull:	0.5
W / D Ratio:	10.8
Entrenchment Ratio:	>7
Bank Height Ratio:	1.0

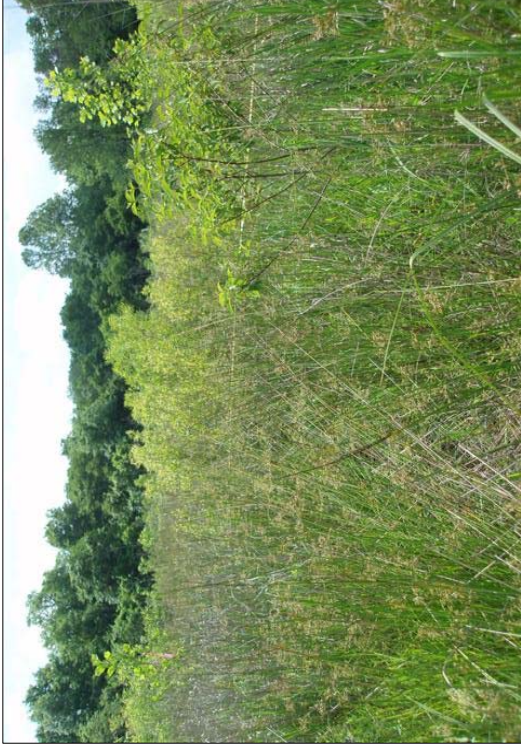
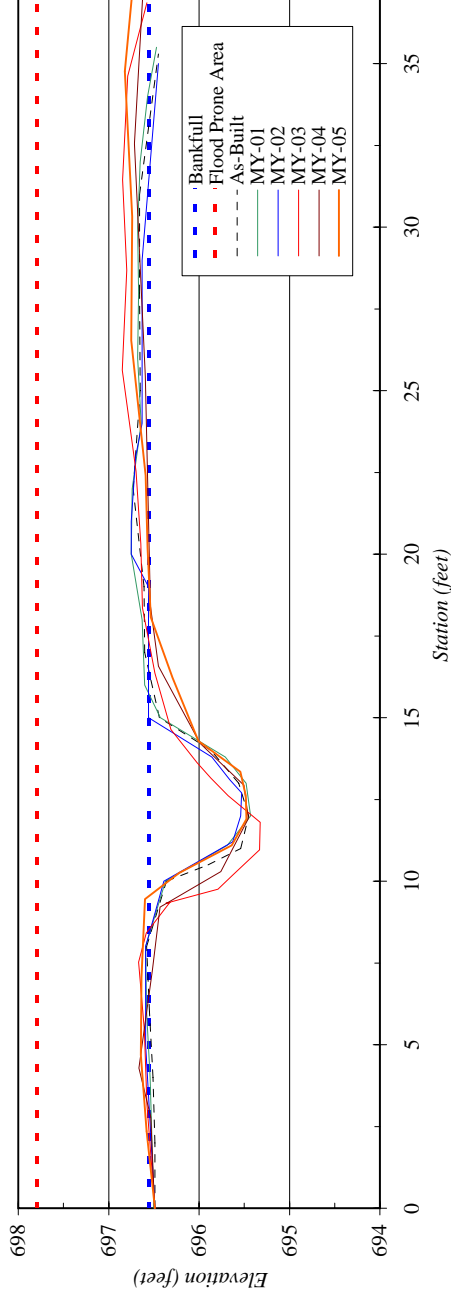
Yadkin River Basin, Rich Fork, MY05, Main XS 4, Riffle

SUMMARY DATA	
Bankfull Elevation:	696.56
Bankfull Cross-Sectional Area:	4.8
Bankfull Width:	10.0
Flood Prone Area Elevation:	697.8
Flood Prone Width:	>50
Max Depth at Bankfull:	1.1
Mean Depth at Bankfull:	0.5
W / D Ratio:	20.8
Entrenchment Ratio:	>5
Bank Height Ratio:	1.0

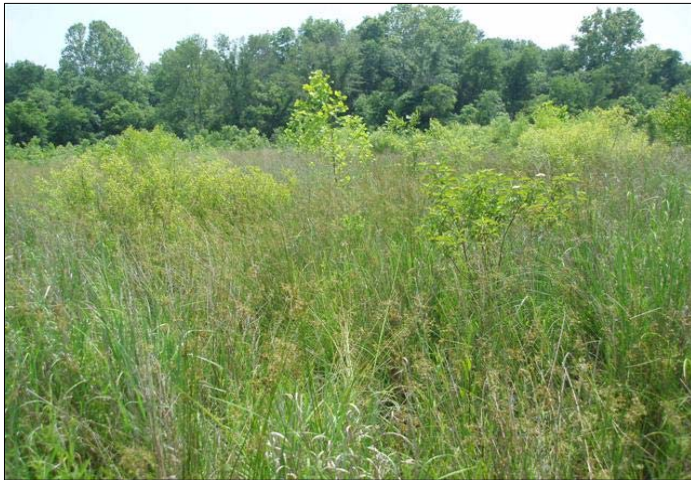
View of mainstem upstream planform looking downstream

SUMMARY DATA	
Stream Segment Length:	150
Distance Between Survey Points:	124
Distance Between Stations:	2
Sinuosity:	1.2
Mean Radius of Curvature:	11.8
Belt Width:	21.9

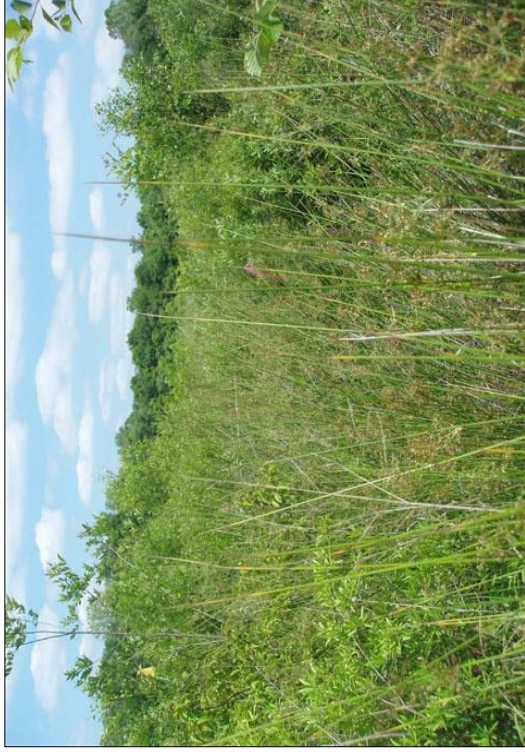
River Basin:	Yadkin
Watershed:	Rich Fork, MY05
XS ID	Trib XS 1, Pool
Date:	5/28/2008
Field Crew:	B. Roberts, K. Vaughan

Station	Elevation
0.0	696.07
2.0	696.07
4.0	696.17
6.7	696.35
8.6	696.26
9.3	696.27
10.4	696.08
11.1	695.93
11.8	695.80
12.7	695.54
13.4	695.46
14.1	695.87
14.9	696.14
16.1	696.27
17.7	696.36
19.6	696.43
22.0	696.25
25.0	696.41
27.2	696.33
28.8	696.35

SUMMARY DATA	
Bankfull Elevation:	696.19
Bankfull Cross-Sectional Area:	1.8
Bankfull Width:	5.6
Flood Prone Area Elevation:	697.0
Flood Prone Width:	>30
Max Depth at Bankfull:	0.5
Mean Depth at Bankfull:	0.3
W / D Ratio:	16.9
Entrenchment Ratio:	>5
Bank Height Ratio:	1.5

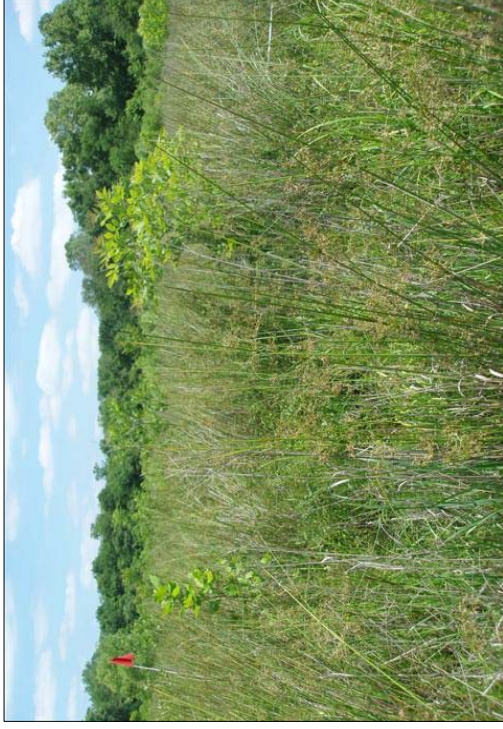
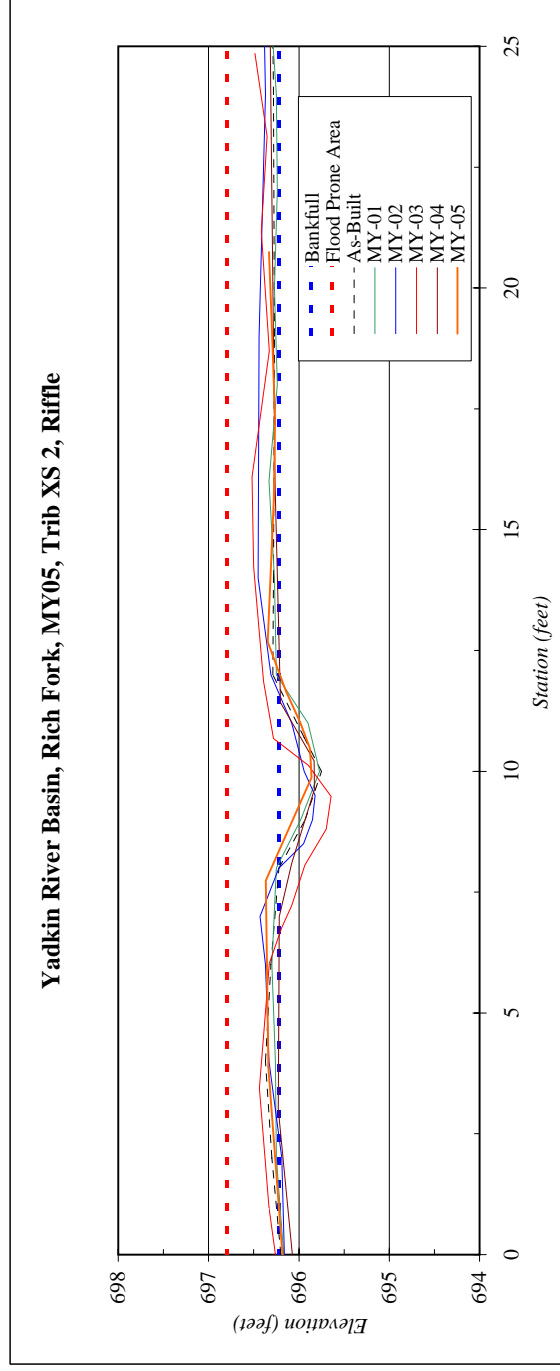
SUMMARY DATA	
Bankfull Elevation:	696.22
Bankfull Cross-Sectional Area:	1.0
Bankfull Width:	4.1
Flood Prone Area Elevation:	696.8
Flood Prone Width:	>25
Max Depth at Bankfull:	0.4
Mean Depth at Bankfull:	0.2
W / D Ratio:	17.6
Entrenchment Ratio:	>6
Bank Height Ratio:	1.9

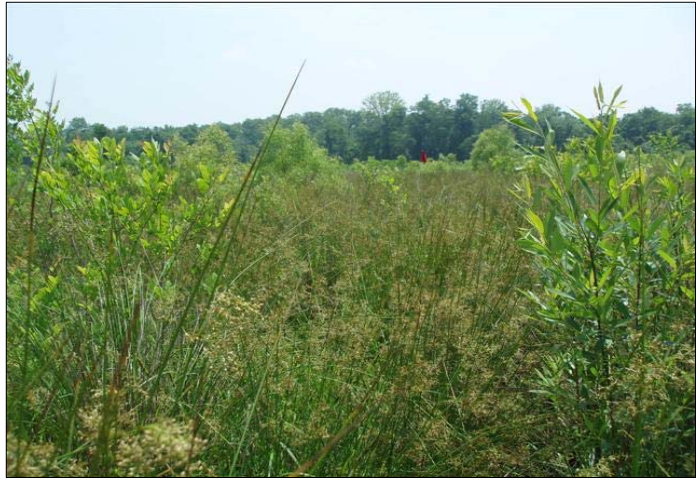
SUMMARY DATA	
Stream Segment Length:	107
Distance Between Survey Points:	88
Distance Between Stations:	2
Sinuosity:	1.2
Mean Radius of Curvature:	7.0
Belt Width:	17.6

View of tributary upstream planform looking downstream

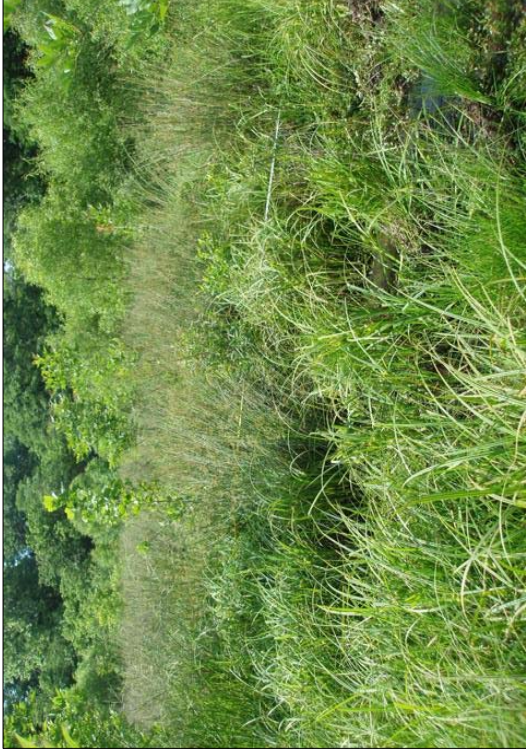
River Basin:	Yadkin
Watershed:	Rich Fork, MY05
XS ID	Trib XS 3, Pool
Date:	5/28/2008
Field Crew:	B. Roberts, K. Vaughan

Station	Elevation
0.0	695.95
2.0	695.95
4.0	695.85
6.4	695.88
8.0	695.78
9.6	695.32
11.6	695.64
13.8	695.87
15.0	695.93
16.0	695.99
17.1	696.04
18.6	696.06
19.9	696.04
21.2	695.92

SUMMARY DATA	
Bankfull Elevation:	695.77
Bankfull Cross-Sectional Area:	1.0
Bankfull Width:	4.8
Flood Prone Area Elevation:	696.6
Flood Prone Width:	>30
Max Depth at Bankfull:	0.4
Mean Depth at Bankfull:	0.2
W / D Ratio:	22.7
Entrenchment Ratio:	>6
Bank Height Ratio:	1.0

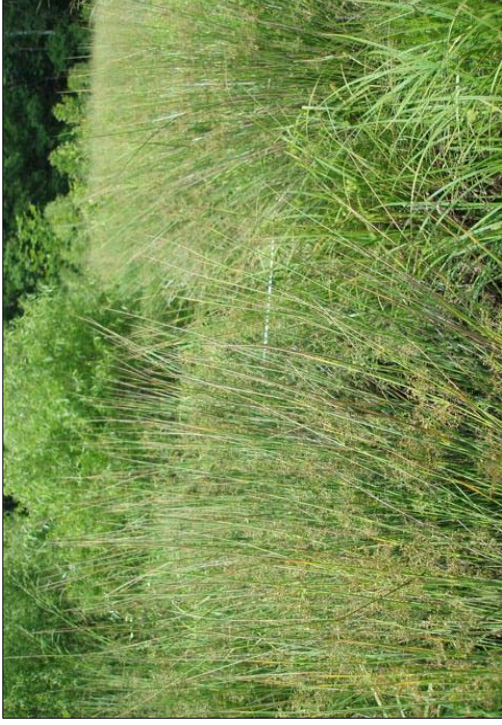
River Basin:	Yadkin
Watershed:	Rich Fork, MY05
XS ID	Trib XS 4, Riffle
Date:	5/28/2008
Field Crew:	B. Roberts, K. Vaughan

Station	Elevation
0.0	695.93
1.4	696.08
3.5	695.82
5.9	695.78
7.7	695.70
8.9	695.41
10.2	695.64
11.3	695.91
12.6	696.03
14.7	696.05
16.1	696.08
18.3	695.99

SUMMARY DATA	
Bankfull Elevation:	695.85
Bankfull Cross-Sectional Area:	1.6
Bankfull Width:	6.2
Flood Prone Area Elevation:	696.29
Flood Prone Width:	>20
Max Depth at Bankfull:	0.4
Mean Depth at Bankfull:	0.3
W / D Ratio:	23.9
Entrenchment Ratio:	>3
Bank Height Ratio:	1.0

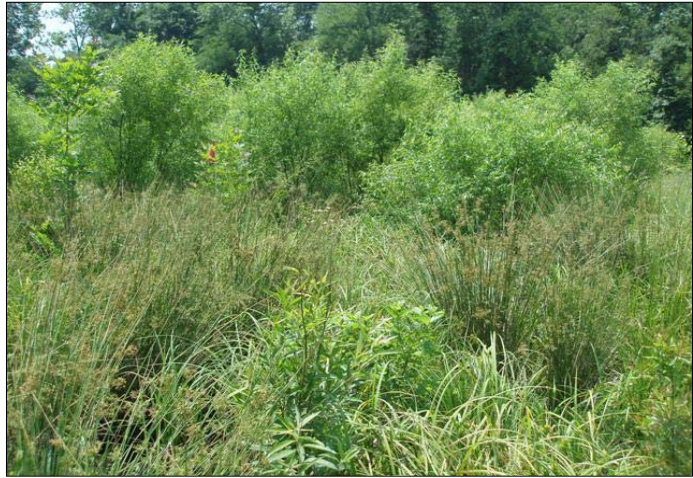
SUMMARY DATA	
Stream Segment Length:	123
Distance Between Survey Points:	92
Distance Between Stations:	2
Sinuosity:	1.3
Mean Radius of Curvature:	7.0
Belt Width:	25.7

View of tributary downstream planform looking downstream

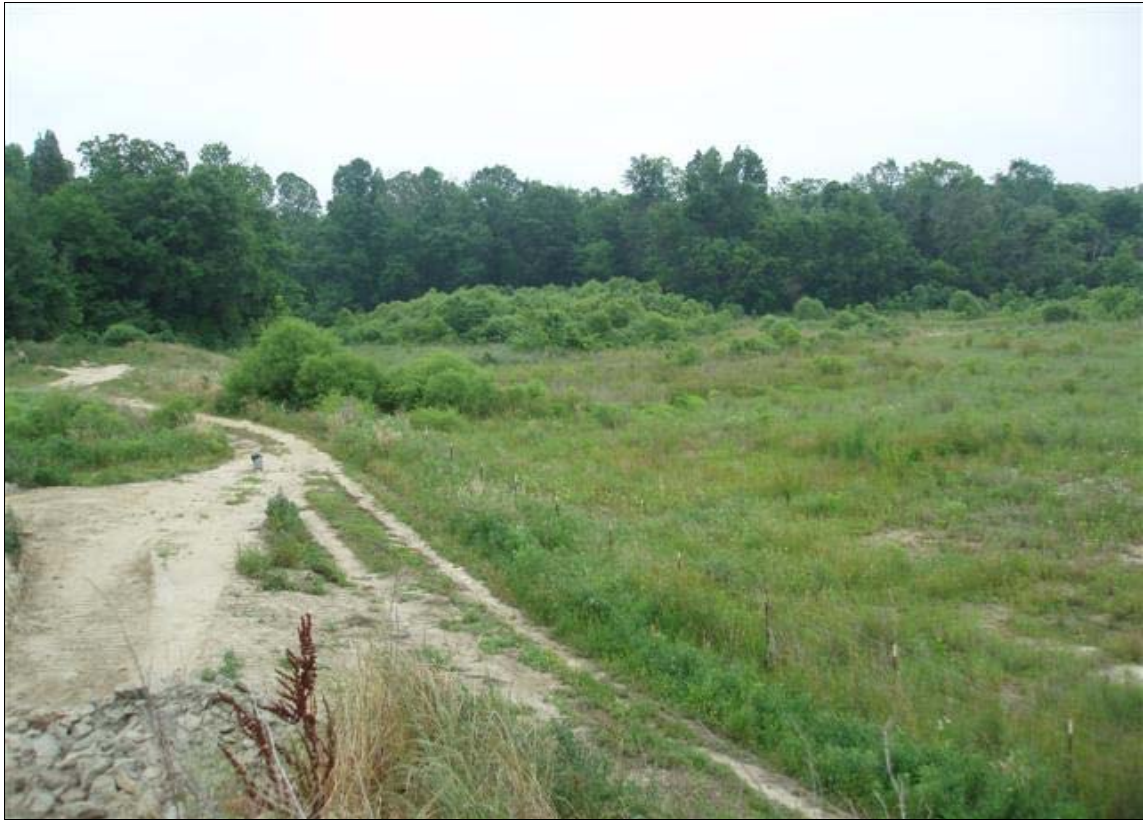
Photo Location 2, Photo 2: View looking east. 6/4/08 MY05

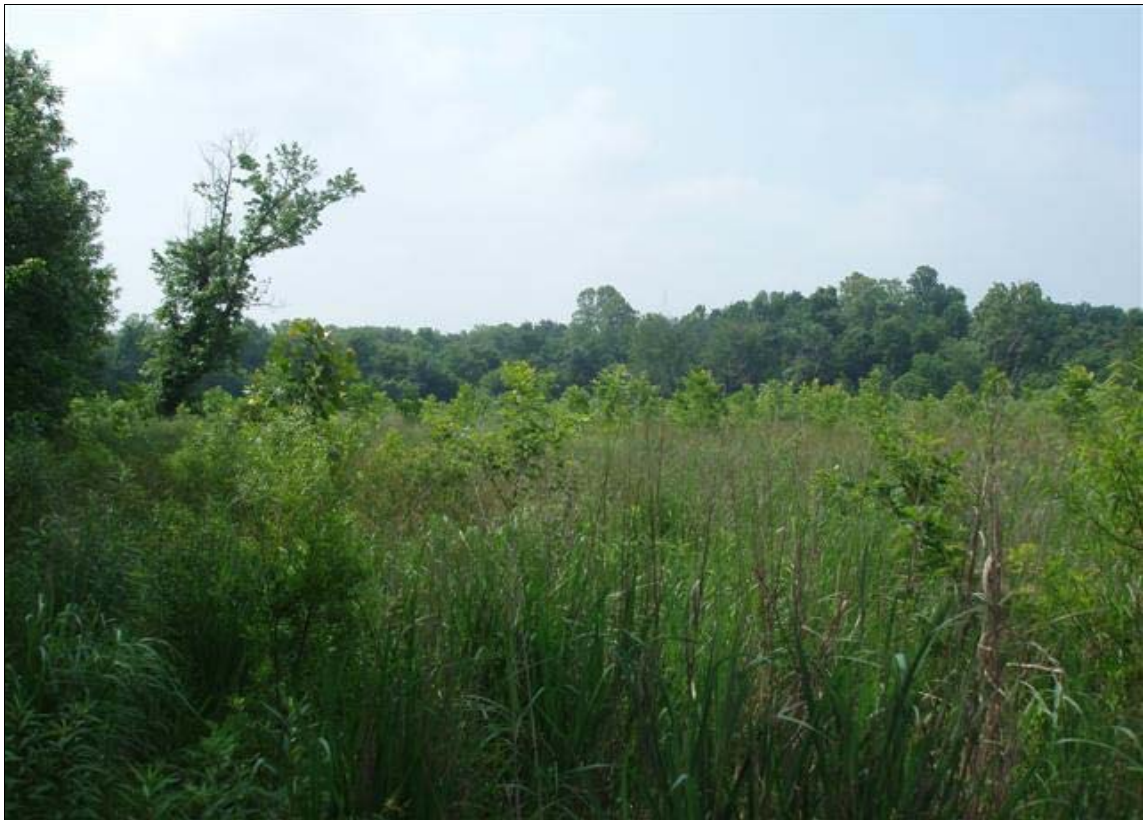
Photo Location 3: View looking east at the wetland preservation area. 6/4/08 MY05

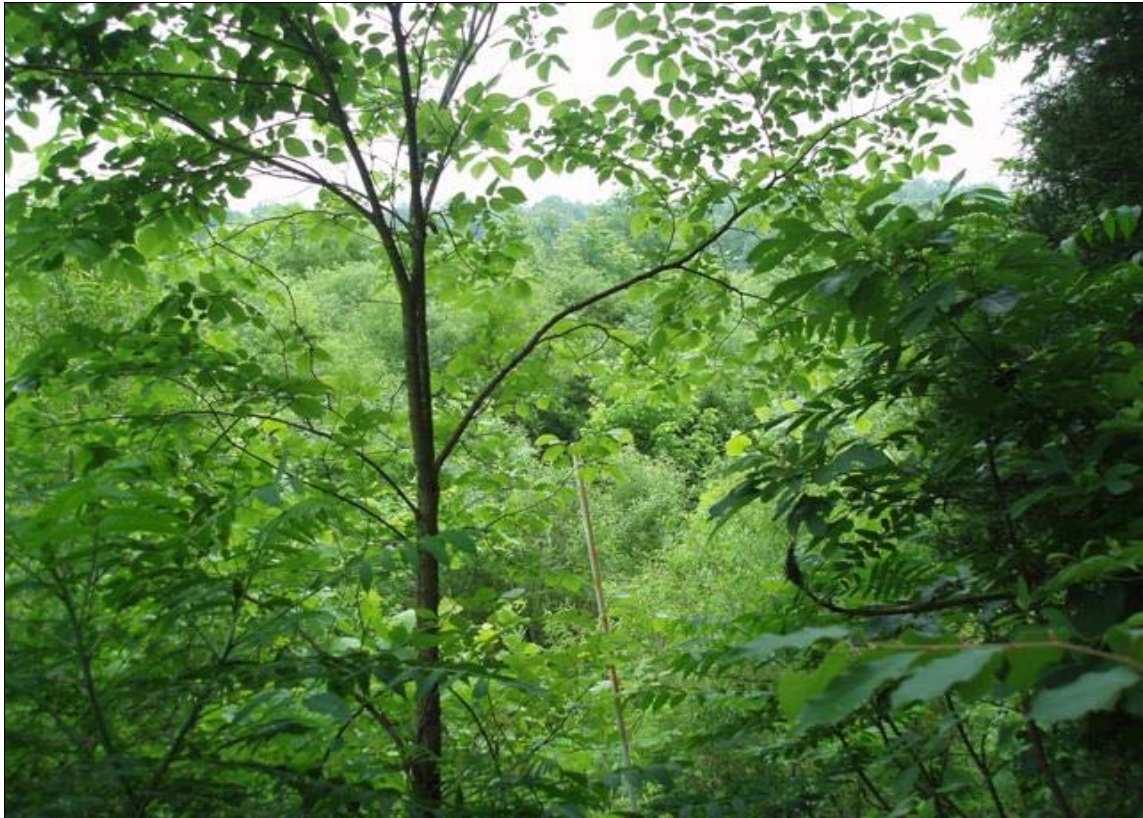
Photo Location 1: View looking toward large cedar and restored channel at confluence with Rich Fork Creek. 6/4/08 MY05

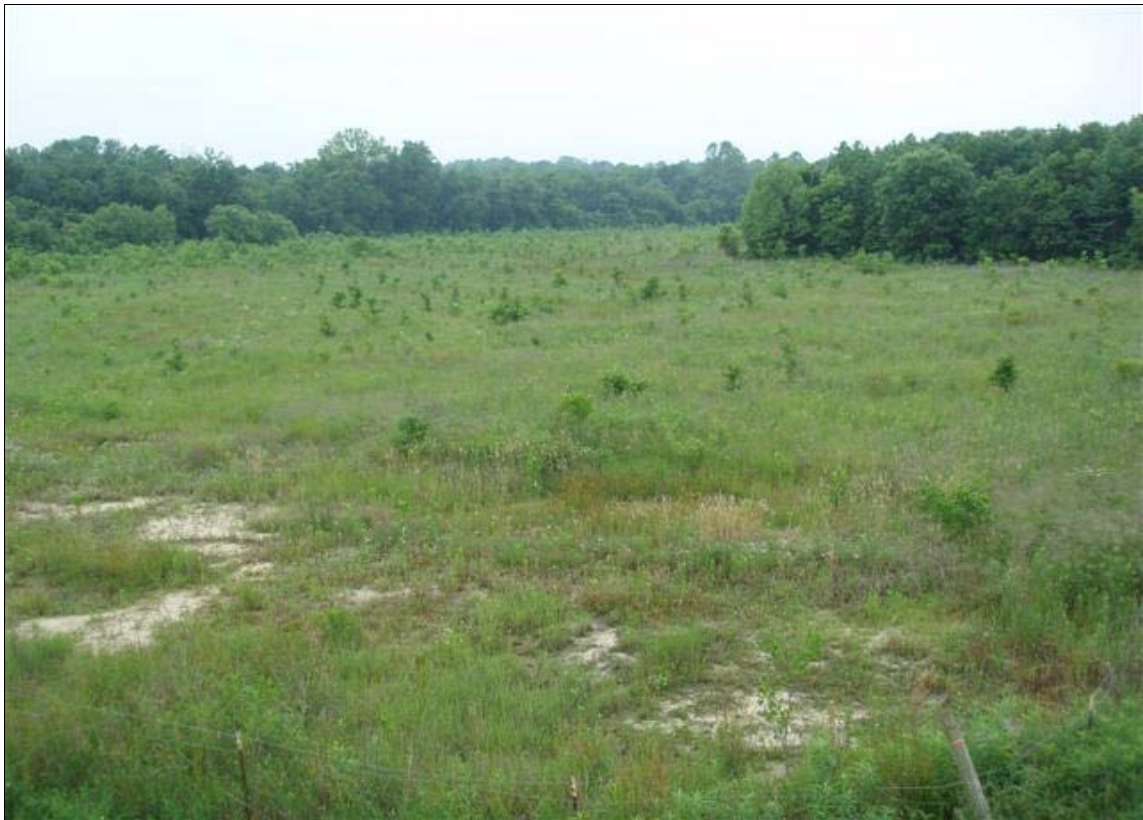
Photo Location 2, Photo 1: View looking south toward large cedar. 6/4/08 MY05

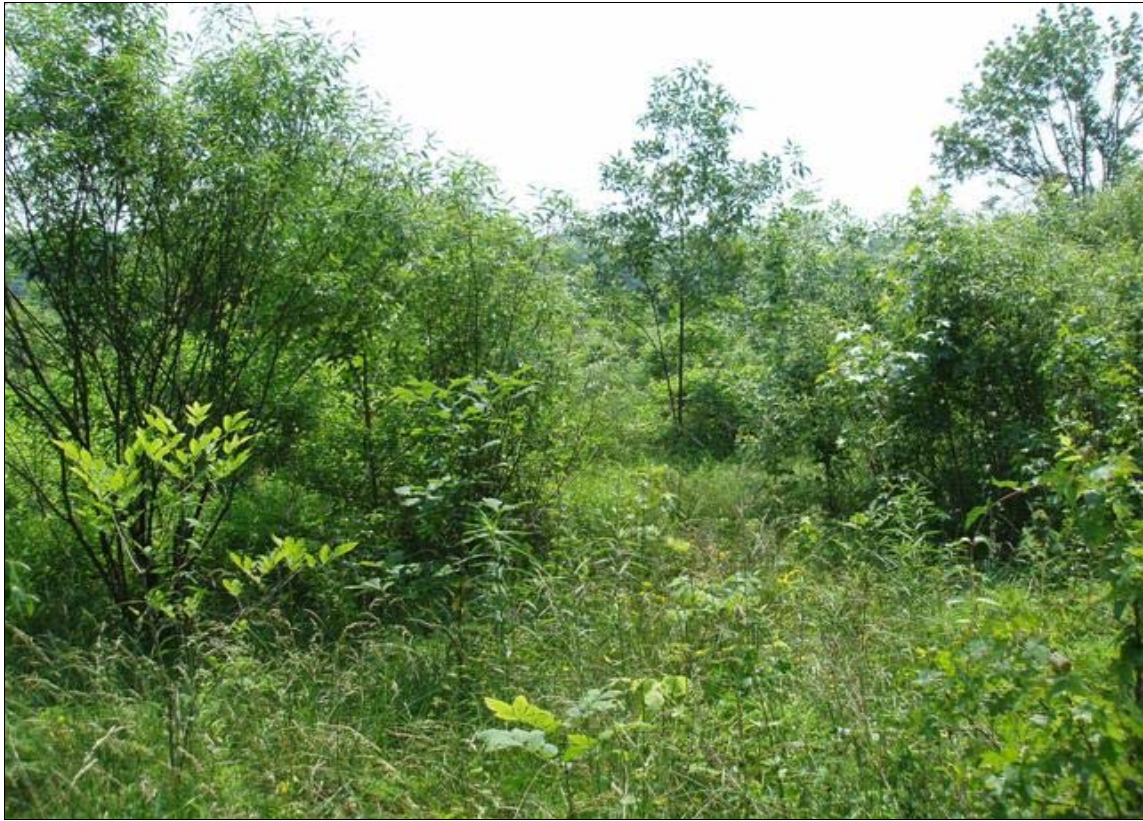
Photo Location 4: View looking east. 6/4/08 MY05

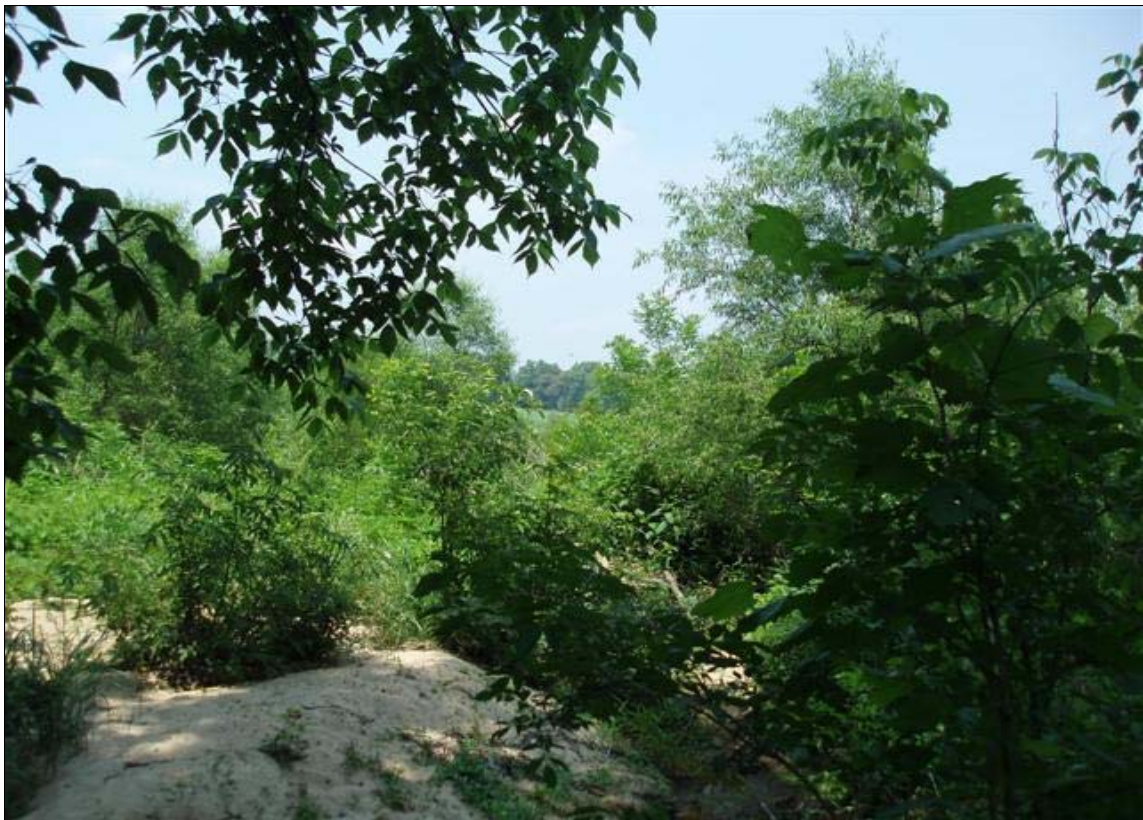
Photo Location 5: View looking north toward tree line of wetland preservation area. 6/4/08 MY05

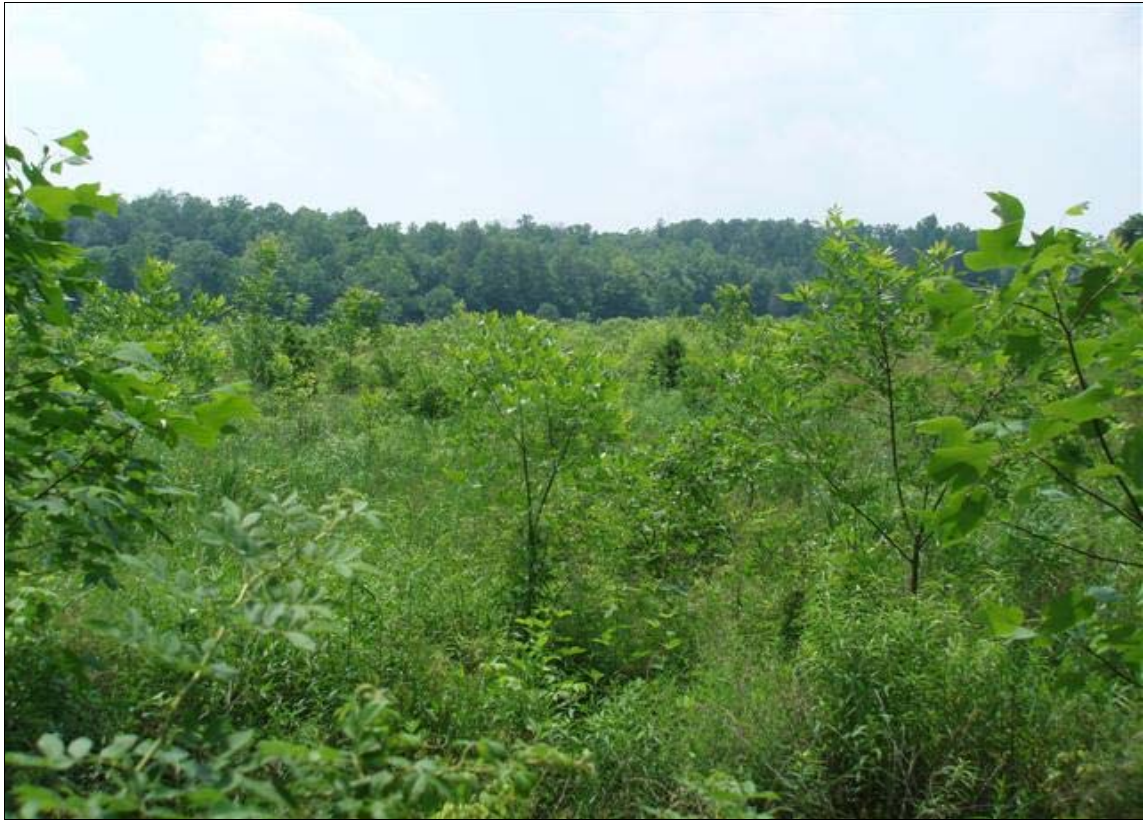
Photo Location 6, Photo 1: View looking west. 6/4/08 MY05

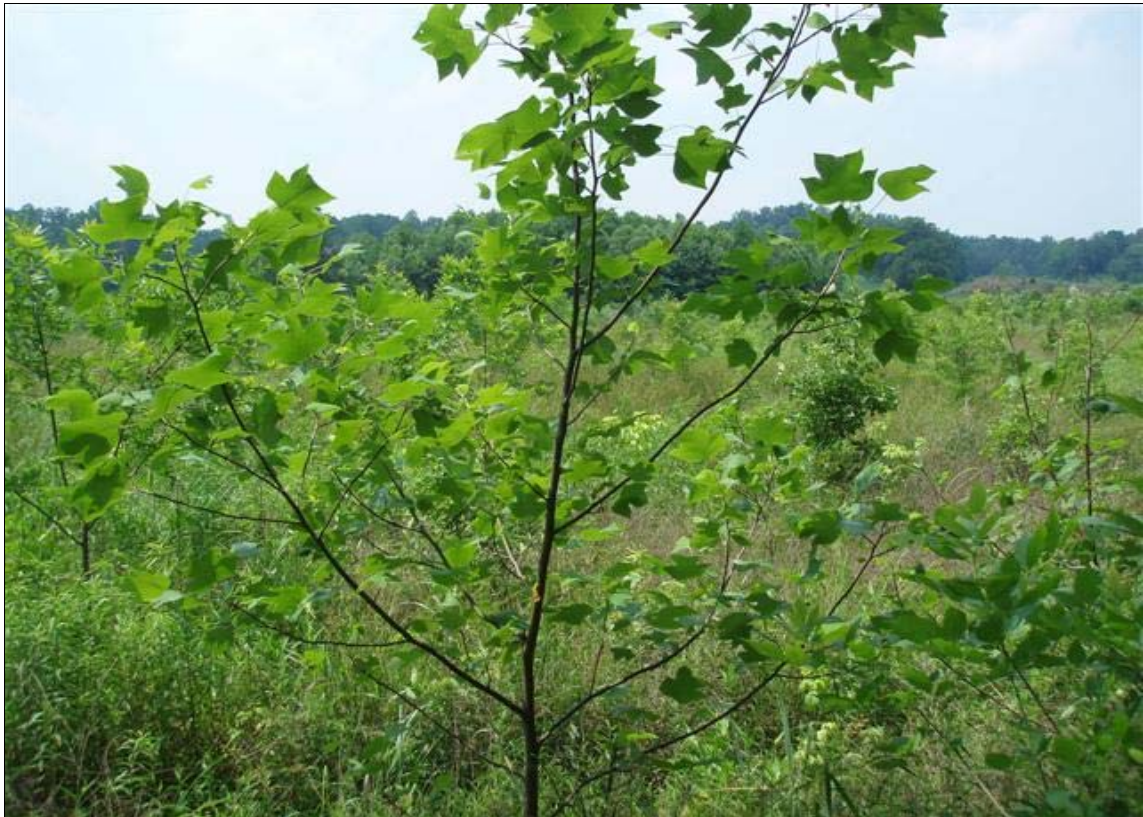
Photo Location 6, Photo 2: View looking northwest from Rich Fork. 6/4/08 MY05
