*Restoration Plan*

## Rockwell Pastures Site

**Stanly County, North Carolina**

**Project ID# 000624**

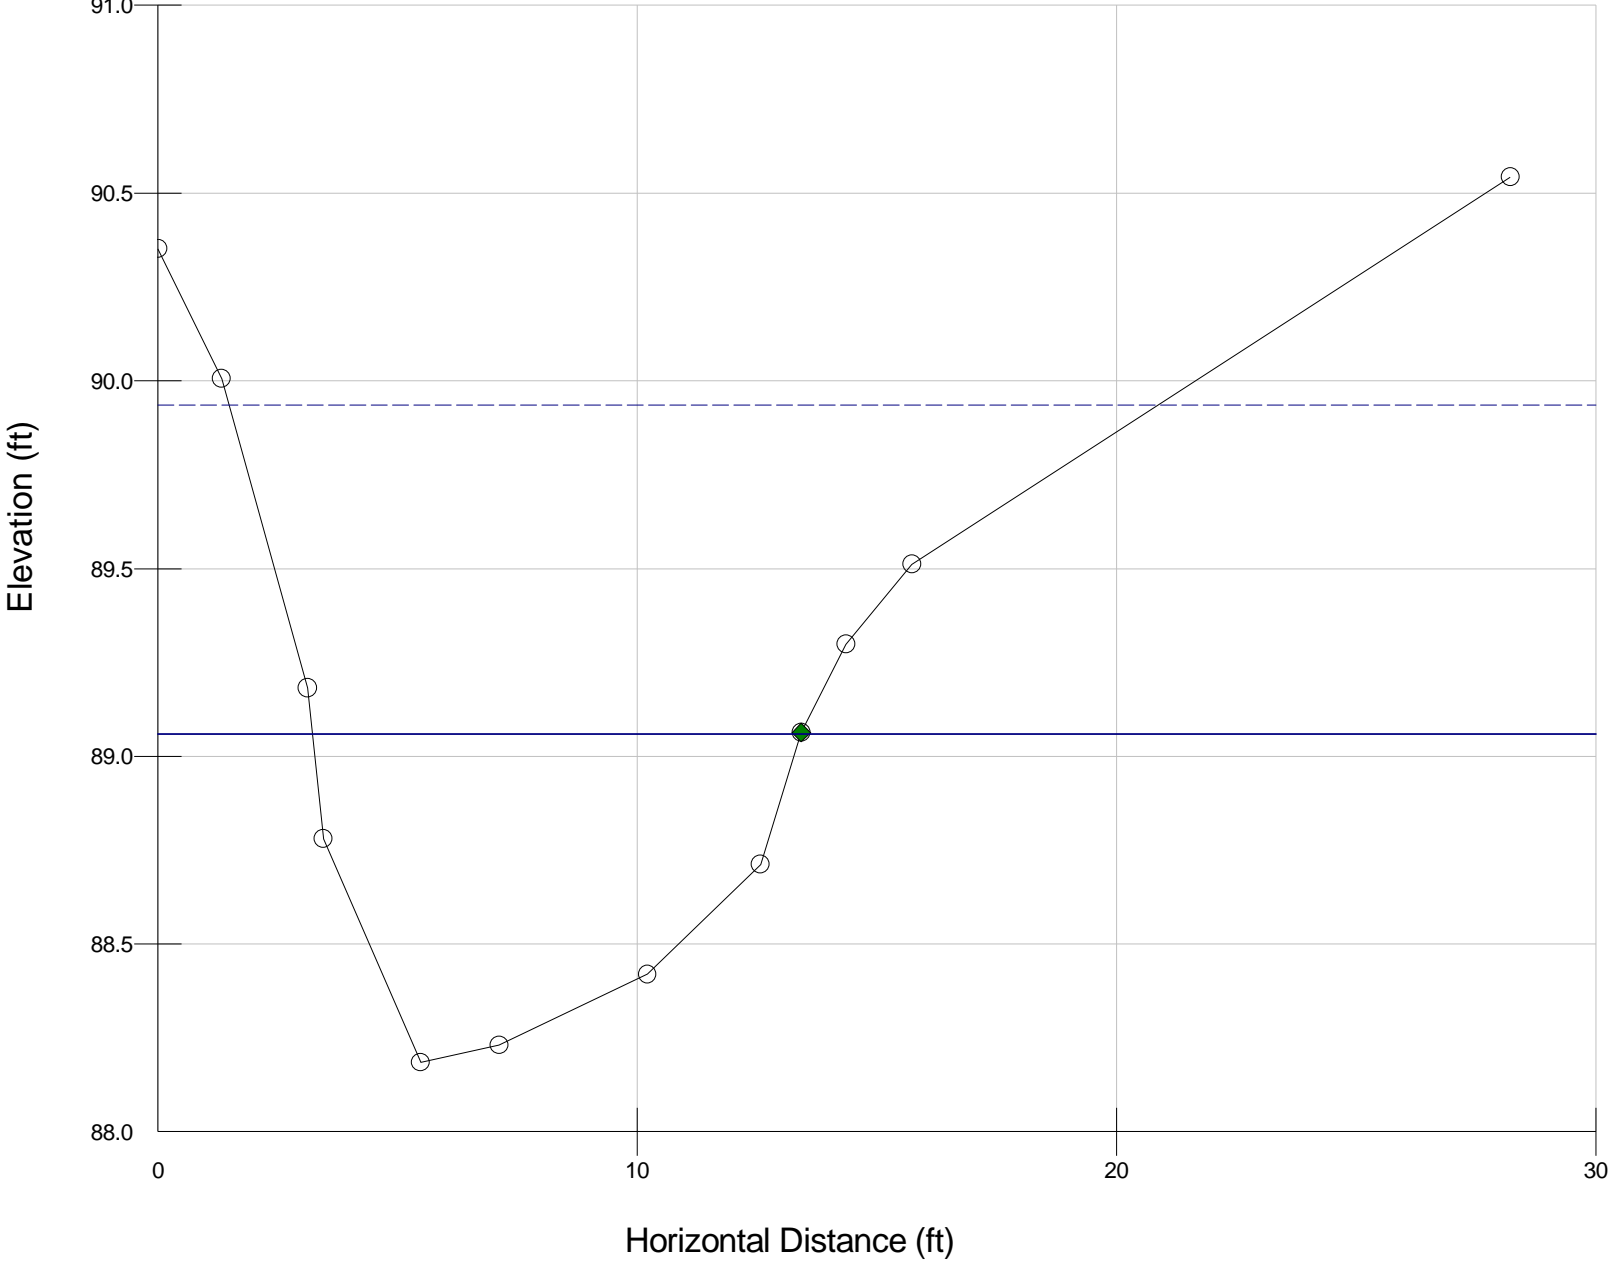
# Cross-section 2 - Riffle UT2

○ Ground Points      ◆ Bankfull Indicators      ▼ Water Surface Points  
wbkf = 10.2      Dbkf = .61      Abkf = 6.18
