**Rockwell Pastures Site
Stanly County, North Carolina
FINAL - Year 3 Annual Monitoring Report
Monitoring Year 2011**

**Monitoring Year: 2011
Measurement Year 3
As-Built Date: 2009
NCEEP Project ID Number D-000624**

**ROCKWELL PASTURES SITE
2011 MONITORING REPORT**

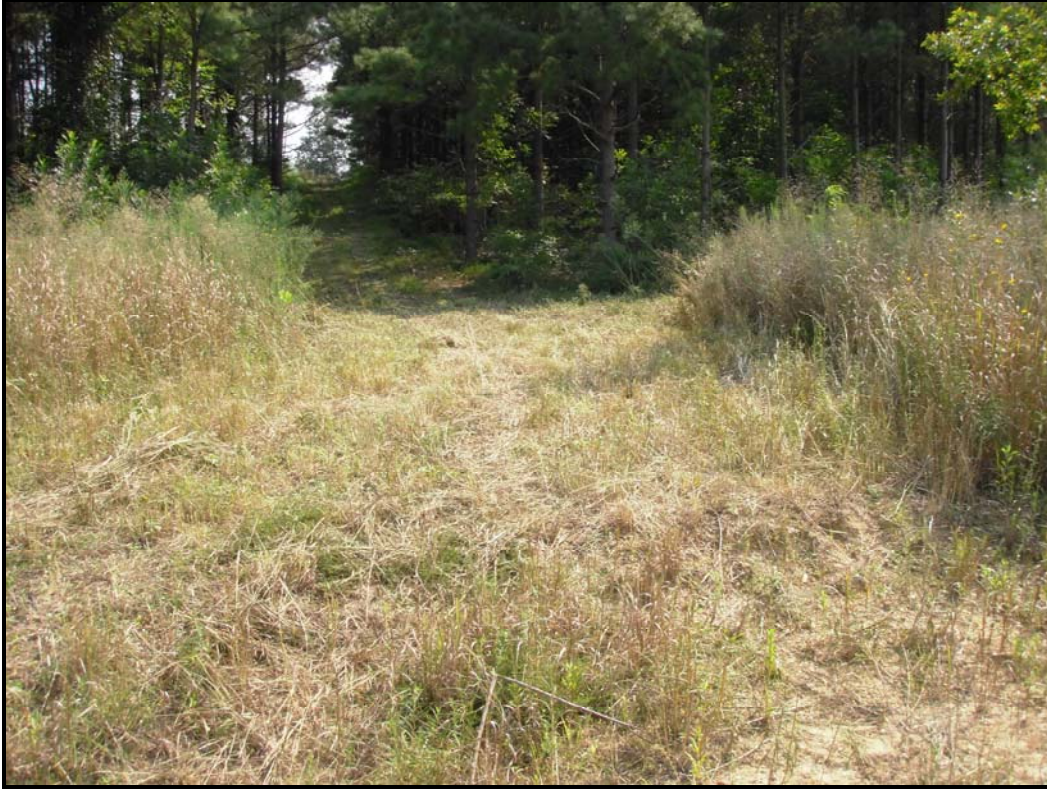
VPA1 and VPA2. Mowing encroachment observed in the buffer along UT 4 and UT 5.

In the 2011 monitoring year, six potential problem areas were observed. A number of areas were observed where farming activities have encroached on the buffer. The activities occurred along three tributaries, UT 4, UT 5, and UT 6, where the field is cultivated up to the easement boundary. Along UT 4 (VPA 1), mowing of four to ten feet into the buffer has occurred. Planted trees were obviously mowed leaving woody snags four to eight inches tall. Marker poles have been removed or knocked down by equipment in many places. Vegetation-monitoring plot VP 16 was directly impacted, resulting in the loss of two of the eleven live trees recorded last monitoring year. This area is approximately 500 feet in length. Along the right bank buffer of UT 5 (VPA 2), a ten-foot strip was mowed along the outside of the buffer and extended across UT 4. This area is approximately 1,100 feet in length. Along the left bank buffer of UT 6 (VPA 3), a ten-foot strip was impacted with herbicide spray, leaving most of the herbaceous vegetation killed back and planted trees partially defoliated or dead. This area is approximately 1,050 feet in length. These encroachment activities only appear to be occurring adjacent to cultivated fields. It is possible that other areas of encroachment are present or will be impacted in the future because much of the site was un-harvested soybean and corn at the time of the monitoring activity. Supplemental planting will be conducted in isolated areas of easement intrusion. The downstream half of the project site will be fertilized, and additional supplemental planting with three-gallon stock will be conducted as needed during the 2012-2013 planting season.

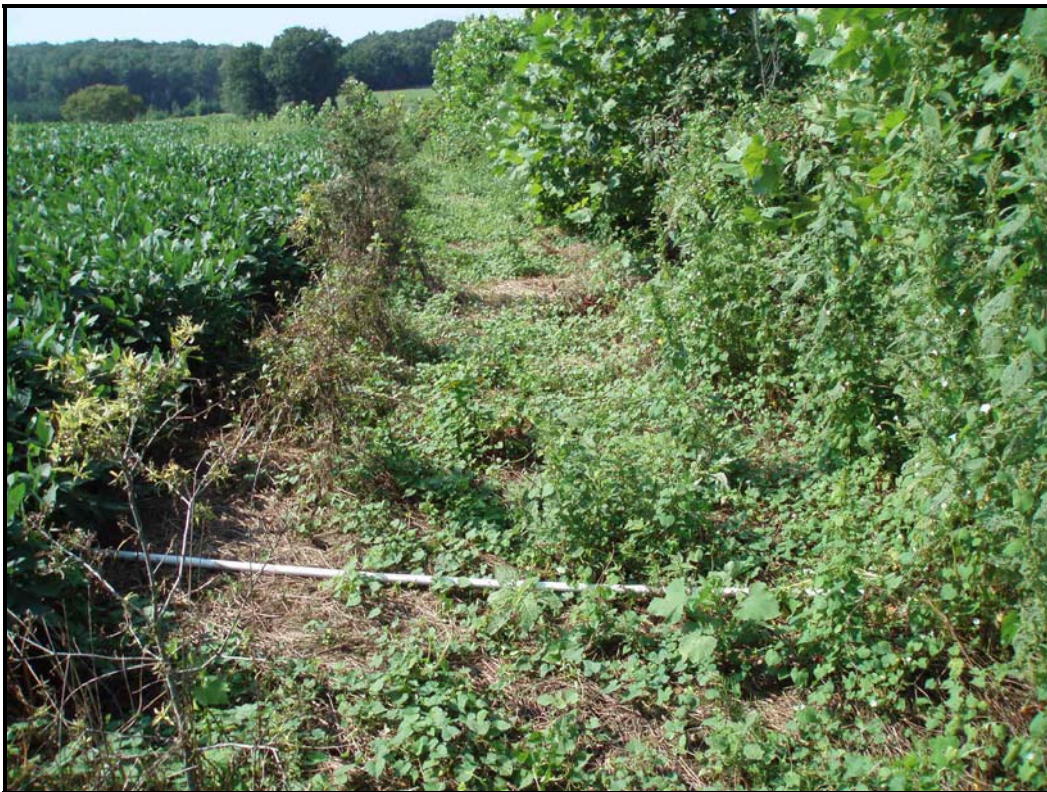
VPA3. Spraying with an agricultural herbicide in the buffer easement along UT 6.

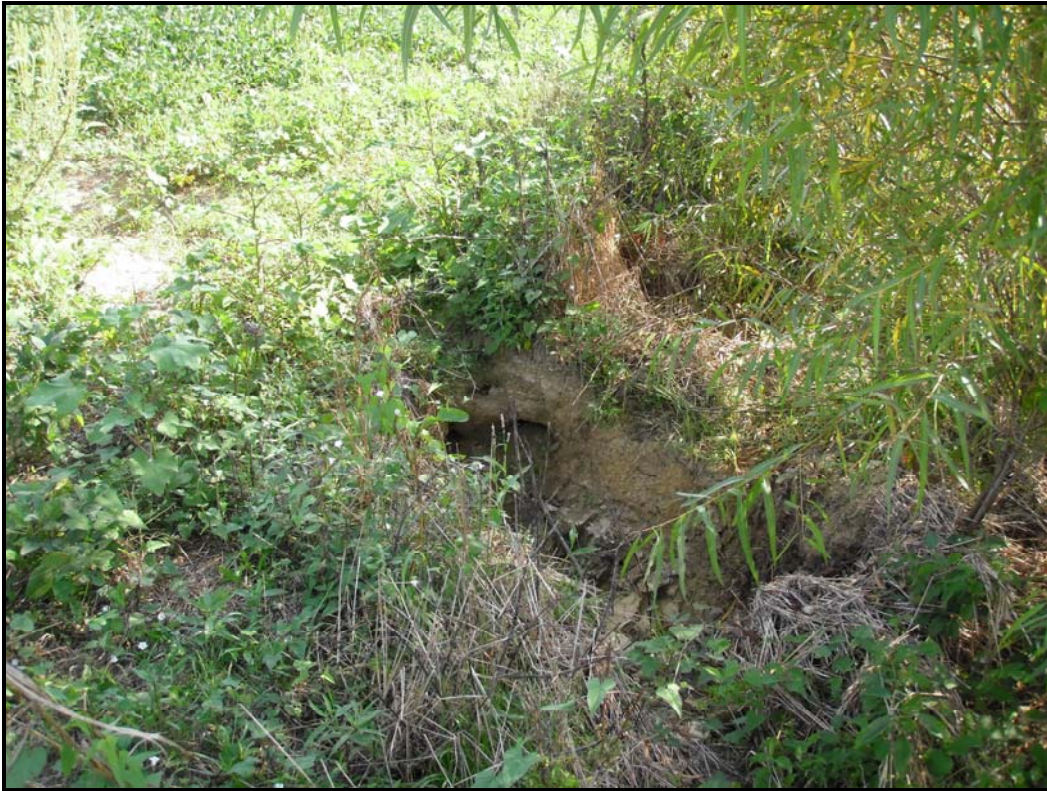
A small area of erosion was observed forming a headcut (VPA 4) below a swale above the vernal pool along UT 7 (near Station 704+50). It has formed at the edge of the cultivated field. It is likely to extend further into the cultivated field. It is recommended that this headcut be stabilized.

VPA4. Minor erosion forming a headcut at cultivated field edge and buffer.

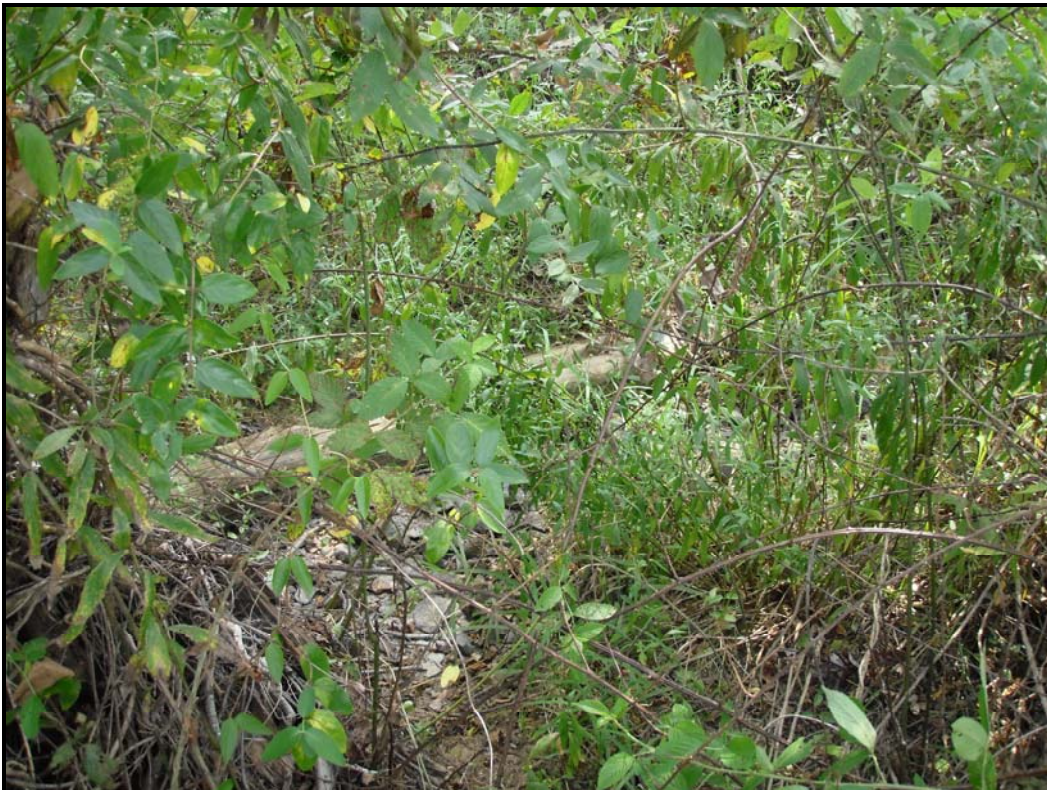
The invasive Chinese privet was observed to be common or present along portions of UT 4 and UT 7. Along portions of UT 4, Chinese privet was observed to be common (VPA 5) with areas downstream where it was observed to be present. It is also present along UT 7 (VPA 6). EBX will initiate invasive species control measures in February 2012, and will continue treatment until the end of the Year 4 monitoring period.

VPA 5 & VPA6. Invasive species present and common along UT4 and UT7.

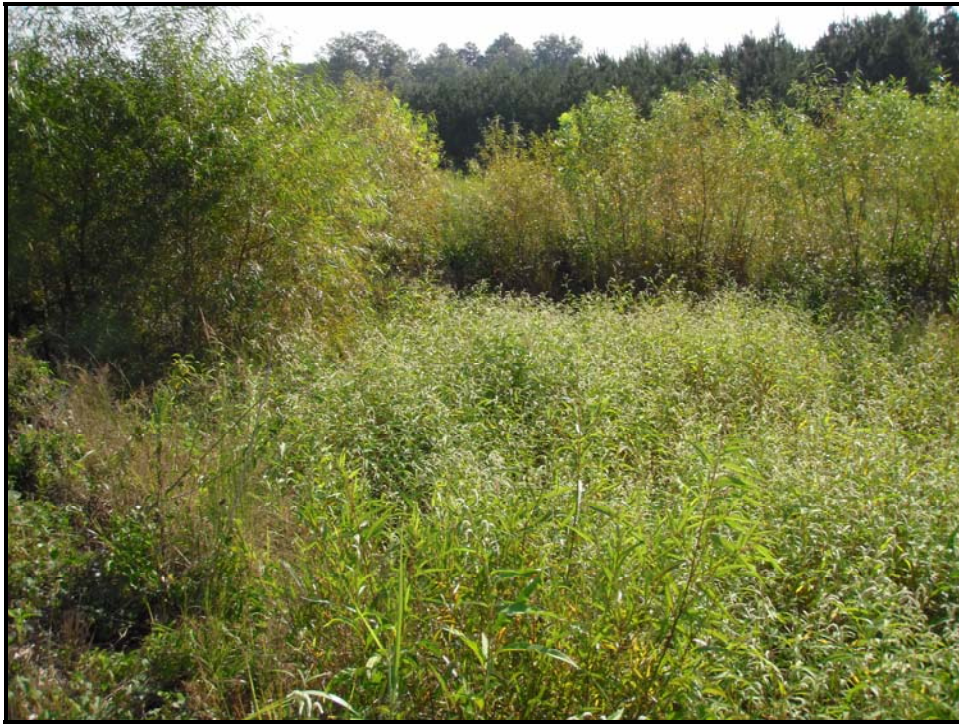
Stream Photo # 29 Vernal Pool on Right Bank at Sta. 704+50

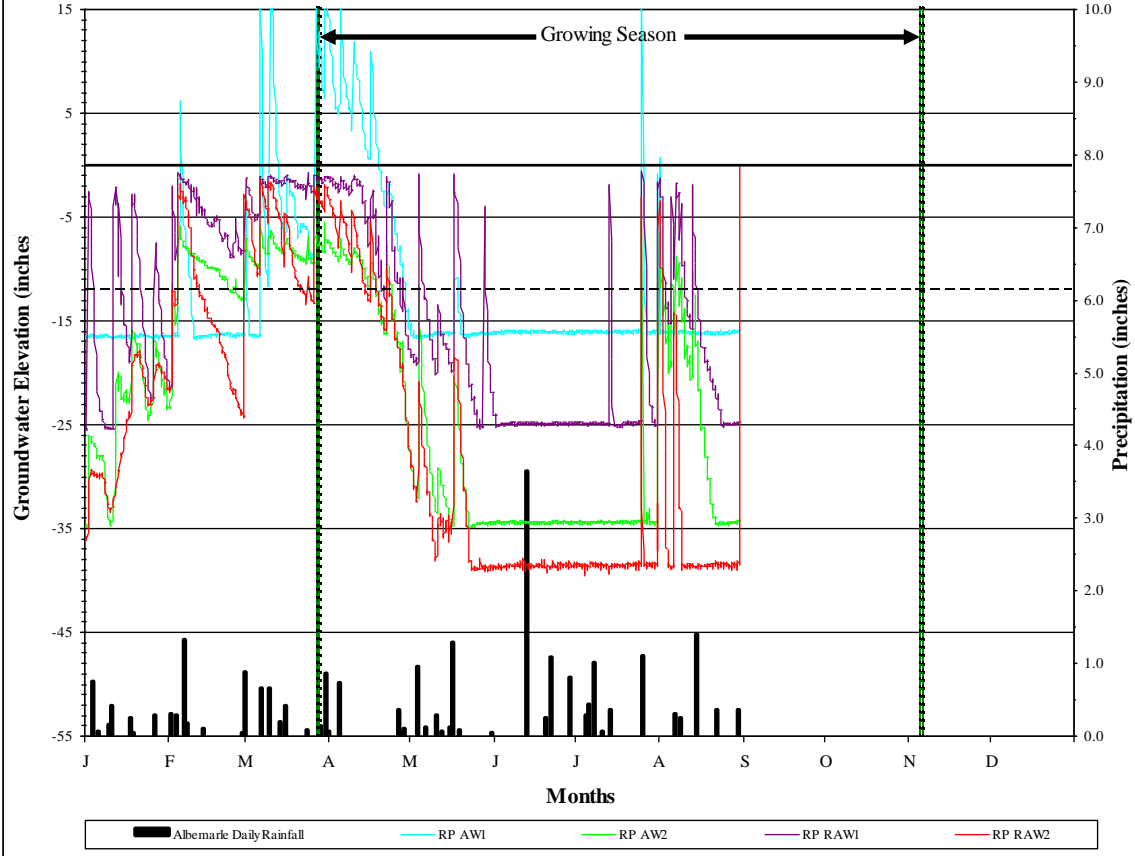
2011 Rockwell Pastures Groundwater Gauges

In 2011, AW1 and AW2 hydrology monitoring gauges recorded hydroperiods of 15 and 10 percent of the growing season, well above the success criteria of 7 percent of the growing season specified in the Restoration Plan. The two monitoring gauges at the reference site recorded hydroperiods from 8 to 11 percent of the growing season. Overall, the site was within the range of hydrologic conditions expected in undisturbed non-riparian wetland seeps.
