**Rockwell Pastures Site
Stanly County, North Carolina
Year 5 Annual Monitoring Report
Monitoring Year 2013**

**Monitoring Year: 2013
Measurement Year 5
As-Built Date: 2009
NCEEP Project ID Number D-000624**

**ROCKWELL PASTURES SITE
2013 ANNUAL MONITORING REPORT**

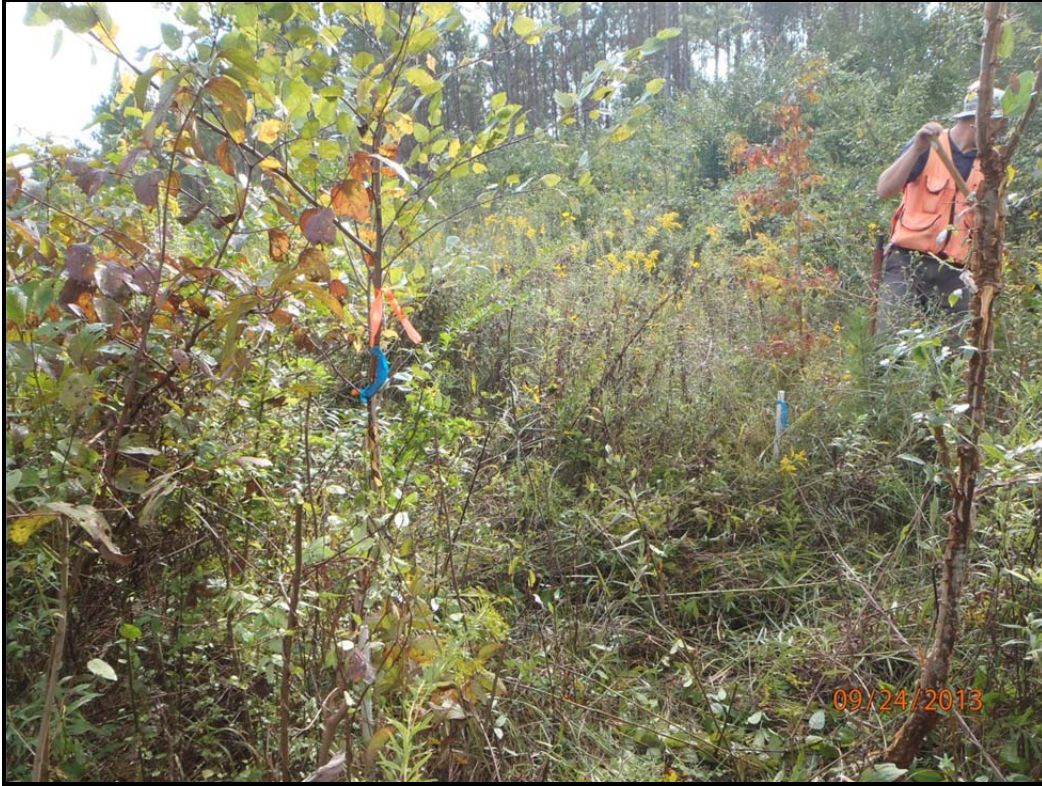
One vegetation problem area was noted during Monitoring Year 4. Invasive Chinese privet was observed along portions of UT 4 and UT 7. This problem area has continued to be observed during Monitoring Year 5; however, the invasive species pose no threat to achieving the vegetation success criteria. The Rockwell Pastures Site has met the final vegetative success criteria as specified in the Restoration Plan.

VPA1. Invasive species present, but not common, along UT4.

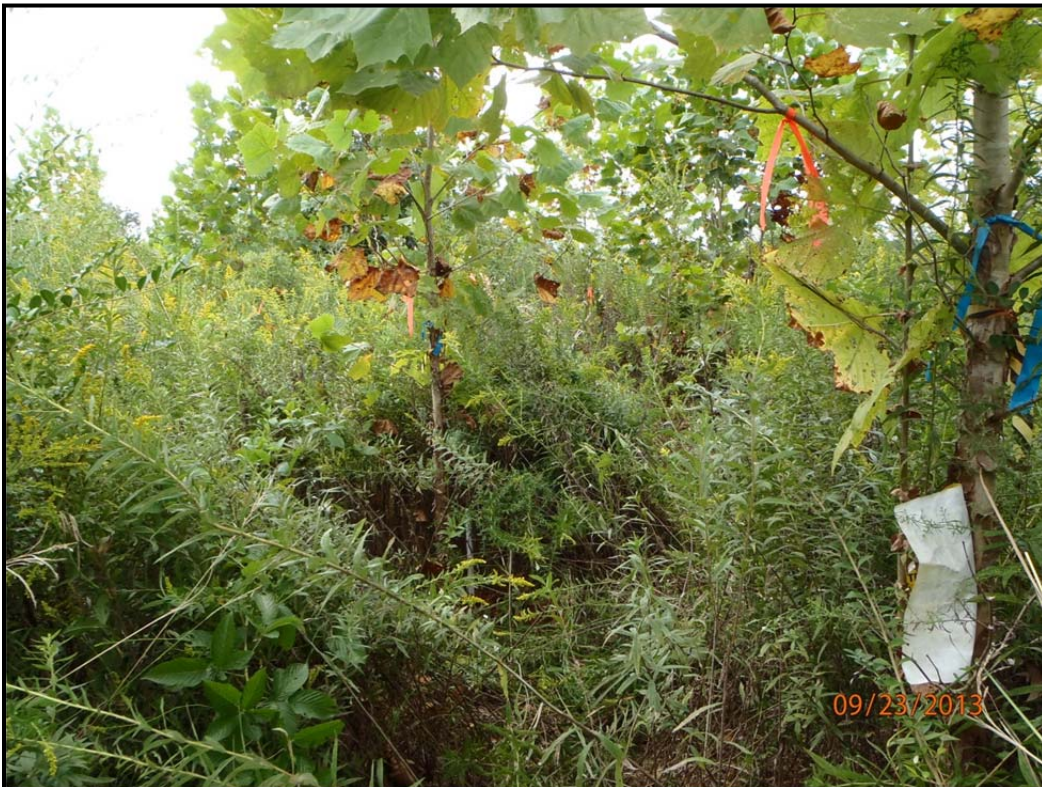
VPA2. Invasive species present and common along UT7.

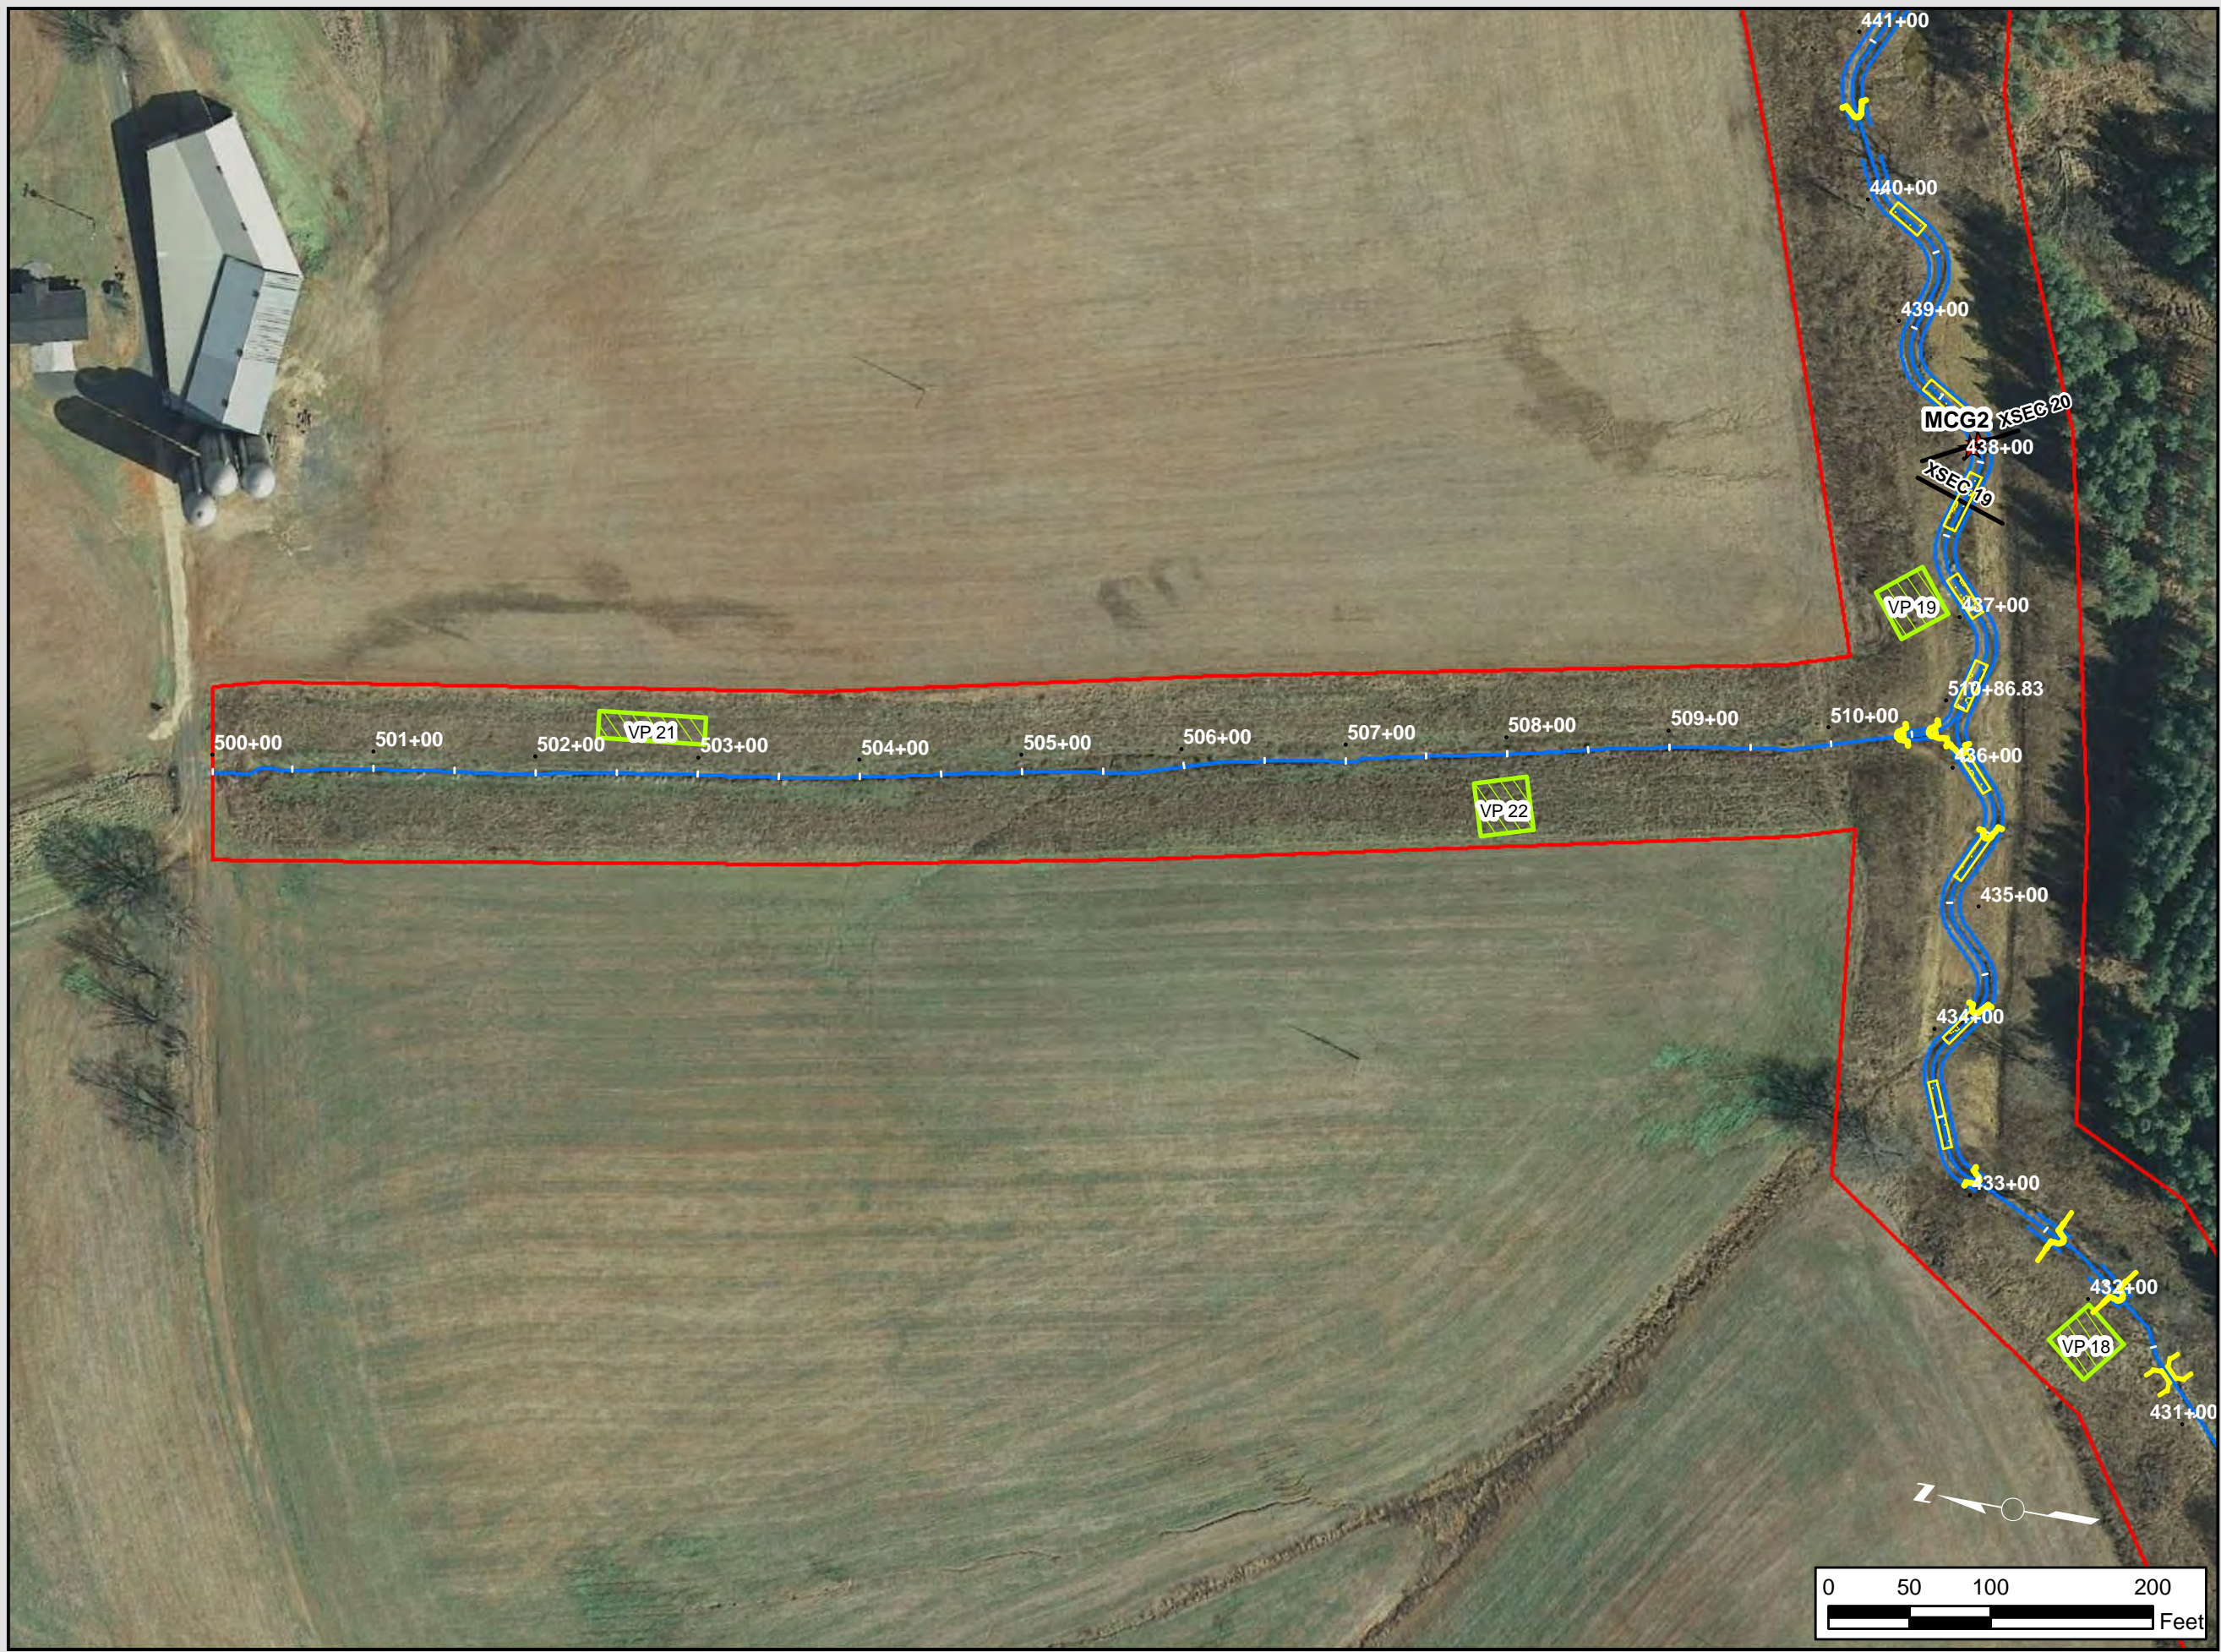
Figure B-11.
 Rockwell Pastures Site
 Current Conditions Map
 Reach: UT 6 / UT 7
 Stanly County, NC

Target Community		
		Present	Marginal	Absent
Invasive Species	Absent	No Fill		
	Present			
	Common

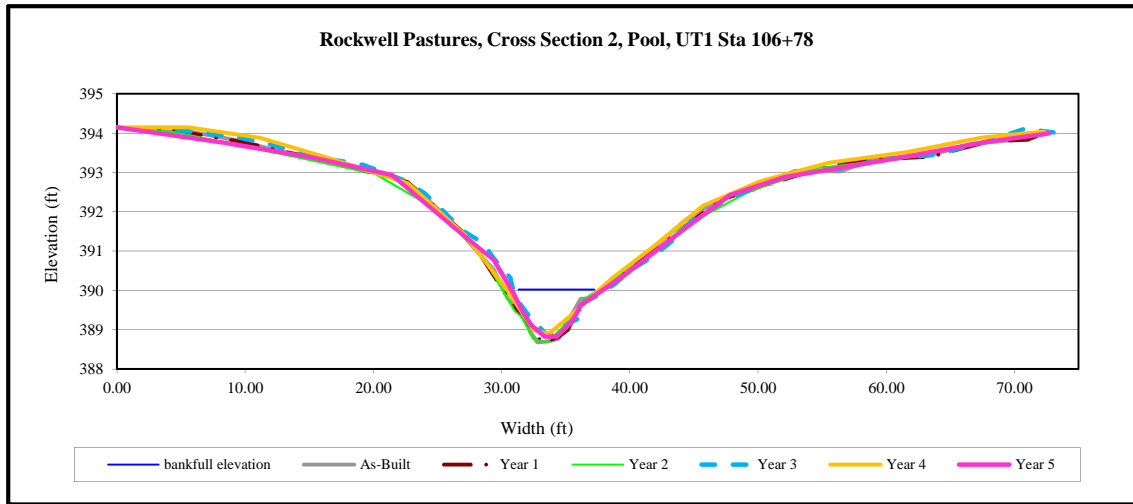
Reach ID	UT 1
Cross Sectional Area	4.9
Bankfull Width	7.1
Mean Depth	0.7
Wetted Perimeter	7.5
Hydraulic Radius	0.7
Width:Depth Ratio	10.1

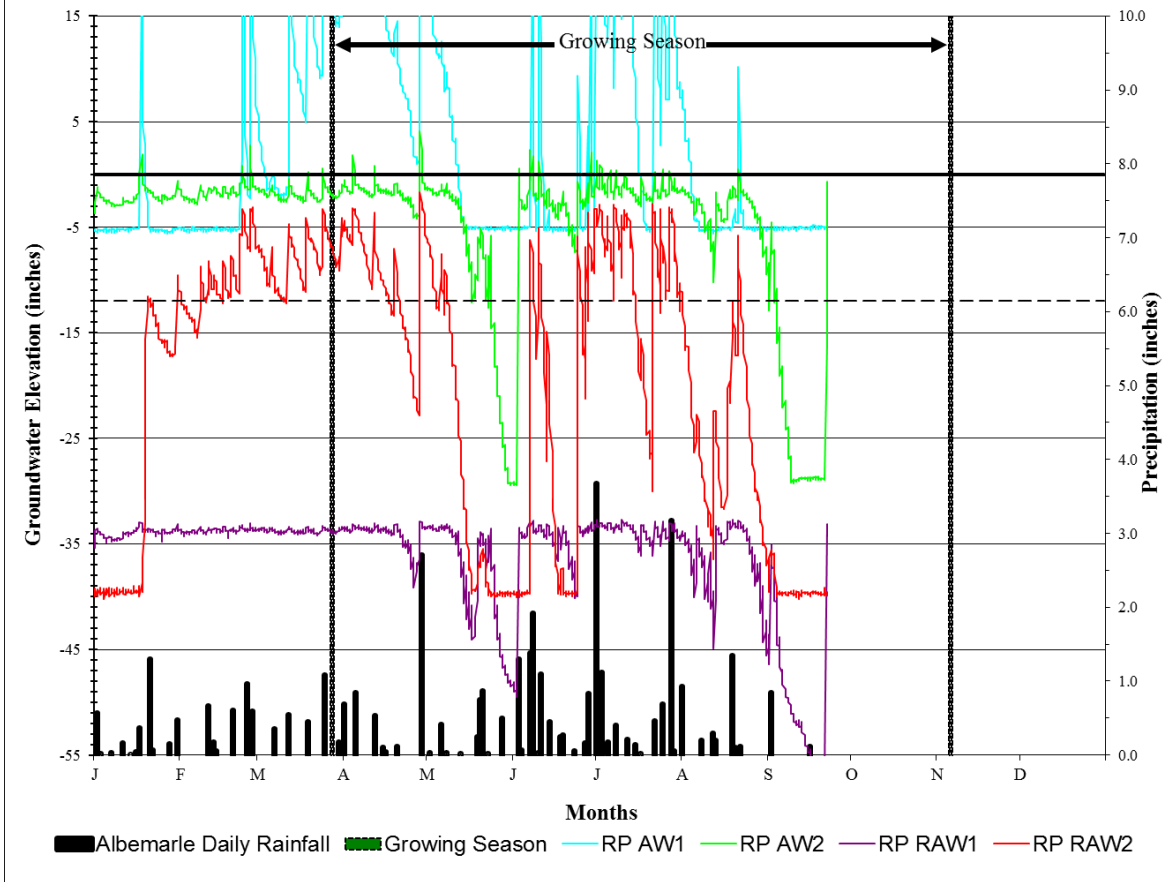
2013 Rockwell Pastures Groundwater Gauges

In 2013, AW1 and AW2 hydrology monitoring gauges recorded hydroperiods of 82 and 41 percent of the growing season, respectively, meeting the success criteria of seven percent of the growing season specified in the Restoration Plan. Overall, the site was within the range of hydrologic conditions expected in non-riparian wetland seeps.
