# Rocky Branch Stream Restoration

2010 Year 3 Monitoring Report - Final

EEP Project Number: 308

## CONSOLIDATED CURRENT CONDITIONS PLAN VIEW - YEAR THREE MONITORING

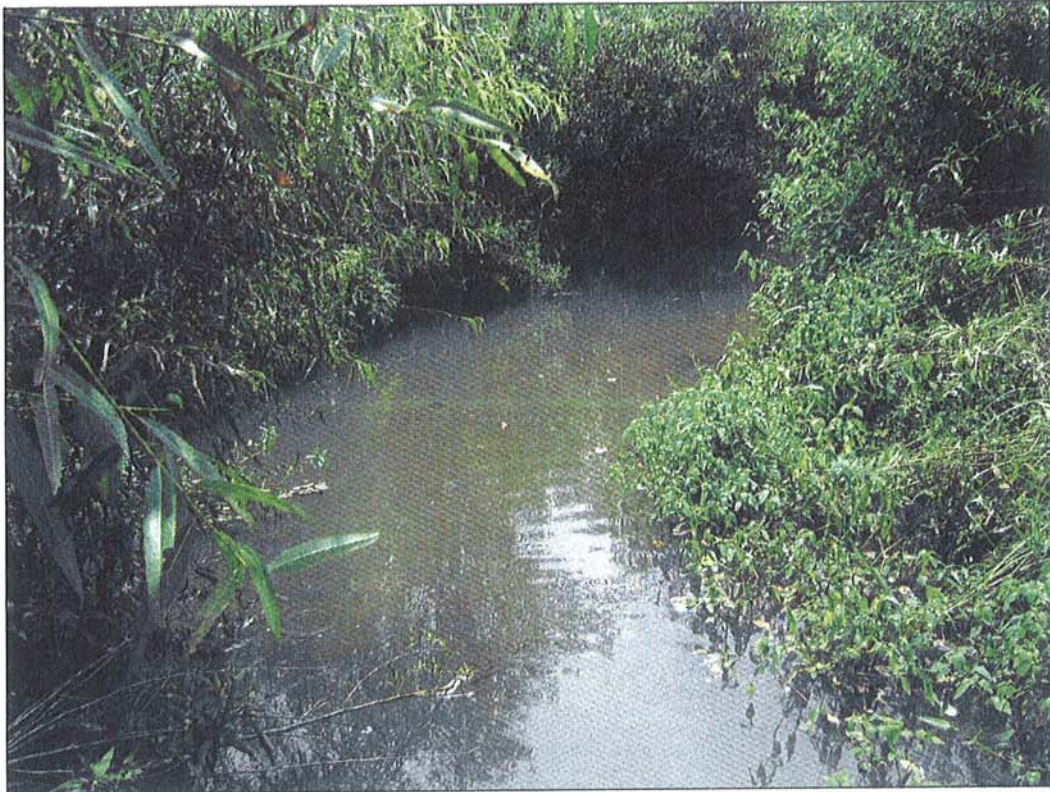
CROSS SECTION 1 - POOL. (ROCKY BRANCH, STA 4 + 25) VIEW LOOKING DOWNSTREAM.

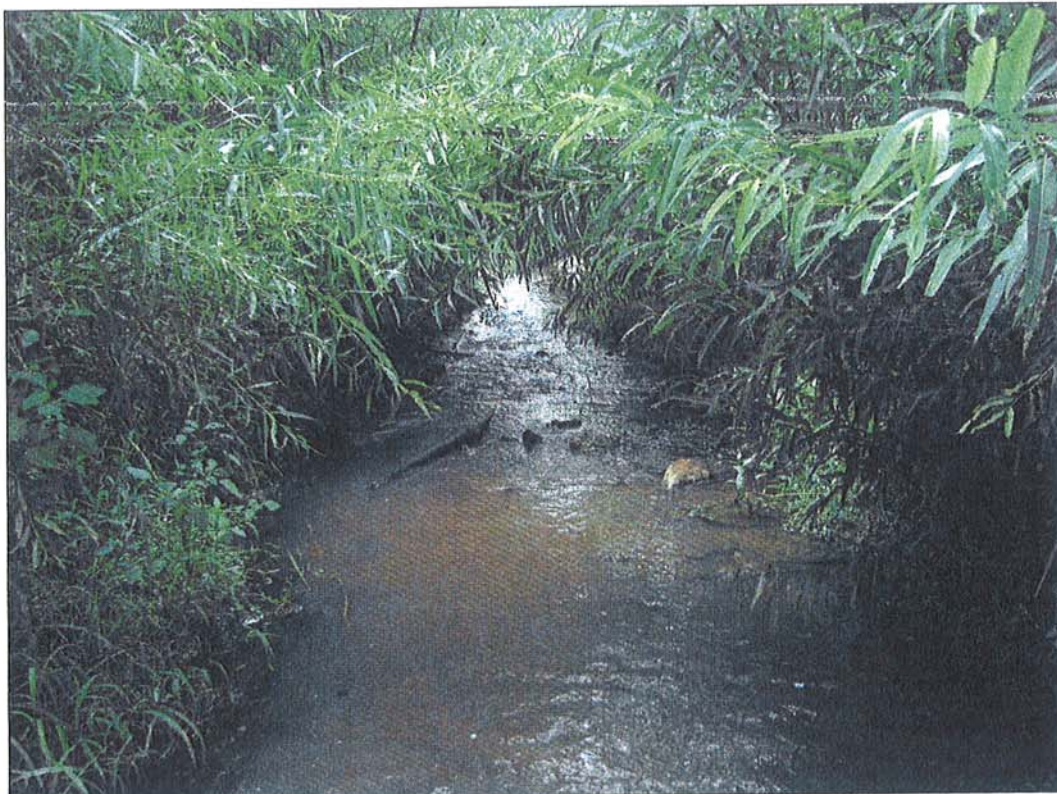
CROSS SECTION 2 - RIFFLE. (ROCKY BRANCH, STA 9 + 22) VIEW LOOKING DOWNSTREAM.

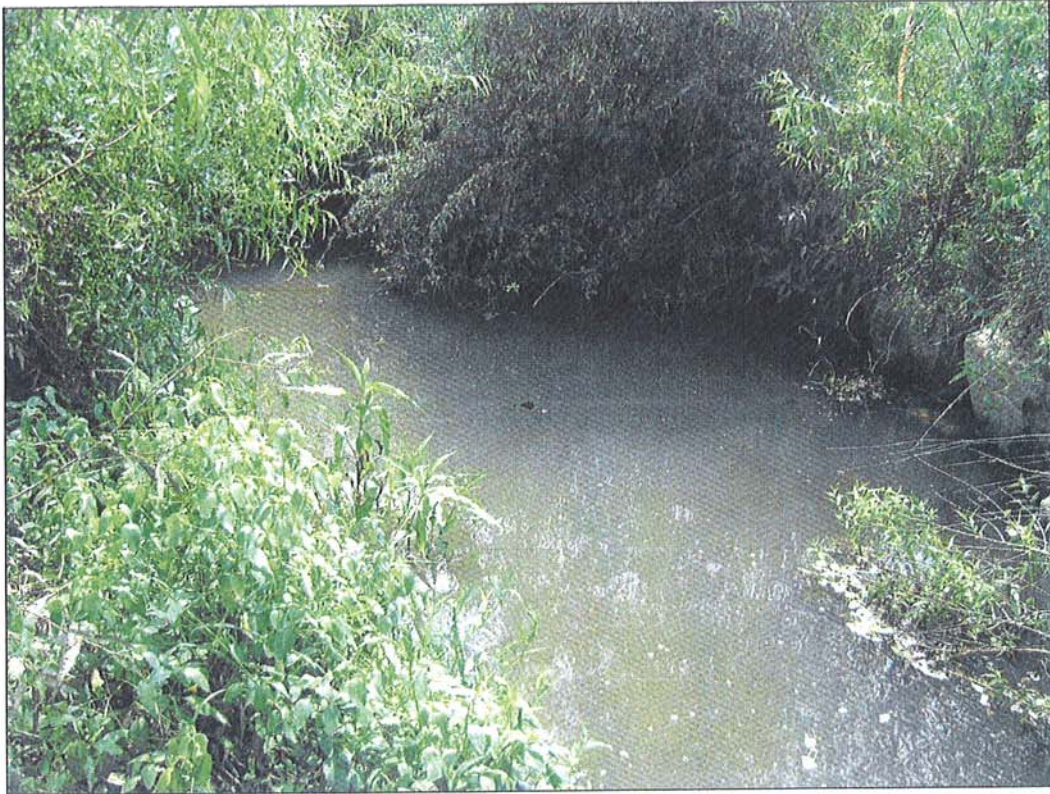
CROSS SECTION 3 - POOL. (ROCKY BRANCH, STA 13 + 25) VIEW LOOKING DOWNSTREAM.

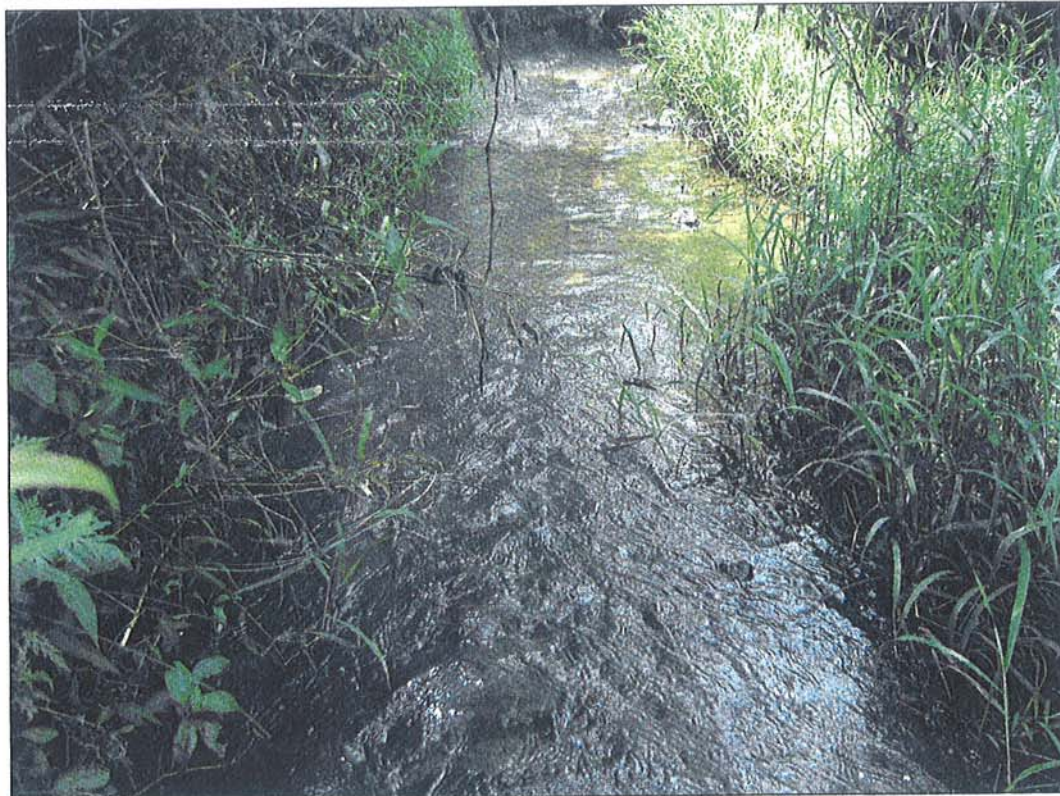
CROSS SECTION 4 - RIFFLE. (ROCKY BRANCH, STA 17 + 49) VIEW LOOKING DOWNSTREAM.

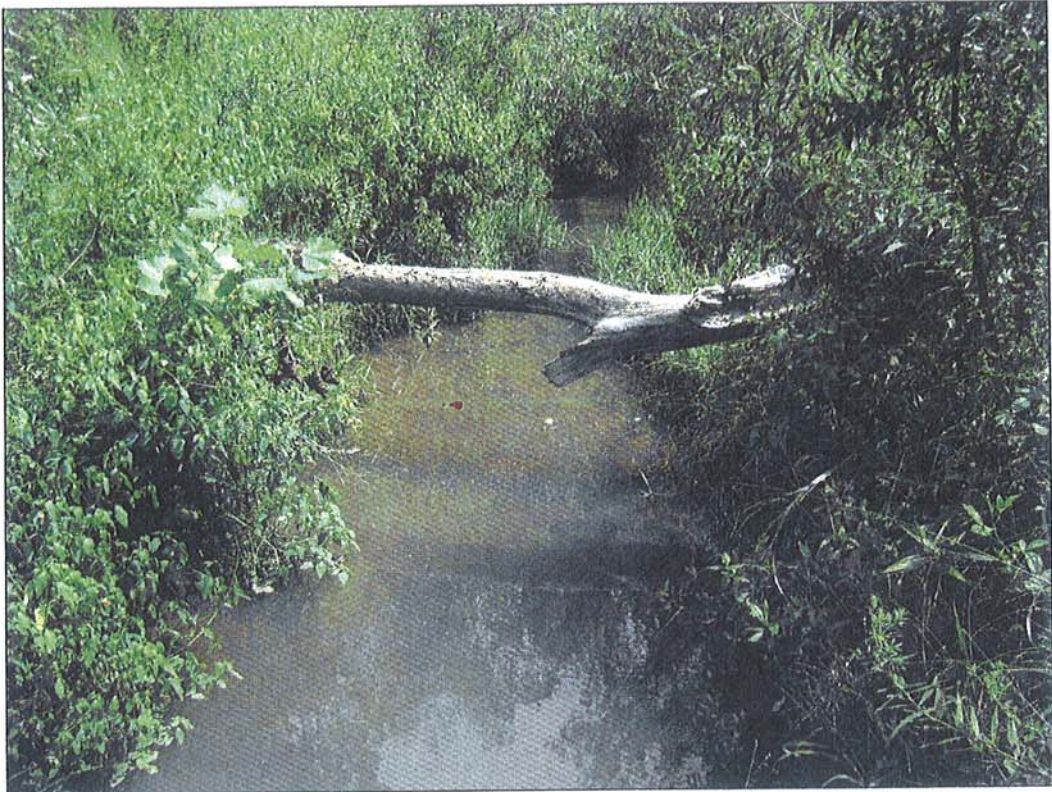
CROSS SECTION 5 - POOL. (ROCKY BRANCH, STA 22 + 32) VIEW LOOKING DOWNSTREAM.

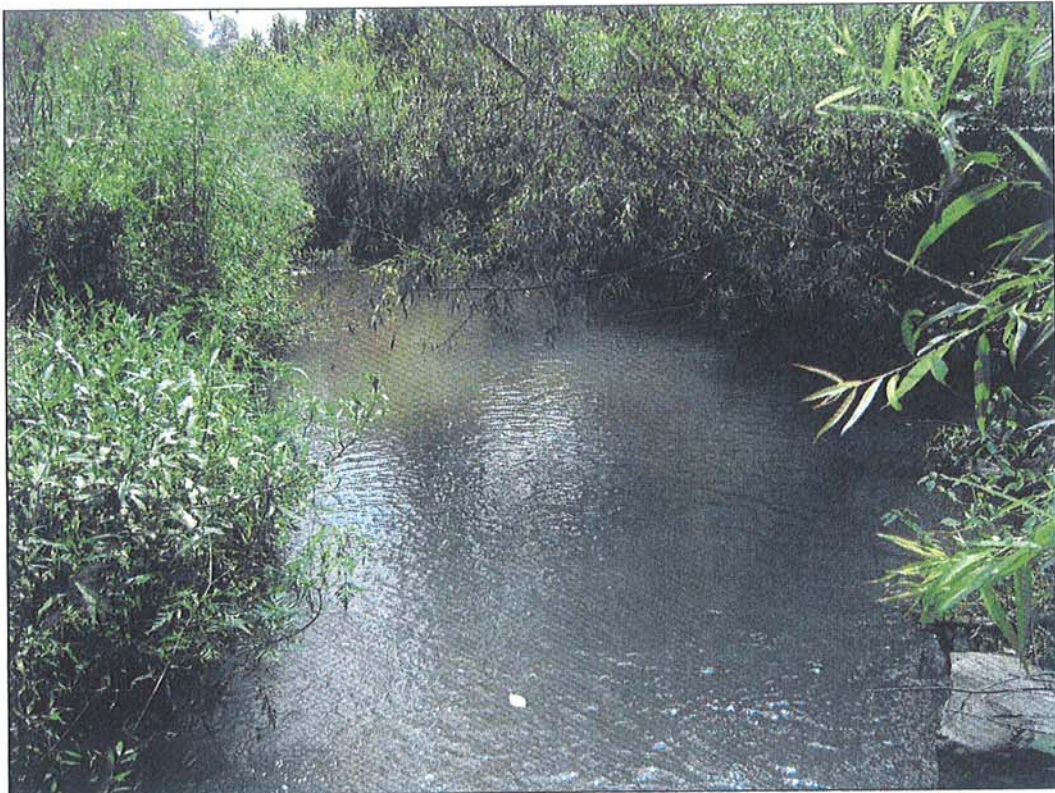
CROSS SECTION 6 - RIFFLE. (ROCKY BRANCH, STA 26 + 22) VIEW LOOKING DOWNSTREAM.

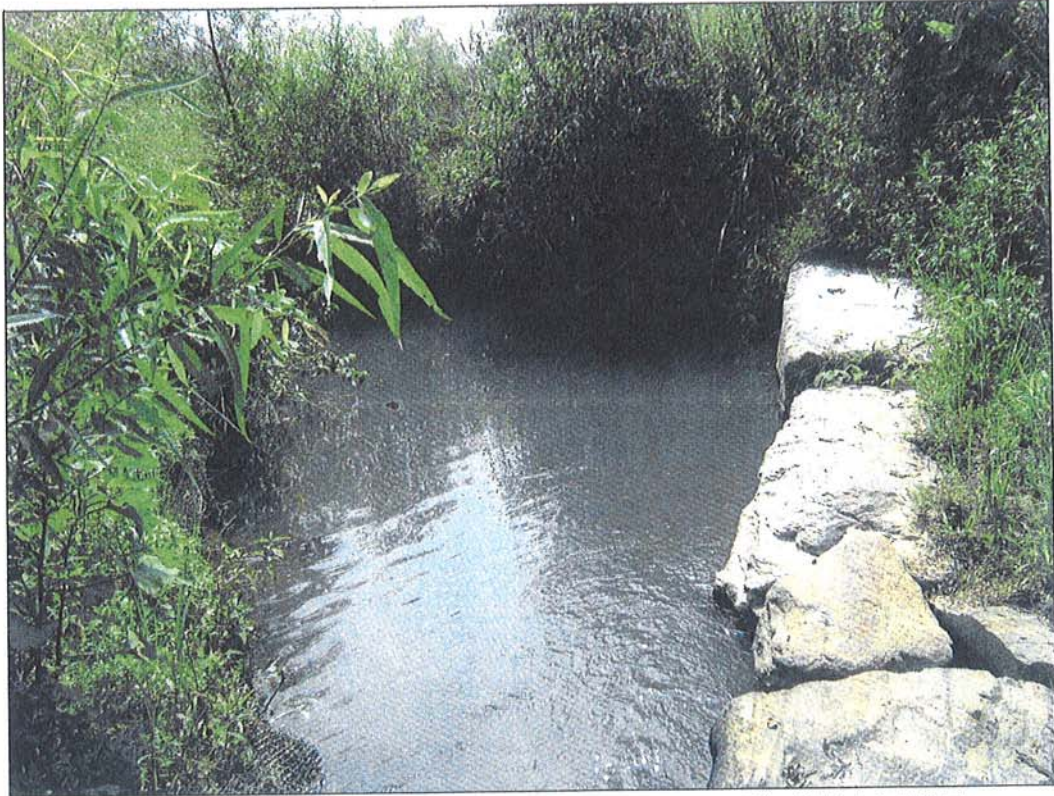
CROSS SECTION 7 - RIFFLE. (ROCKY BRANCH, STA 30 + 75) VIEW LOOKING DOWNSTREAM.

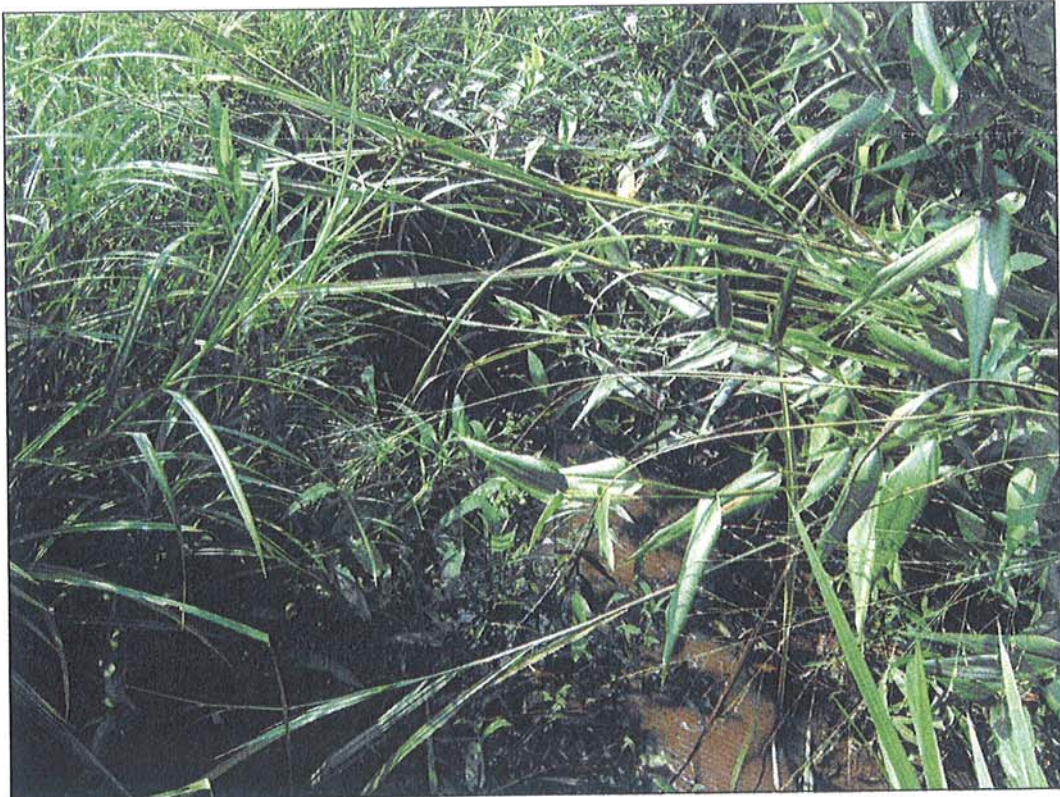
CROSS SECTION 8 - RIFFLE. (TRIBUTARY 1, STA 0 + 75) VIEW LOOKING DOWNSTREAM.

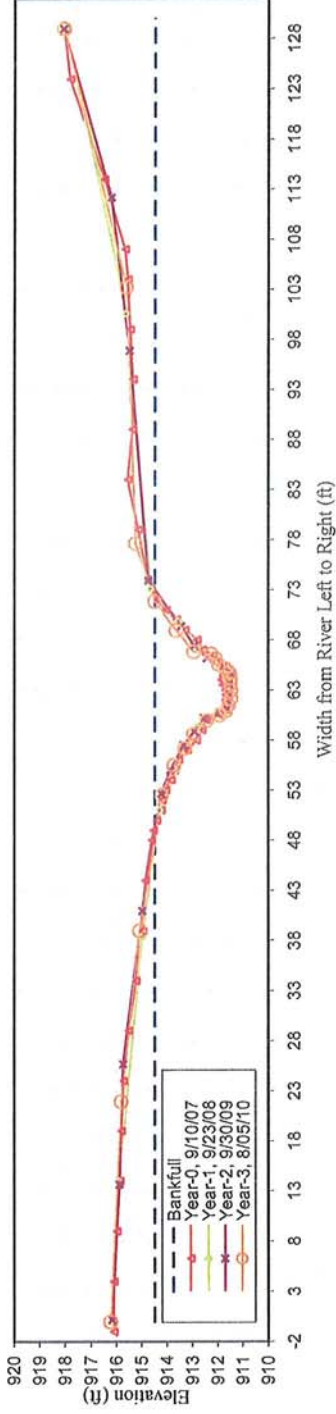
Rocky Branch Cross Section 7 - Riffle

CROSS SECTION PLOT - LOOKING DOWNSTREAM

Bankfull X-sec area	31.0	sq. ft.
Bankfull Width	23.7	ft.
Bankfull Mean Depth	1.3	ft.
Bankfull Max Depth	3.0	ft.
Width/Depth Ratio	>12	
Entrenchment Ratio	>2.2	
Classification	C	
Bank Height Ratio	1.0	
Bankfull Elevation:	914.49	ft.

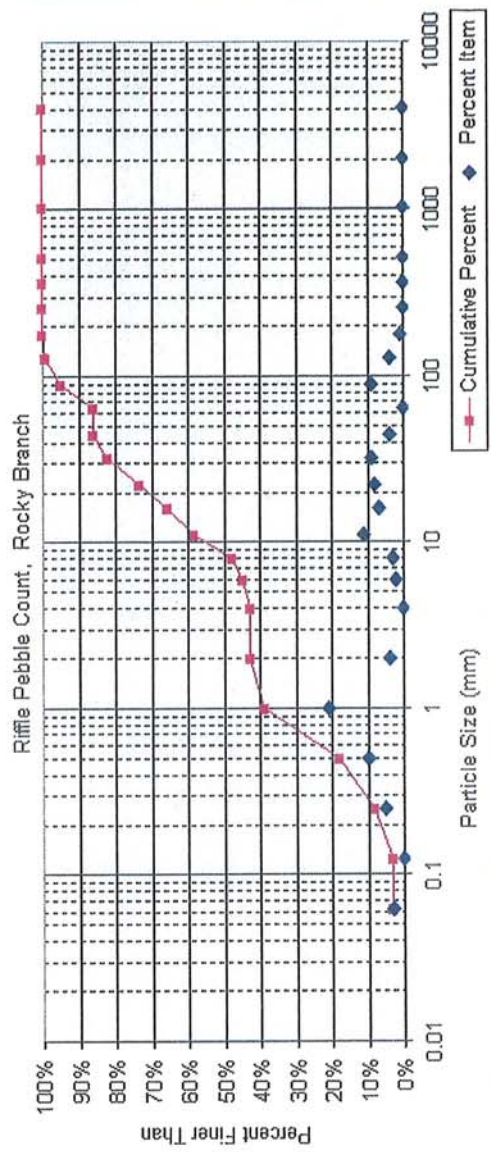
Rocky Branch  
 8/2/2010

Size percent less than (mm)		Percent by substrate type			
D16	D35	D50	D84	D95	bedrock
0.440	0.89	8.6	37	90	0%
					bedrock
					boulder
					0%
					cobble
					14%
					gravel
					44%
					sand
					40%
					silt/clay
					3%
