Roquist Wetland Restoration Monitoring Report

**EEP Project # 312
EEP Contract # 004476
Monitoring Year – 05**

**Construction Completed: 2008
Data Collection: August 2012
Submitted: January 2013**

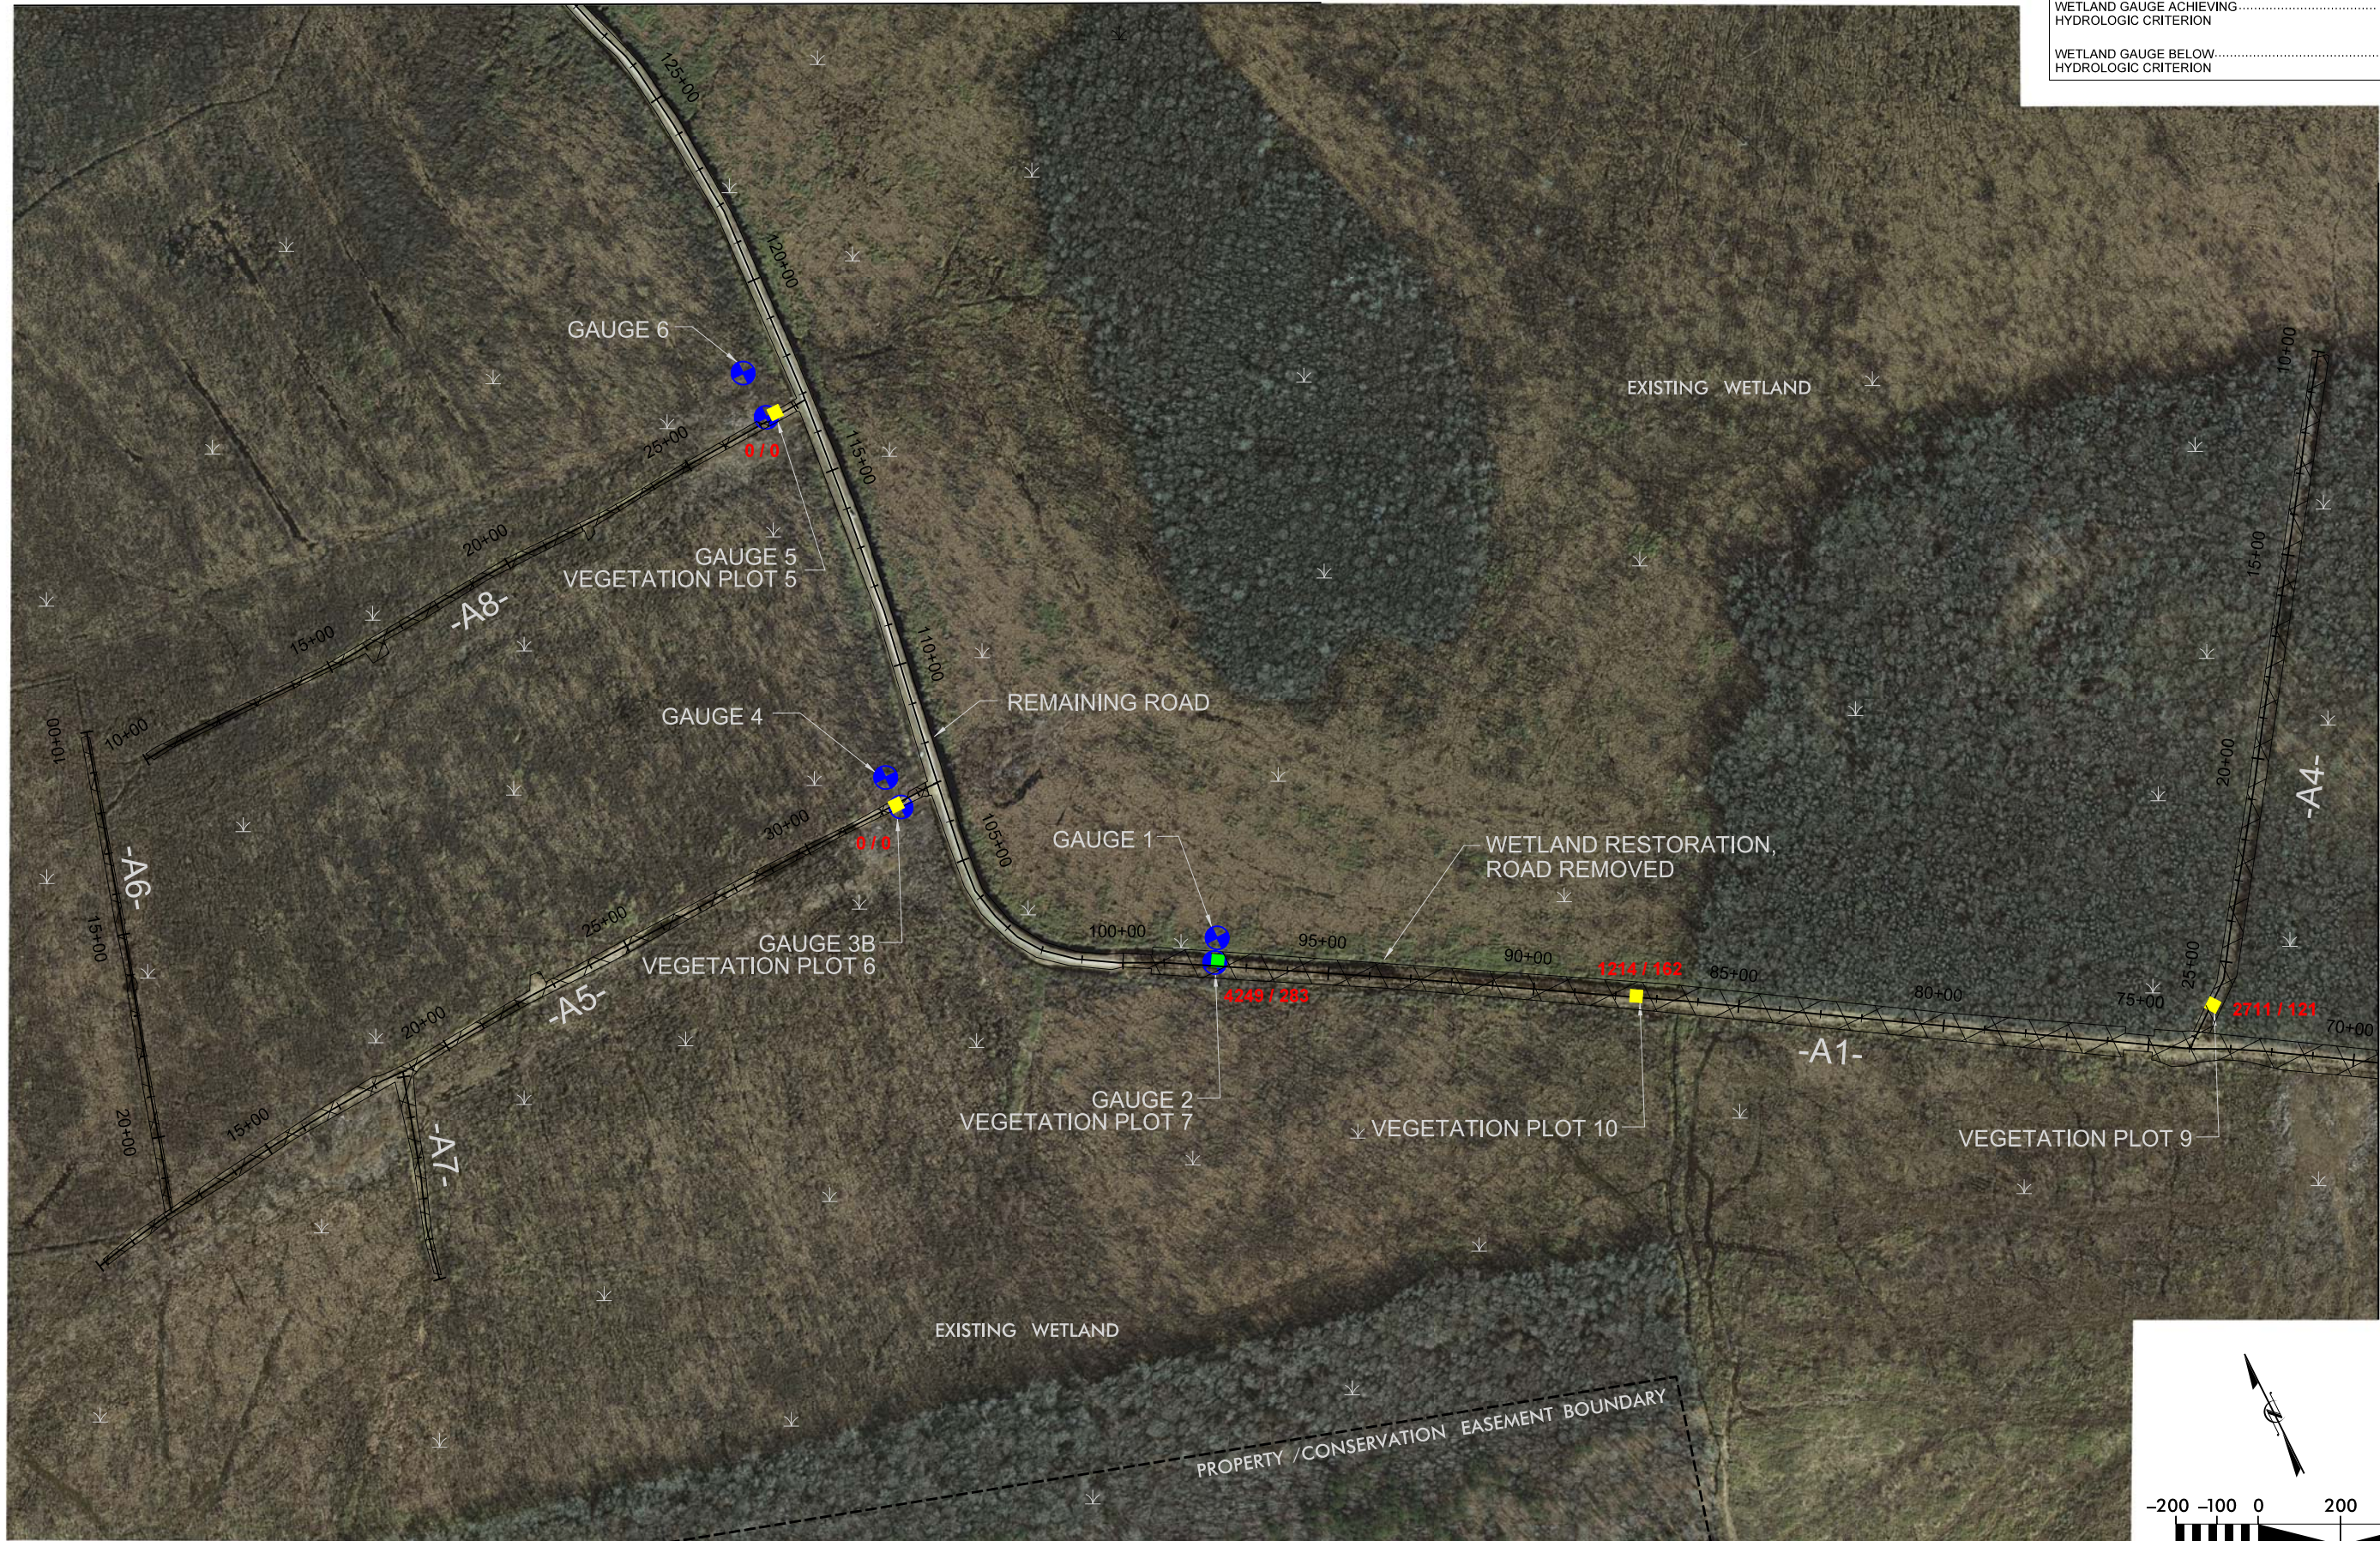
DATE: NOV 2012
SCALE: 1" = 400'
CURRENT CONDITION PLAN VIEW
SHEET 2 OF 5

VEG PLOT TOTAL / PLANTED STEM DENSITY..... **890/423**

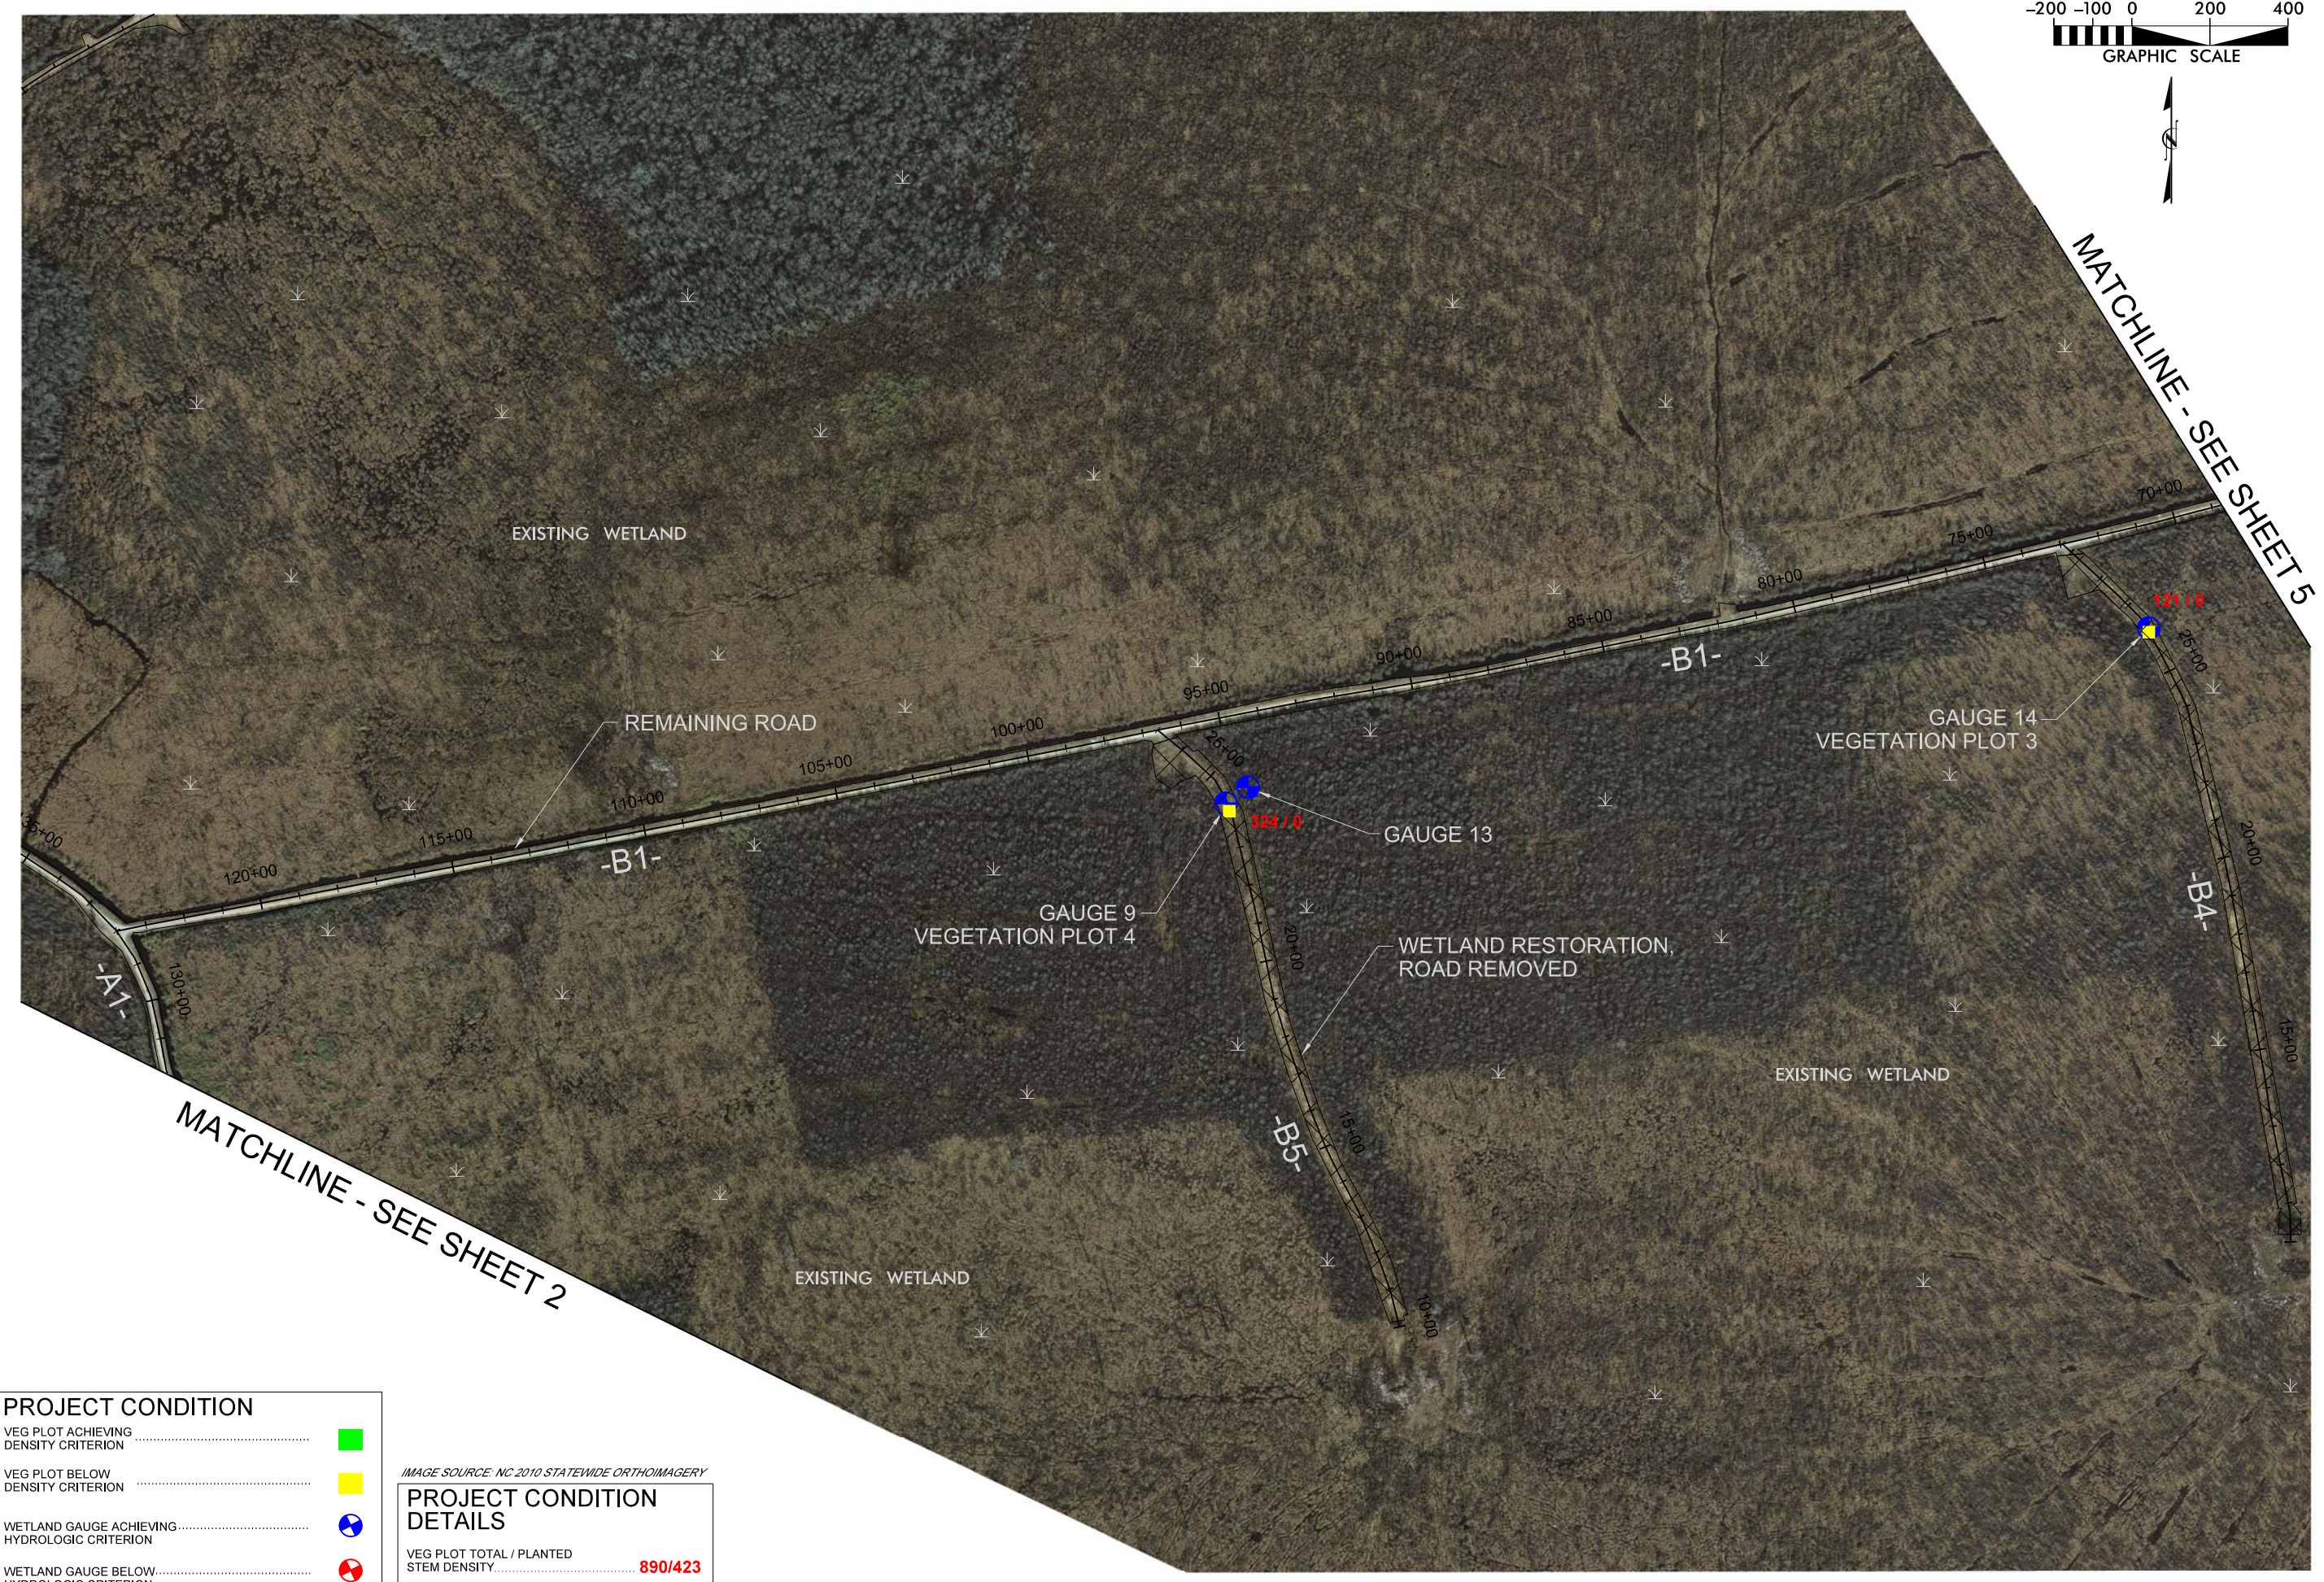
DATE: NOV 2012
 SCALE: 1"= 400'
 CURRENT CONDITION
 PLAN VIEW
 SHEET 4 OF 5

IMAGE SOURCE: NC 2010 STATEWIDE ORTHOIMAGERY
PROJECT CONDITION DETAILS
 VEG PLOT TOTAL / PLANTED STEM DENSITY: **890/423**
