MITIGATION PLAN

ROSES CREEK STREAM MITIGATION SITE

Burke County, North Carolina
NCDMS Project No. 96309

Catawba River Basin
Cataloging Unit 03050101

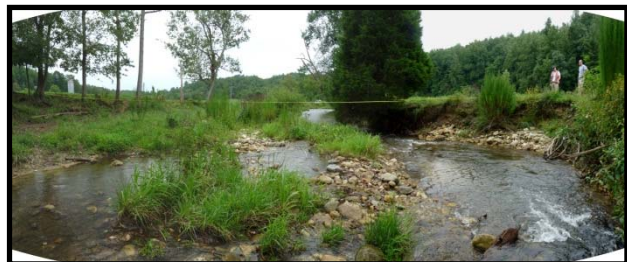
F-Channel Section

Cross-section 4 is classified as an F4 type channel with a width-to-depth ratio of 73.6 and entrenchment ratio of 1.37. This cross-section is typical of several reaches through the Site which appear to be actively morphing, due to substantial over widening. Much of this is attributed to the lack of deeply rooted vegetation along the channel banks and hoof shear from cattle continually accessing the channel. The channel is in the process of widening to the point that flow has been split between a high bar in the channel on large flows, creating, and functioning similar to a braided system. Additionally, like other reaches described above, the channel has abandoned its floodplain as evidenced by a bank-height ratio of 2.0.

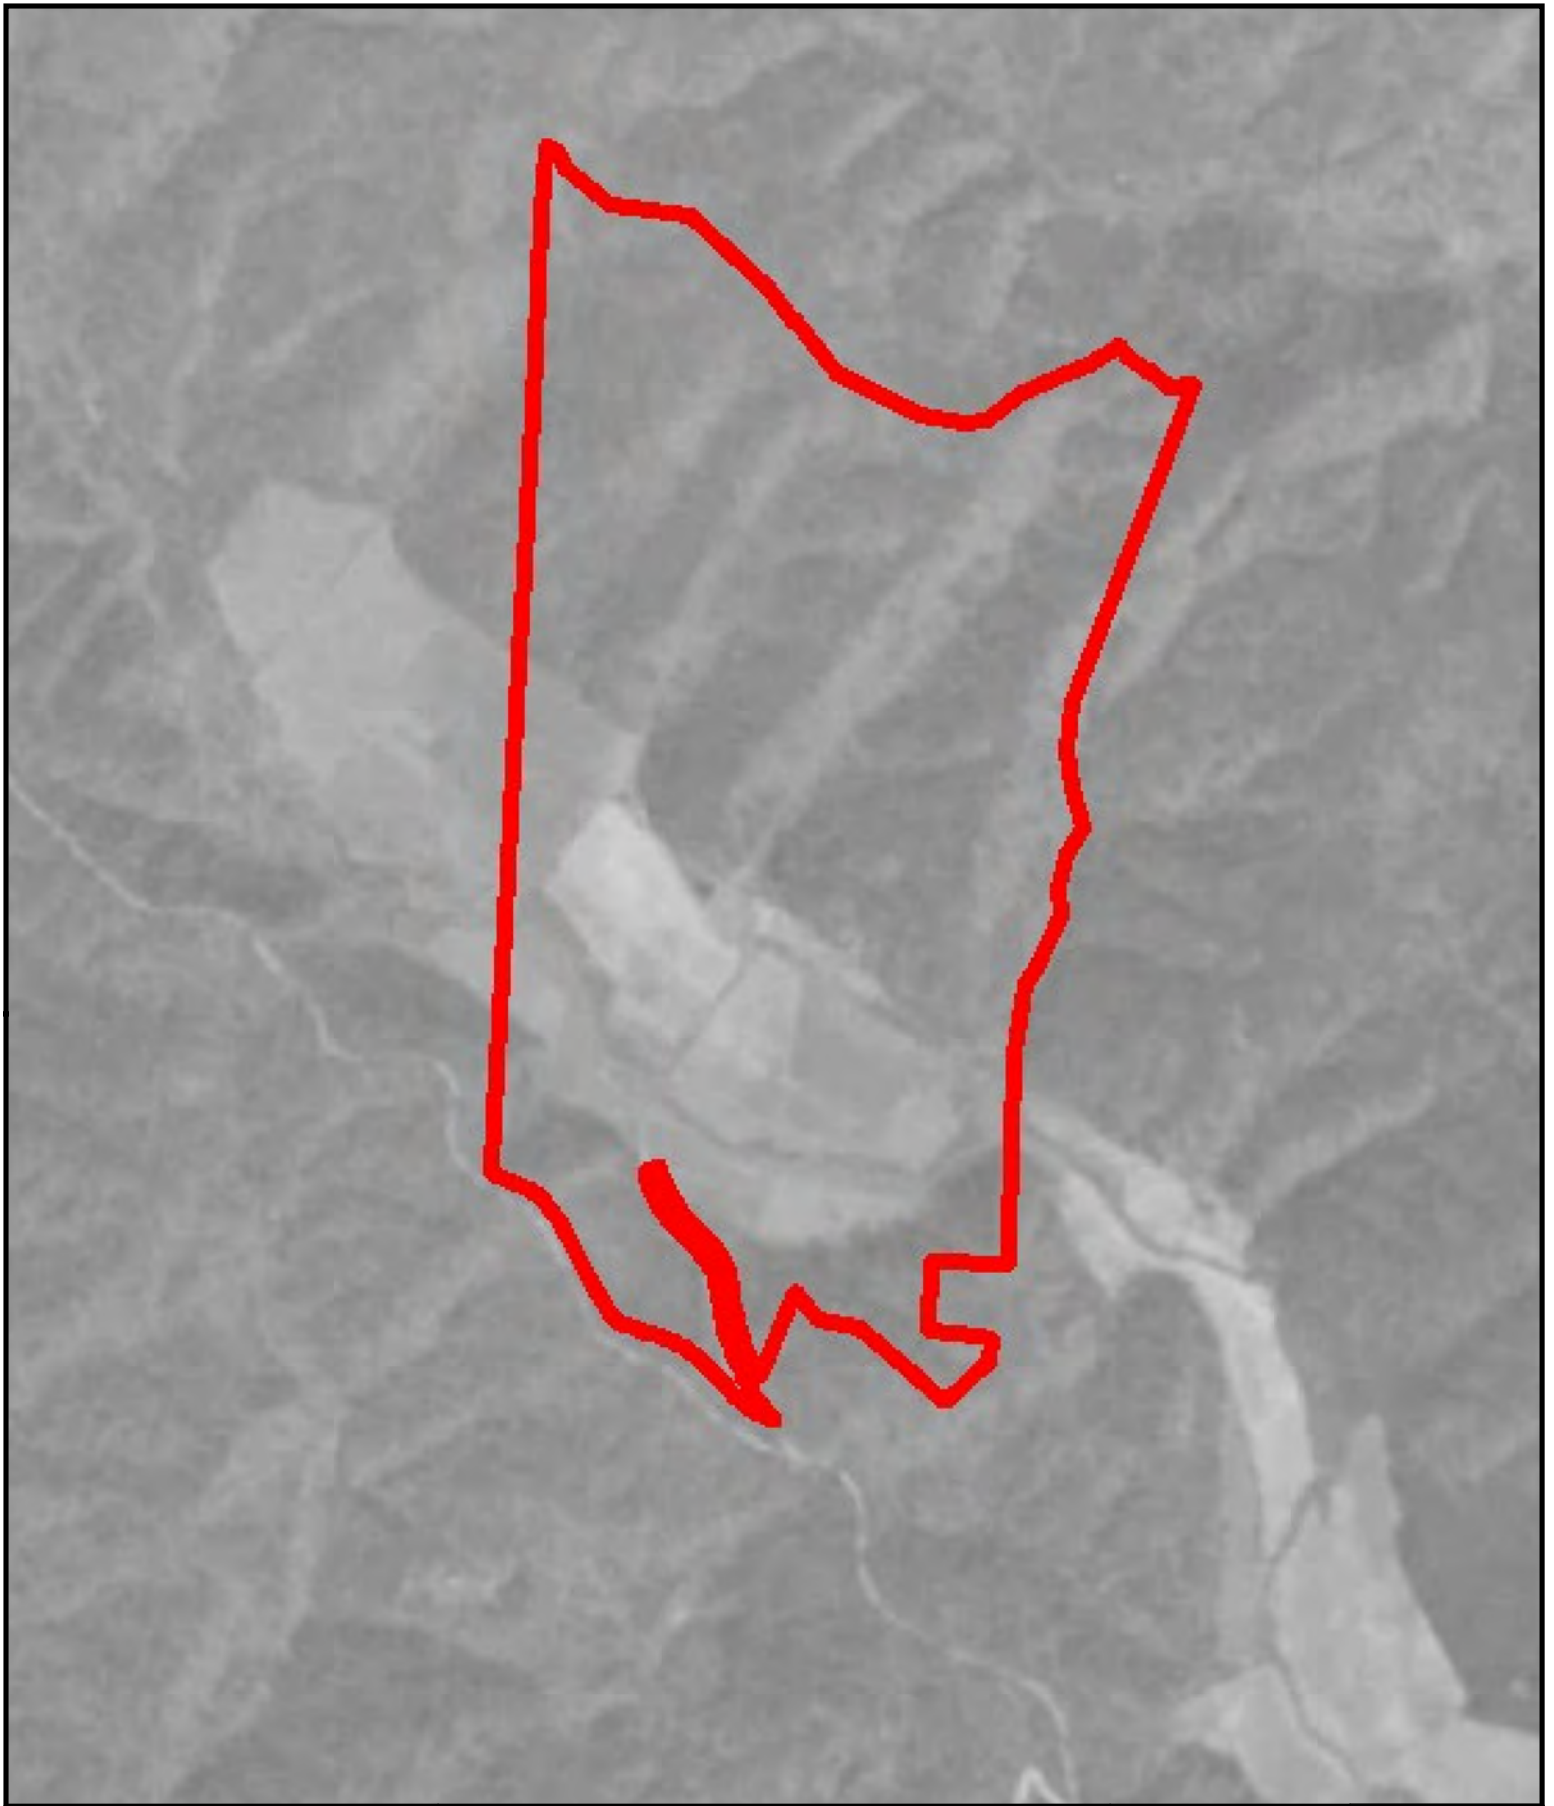
Historic Photo 1947

UT 1 and UT 2 appear to have been straightened in the 1947 historic aerial (Figure 6). It appears UT 3 had already been relocated to the toe of slope of a hill at the edge of the valley in the 1947 aerial photograph. This is evidenced by hay production in UT 3's natural valley location on the 1947 aerial photograph and because there are currently large mature trees on the berm adjacent to UT 3, which would indicate that the berm has been in place for a substantial amount of time. Roses Creek, UT 1 and UT 2 had very minimal buffer in 1947.
