# **Monitoring Year 3 Report 2022**

## **Rough Horn Swamp Restoration Site Monitoring Year – MY03**

## **Rough Horn Swamp II Restoration Site**

**Columbus County, North Carolina**

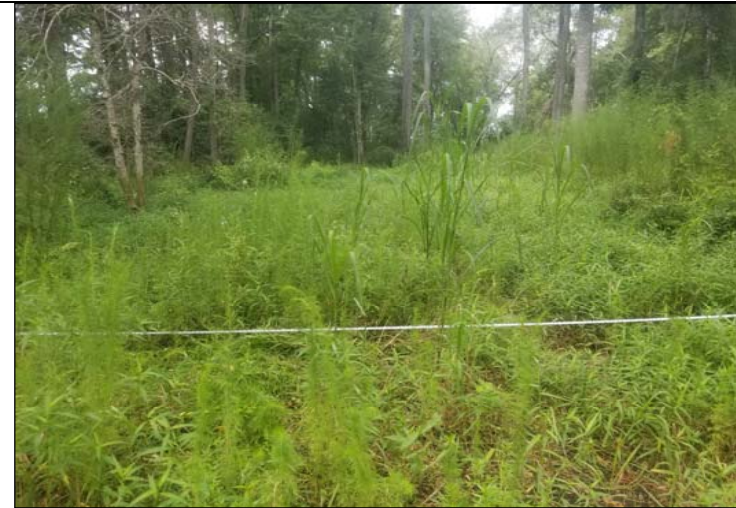
<b>River Basin:</b>	Lumber River
<b>Site:</b>	Rough Horn Swamp II
<b>XS ID</b>	XS1
<b>Drainage Area (sq mi):</b>	1.50
<b>Date:</b>	8/17/2022
<b>Field Crew:</b>	T. Seelinger, K. Bartlett

The Monitoring Year 3 cross-section survey found the stream stable and functioning as designed. Because the project streams are part of a headwater system with multiple flow paths, traditional cross-sections measurements such as cross-sectional area, bank height ratio, and entrenchment ratio cannot be calculated. These cross-sections were set to span the entire 100 foot width of the stream valley to monitor where and how the water is flowing through this valley. All three cross-sections showed evidence of the development of multiple flow paths. XS3, because of its proximity to the culvert under CCC Rd. showed the most evidence of having a single flow path, but even this cross-section demonstrated multiple flow paths. XS1 has shown some aggradation over the course of monitoring. While this would present a potential cause for concern in a traditional stream restoration project, this aggradation has helped to spread the flow of water outside of the main channel and has contributed to the development of multiple flow paths throughout the stream valley.
