Monitoring Year 1 Report Final

Rough Horn Swamp Restoration Site Monitoring Year – MY01 2020

Rough Horn Swamp II Restoration Site RFP #16-007337

Columbus County, North Carolina

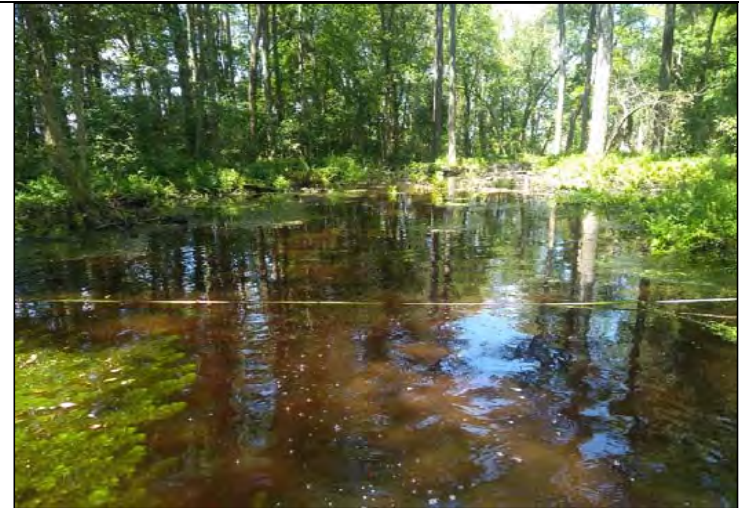
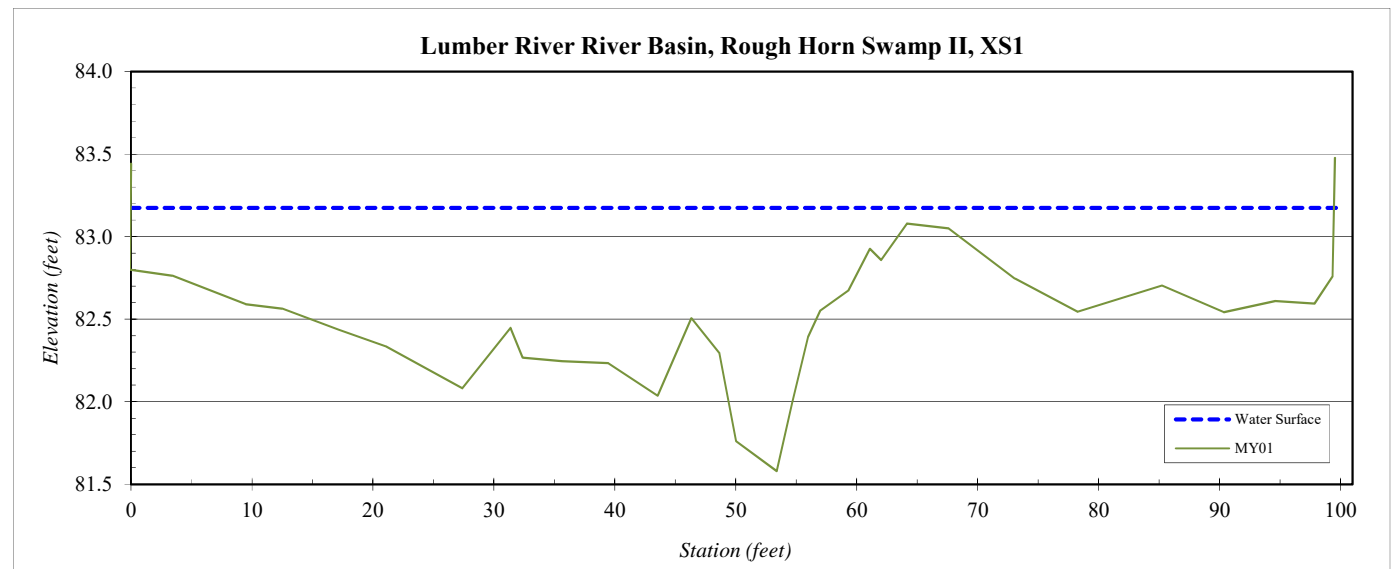
River Basin:	Lumber River
Site:	Rough Horn Swamp II
XS ID	XS1
Drainage Area (sq mi):	1.50
Date:	8/12/2020
Field Crew:	T. Seelinger, A. Gutierrez

The Monitoring Year 1 cross-section survey found the stream stable and functioning as designed. Because the project streams are part of a headwater system with multiple flow paths, traditional cross-sections measurements such as cross-sectional area, bank height ratio, and entrenchment ratio cannot be calculated. These cross-sections were set to span the entire 100 foot width of the stream valley to monitor where and how the water is flowing through this valley. All three cross-sections showed evidence of the development of multiple flow paths. XS3, because of its proximity to the culvert under CCC Rd. showed the most evidence of having a single flow path, but even this cross-section demonstrated multiple flow paths.

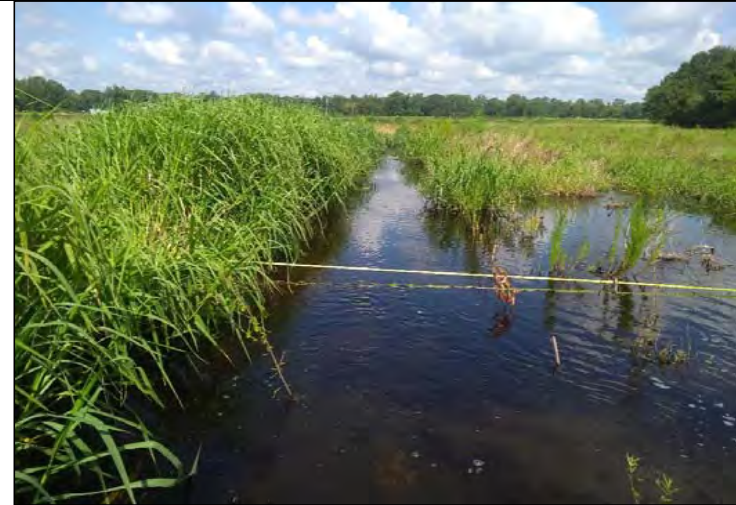
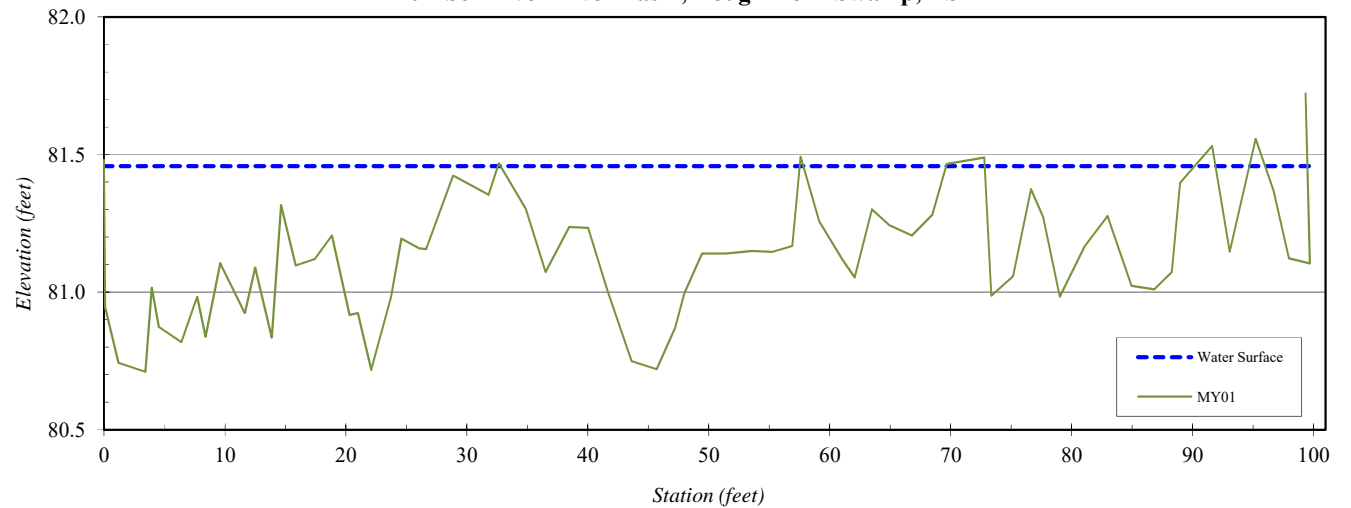
Lumber River River Basin, Rough Horn Swamp, XS2

River Basin:	Lumber River
Site:	Rough Horn Swamp
XS ID	XS2
Drainage Area (sq mi):	1.60
Date:	8/12/2020
Field Crew:	T. Seelinger, A. Gutierrez

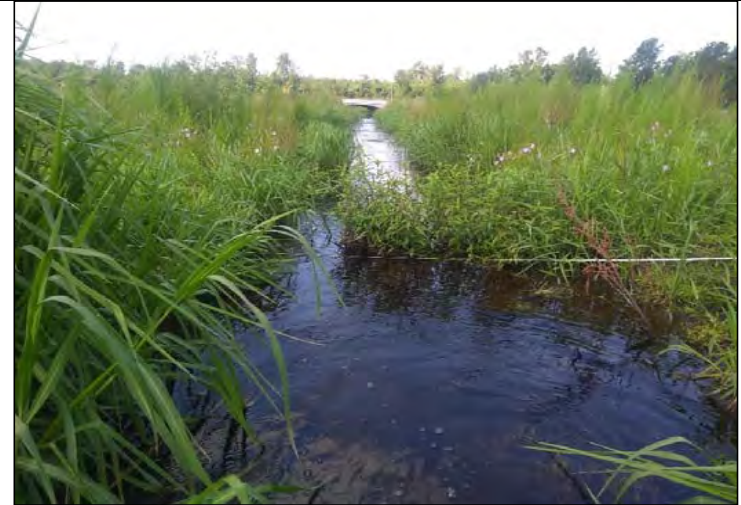
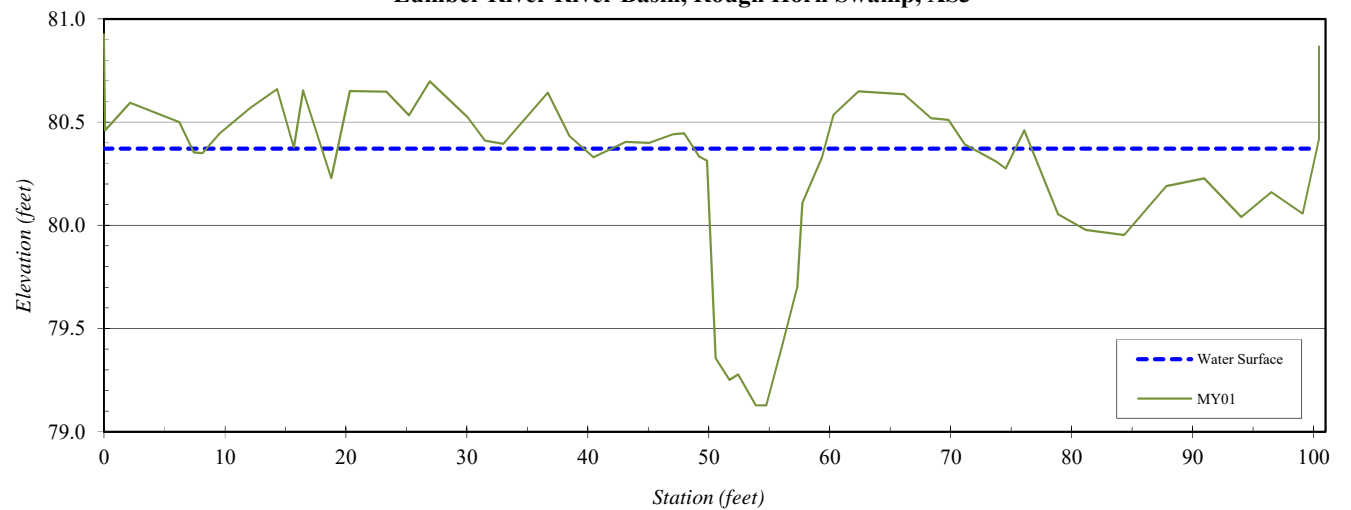
Lumber River River Basin, Rough Horn Swamp, XS3

River Basin:	Lumber River
Site:	Rough Horn Swamp
XS ID	XS3
Drainage Area (sq mi):	2.80
Date:	8/12/2020
Field Crew:	T. Seelinger, A. Gutierrez

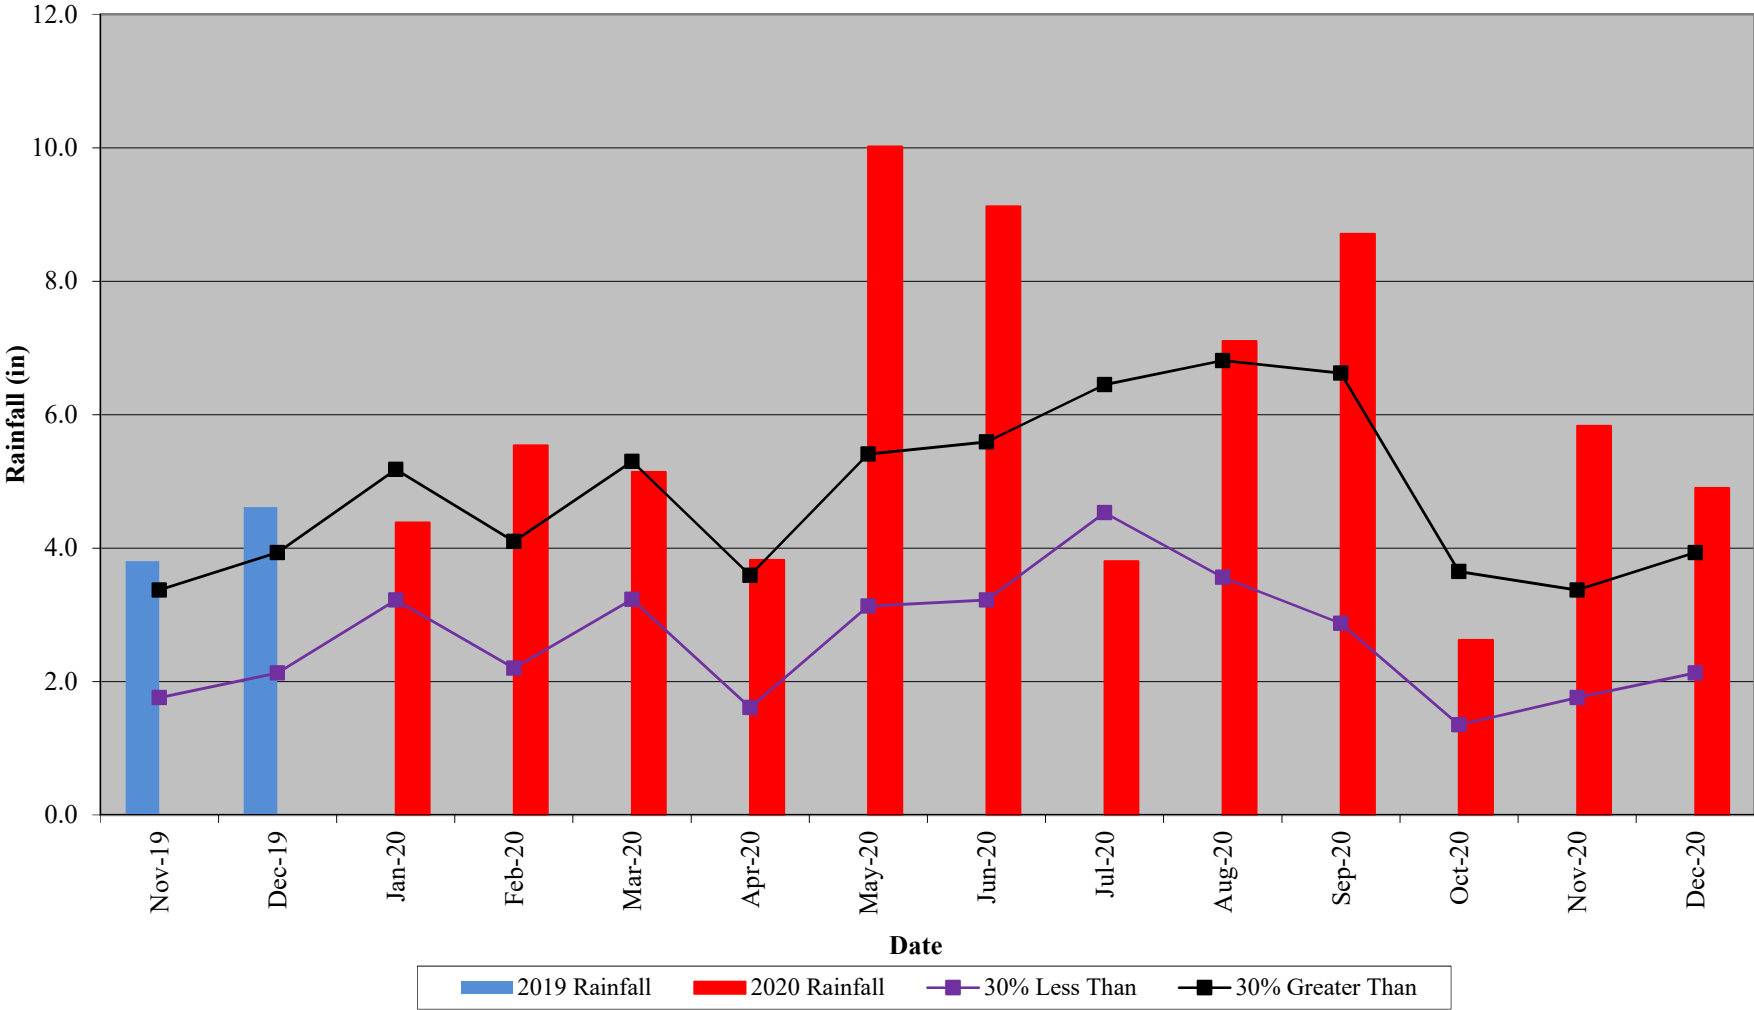
**Rough Horn Swamp Restoration Site
30-70 Percentile Graph
WETS Station Name: Whiteville 7**

During 2020, the months of January, March and October experienced average rainfall. The months of February, April, May, June, August, September, November, and December experienced above average rainfall and the month of July experienced below average rainfall. Overall the site experienced above average rainfall during the 2020 growing season.

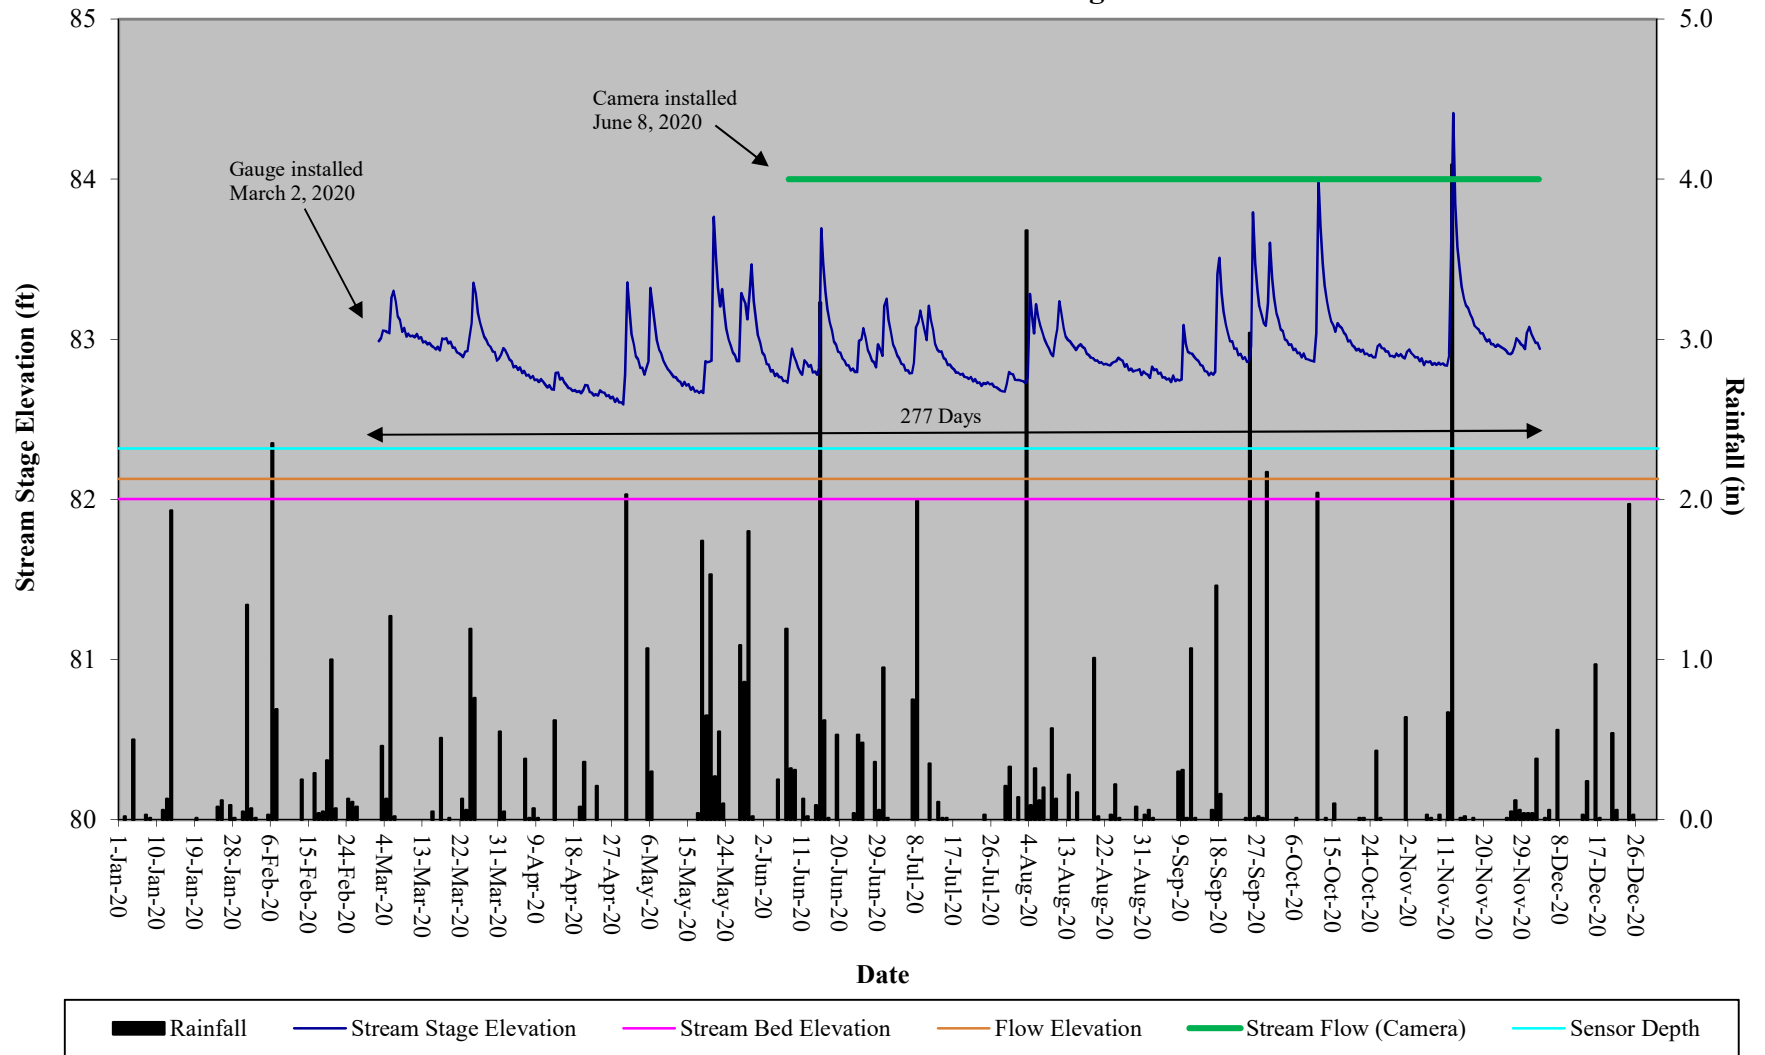
Rough Horn Swamp Restoration Site Hydrograph LBC Stream Flow Gauge

The gauge on Long Bay Creek was installed on March 2, 2020, while the rest of the stream gauges were installed on September 24, 2020. All of the gauges recorded flow for the entirety of the time they collected data (277 days for LBC, 71 days for UT1, UT2-2, UT3-2, and UT4). This was further backed up by the data recorded by the cameras. The camera on LBC was installed on June 8, 2020 and recorded flow for the entire duration that it recorded (179 days). The camera on UT3-2 was installed on April 10, 2020 and recorded a maximum of 78 days. The cameras on UT1, UT2-2, and UT4 were all installed on September 24, 2020 and recorded flow for the entire duration that they recorded (71 days).
