## MITIGATION PLAN

**Round Hill Branch Restoration Site  
Buncombe County, North Carolina  
DMS Project Number 100066  
DEQ Contract 7534  
USACE AID #: SAW-2018-01168  
NC DWR#: 20181031 v1**

**French Broad River Basin  
Cataloging Unit 06010105**

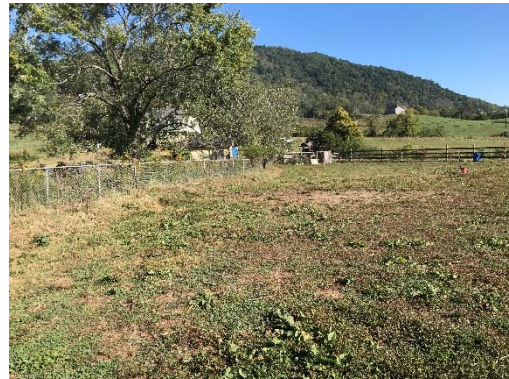
RHB-1 as it nears the confluence with T1; straightened stream is to left of fence and spoil is blocking overland flow on right of fence.

Below the ford crossing, RHB-1 continues in a similar condition with a straight, channelized pattern and spoil piles along the right bank. There is a series of spoil remnants along the right bank, which are preventing diffuse flow of runoff through the riparian zone. Wetland W1 is present along the floodplain in this area, originating from hillside seepage from the western slope. Riparian vegetation is limited to isolated trees along the tops of banks.

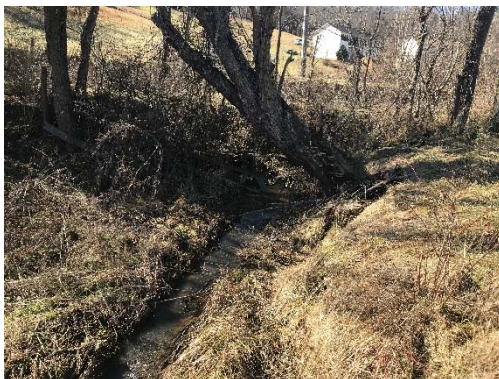
Looking upstream at the old roadbed and culvert in T1 causing a blockage.

T1 enters the project site flowing east after exiting the 24" CMP culvert under Bridges Cove Road. After 15 lf, T1 then flows through an older, unused road crossing with a crushed and failing 18" CMP pipe. The channel fill from the old crossing is severely impacting the channel dynamics and altering the flow and sediment transport downstream of the blockage. Approximately 130 lf downstream of the beginning of T1, a wetland seep (W4) joins enters T1 from the left bank. This seep was historically ditched and is currently functioning more as a vegetated ditch with a combination of pasture grasses and soft rush (*Juncus effusus*). After the seep enters, T1 flows straight along a fence line to the confluence with RHB and lacks any distinct bed feature morphology. There is

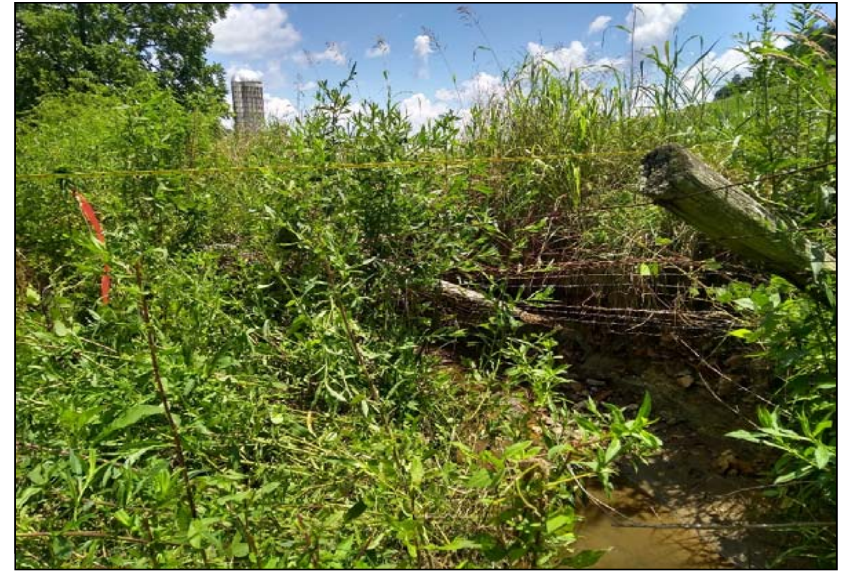
<b>River Basin:</b>	French Broad
<b>Watershed:</b>	Round Hill Branch
<b>XS ID</b>	RHB-XSB Riffle
<b>Drainage Area (sq mi):</b>	0.48
<b>Date:</b>	7/2/2019
<b>Field Crew:</b>	T. Seelinger, A. Gutierrez

SUMMARY DATA	
<b>Bankfull Elevation:</b>	2177.30
<b>Bankfull Cross-Sectional Area:</b>	5.4
<b>Bankfull Width:</b>	5.2
<b>Flood Prone Area Elevation:</b>	2178.7
<b>Flood Prone Width:</b>	23.1
<b>Max Depth at Bankfull:</b>	1.4
<b>Mean Depth at Bankfull:</b>	1.0
<b>W / D Ratio:</b>	5.1
<b>Entrenchment Ratio:</b>	4.4
<b>Bank Height Ratio:</b>	1.3

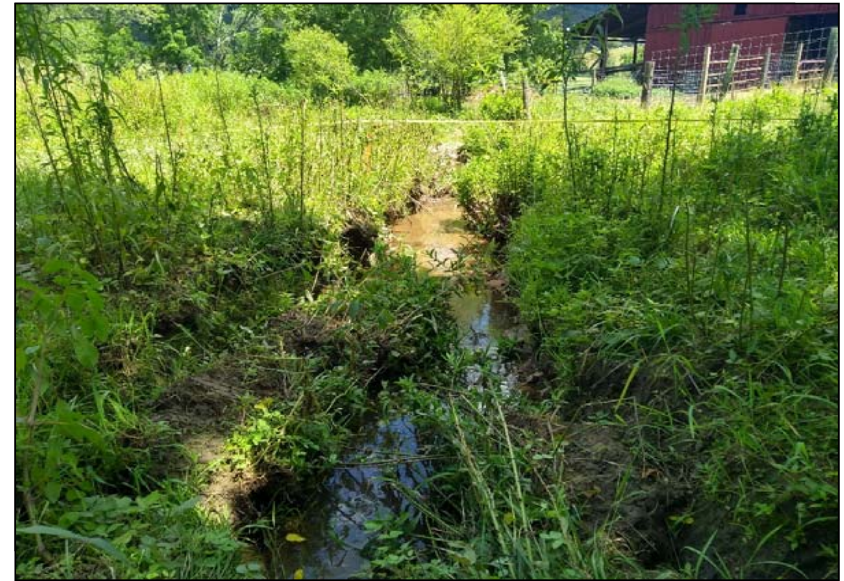
<b>River Basin:</b>	French Broad
<b>Watershed:</b>	Round Hill Branch
<b>XS ID</b>	RHB-XSC Riffle
<b>Drainage Area (sq mi):</b>	0.48
<b>Date:</b>	7/2/2019
<b>Field Crew:</b>	T. Seelinger, A. Gutierrez

SUMMARY DATA	
<b>Bankfull Elevation:</b>	2175.48
<b>Bankfull Cross-Sectional Area:</b>	6.2
<b>Bankfull Width:</b>	5.2
<b>Flood Prone Area Elevation:</b>	2177.4
<b>Flood Prone Width:</b>	60.6
<b>Max Depth at Bankfull:</b>	1.9
<b>Mean Depth at Bankfull:</b>	1.2
<b>W / D Ratio:</b>	4.3
<b>Entrenchment Ratio:</b>	11.7
<b>Bank Height Ratio:</b>	1.1

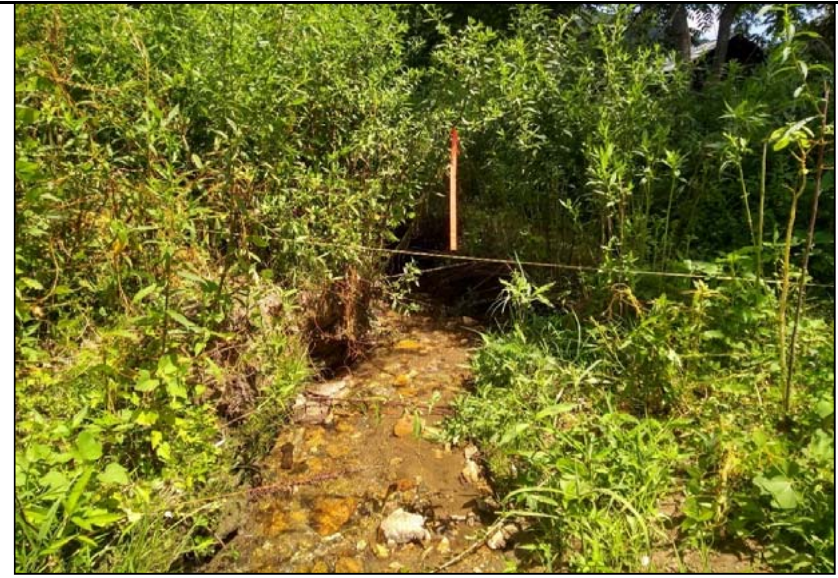
<b>River Basin:</b>	French Broad
<b>Watershed:</b>	Round Hill Branch
<b>XS ID</b>	RHB-XSD Riffle (reference)
<b>Drainage Area (sq mi):</b>	0.48
<b>Date:</b>	7/2/2019
<b>Field Crew:</b>	T. Seelinger, A. Gutierrez

SUMMARY DATA	
<b>Bankfull Elevation:</b>	2173.00
<b>Bankfull Cross-Sectional Area:</b>	6.0
<b>Bankfull Width:</b>	6.8
<b>Flood Prone Area Elevation:</b>	2174.5
<b>Flood Prone Width:</b>	31.8
<b>Max Depth at Bankfull:</b>	1.5
<b>Mean Depth at Bankfull:</b>	0.9
<b>W / D Ratio:</b>	7.6
<b>Entrenchment Ratio:</b>	4.7
<b>Bank Height Ratio:</b>	1.3

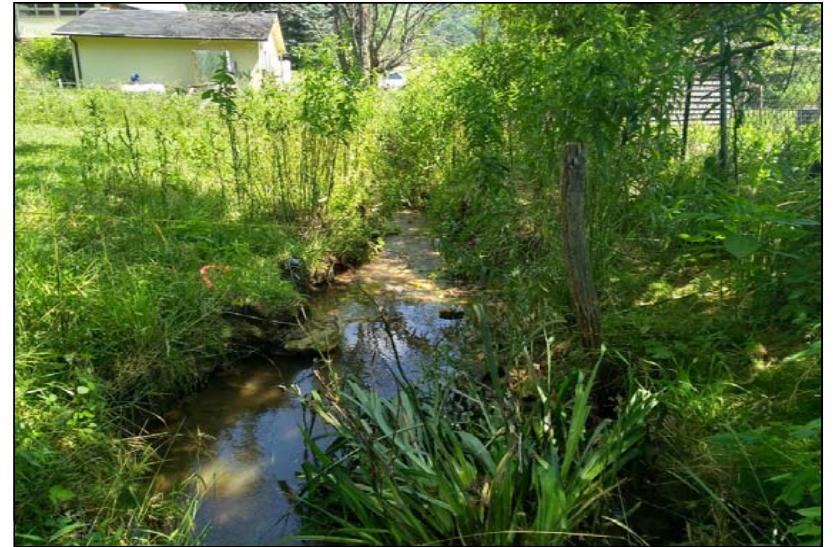
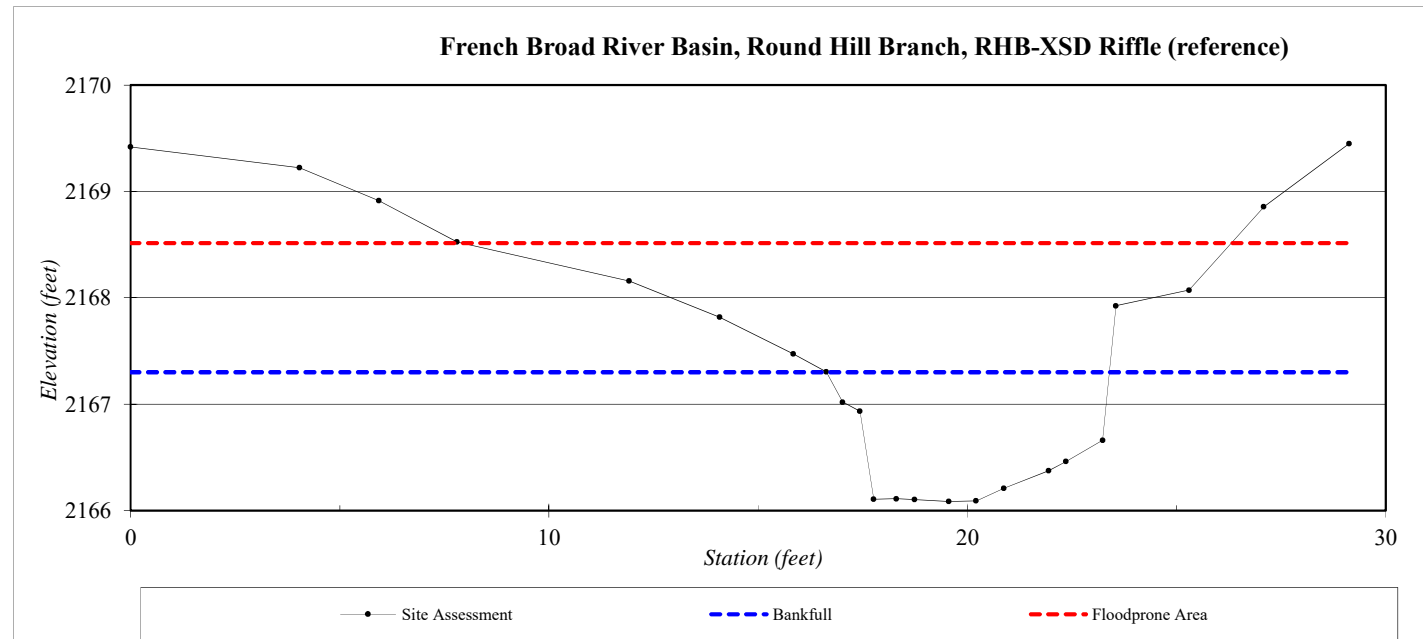
<b>River Basin:</b>	French Broad
<b>Watershed:</b>	Round Hill Branch
<b>XS ID</b>	RHB-XSE Pool
<b>Drainage Area (sq mi):</b>	0.62
<b>Date:</b>	7/2/2019
<b>Field Crew:</b>	T. Seelinger, A. Gutierrez

Station	Elevation
0.00	2169.42
4.04	2169.22
5.93	2168.91
7.80	2168.52
11.92	2168.16
14.08	2167.82
15.84	2167.47
16.63	2167.30
17.02	2167.02
17.43	2166.93
17.76	2166.11
18.30	2166.11
18.74	2166.10
19.56	2166.09
20.21	2166.09
20.87	2166.21
21.94	2166.37
22.35	2166.46
23.24	2166.66
23.55	2167.93
25.30	2168.07
27.09	2168.86
29.12	2169.45

SUMMARY DATA	
<b>Bankfull Elevation:</b>	2167.30
<b>Bankfull Cross-Sectional Area:</b>	6.3
<b>Bankfull Width:</b>	6.8
<b>Flood Prone Area Elevation:</b>	2168.5
<b>Flood Prone Width:</b>	18.4
<b>Max Depth at Bankfull:</b>	1.2
<b>Mean Depth at Bankfull:</b>	0.9
<b>W / D Ratio:</b>	7.3
<b>Entrenchment Ratio:</b>	2.7
<b>Bank Height Ratio:</b>	1.0

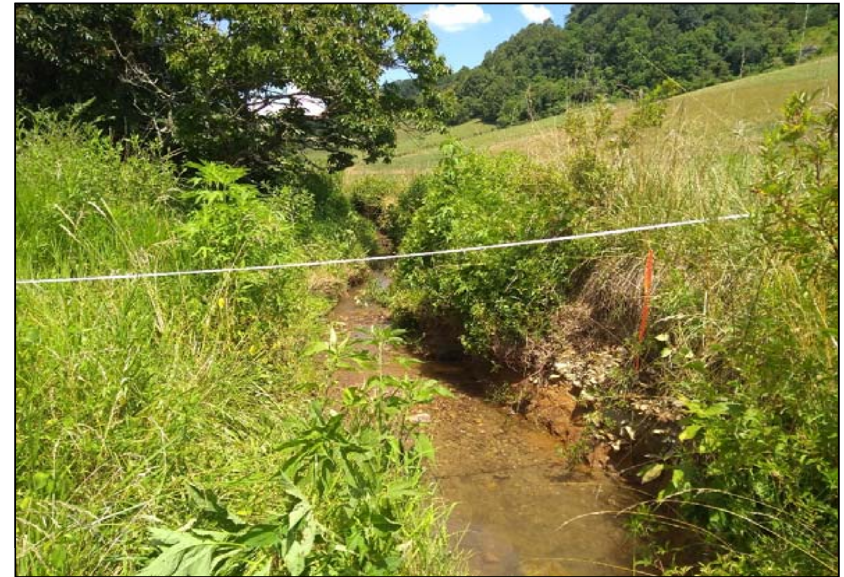
<b>River Basin:</b>	French Broad
<b>Watershed:</b>	Round Hill Branch
<b>XS ID</b>	RHB-XSF Riffle (reference)
<b>Drainage Area (sq mi):</b>	0.63
<b>Date:</b>	7/2/2019
<b>Field Crew:</b>	T. Seelinger, A. Gutierrez

SUMMARY DATA	
<b>Bankfull Elevation:</b>	2159.52
<b>Bankfull Cross-Sectional Area:</b>	9.2
<b>Bankfull Width:</b>	7.4
<b>Flood Prone Area Elevation:</b>	-
<b>Flood Prone Width:</b>	-
<b>Max Depth at Bankfull:</b>	1.6
<b>Mean Depth at Bankfull:</b>	1.2
<b>W / D Ratio:</b>	-
<b>Entrenchment Ratio:</b>	-
<b>Bank Height Ratio:</b>	-

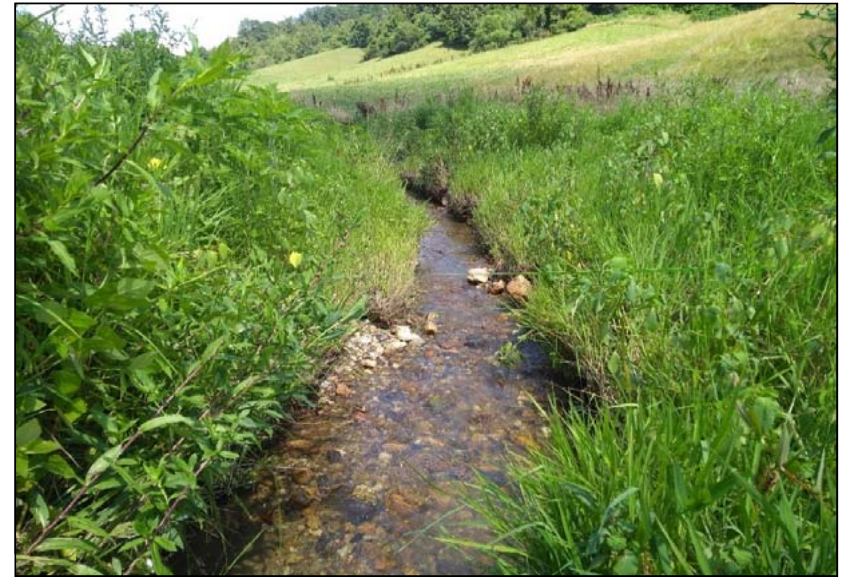
<b>River Basin:</b>	French Broad
<b>Watershed:</b>	Round Hill Branch
<b>XS ID</b>	RHB-XSG Riffle
<b>Drainage Area (sq mi):</b>	0.73
<b>Date:</b>	7/2/2019
<b>Field Crew:</b>	T. Seelinger, A. Gutierrez

SUMMARY DATA	
<b>Bankfull Elevation:</b>	2156.51
<b>Bankfull Cross-Sectional Area:</b>	7.1
<b>Bankfull Width:</b>	5.5
<b>Flood Prone Area Elevation:</b>	2158.2
<b>Flood Prone Width:</b>	34.7
<b>Max Depth at Bankfull:</b>	1.6
<b>Mean Depth at Bankfull:</b>	1.3
<b>W / D Ratio:</b>	4.2
<b>Entrenchment Ratio:</b>	6.3
<b>Bank Height Ratio:</b>	1.0

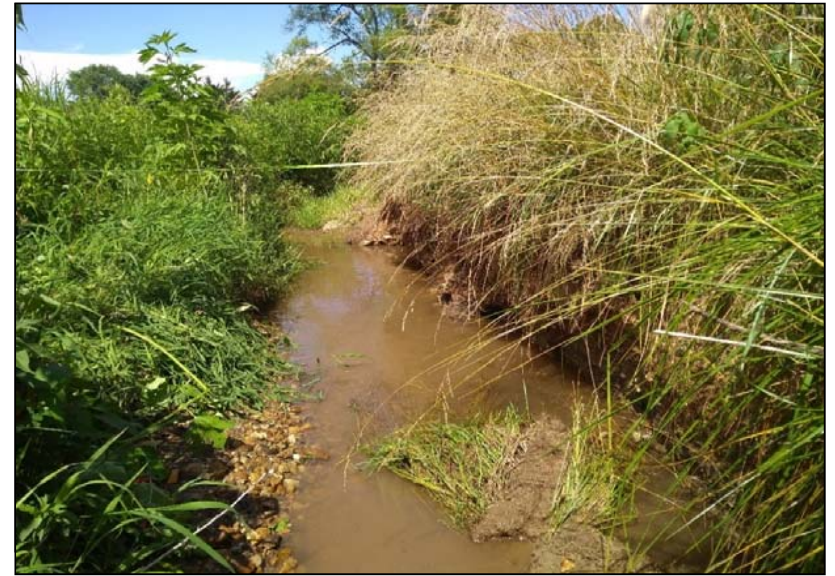
<b>River Basin:</b>	French Broad
<b>Watershed:</b>	Round Hill Branch
<b>XS ID</b>	T1-XSA Pool
<b>Drainage Area (sq mi):</b>	0.11
<b>Date:</b>	7/2/2019
<b>Field Crew:</b>	T. Seelinger, A. Gutierrez

SUMMARY DATA	
<b>Bankfull Elevation:</b>	2153.94
<b>Bankfull Cross-Sectional Area:</b>	8.0
<b>Bankfull Width:</b>	7.7
<b>Flood Prone Area Elevation:</b>	2156.1
<b>Flood Prone Width:</b>	29.4
<b>Max Depth at Bankfull:</b>	2.1
<b>Mean Depth at Bankfull:</b>	1.0
<b>W / D Ratio:</b>	7.5
<b>Entrenchment Ratio:</b>	3.8
<b>Bank Height Ratio:</b>	1.0

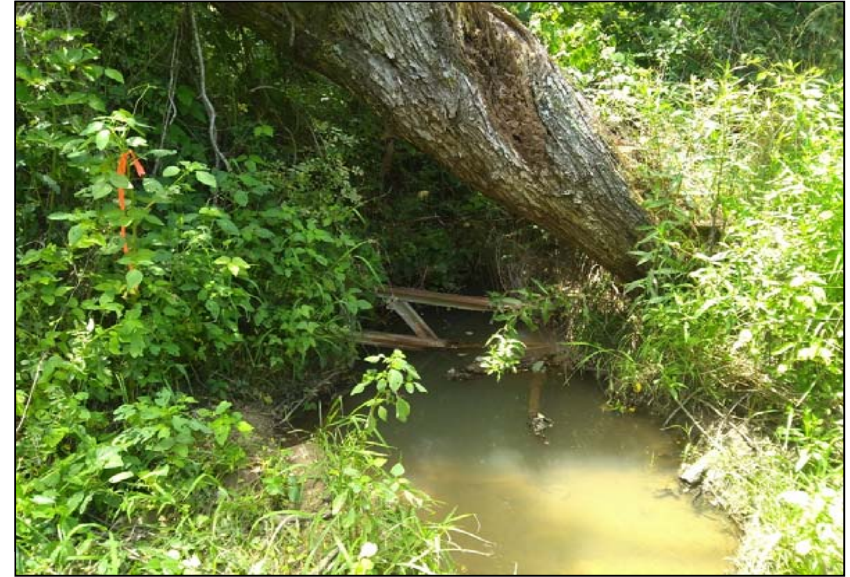
<b>River Basin:</b>	French Broad
<b>Watershed:</b>	Round Hill Branch
<b>XS ID</b>	T1-XSB Riffle (reference)
<b>Drainage Area (sq mi):</b>	0.11
<b>Date:</b>	7/2/2019
<b>Field Crew:</b>	T. Seelinger, A. Gutierrez

SUMMARY DATA	
<b>Bankfull Elevation:</b>	2171.1
<b>Bankfull Cross-Sectional Area:</b>	6.2
<b>Bankfull Width:</b>	5.9
<b>Flood Prone Area Elevation:</b>	-
<b>Flood Prone Width:</b>	-
<b>Max Depth at Bankfull:</b>	1.3
<b>Mean Depth at Bankfull:</b>	1.1
<b>W / D Ratio:</b>	-
<b>Entrenchment Ratio:</b>	-
<b>Bank Height Ratio:</b>	-

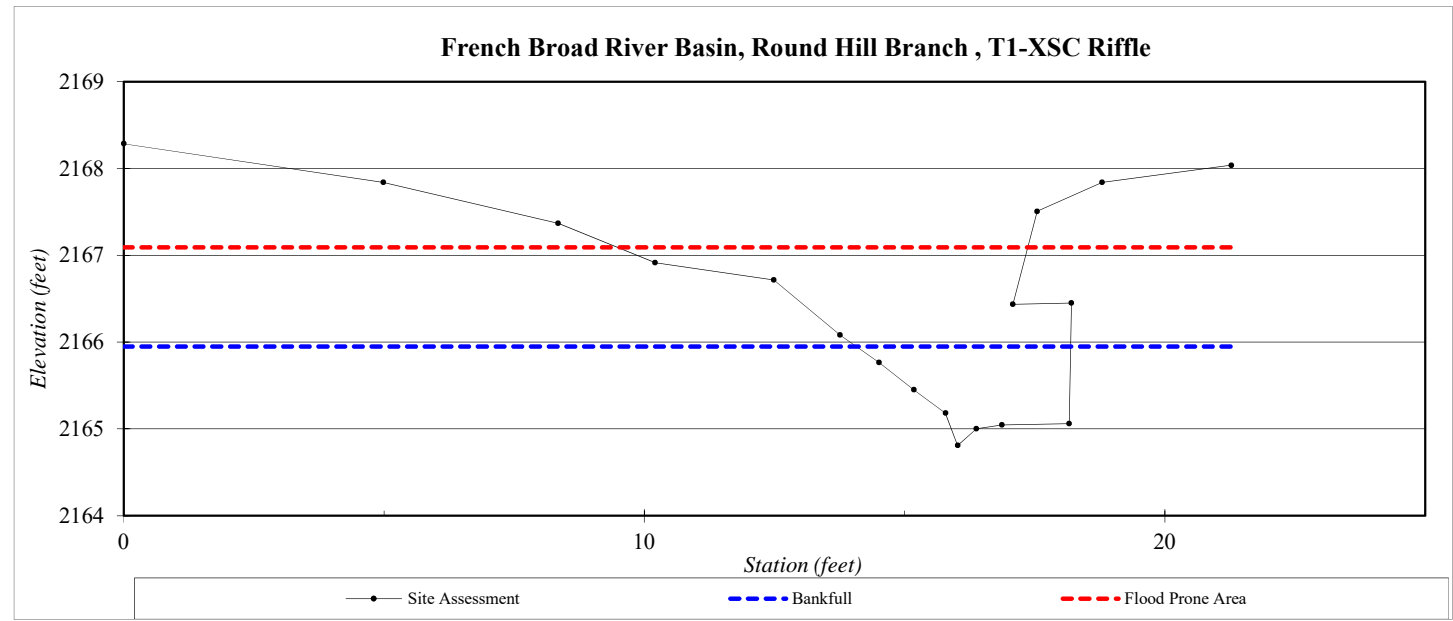
<b>River Basin:</b>	French Broad
<b>Watershed:</b>	Round Hill Branch
<b>XS ID</b>	T2-XSA Riffle
<b>Drainage Area (sq mi):</b>	0.11
<b>Date:</b>	7/2/2019
<b>Field Crew:</b>	T. Seelinger, A. Gutierrez

SUMMARY DATA	
<b>Bankfull Elevation:</b>	2165.95
<b>Bankfull Cross-Sectional Area:</b>	2.9
<b>Bankfull Width:</b>	4.1
<b>Flood Prone Area Elevation:</b>	2167.1
<b>Flood Prone Width:</b>	7.9
<b>Max Depth at Bankfull:</b>	1.1
<b>Mean Depth at Bankfull:</b>	0.7
<b>W / D Ratio:</b>	5.9
<b>Entrenchment Ratio:</b>	1.9
<b>Bank Height Ratio:</b>	1.7

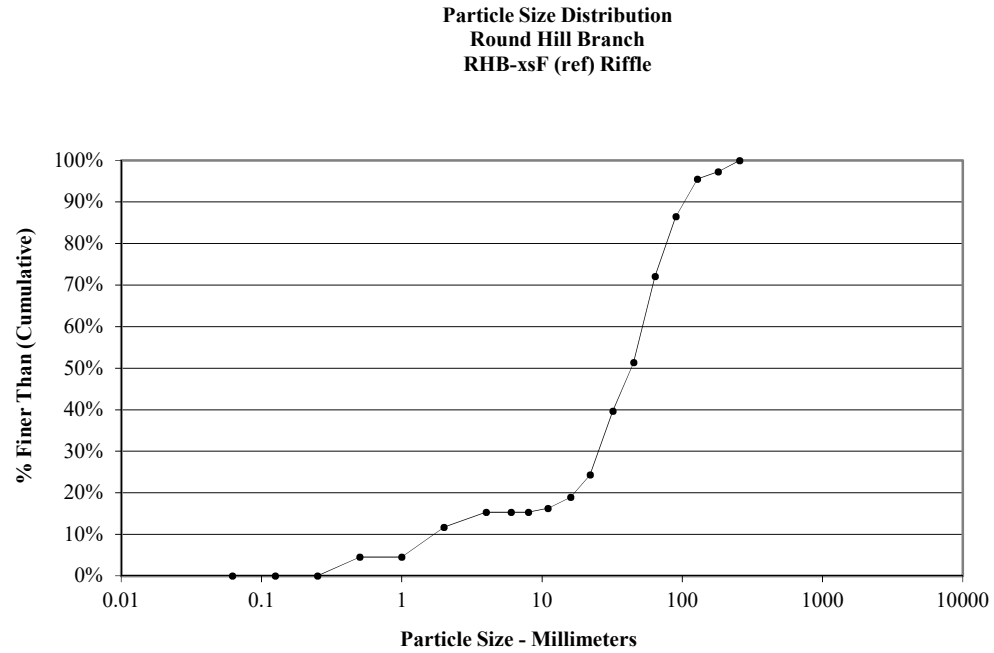
Size (mm)	
D16	10
D35	29
D50	43
D65	57
D84	85
D95	130

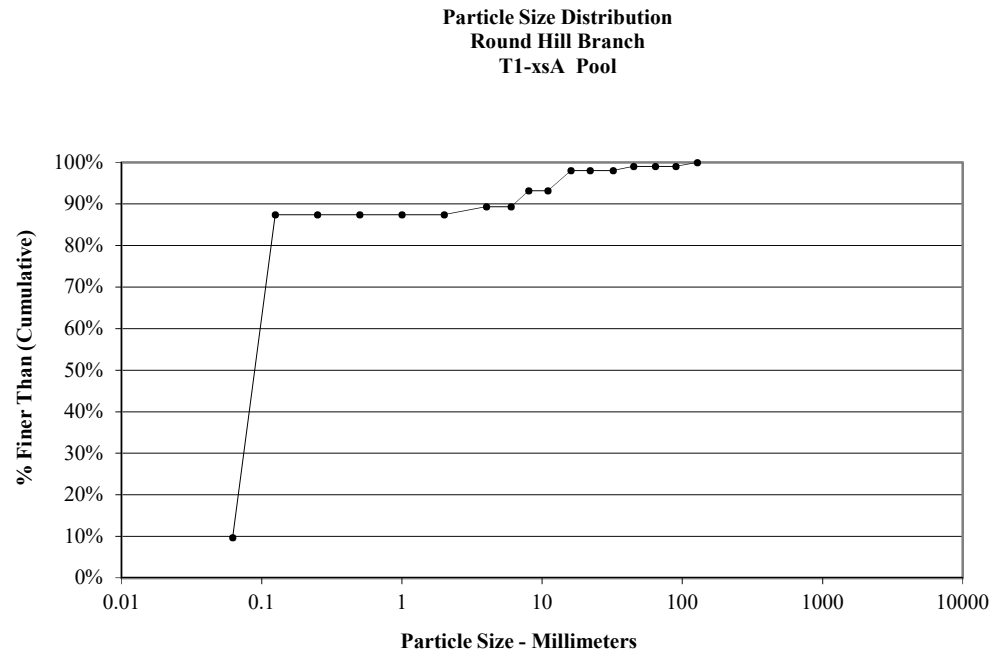
Size (mm)	
D16	0.066
D35	0.078
D50	0.089
D65	0.1
D84	0.12
D95	13

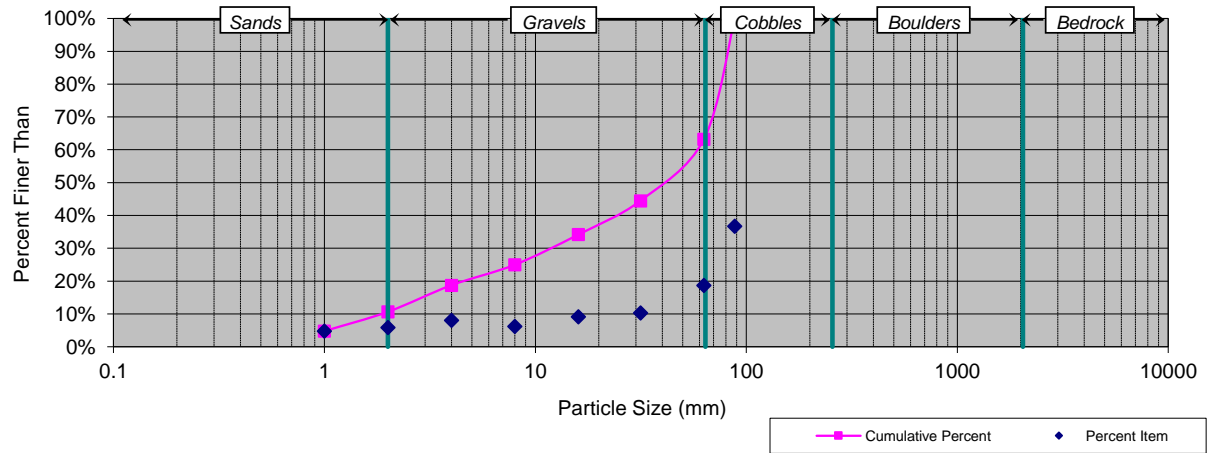
Pavement Sample Sieve Analysis

Size percent less than (mm)					Percent by substrate type					
D16	D35	D50	D84	D95	silt/clay	sand	gravel	cobble	boulder	bedrock
3.2	16.9	38.6	76.1	84.1	0%	11%	53%	37%	---	---
