WETLAND MITIGATION PLAN

SALT MITIGATION SITE
MOORE COUNTY, NORTH CAROLINA

THE NORTH CAROLINA DEPARTMENT OF TRANSPORTATION
RALEIGH, NORTH CAROLINA

August 2000

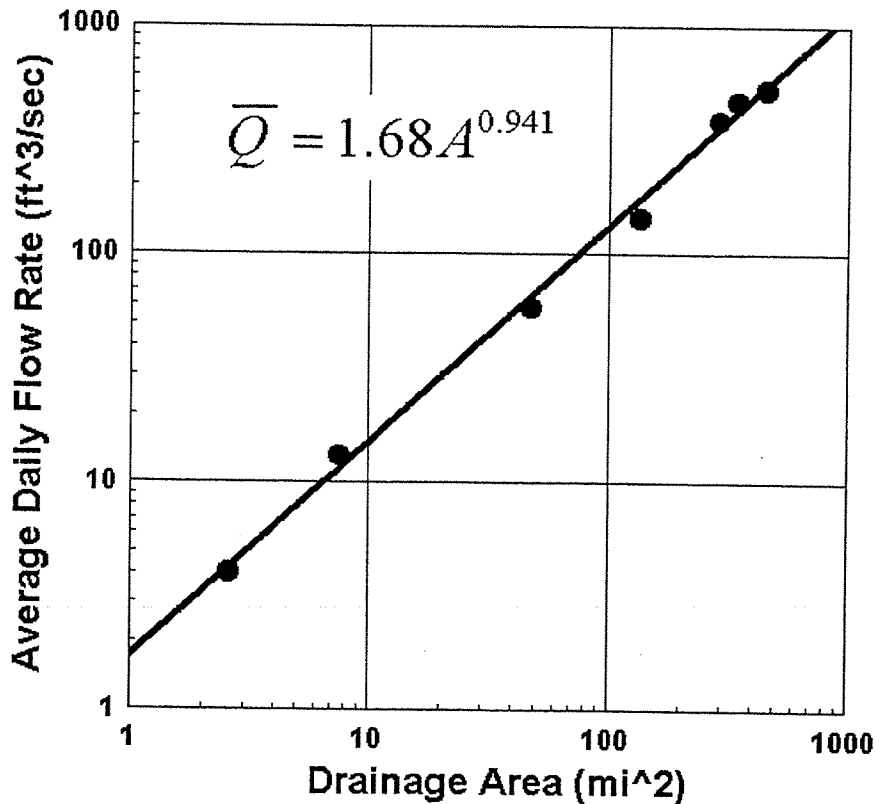
$$\bar{Q} = 1.680 A^{0.941} \quad (3)$$

where \bar{Q} = growing season average daily flow rate in ft³/sec, and A = drainage area in mi². The average daily flow relation has a coefficient of determination of 0.996 and is shown in Figure 2. Based on the analysis of data from nearby gaging stations, growing season average daily flow of the Little River at the Taylor Tract is 139 ft³/sec.

Figure 2. Relation between average daily flow rate and drainage area for streams in the sandhills region of North Carolina.

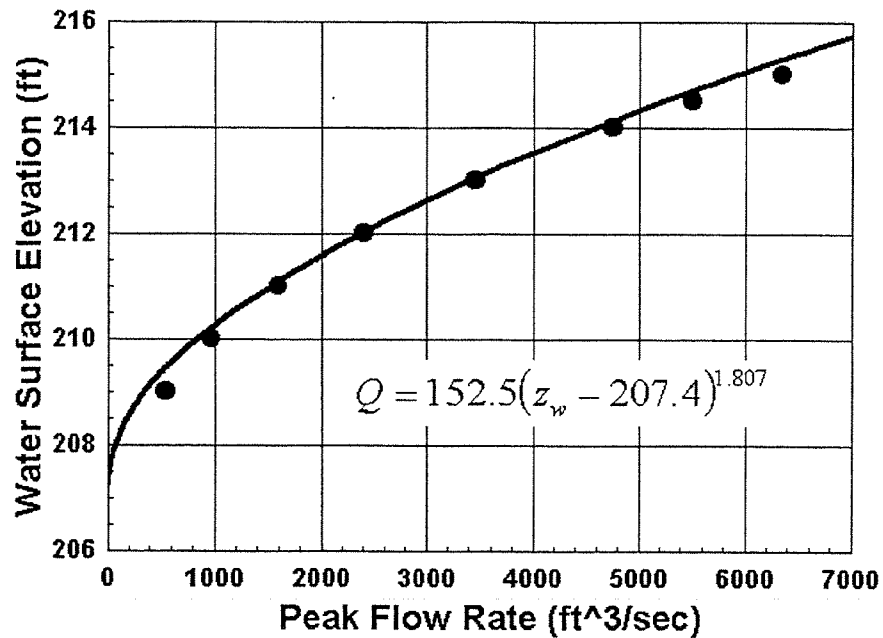
Water surface elevations used as boundary conditions at the downstream limit of the finite element network were obtained from a rating curve developed using the slope area method. A stream slope of 0.002 ft/ft was measured from U.S. Geological Survey 1:24000 scale topographic maps and used to calculate flow rate as a function of water-surface elevation. The rating curve relation is shown in Figure 6.

Figure 6. Rating curve used to establish water-surface elevations at the downstream boundary of the two-dimensional finite element model.

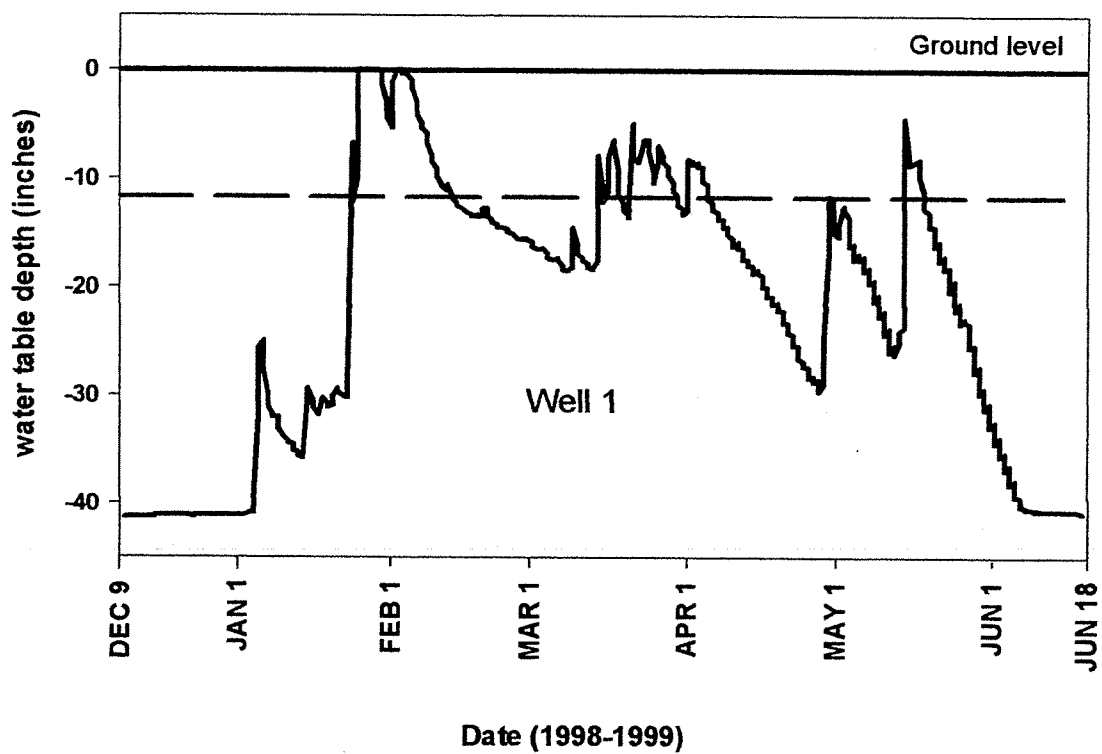
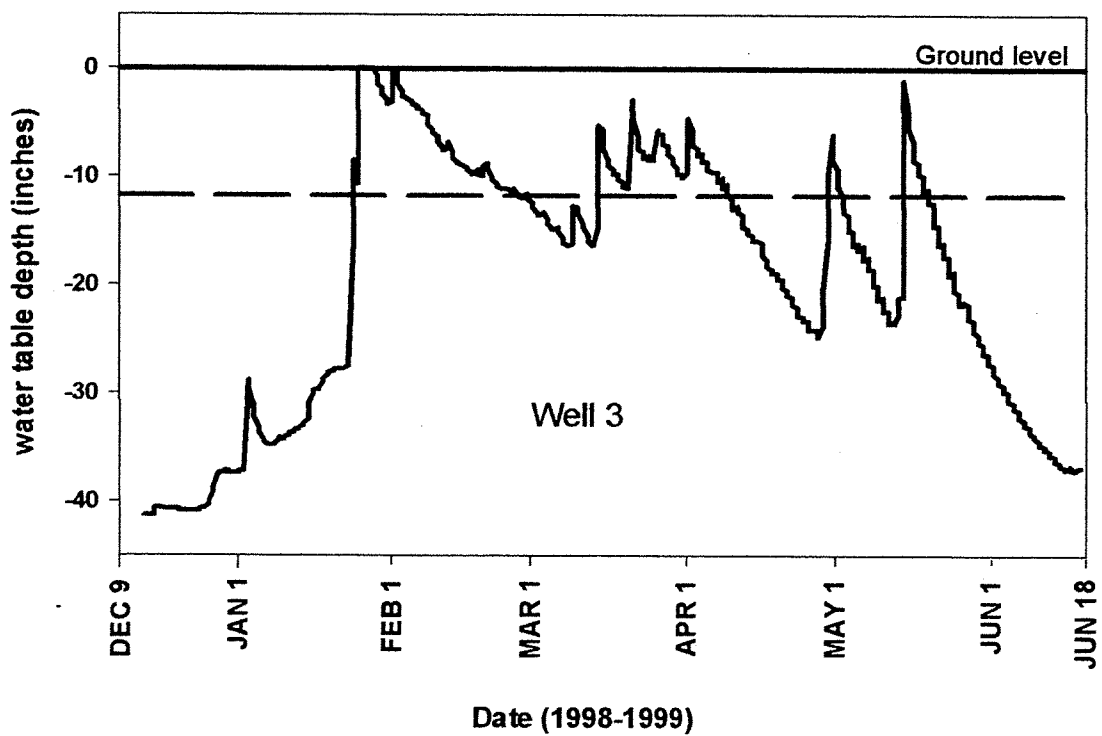
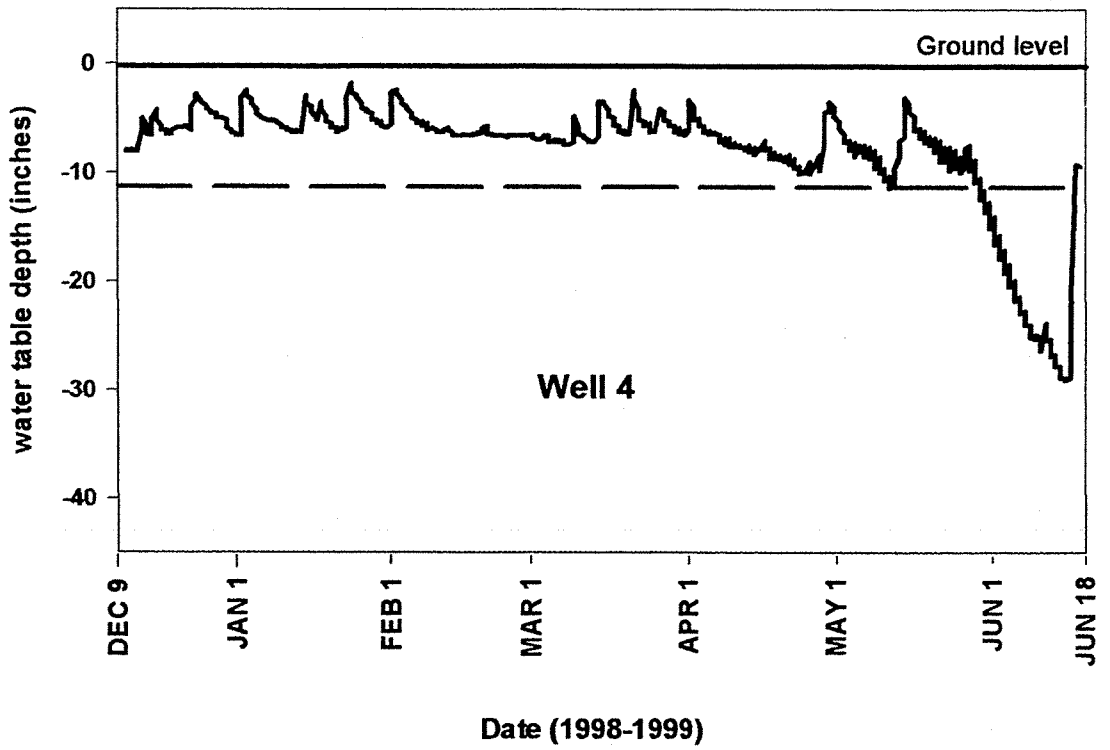
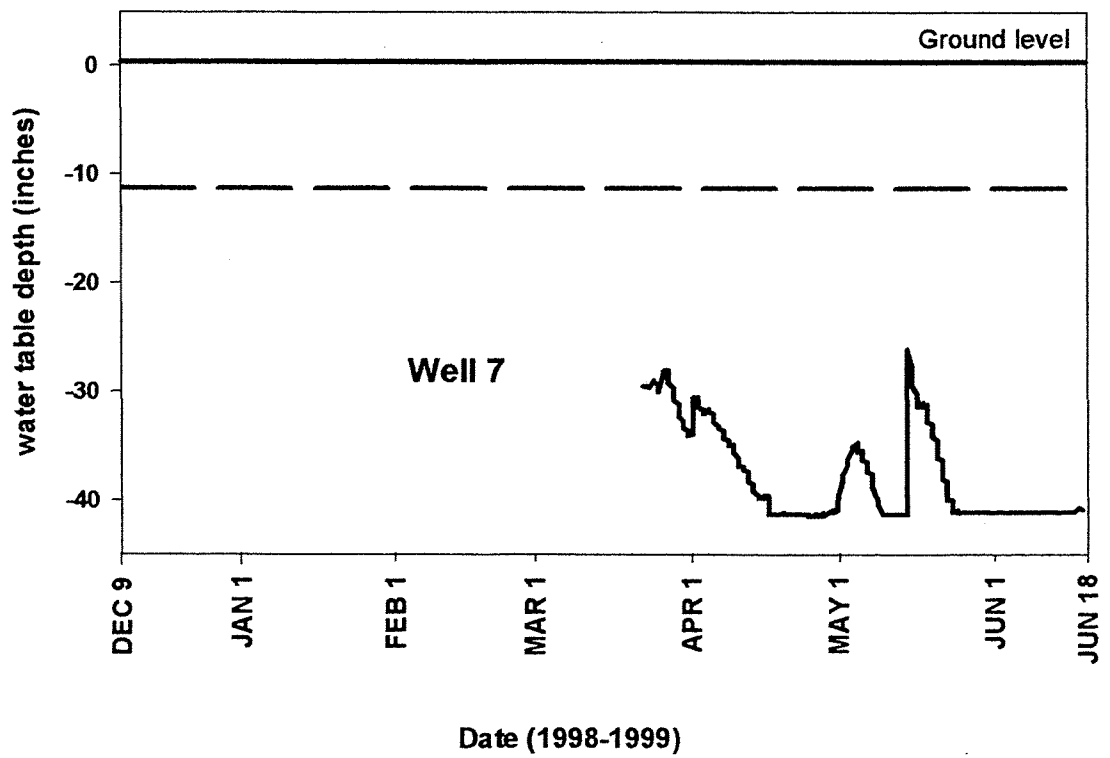
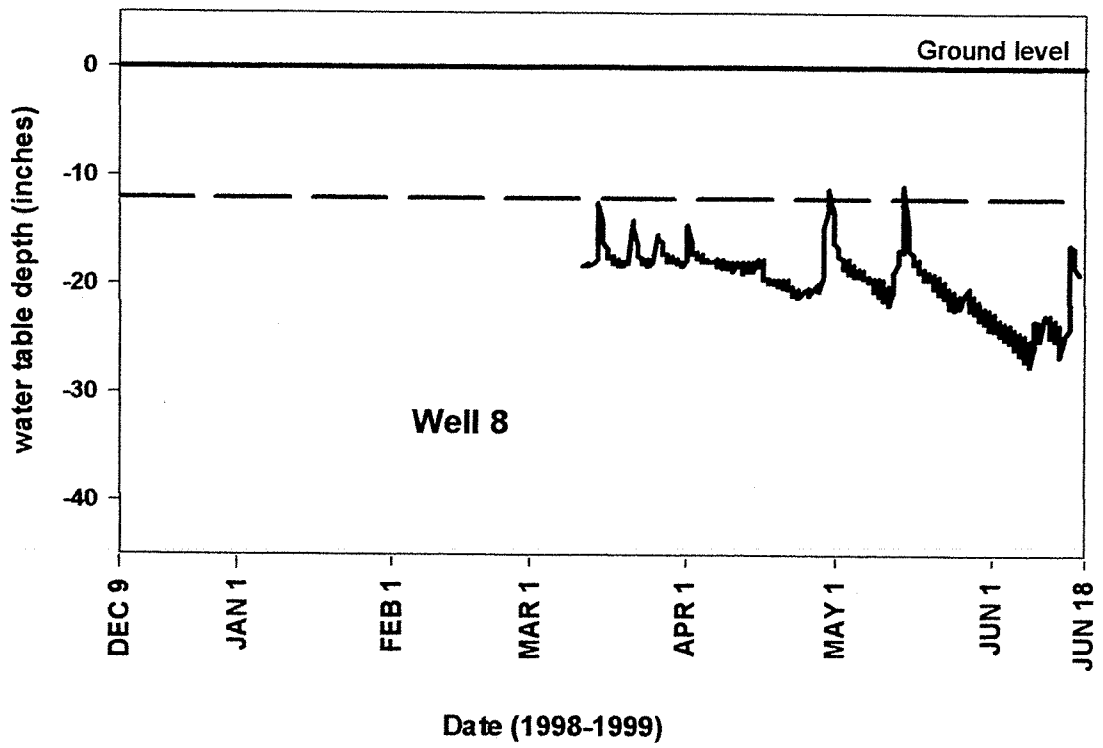
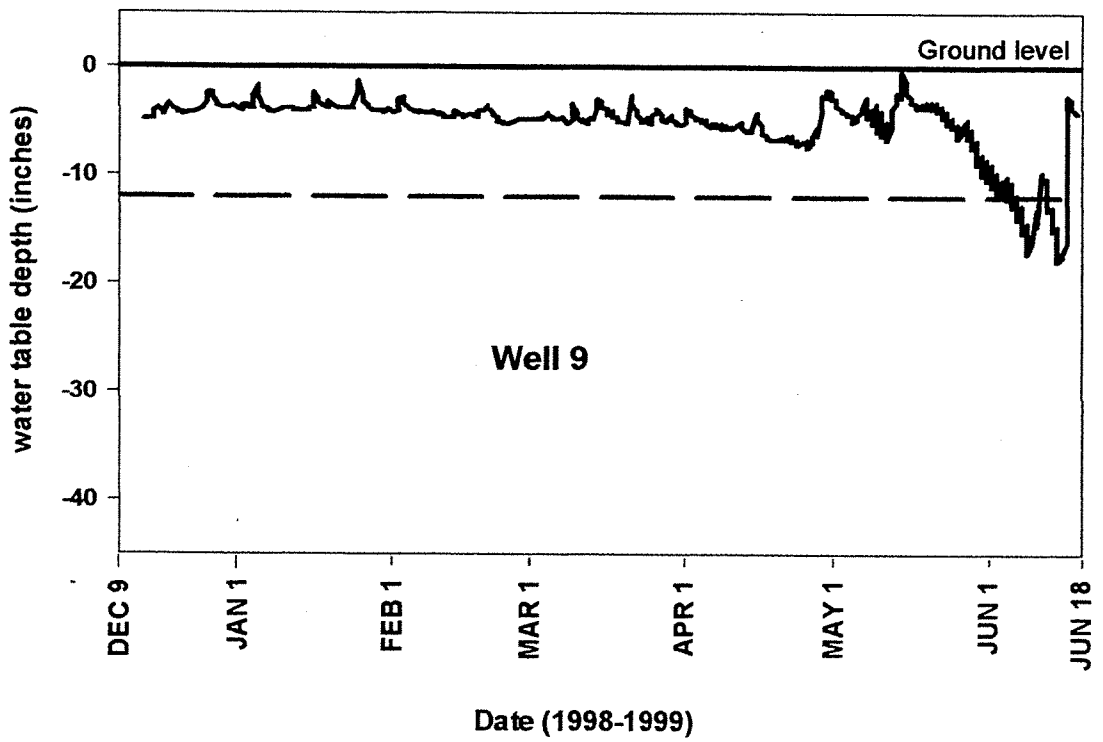
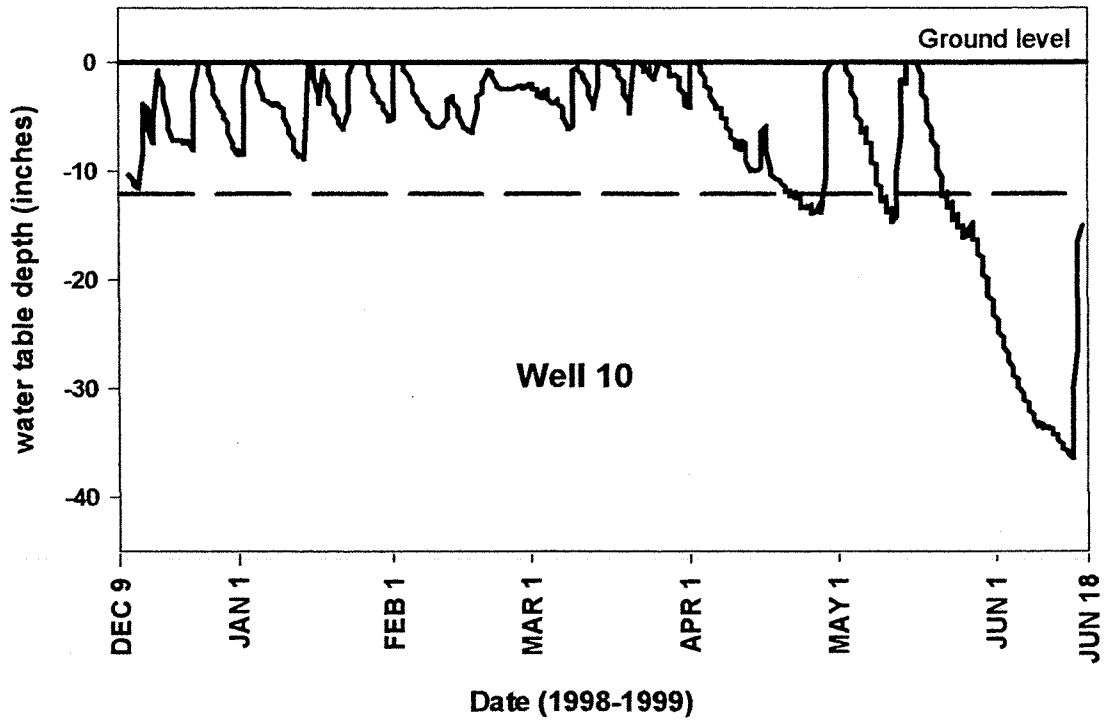
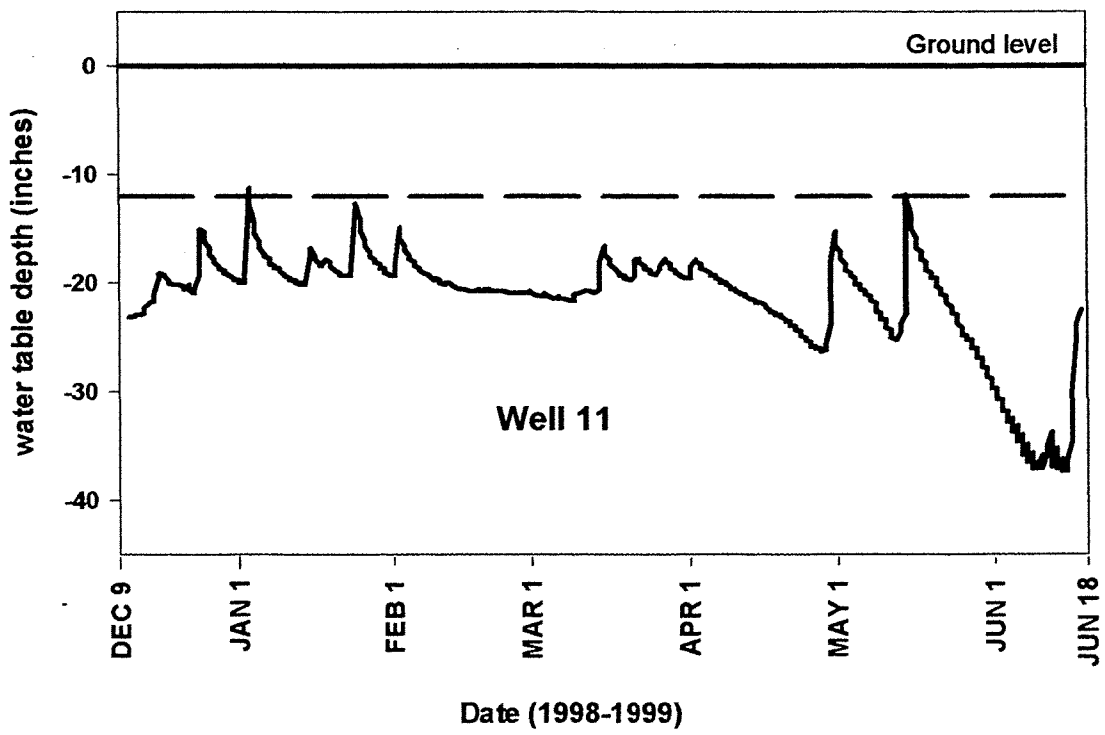
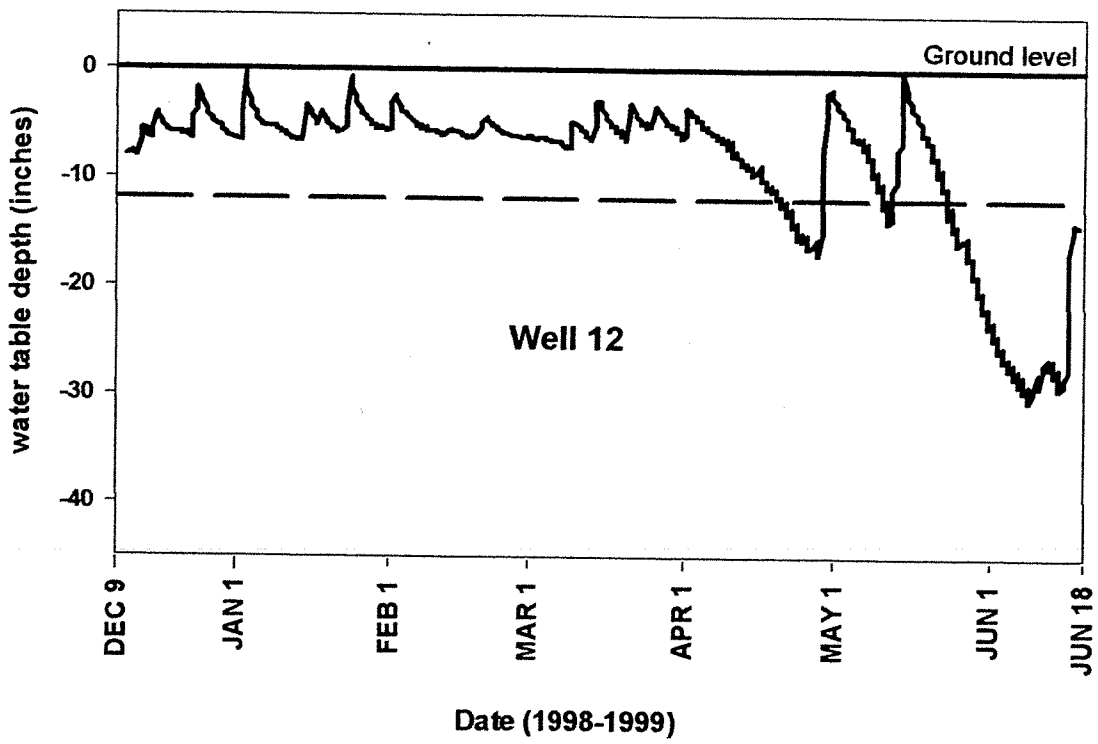
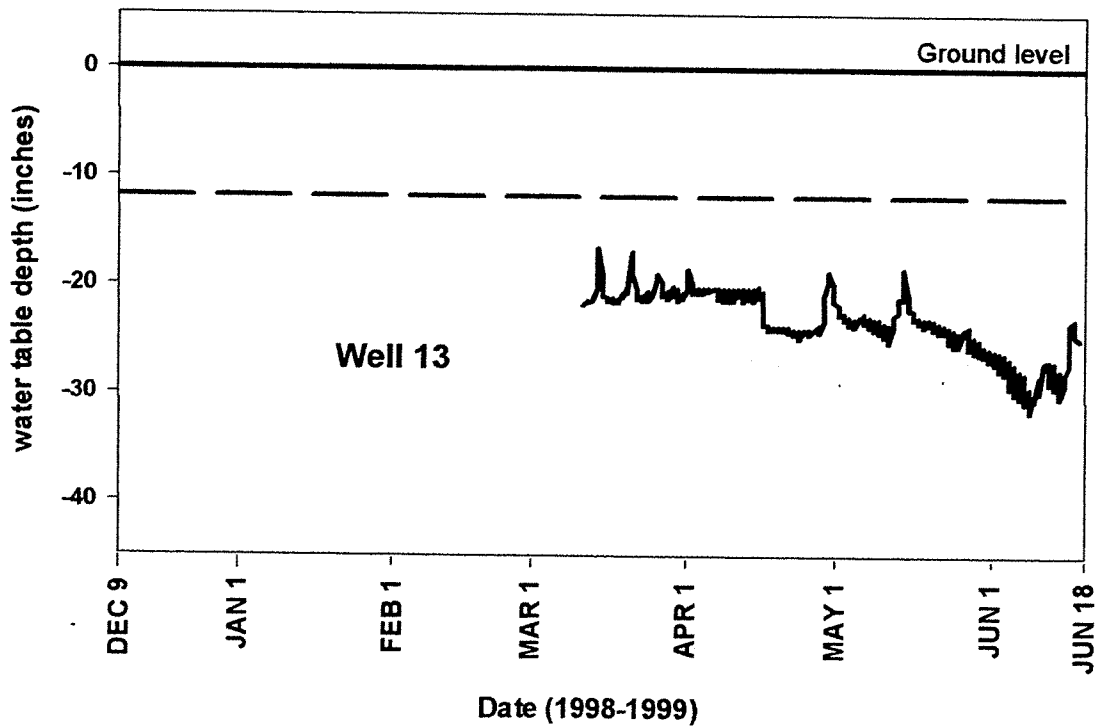
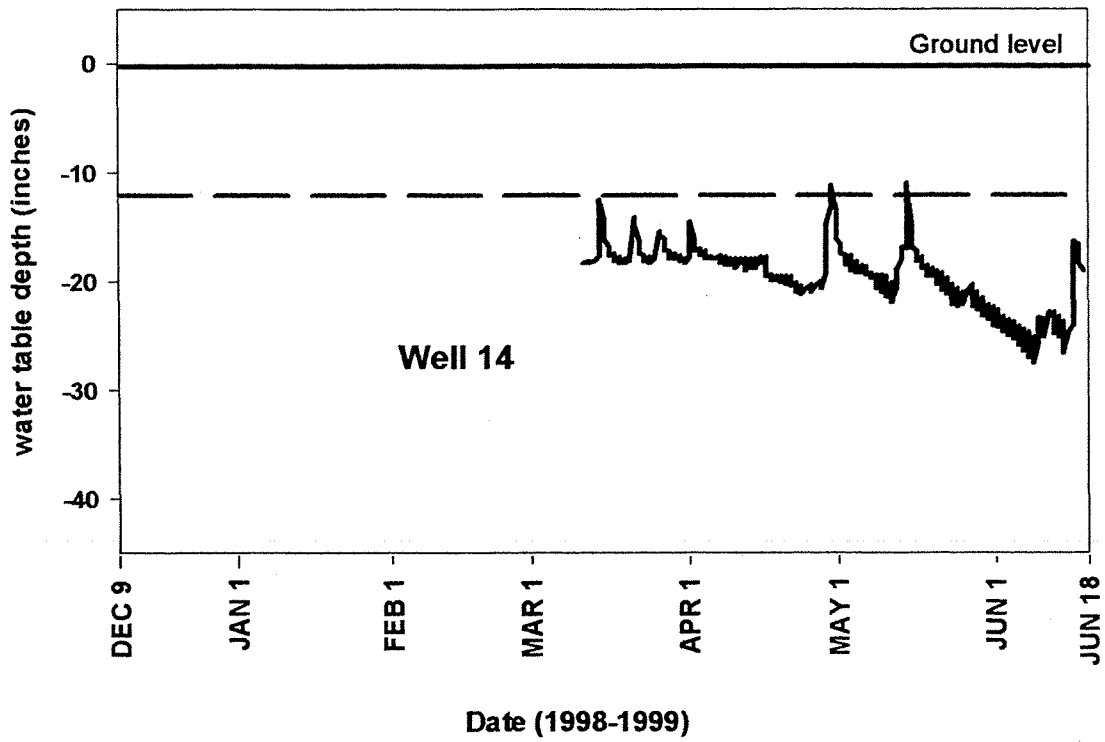
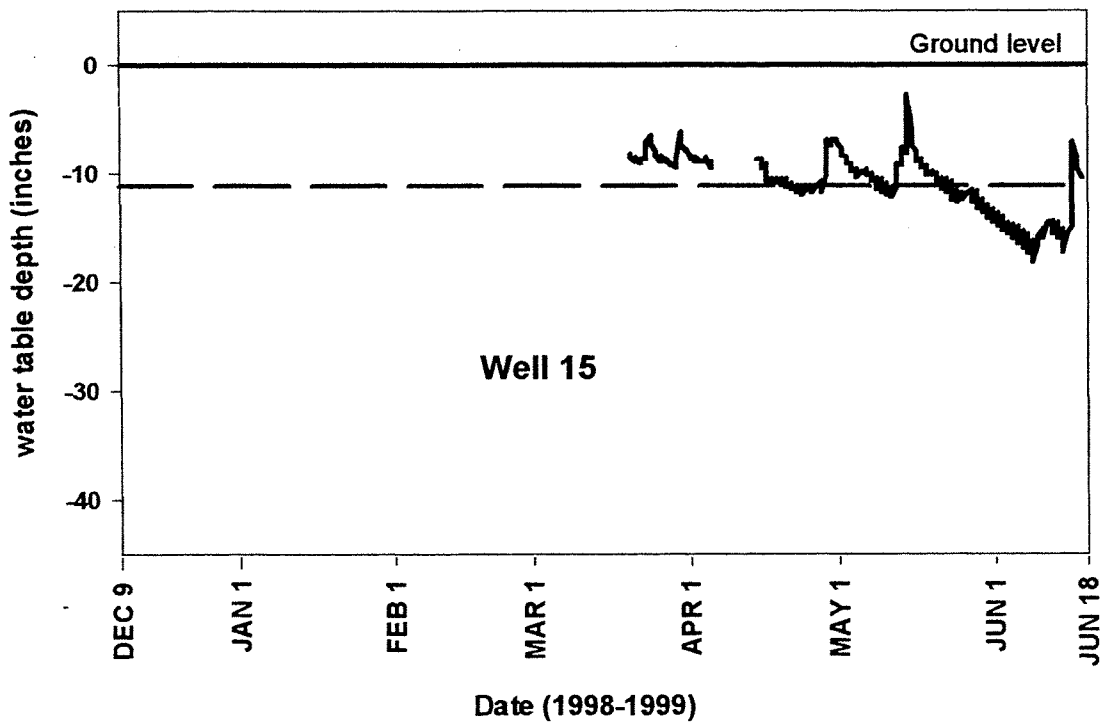
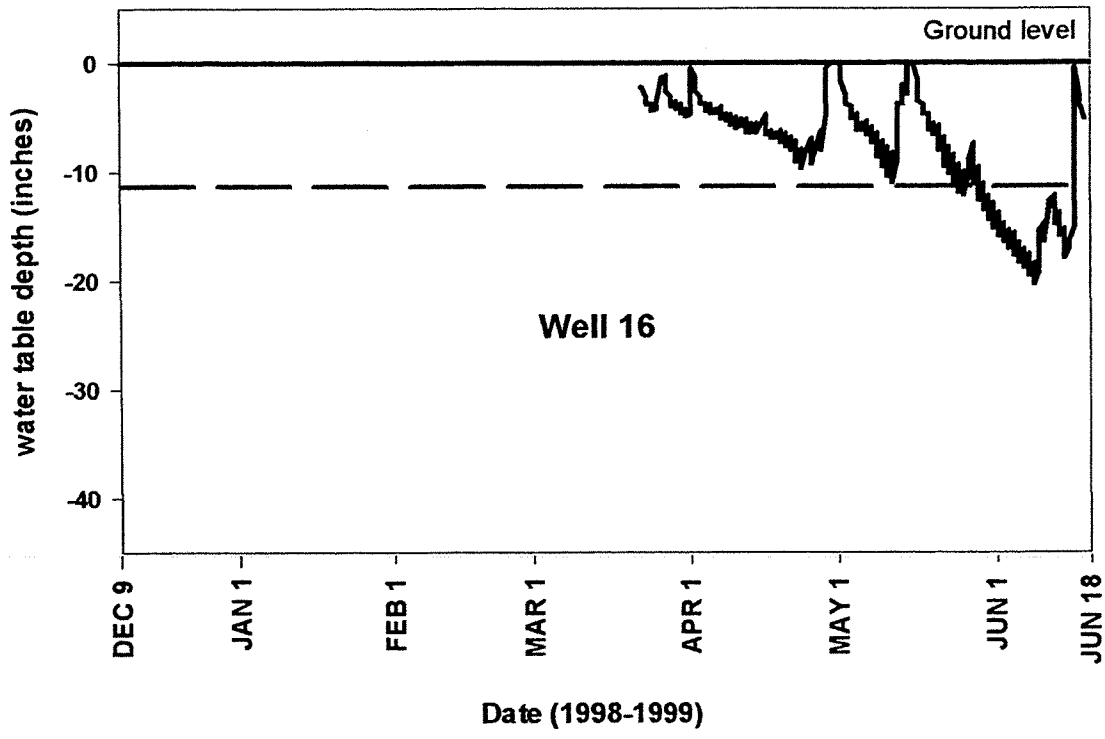
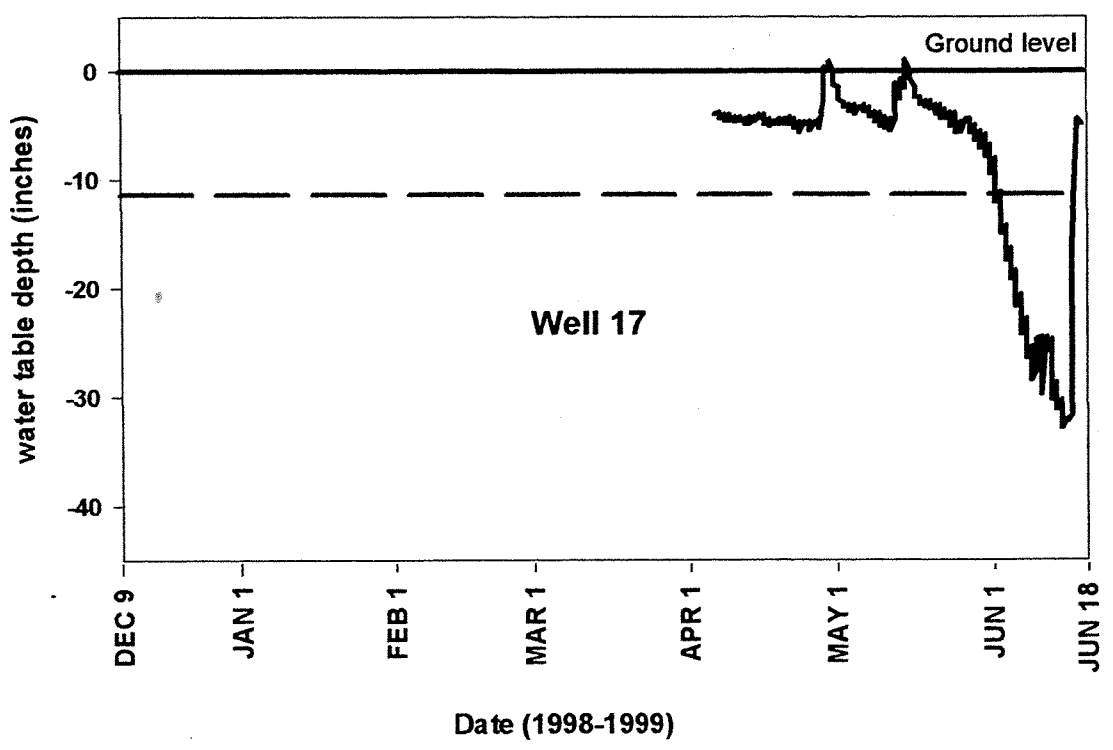
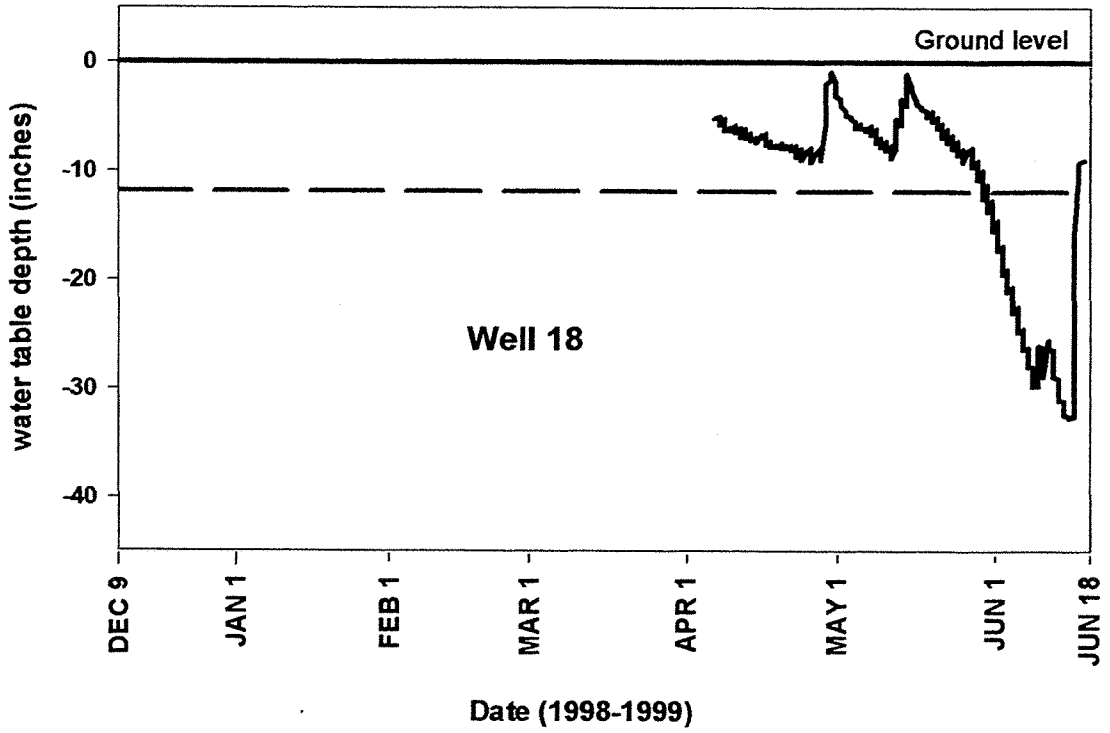
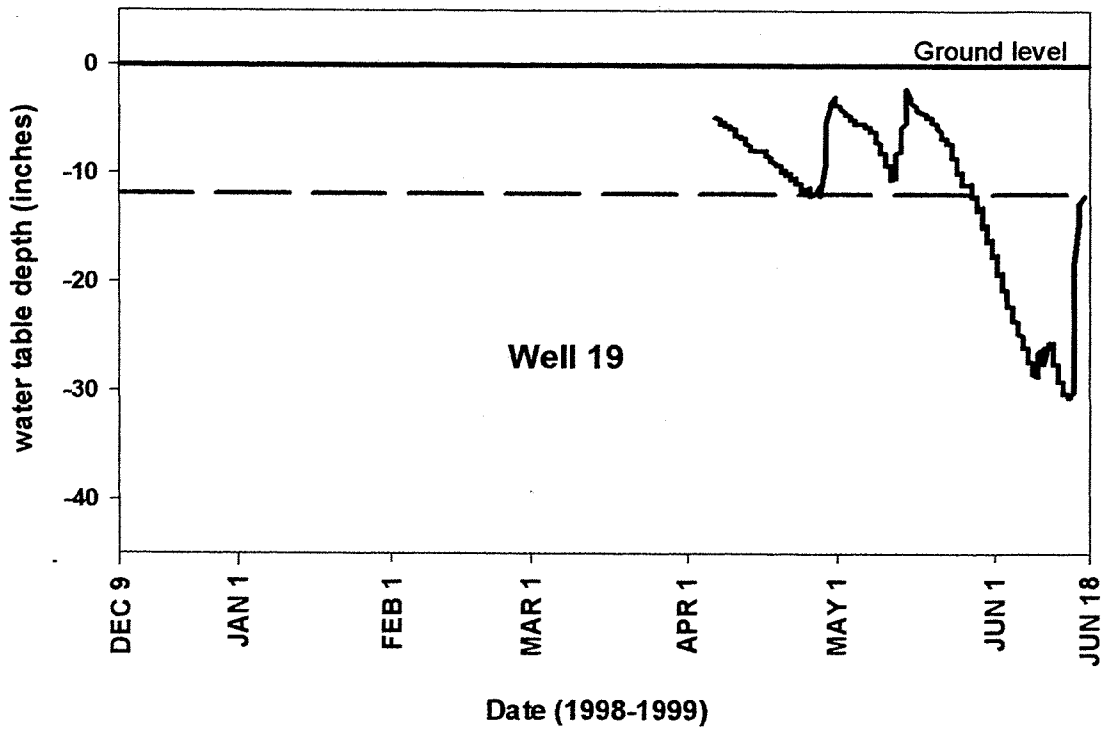
APPENDIX C

**Hydrographs for the
Groundwater Monitoring Wells**

Sixteen continuous groundwater monitoring wells were installed to provide groundwater flow data and wetland hydroperiod information relative to drainage networks. Groundwater conditions were conceptually modeled using DRAINMOD, a computer model for simulating relatively shallow soils with high water tables. Drainage impacts to wetlands resulting from ditches were evaluated based on NRCS soil series and regional rainfall data. The conceptual model was utilized to predict the extent of wetland degradation due to ditching and the potential for wetland restoration through effective removal of the drainage network.
