MITIGATION PLAN

**Sandy Bridge Farm Restoration Site
Rutherford County, North Carolina
DMS Contract 6400
DMS Project Number 96920**

**Broad River Basin
Cataloging Unit 03050105**

June 2016

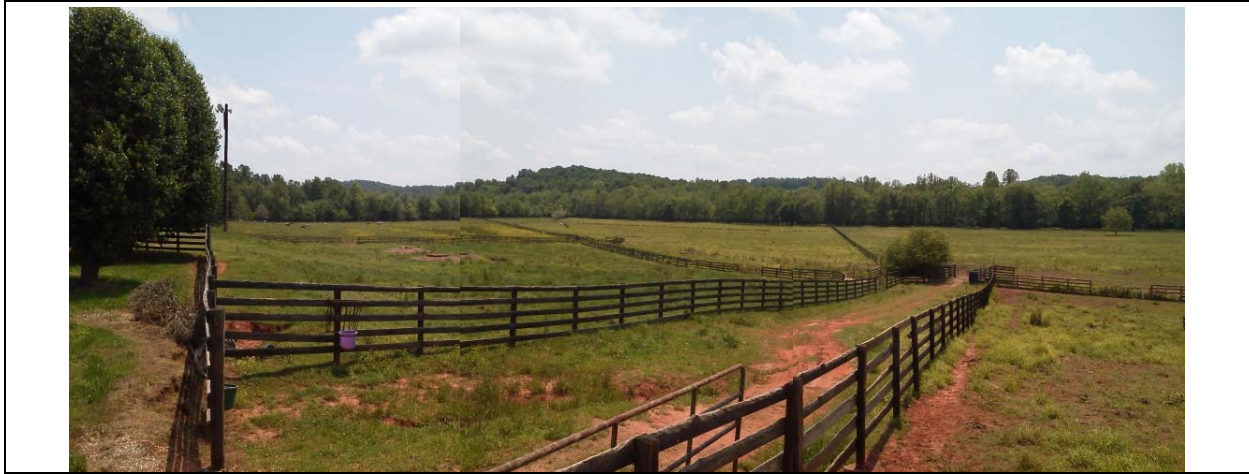
2.8 Site Photographs

Project site overview, looking southwest from the top of the project site near Rock Road. 2/12/13.

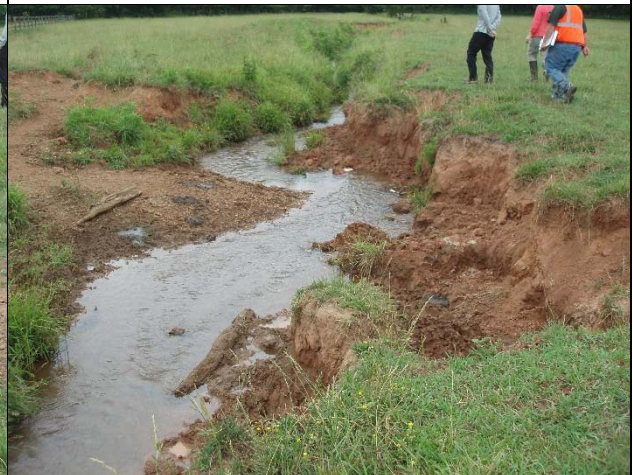
View looking south and downstream at T1. Significant bank erosion has been caused by cattle access to the stream. 6/4/15

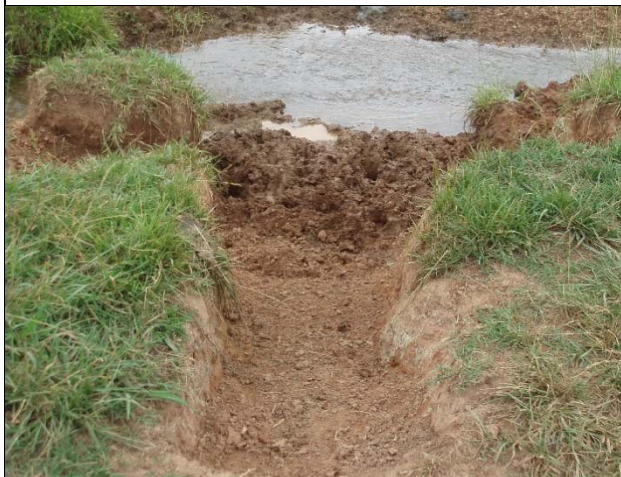
View looking east at erosion from cattle access to T1. 6/4/15

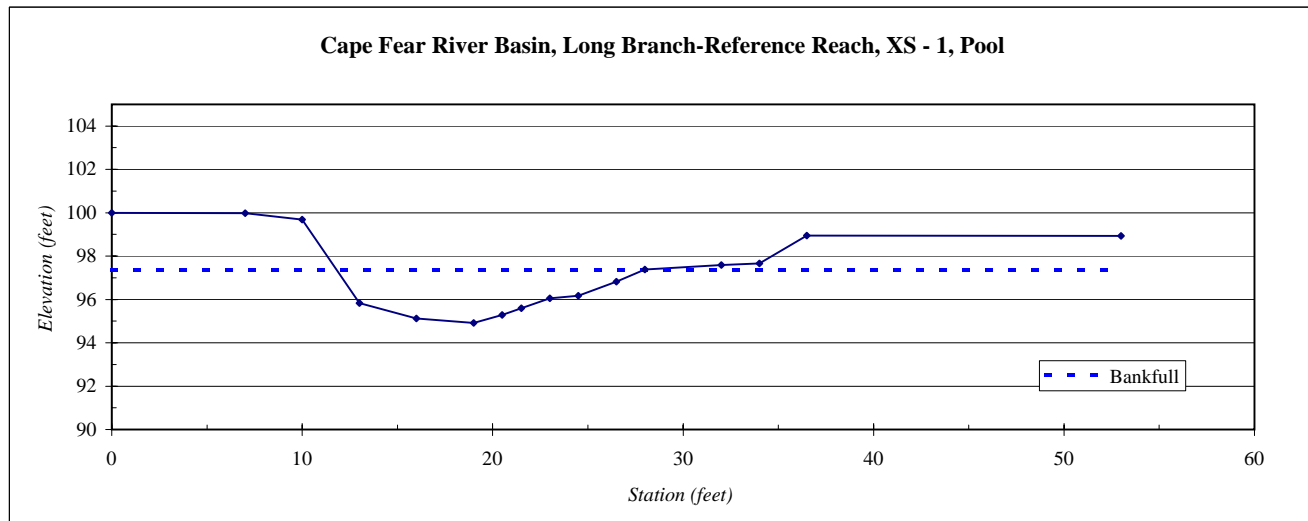
Cape Fear River Basin, Long Branch-Reference Reach, XS - 1, Pool

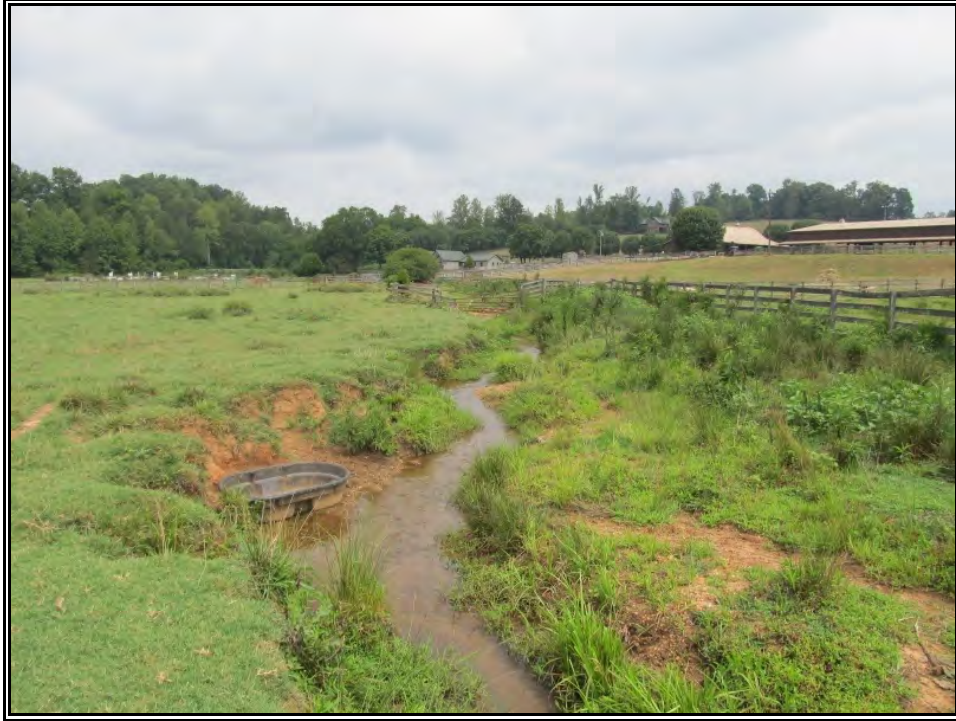
Figure 3. View of the unnamed tributary in the project tract, looking north.

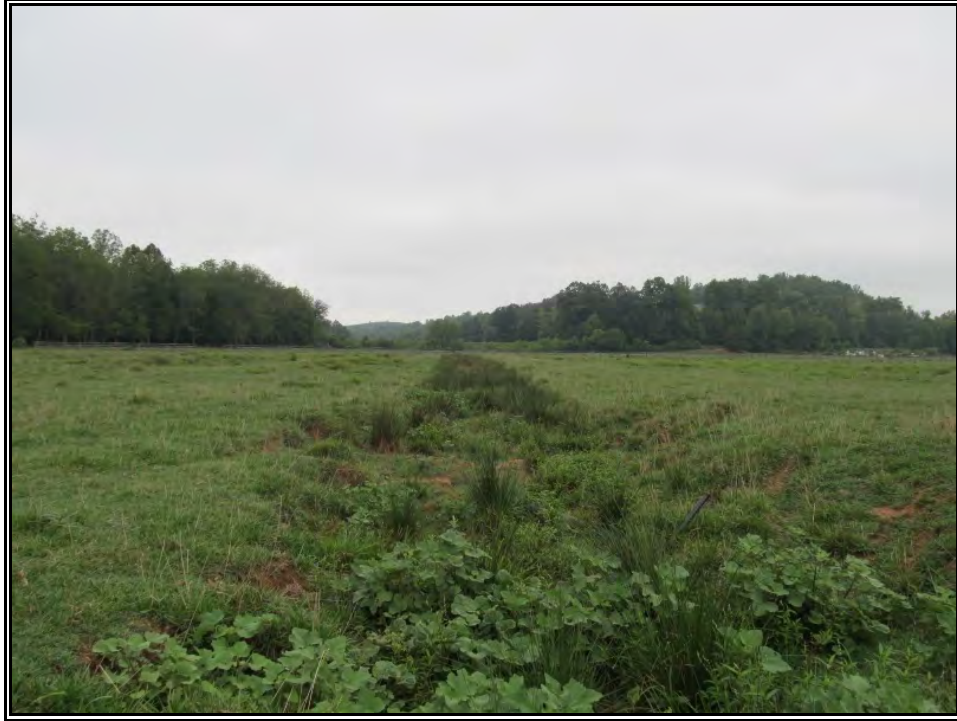
Figure 5. View of a drainage ditch in the western portion of the tract, looking northwest.

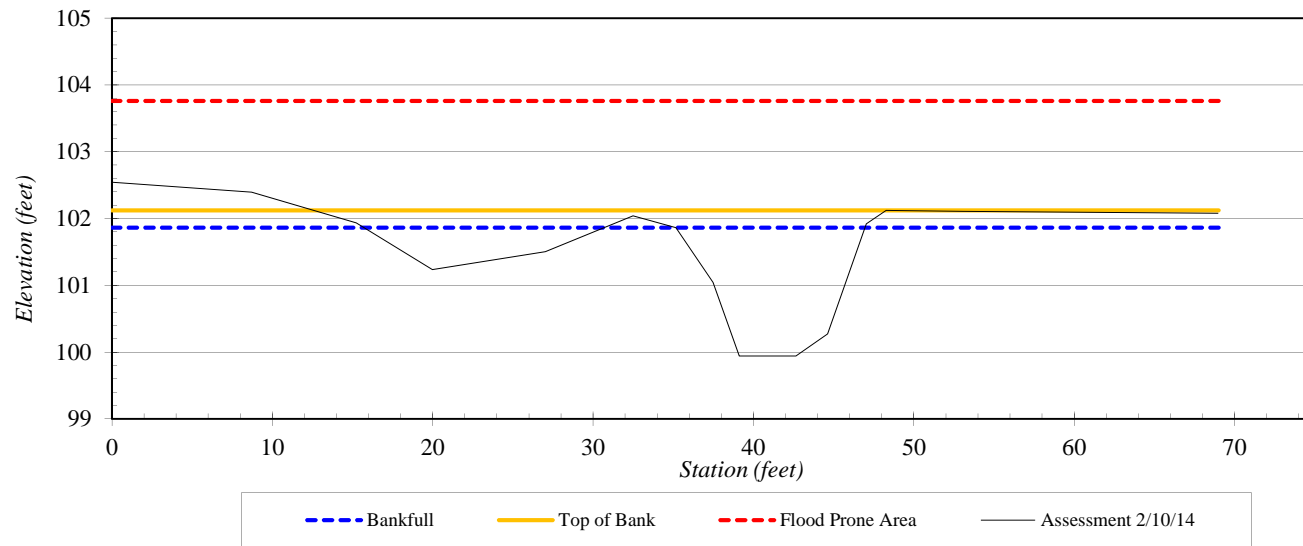
Broad River Basin, Catheys Creek, XS-1

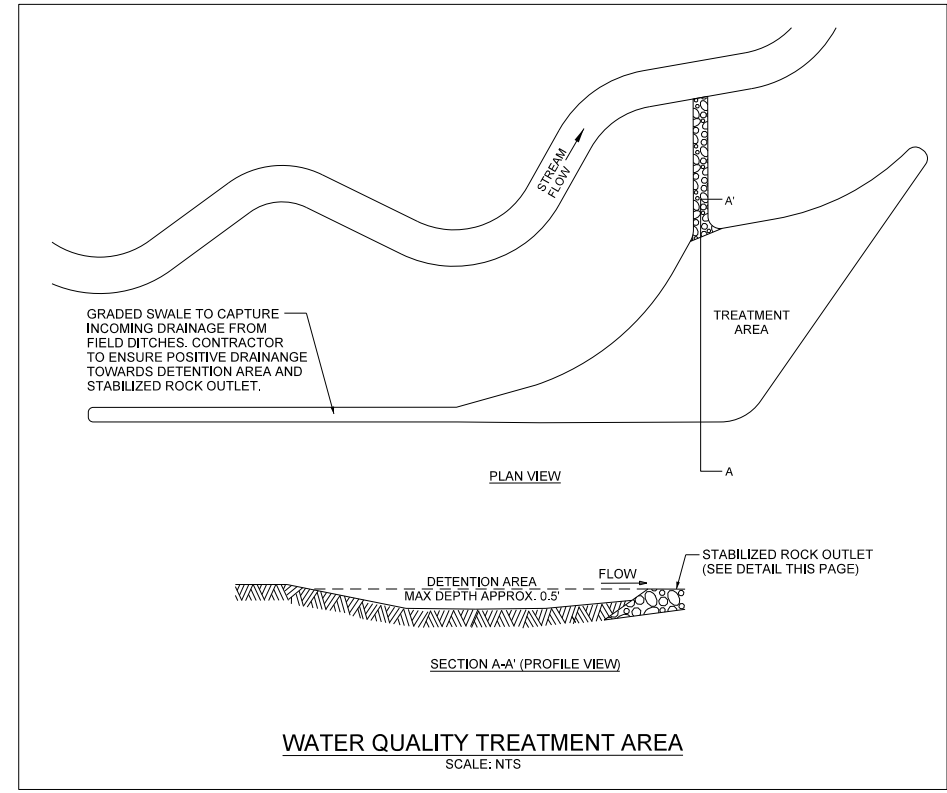
WATER QUALITY TREATMENT AREA
SCALE: NTS
