**RE: Sandy Creek MY-05 2010 Monitoring Report, Mary's Creek and Cane
Creek: 2009 Annual Monitoring Report - Year 3**

SANDY CREEK

Durham County, North Carolina
EEP Project No. 322

2010 Annual Monitoring Report
(Measurement Year-5 - MY5 (2010) – 1st year post-repair)
Site Constructed 2003/Repaired 2008-2009

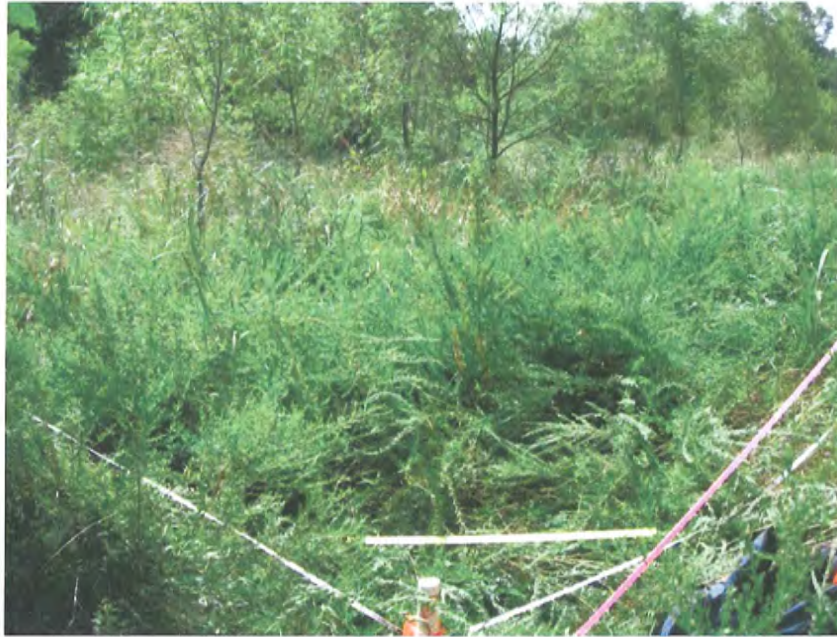
Invasive exotic species on site include several stands of Chinese lespedeza (*Lespedeza cuneata*), observed along the woodland margins and within vegetation monitoring plot 1. These areas were not disturbed during the wetland maintenance activities conducted between December 2009 and February 2010.

Photo 1. Vegetation Monitoring Plot 1.

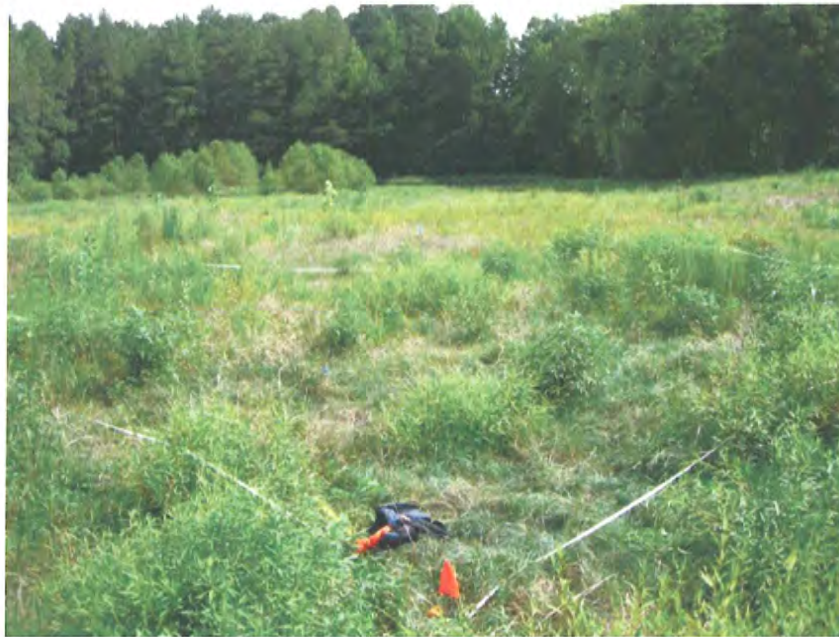
Wetland maintenance activities conducted in December 2009 involved the removal of vegetation where vegetation monitoring plots 2, 3, and 4 were located, leaving only vegetation monitoring plot 1 intact. The site was replanted and plots 2, 3, and 4, were re-established in February 2010. Level I of the CVS-EEP protocol was administered for plots 2, 3, and 4 for Monitoring Year (MY)-05, which accounts for planted stems only. Vegetation monitoring plot 1 was not replanted therefore it remained in place where it was originally established in 2004. Level II of the CVS-EEP protocol was administered for plot 1 which includes planted and natural stems. As of the August of 2010, including all four monitoring plots, there were 242 planted stems/acre and 333 stems/acre including natural and planted stems. The success criterion for planted woody species is 320 stems/acre after MY-03. A mortality rate of ten percent will be allowed after MY-04 (288 stems/acre), with another ten percent allowed after MY-05 (260 stems/acre). The primary reason for low plant survivorship in 2010 was due to abnormally wet conditions in the Spring 2010 resulting in long periods of standing water that essentially drowned to newly installed plants before plantings could get established. Soil conditions at the site were improved with the addition of topsoil during the wetland maintenance activities. Due to a high mortality rate of the plantings installed in January 2010, the contractor was required to replant the site in March 2011. Planted stems were

Photo 2. Vegetation Monitoring Plot 2.

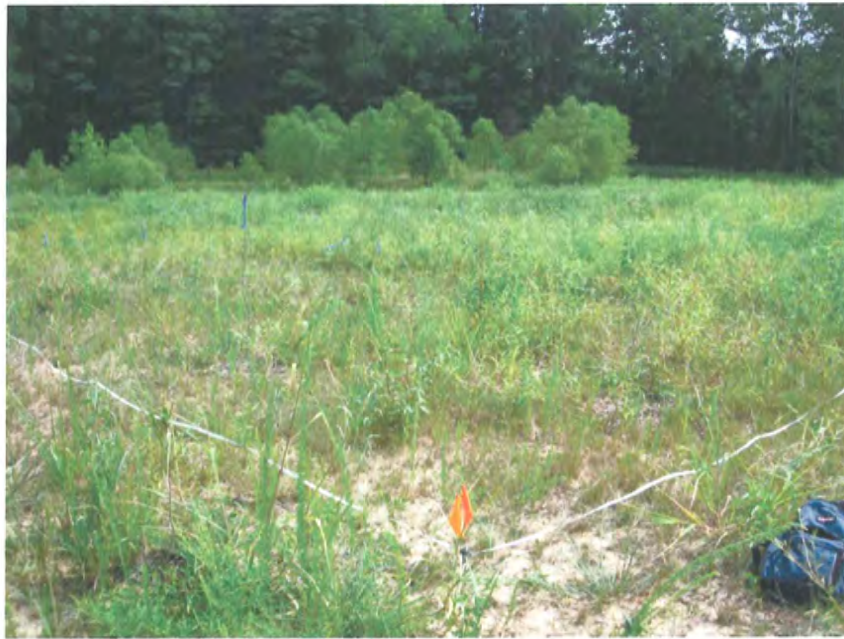
Photo 3. Vegetation Monitoring Plot 3.

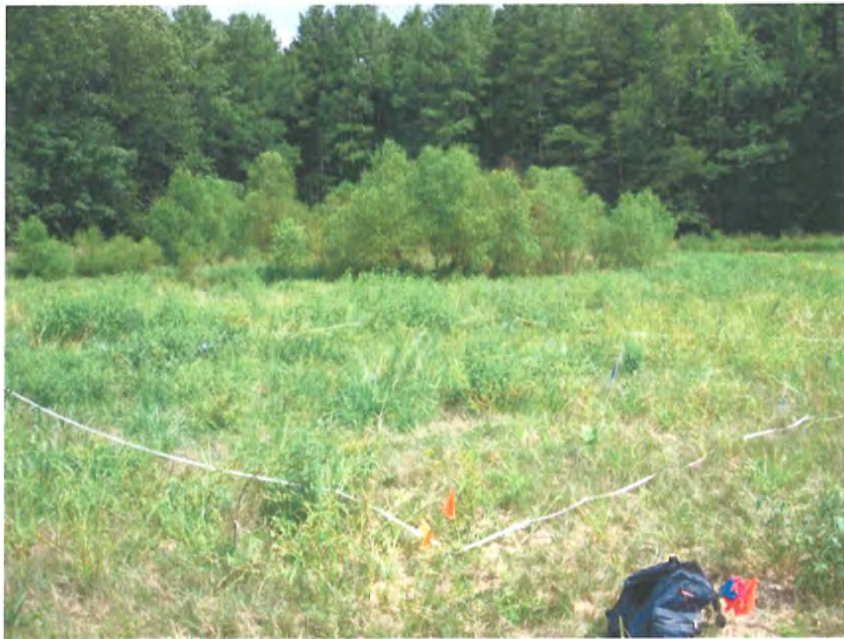
Photo 4. Vegetation Monitoring Plot 4.

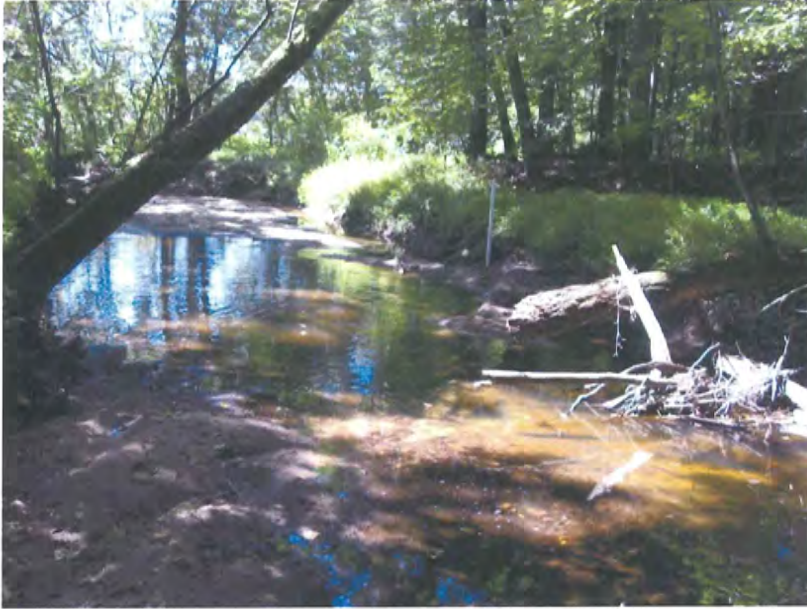
Photo Station 1: Log Vane #1 (Station 2 + 04)

The log vanes in Sandy Creek were evaluated for stability and effectiveness. Structurally, the site looks increasingly stable. The stream banks exhibit very little degradation and are stable and vegetated for the majority of the stream. There are a few areas where debris has collected that is creating minor bank erosion. Most of the log vanes were located and photographed. Some log vanes appear to have been covered by sediment. Photographs were also taken of the debris areas.

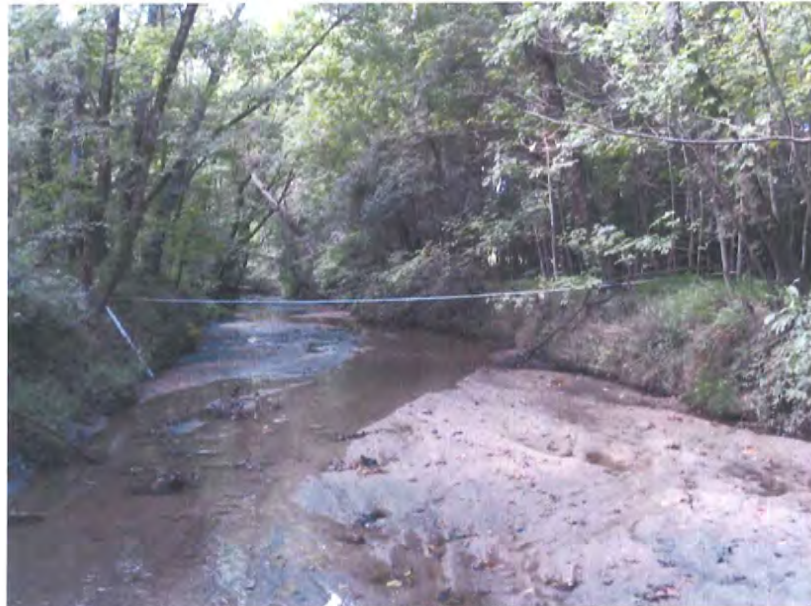
Photo Station 14: Permanent Cross-Section (18 + 25) Viewed Looking Downstream

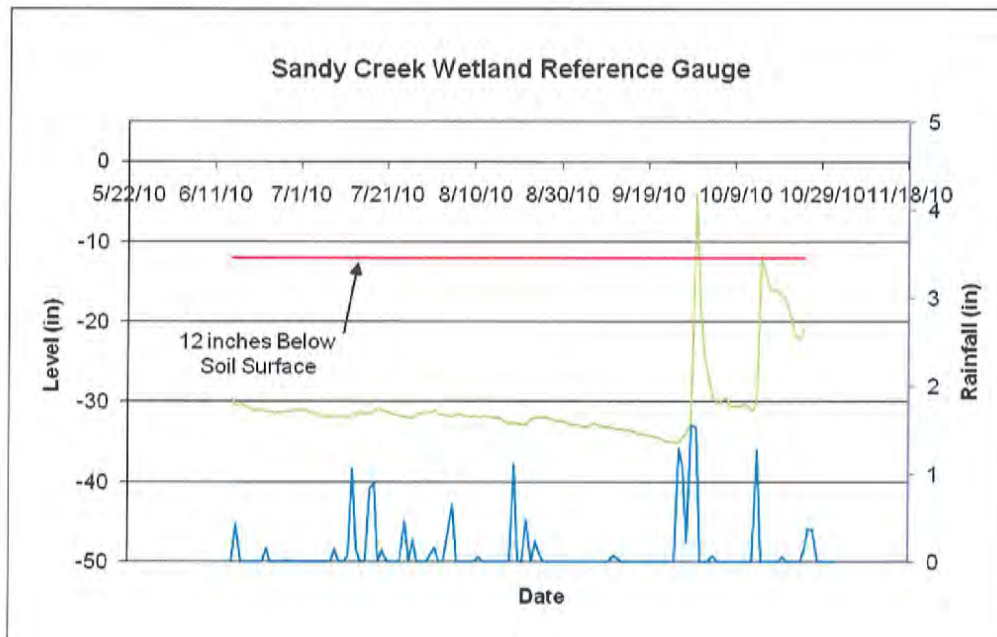
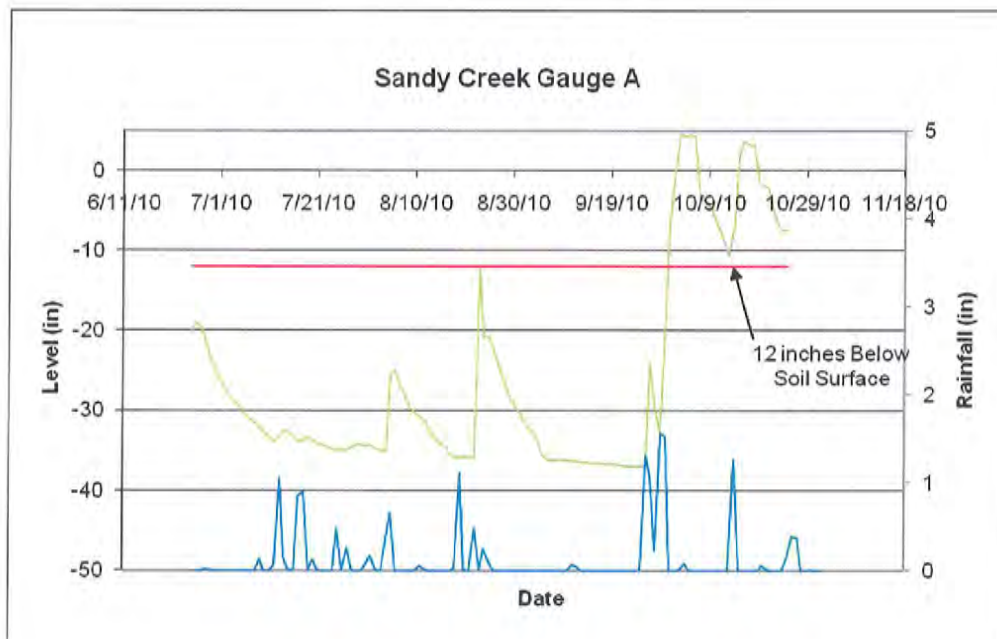
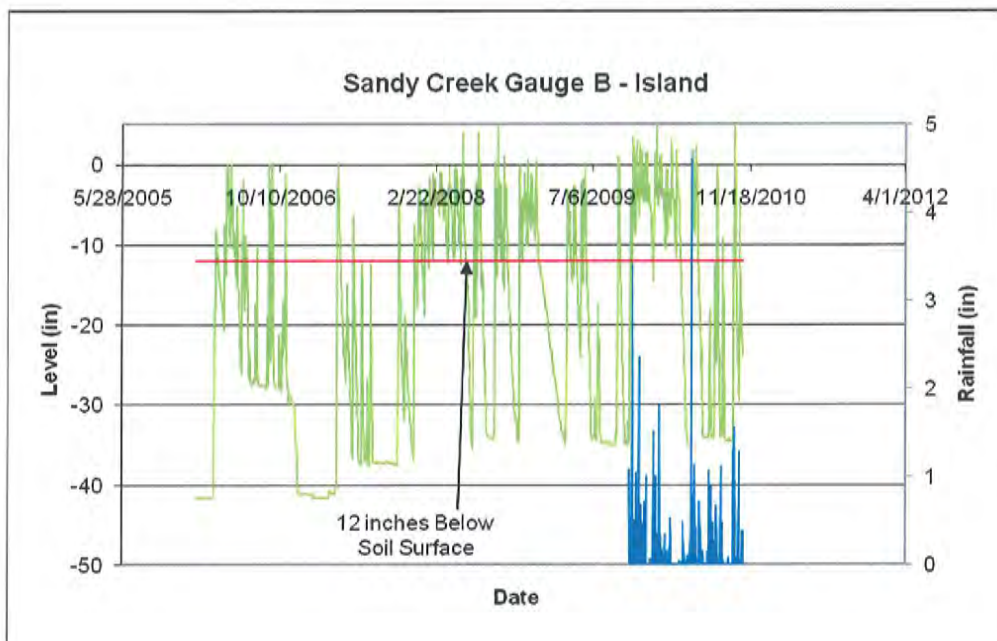
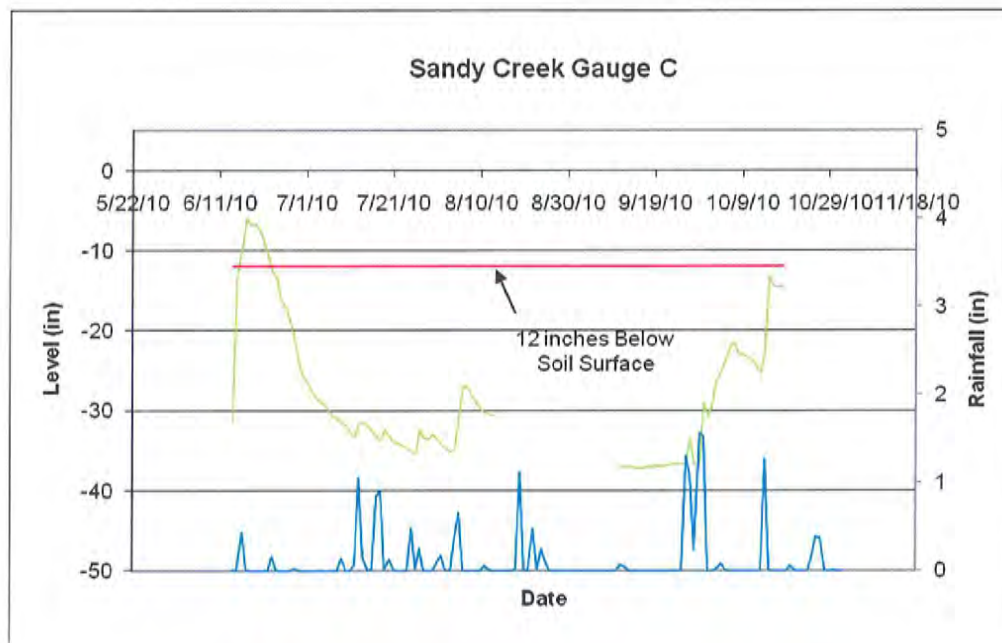
Figure 5. Precipitation and Water Level Plots

The site was re-graded between December 2009 and February 2010. New groundwater gauges were installed in the spring of 2010 at three locations – the reference wetland gauge, gauge A, and gauge C. Gauge B remained undisturbed in its original location. There are data gaps from March to June 2010 for the reference gauge, gauge A, and gauge C. A complete growing season dataset was only collected from gauge B. Gauge B did exhibit saturation within 12 inches of the ground surface for more than 12.5% of the growing season. The average annual growing season for Durham County is 227 days (March 30 - November 11). Groundwater data for a complete growing season for all gauges will be available from the 2011 growing season and will be provided in the 2011 Monitoring Year 6 Report.
