# **SANDY CREEK**

Durham County, North Carolina  
EEP Project No. 322  
Contract No. D08039S

2013 Annual Monitoring Report  
(Measurement Year-8 – MY8 (2013) – 4<sup>th</sup> year post-repair)  
Site Constructed 2003/Repaired 2008-2009/Replanted 2011

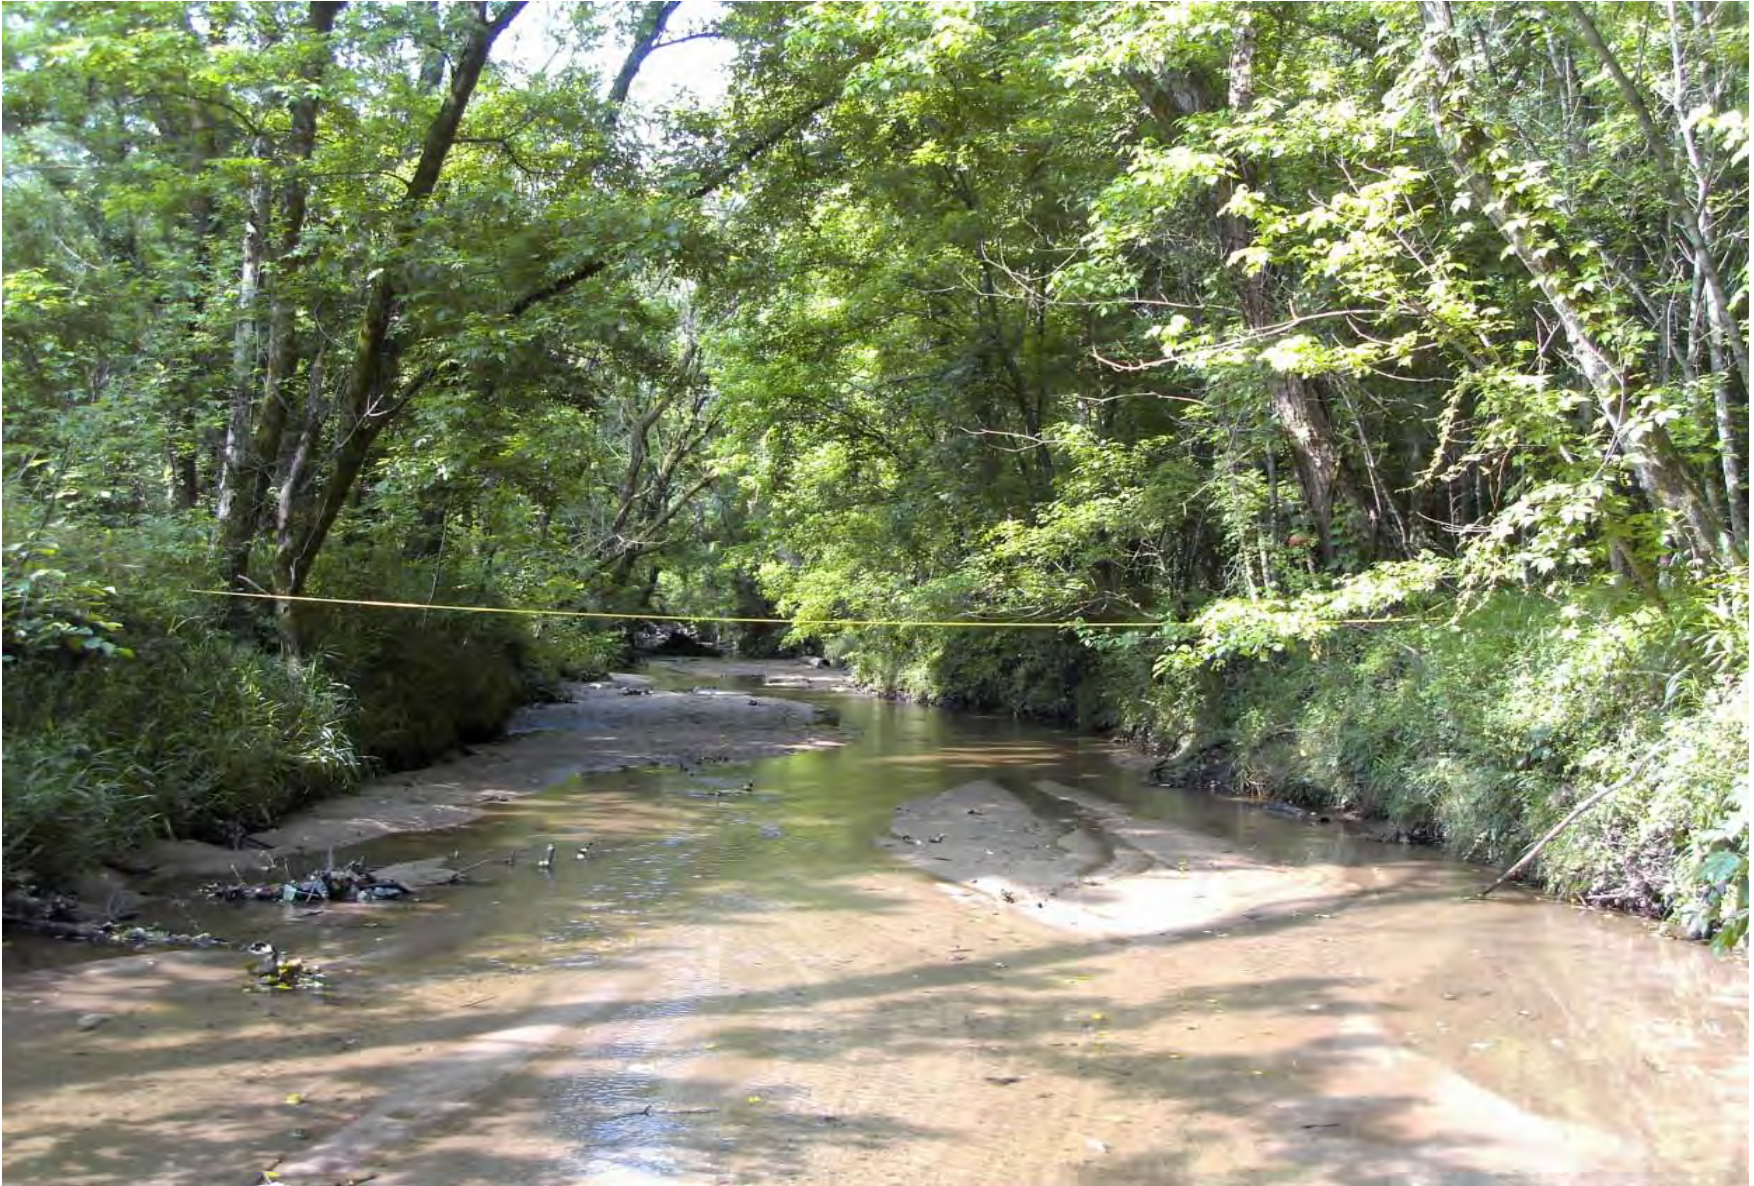
Project: Sandy Creek/Project No. 322		Summary (bankfull)															
Cross Section: Cross Section 1			MY0	MY1	MY3	MY5	MY7	MY8									
Feature: Riffle		A (BKF)	109.6	114.7	119.7	110.5	107.9	112.6									
Station: 18+25		W (BKF)	31.4	31.4	31.2	31.3	30.7	30.3									
Date: 6/5/12		Max d	4.1	4.6	5.3	4.2	4.2	4.4									
Crew: BW, RZ		Mean d	3.5	3.7	3.8	3.5	3.5	3.3									
		W/D	9.0	8.6	8.1	8.9	8.7	8.2									
MY00-2003			MY01-2005			MY03-2006			MY05-2010			MY07-2012			MY08-2013		
Station	Elevation	Notes	Station	Elevation	Notes	Station	Elevation	Notes	Station	Elevation	Notes	Station	Elevation	Notes	Station	Elevation	Notes

**Downstream facing view of Cross Section 1.**
