Charles Williams Stream, Wetland and Buffer Site

**Randolph County, North Carolina
State Construction Office Project No. 070712501
EEP Project No. 80**

Final Stream Restoration Plan

May 1, 2009

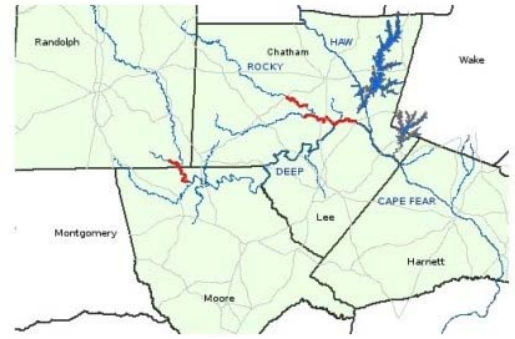
Red areas denote designated Critical Habitat for the Cape Fear shiner.

Critical habitat is defined under the Endangered Species Act as the specific areas within the geographical area occupied by a species which have physical or biological features essential to the conservation of the species and that may require special management considerations or protection, or specific areas outside the geographical area occupied by a species but for which those areas are essential for the conservation of the species. According to USFWS (2008), three designated areas of Critical Habitat exist for the Cape Fear Shiner:

1. Chatham County. Approximately 4.1 miles of the Rocky River from the NC 902 Bridge downstream to the bridge on SR 1010;
2. Chatham and Lee Counties. Approximately 0.5 river miles of Bear Creek, from the SR 2156 Bridge downstream to the Rocky River, then downstream along the Rocky River approximately 4.2 river miles to the Deep River, then downstream along the Deep River approximately 2.6 river miles to a point 0.3 river miles below the Moncure, North Carolina, USGS Gaging Station; and
3. Randolph and Moore Counties. Approximately 1.5 miles of Fork Creek, from a point 0.1 river miles upstream of the SR 2873 Bridge downstream to the Deep River then downstream approximately 4.1 river miles along the Deep River in Randolph and Moore Counties to a point 2.5 river miles below the SR 1456 Bridge in Moore County.

Based on available documentation, there are no Federal Designated Critical Habitats at or within a ten-mile radius of the Project Site.

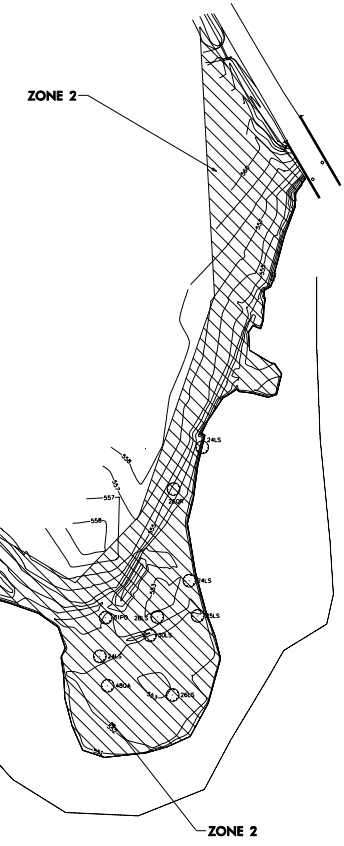
SHEET 5
SHEET

Planting Summary per Planting Zone
Charles Williams Site – SCO Project Number 070712501

PLANTING PLAN
CHARLES WILLIAMS STREAM,
WETLAND, AND BUFFER SITE
PREPARED FOR
ECOSYSTEM ENHANCEMENT PROGRAM

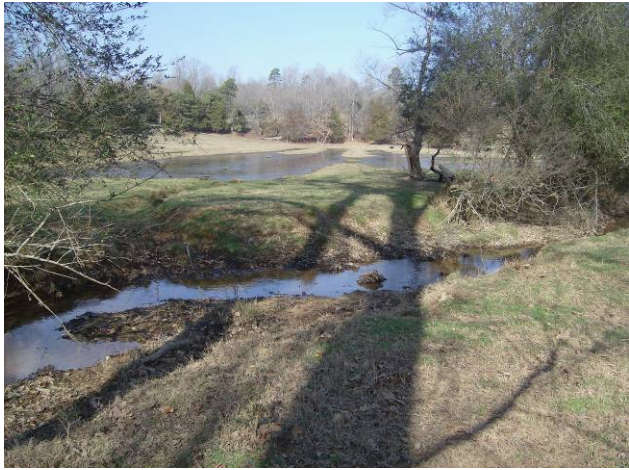
Facing west across the Unnamed Tributary approximately 500 linear feet upstream of the confluence with Sandy Creek.

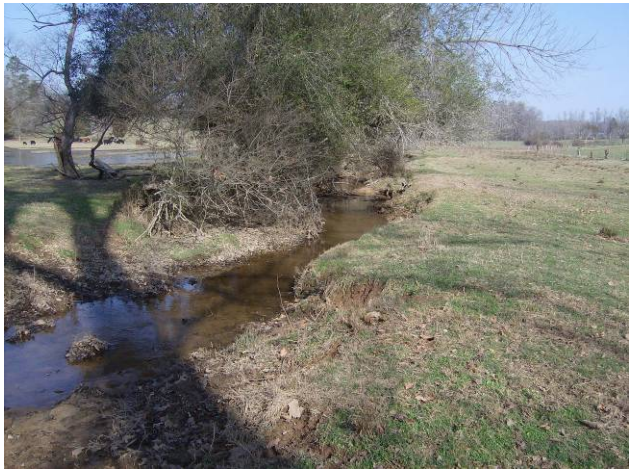
Facing upstream (north) along the Unnamed Tributary approximately 500 linear feet upstream of the confluence with Sandy Creek.

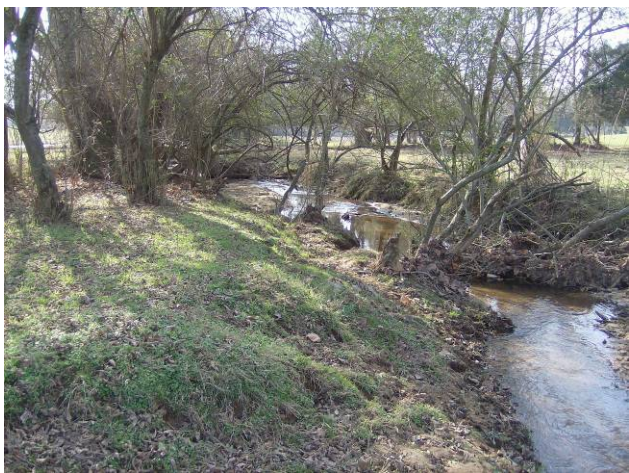
Facing downstream (south) along the Unnamed Tributary approximately 300 linear feet downstream (south) from the northern property boundary.

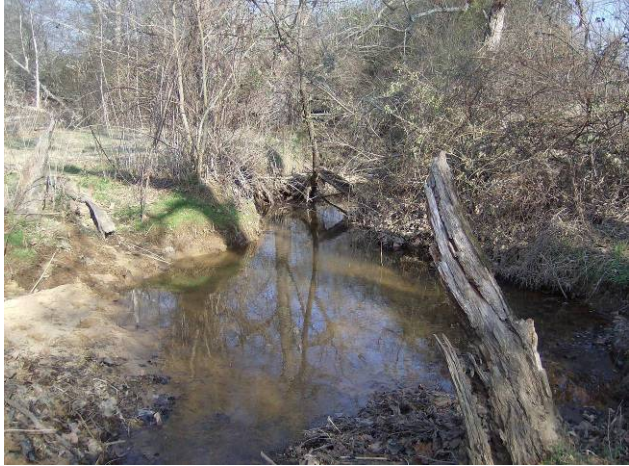
Facing upstream (north) along the Unnamed Tributary approximately 100 linear feet downstream (south) from the northern property boundary.

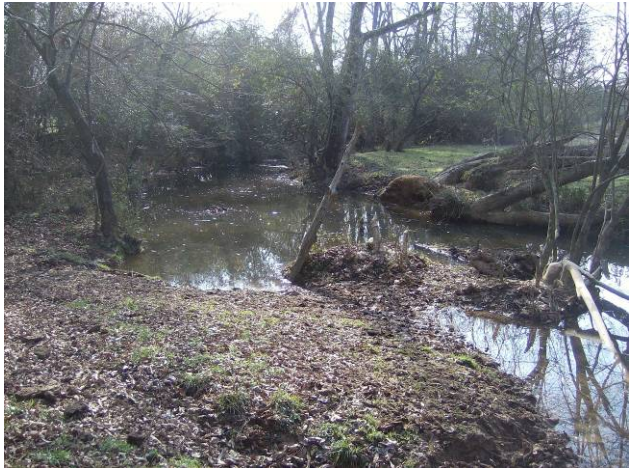
Facing downstream (south) along the Unnamed Tributary approximately 100 feet downstream (south) from the northern property boundary.

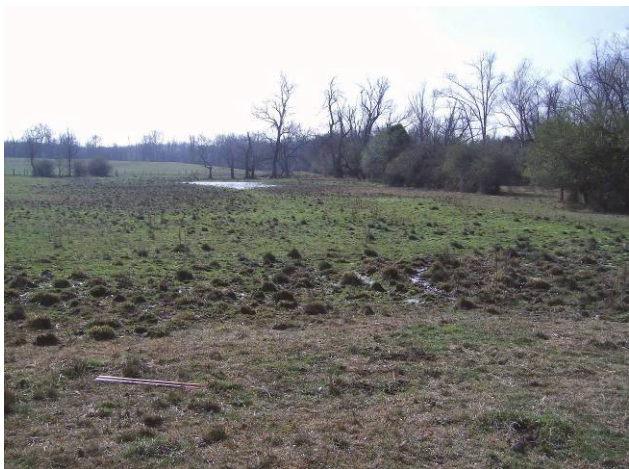
Facing downstream (south) from the northern property boundary at the eastern floodplain area associated with the Unnamed Tributary.

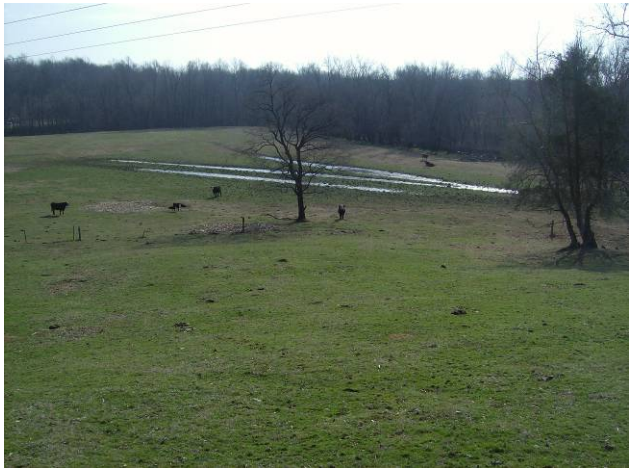
Facing southwest across the large floodplain area of Sandy Creek. Sandy Creek flows from east to west (left to right across picture) just inside the existing tree line.

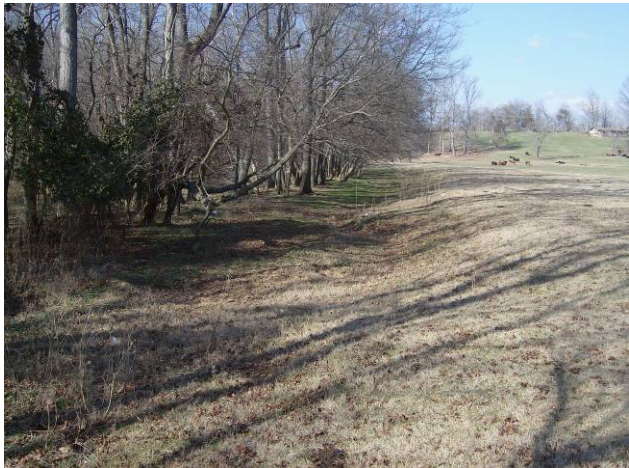
Facing west along the floodplain area of Sandy Creek. Sandy Creek is situated to the left of the photograph. Note the existing terrace feature signifying a historic active floodplain.

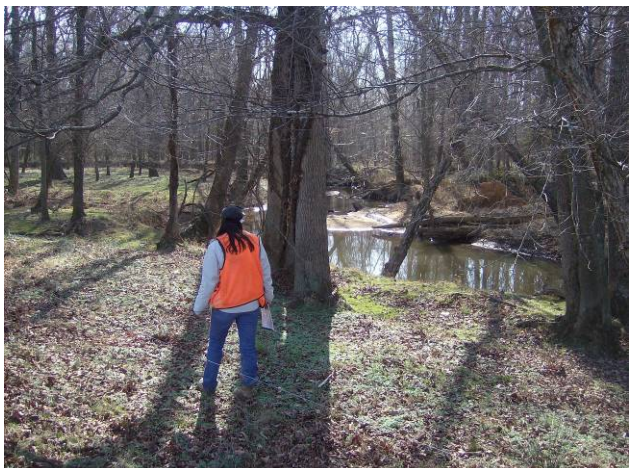
Facing upstream (west) along Sandy Creek. This photograph is taken approximately 1,500 linear feet downstream of the SR 2442 bridge.

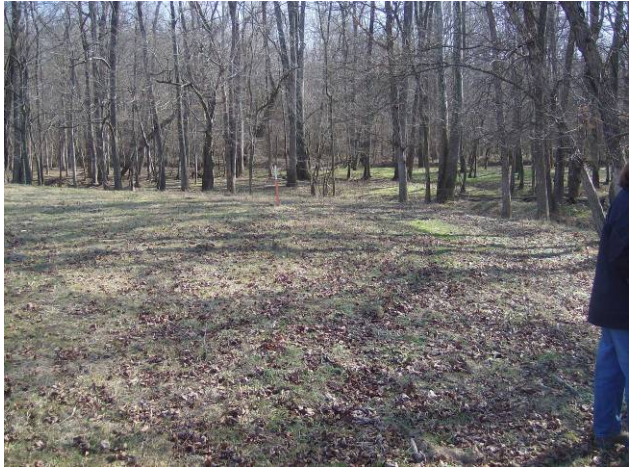
Facing west along the Sandy Creek floodplain area. The carsonite post in the middle of the photograph depicts the conservation easement boundary.

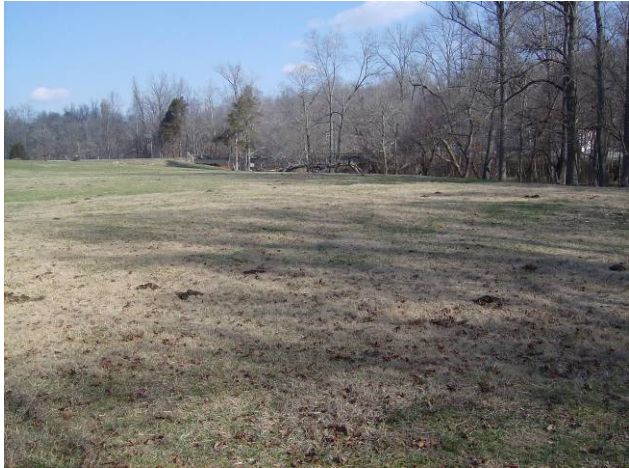
Facing west towards the SR 2442 bridge over Sandy Creek. The easement area and stream channel are along the right edge of the photograph.

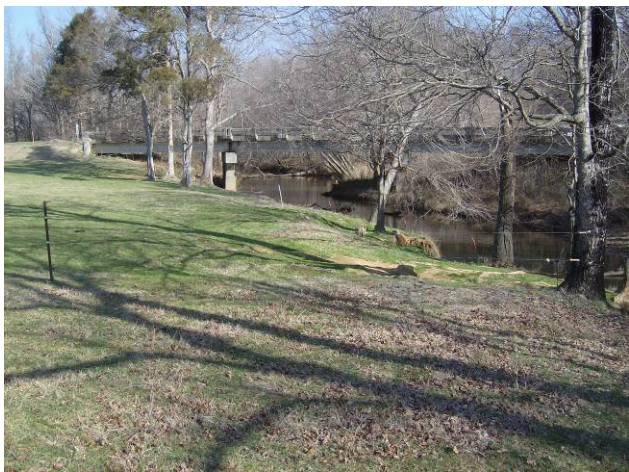
Facing west at the bridge over Sandy Creek. The easement intersects SR 2442 approximately 100 feet north of the structure.

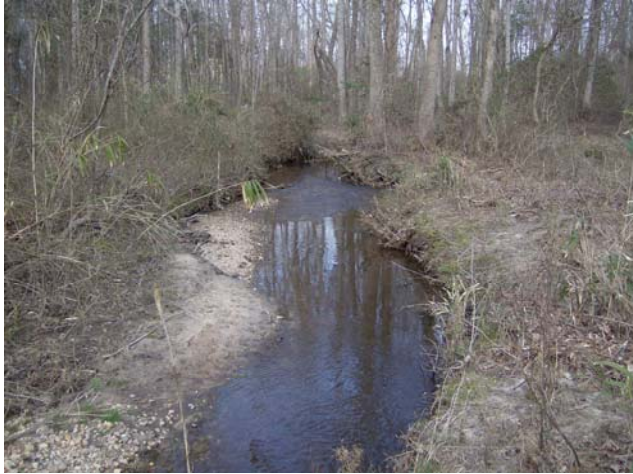
Facing downstream along the reference portion of Terrible Creek.

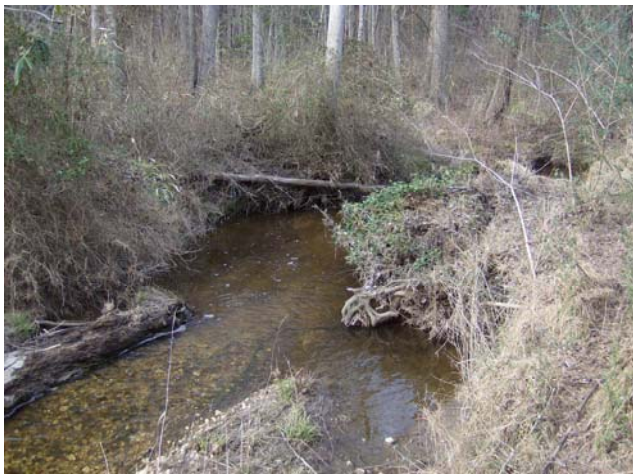
Facing downstream along the reference portion of Terrible Creek.

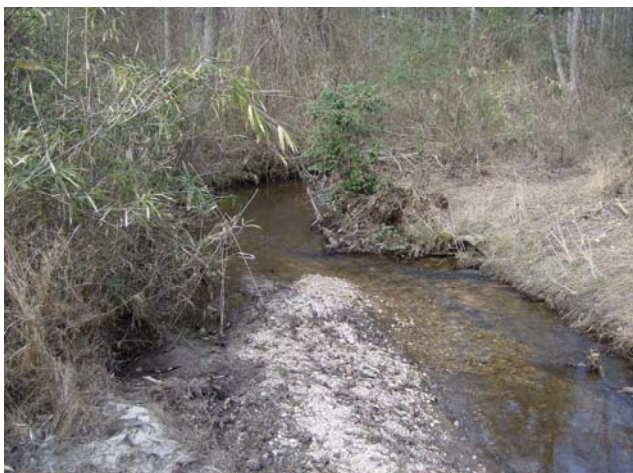
Facing upstream along a riffle associated with the reference portion of Terrible Creek.

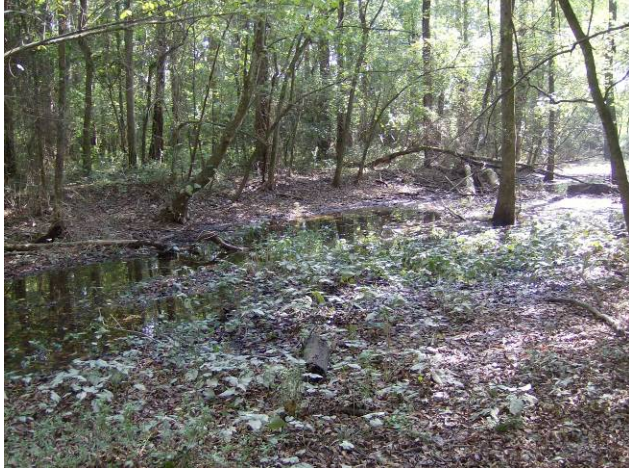
Facing southwest at the reference wetland area along the southern side of Sandy Creek, adjacent to the project site.

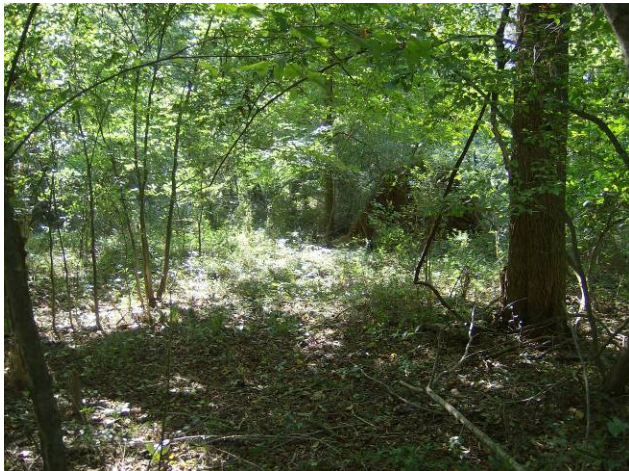
Facing west at the wetland reference area along the southern side of Sandy Creek, adjacent to the project site.

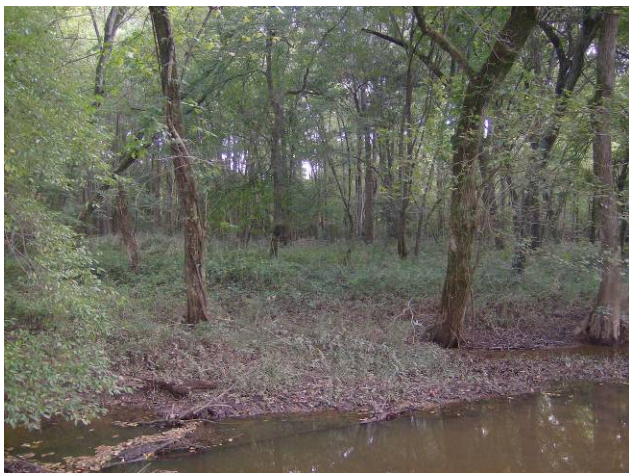
Facing south at the Sandy Creek floodplain and reference wetland area from the project site.

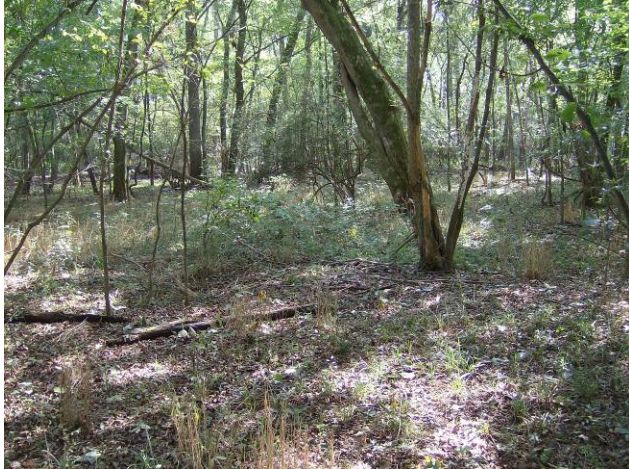
Facing east along the buffer area separating Sandy Creek and the reference wetland area.

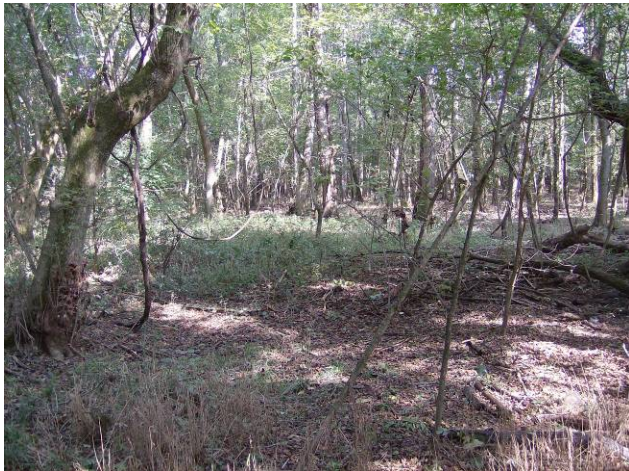
One of the small depressional areas along the southern floodplain of Sandy Creek.
