CHARLES WILLIAMS STREAM, WETLAND, AND BUFFER SITE
EEP Project No. 80

MONITORING YEAR 1 (2014)
Construction Completed February 2013
Planting Completed February 2014

Alamance County, NC
State Construction Project No. 07-07125-01A

FINAL REPORT June 2014

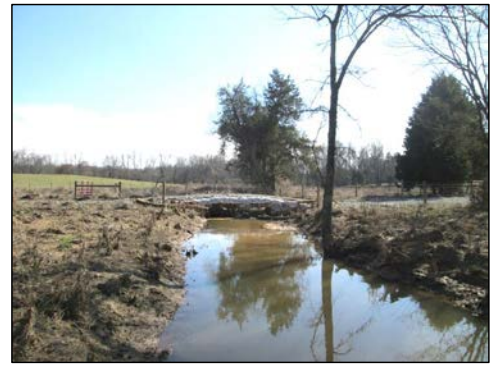
River Basin:	Cape Fear
Watershed:	UT Sandy Creek, MY-01
XS ID:	XS 2, Glide, STA. 19+36
Drainage Area (sq mi):	4.9
Date:	2/26/2014
Field Crew:	E. Hajnos, R. Robol

Station	Elevation
0.0	552.9
7.9	553.6
14.1	553.1
18.5	552.8
20.1	552.2
21.8	551.2
23.5	550.4
24.7	550.0
27.0	550.7
29.4	550.9
32.5	550.9
34.8	551.0
35.3	551.2
37.4	552.2
39.5	552.9
47.0	553.1
57.4	552.9

Stream Type: C5 Photograph facing downstream @ XS 2

SUMMARY DATA	
Bankfull Elevation:	552.8
Bankfull Cross Sectional Area:	32.8
Bankfull Width:	20.5
Flood Prone Area Elevation:	555.6
Flood Prone Width:	200+
Max. Depth at Bankfull:	2.8
Mean Depth at Bankfull:	1.6
Width/Depth Ratio:	12.9
Entrenchment Ratio:	>10
Bank Height Ratio:	1.1

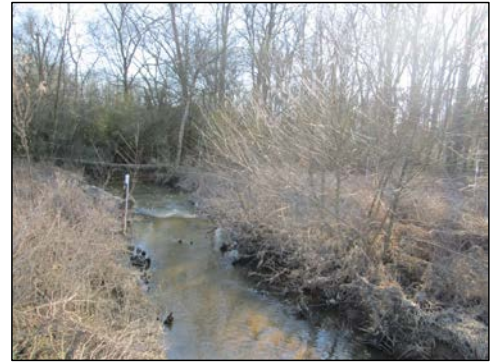
River Basin:	Cape Fear
Watershed:	UT Sandy Creek, MY-01
XS ID:	XS 4, Riffle, STA. 27+14
Drainage Area (sq mi):	4.9
Date:	2/26/2014
Field Crew:	E. Hajnos, R. Robol

Station	Elevation
0.0	551.0
11.2	551.1
16.9	551.5
23.3	551.6
26.0	550.7
27.7	549.8
28.5	548.7
30.4	548.7
31.9	548.8
33.1	548.9
34.7	549.2
35.9	549.8
36.2	549.9
44.5	550.7
48.6	551.9
57.4	551.9
63.8	552.1

Stream Type: C5 Photograph facing downstream @ XS 4

SUMMARY DATA	
Bankfull Elevation:	551.6
Bankfull Cross Sectional Area:	37.8
Bankfull Width:	24.5
Flood Prone Area Elevation:	554.5
Flood Prone Width:	200+
Max. Depth at Bankfull:	2.9
Mean Depth at Bankfull:	1.5
Width/Depth Ratio:	15.8
Entrenchment Ratio:	>8.0
Bank Height Ratio:	0.4

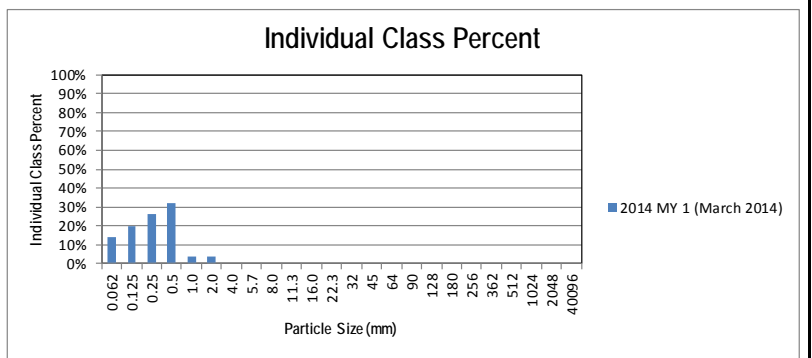
Charles Williams Stream, Wetland, and Buffer Site / 80					
Cross Section: 4					
Feature: Riffle					
2014 MY 1 (March 2014)					
Description	Material	Size (mm)	Total #	Item %	Cum %
Silt/Clay	silt/clay	0.062	7	14%	14%
Sand	very fine sand	0.125	10	20%	34%
	fine sand	0.25	13	26%	60%
	medium sand	0.5	16	32%	92%
	coarse sand	1.0	2	4%	96%
	very coarse sand	2.0	2	4%	100%
Gravel	very fine gravel	4.0	0	0%	100%
	fine gravel	5.7	0	0%	100%
	fine gravel	8.0	0	0%	100%
	medium gravel	11.3	0	0%	100%
	medium gravel	16.0	0	0%	100%
	coarse gravel	22.3	0	0%	100%
	coarse gravel	32	0	0%	100%
	very coarse gravel	45	0	0%	100%
	very coarse gravel	64	0	0%	100%
	Cobble	small cobble	90	0	0%
medium cobble		128	0	0%	100%
large cobble		180	0	0%	100%
very large cobble		256	0	0%	100%
Boulder	small boulder	362	0	0%	100%
	small boulder	512	0	0%	100%
	medium boulder	1024	0	0%	100%
	large boulder	2048	0	0%	100%
Bedrock	bedrock	40096	0	0%	100%
TOTAL % of whole count			50	100%

Summary Data	
D50	0.20 mm
D84	0.40 mm
D95	0.6 mm
