CHARLES WILLIAMS STREAM, WETLAND, AND BUFFER SITE
EEP Project No. 80

MONITORING YEAR 2 (2014)
Construction Completed February 2013
Planting Completed February 2014

Randolph County, NC
State Construction Project No. 07-07125-01A

FINAL REPORT December 2014

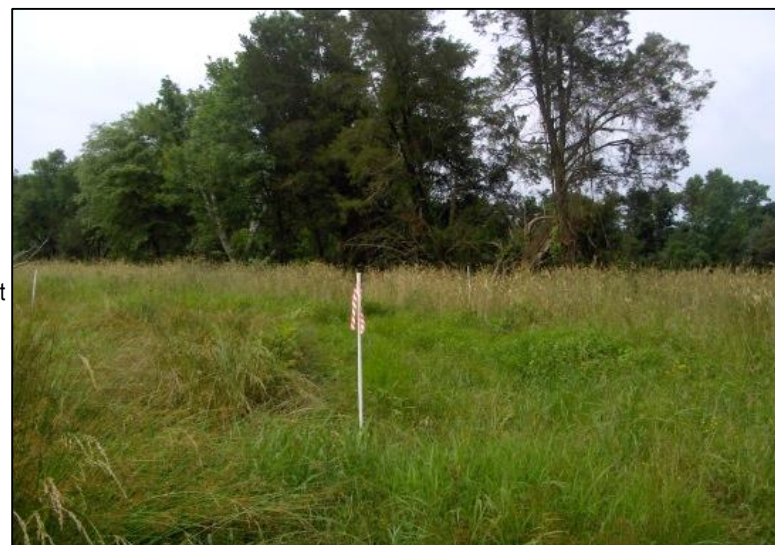
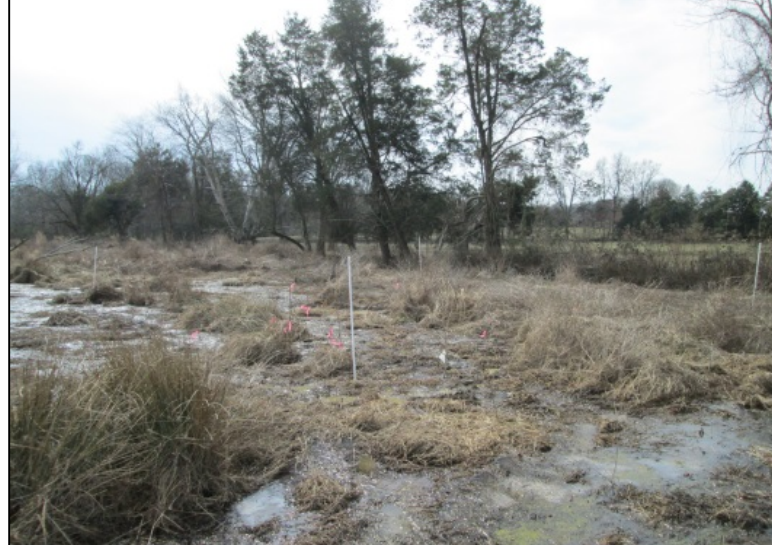
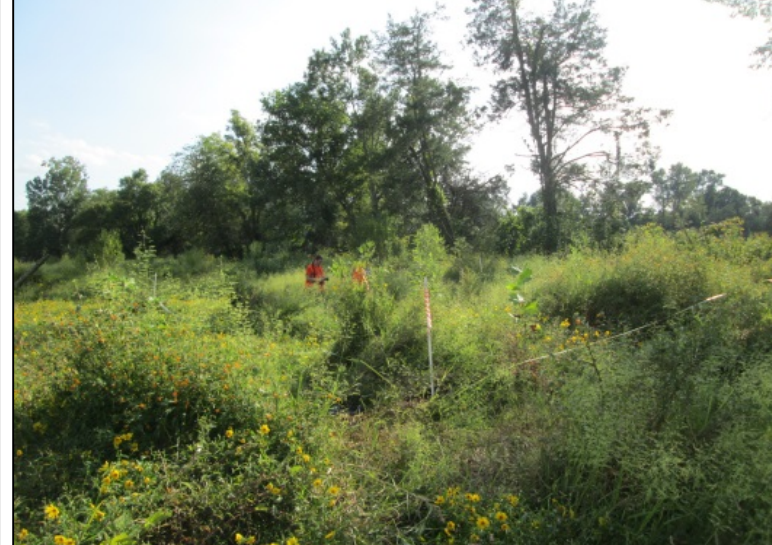
Vegetation Plot 6
Facing Southwest

Due to the random placement of vegetation plots, only one of the eight plots associated with stream/wetland credit is currently placed within the wetland enhancement area (Vegetation Plot #6). The remaining seven plots are situated in non-wetland areas; however, based on current site conditions, three plots (Vegetation Plots #3, #7, and #8) may likely be in wetland areas by MY4 assessments. The locations of the current plots will be reassessed during MY4 activities.

During MY2 monitoring, competition from dense native herbaceous vegetation was observed, and contributed to low planted woody stem counts in 10 of the 12 Vegetation Plots. Supplemental planting and herbaceous control is proposed between December 2014 and March 2015 to augment planted woody stems. Please refer to the letter and tables below.

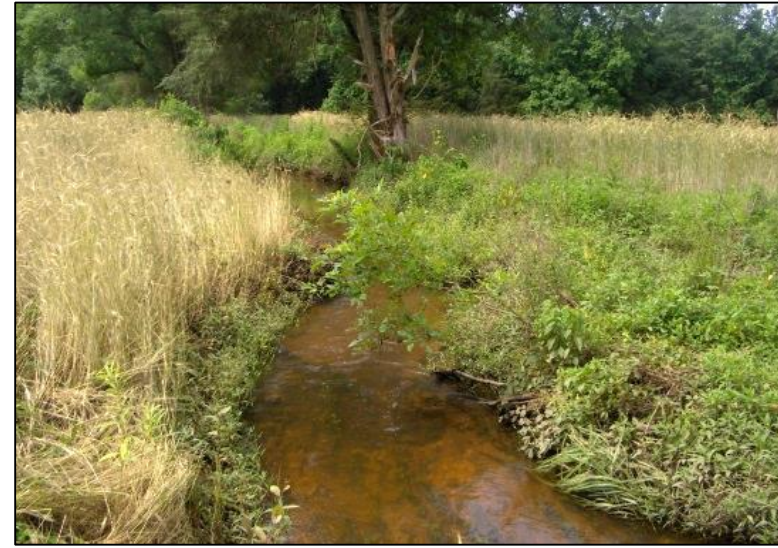
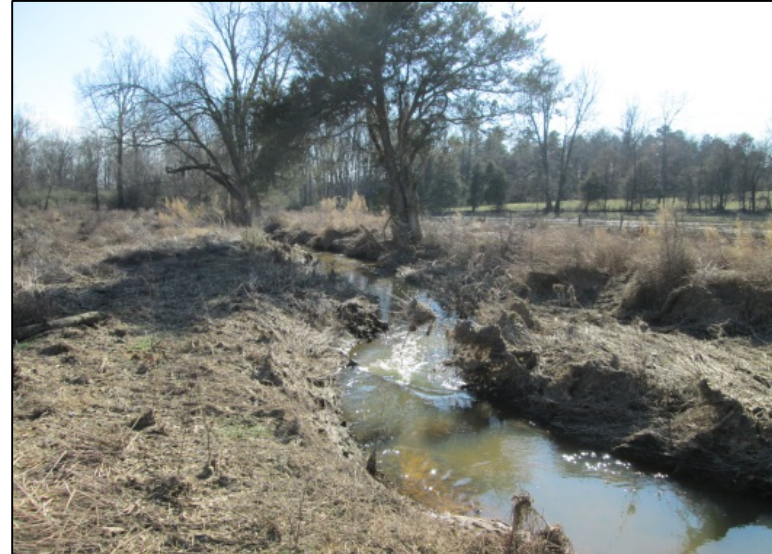
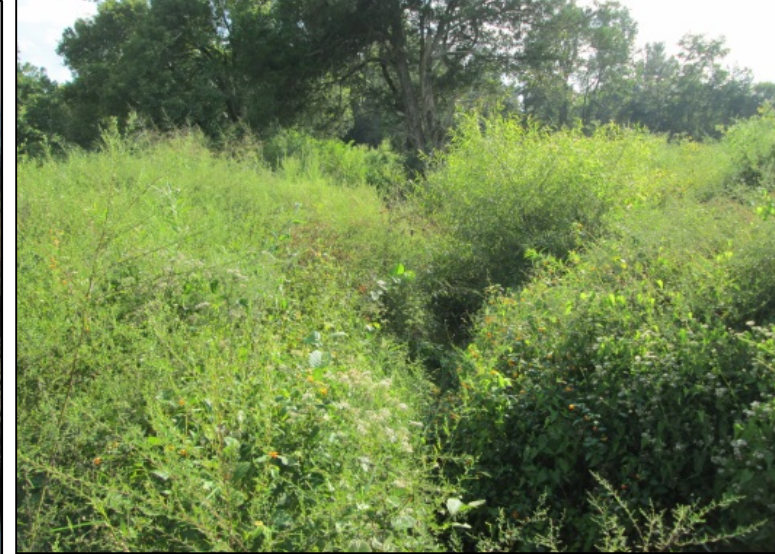
Cross Section 3
Facing
Downstream

Baseline MY0 (June 2013)

MY1 (March 2014)

MY2 (September 2014)

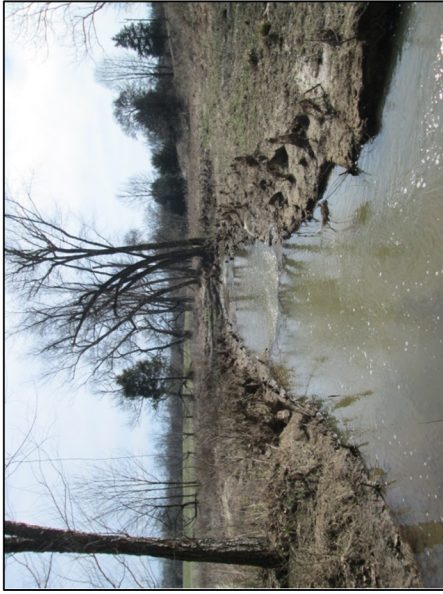
River Basin:	Cape Fear
Watershed:	UT Sandy Creek, MY-01
XS ID:	XS 1, Rifle, STA. 14+41
Drainage Area (sq mi):	4.9
Date:	9/16/2014
Field Crew:	E. Hajnos, R. Robol

Stream Type: C5 Photograph facing downstream @ XS 1

SUMMARY DATA	
Bankfull Elevation:	552.8
Bankfull Cross Sectional Area:	22.7
Bankfull Width:	23.9
Flood Prone Area Elevation:	554.7
Flood Prone Width:	66.1
Max. Depth at Bankfull:	1.8
Mean Depth at Bankfull:	0.9
Width/Depth Ratio:	25.2
Entrenchment Ratio:	2.8
Bank Height Ratio:	1.0

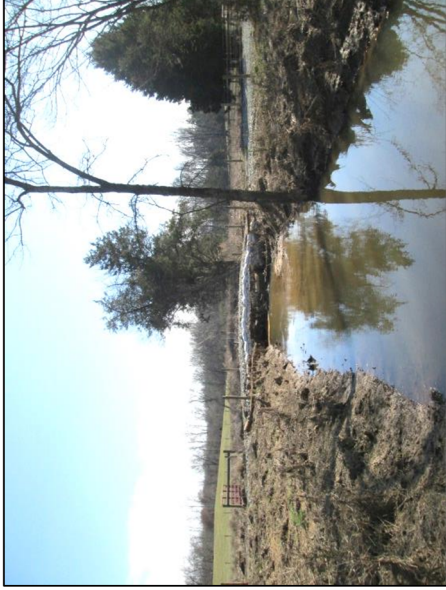
River Basin:	Cape Fear
Watershed:	UT Sandy Creek, MY-01
XS ID:	XS 2, Glide, STA. 19+36
Drainage Area (sq mi):	4.9
Date:	9/16/2014
Field Crew:	E. Hajnos, R. Robol

Stream Type: C5 Photograph facing downstream @ XS 2

SUMMARY DATA	
Bankfull Elevation:	552.83
Bankfull Cross Sectional Area:	35.3
Bankfull Width:	19.4
Flood Prone Area Elevation:	555.9
Flood Prone Width:	200+
Max. Depth at Bankfull:	3.1
Mean Depth at Bankfull:	1.8
Width/Depth Ratio:	10.7
Entrenchment Ratio:	>10
Bank Height Ratio:	1.0

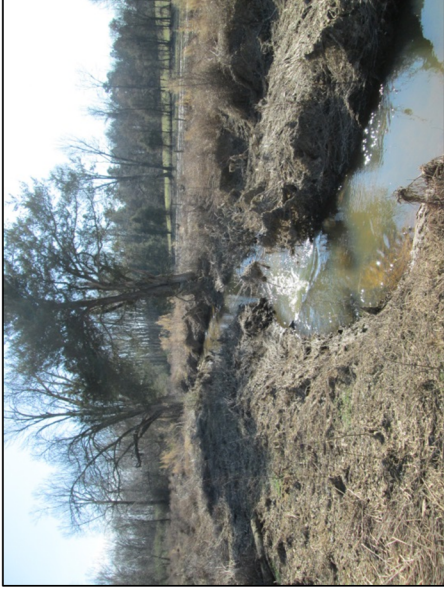
Stream Type: C5 Photograph facing downstream @ XS 3

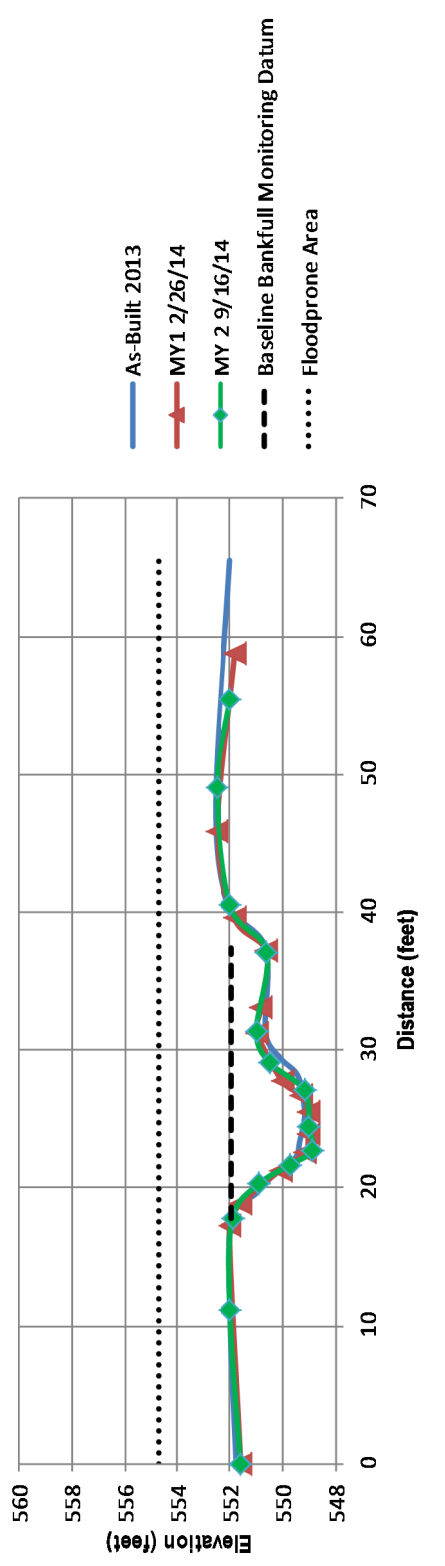
UT to Sandy Creek, Cross Section 3, Glide, Station: 23+49

SUMMARY DATA	
Bankfull Elevation:	551.9
Bankfull Cross Sectional Area:	33.5
Bankfull Width:	20.1
Flood Prone Area Elevation:	554.9
Flood Prone Width:	200+
Max. Depth at Bankfull:	3.0
Mean Depth at Bankfull:	1.7
Width/Depth Ratio:	12.1
Entrenchment Ratio:	>8
Bank Height Ratio:	1.0

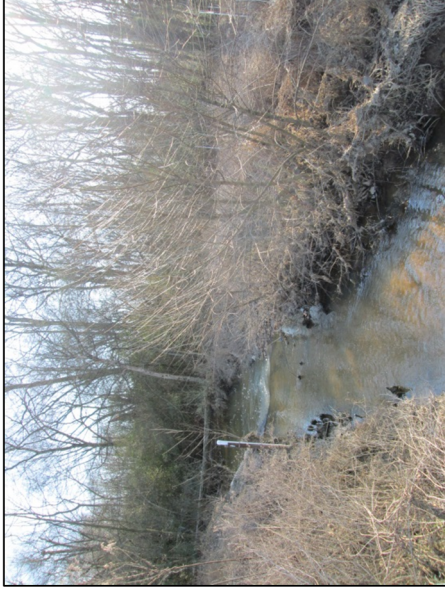
River Basin:	Cape Fear
Watershed:	UT Sandy Creek, MY-01
XS ID:	XS 4, Riffle, STA. 27+14
Drainage Area (sq mi):	4.9
Date:	9/16/2014
Field Crew:	E. Hajnos, R. Robol

Stream Type: C5 Photograph facing downstream @ XS 4

SUMMARY DATA	
Bankfull Elevation:	551.7
Bankfull Cross Sectional Area:	37.1
Bankfull Width:	24.1
Flood Prone Area Elevation:	554.6
Flood Prone Width:	200+
Max. Depth at Bankfull:	2.9
Mean Depth at Bankfull:	1.5
Width/Depth Ratio:	15.6
Entrenchment Ratio:	>8.0
Bank Height Ratio:	1.0

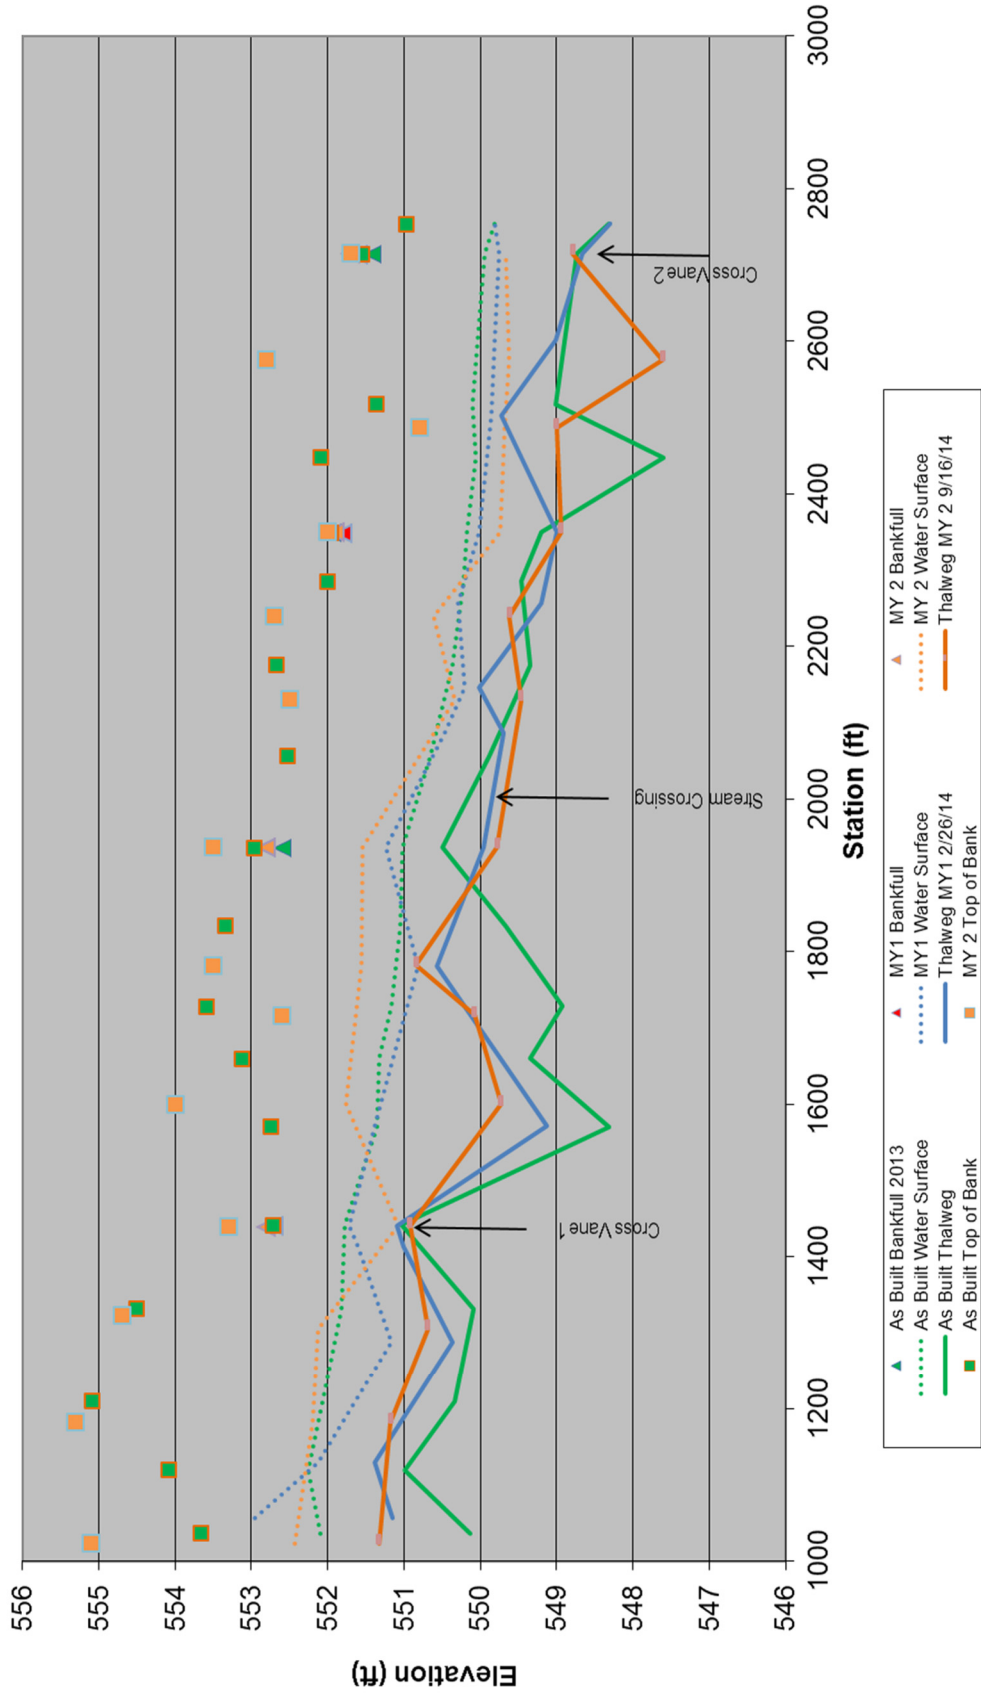
Longitudinal Profile Plot Exhibit

Profile Reach (UT Sandy Creek Sta. 10+00 to 17+53)

To determine the cause of this data representation, the raw point files were opened in Microstation and viewed in plan view. Longitudinal profile data shots were observed to be spaced widely apart and inconsistent in location between subsequent monitoring years. Due to the lack of detailed data collection, it is currently not possible to determine the actual longitudinal profile of the stream. There may be a single pool migrating downstream, or it is also possible that different pools were captured between As-built and MY2 data collection and the pools were completely missed during MY1. Because data points were not taken in the same spots, we cannot currently assess which of these possibilities is correct.
