ANNUAL REPORT FOR 2004

**Sandy Creek Mitigation Site
Randolph County
Project No. 8.U492301
TIP no. I-2402WM**

Prepared By:
Office of Natural Environment & Roadside Environmental Unit
North Carolina Department of Transportation
December 2004

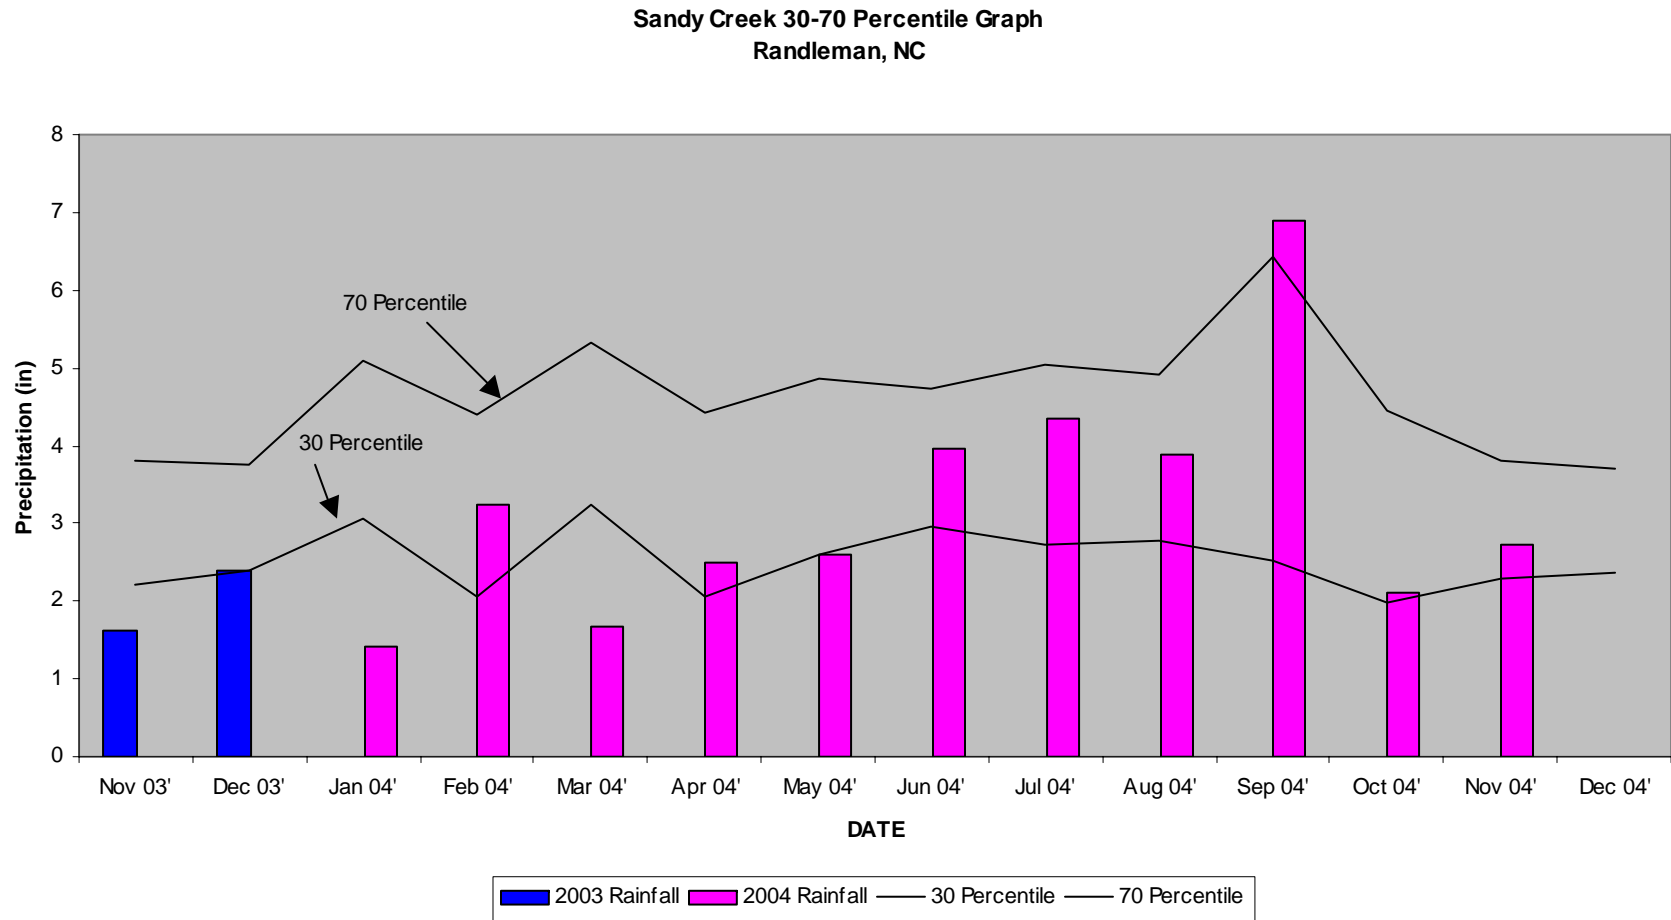
Figure 4: 30-70 Percentile Graph

Figure 4 provides an evaluation of the 2004 rainfall in comparison with historical rainfall data in order to determine whether 2004 was “average” in terms of precipitation. The historical rainfall data was collected from 1973 through 2004 (30 years). All rainfall data used in this analysis was obtained from the NC State Climate Office, Randleman weather station.

For the 2004-year, November (03’), January, March, and May experienced below average rainfall. December (03’), February, April, June, July, August, October, and November all recorded average rainfall for the site. September was the only month to experience above average rainfall. Overall, 2004 experienced an average rainfall year.
