**Sandy Creek Wetland Restoration
Randolph County, North Carolina
Annual Monitoring Report**
Monitoring Year: 2005

Monitoring Year: 2005
Measurement Year 5
As-Built Date: 1999
NCEEP Project Number: 321

SANDY CREEK WETLAND RESTORATION 2005 MONITORING REPORT

CONDUCTED FOR THE NORTH CAROLINA DEPARTMENT
OF
ENVIRONMENT AND NATURAL RESOURCES

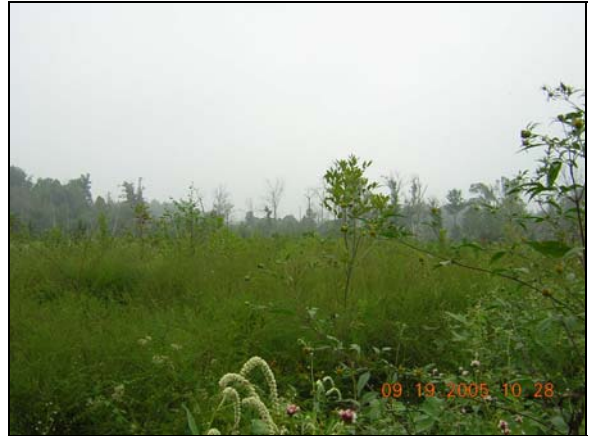
Photo 2. Photopoint 1 facing WNW and view of Vegetation plot 1.
