ANNUAL REPORT FOR 2006 (Year 6)

Sandy Creek Mitigation Site
Randolph County
EEP Project No. 321

*Sandy Creek Wetland Mitigation Site
FINAL Annual Monitoring Report for 2006 (Year 6)*

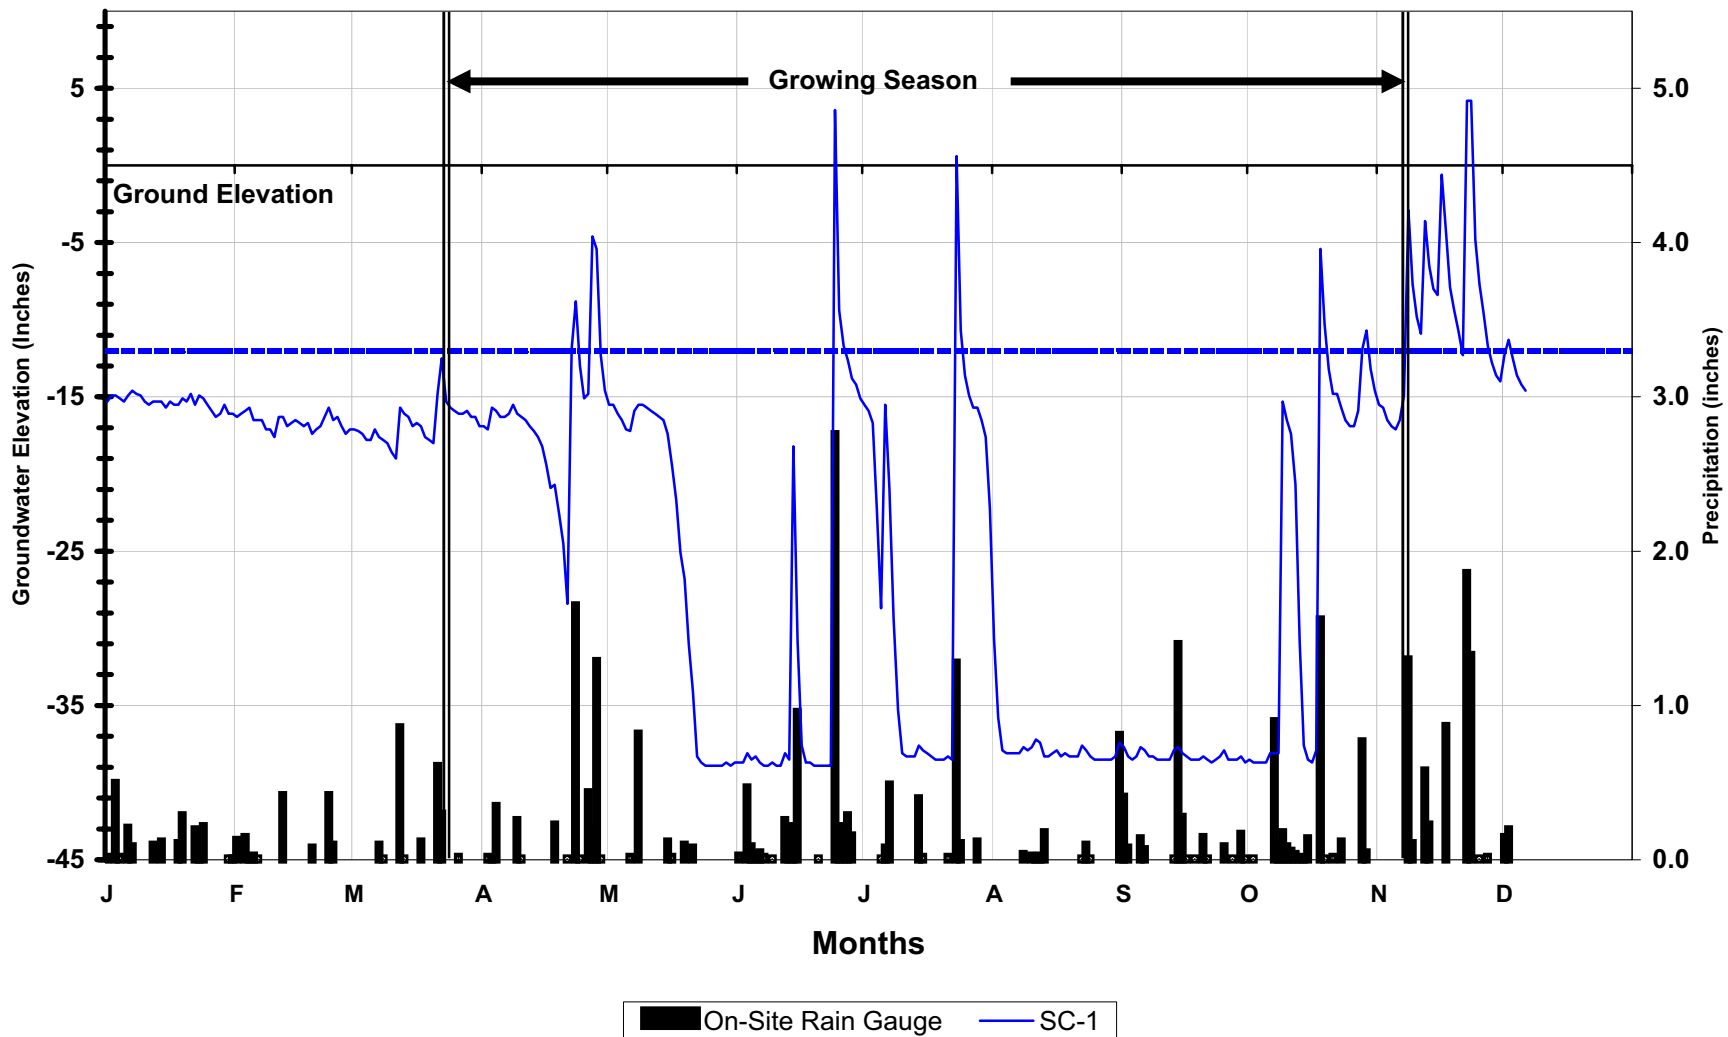
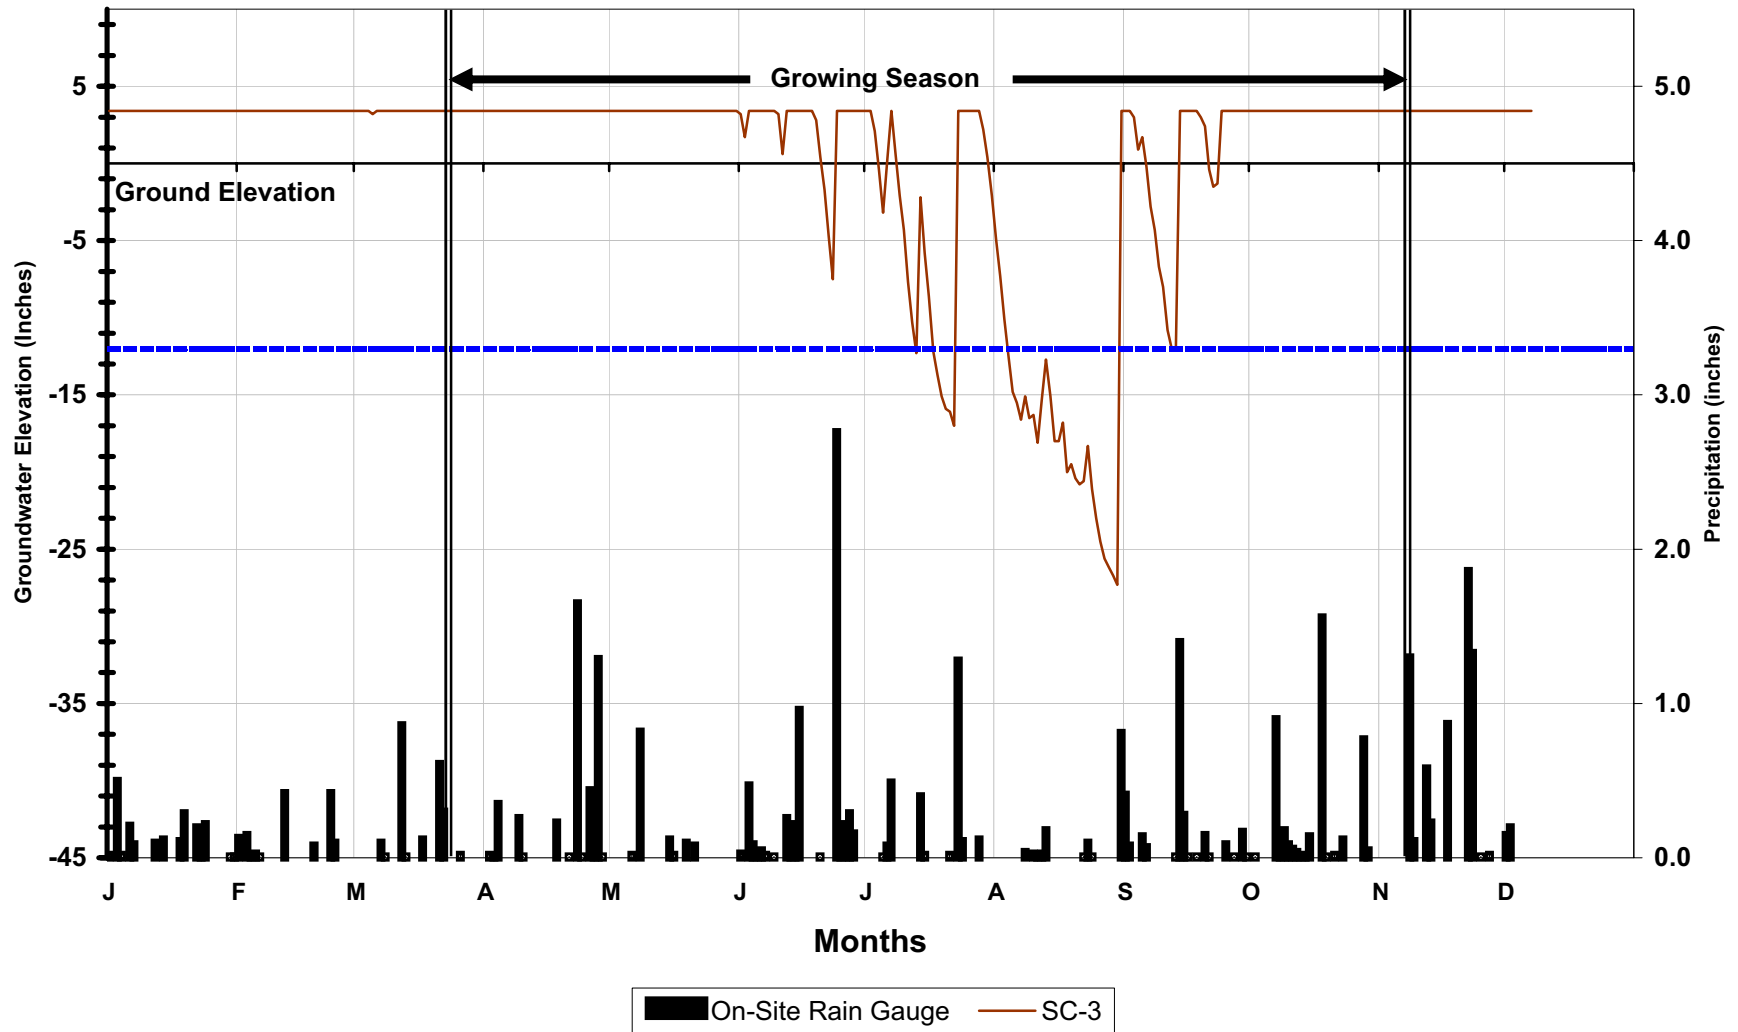
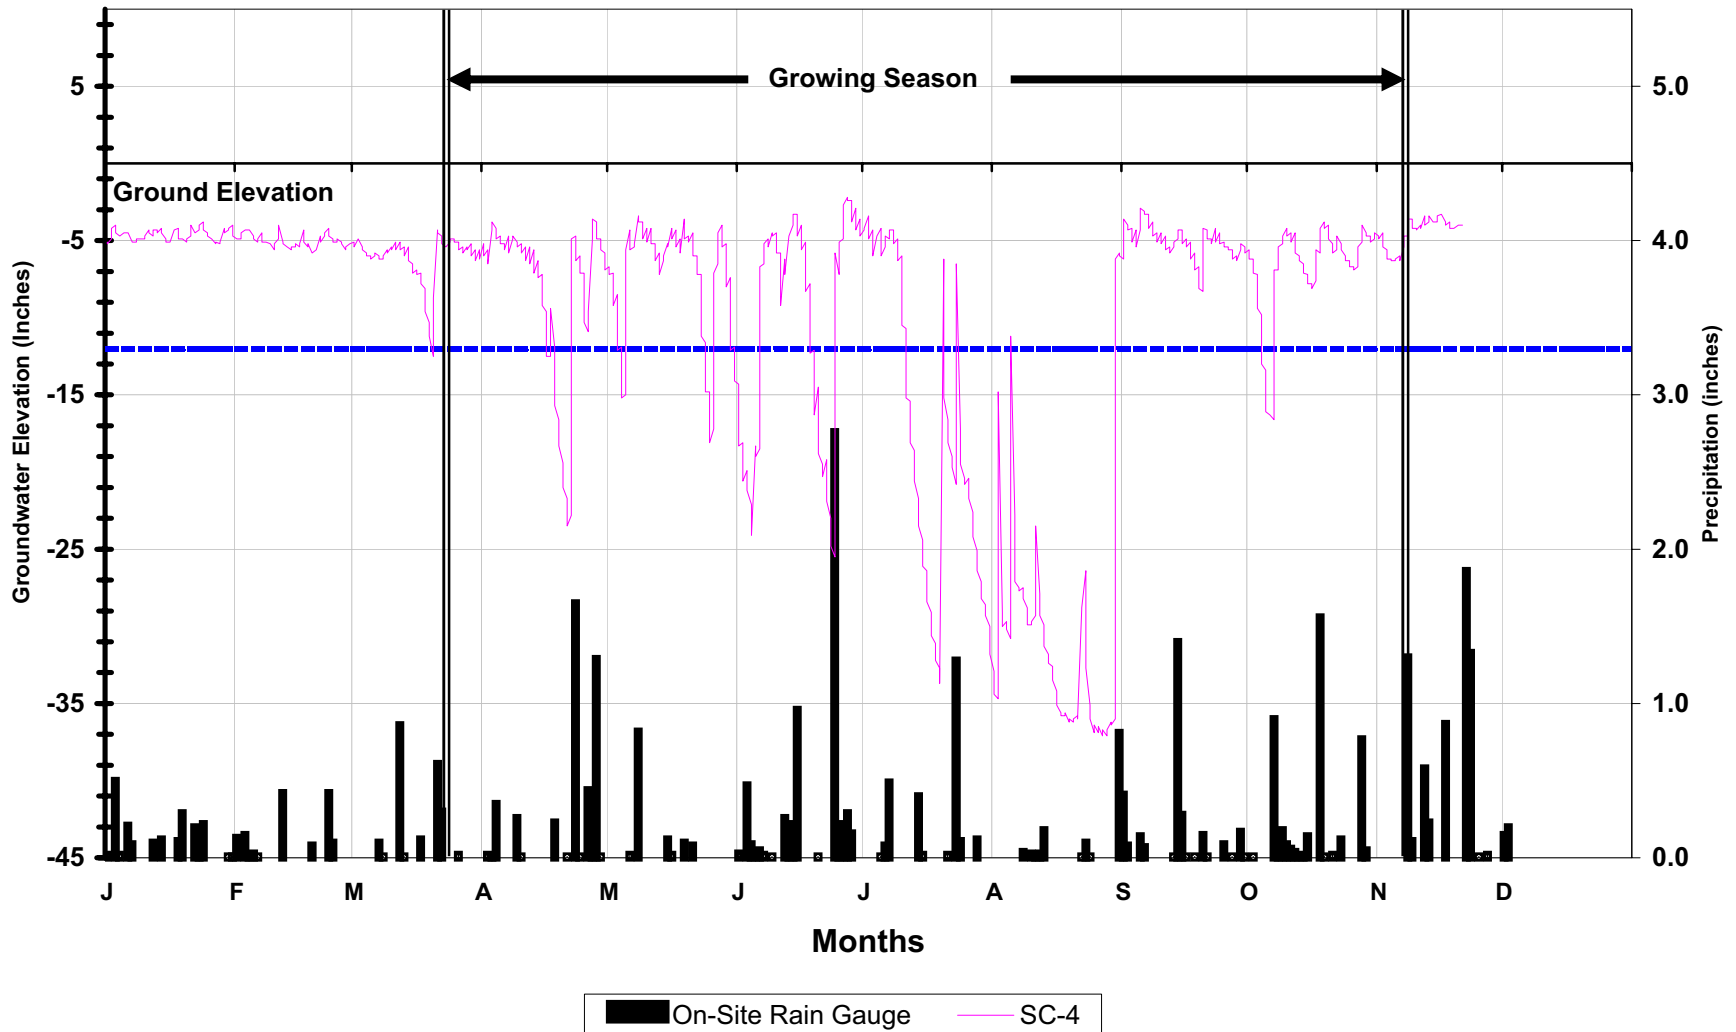
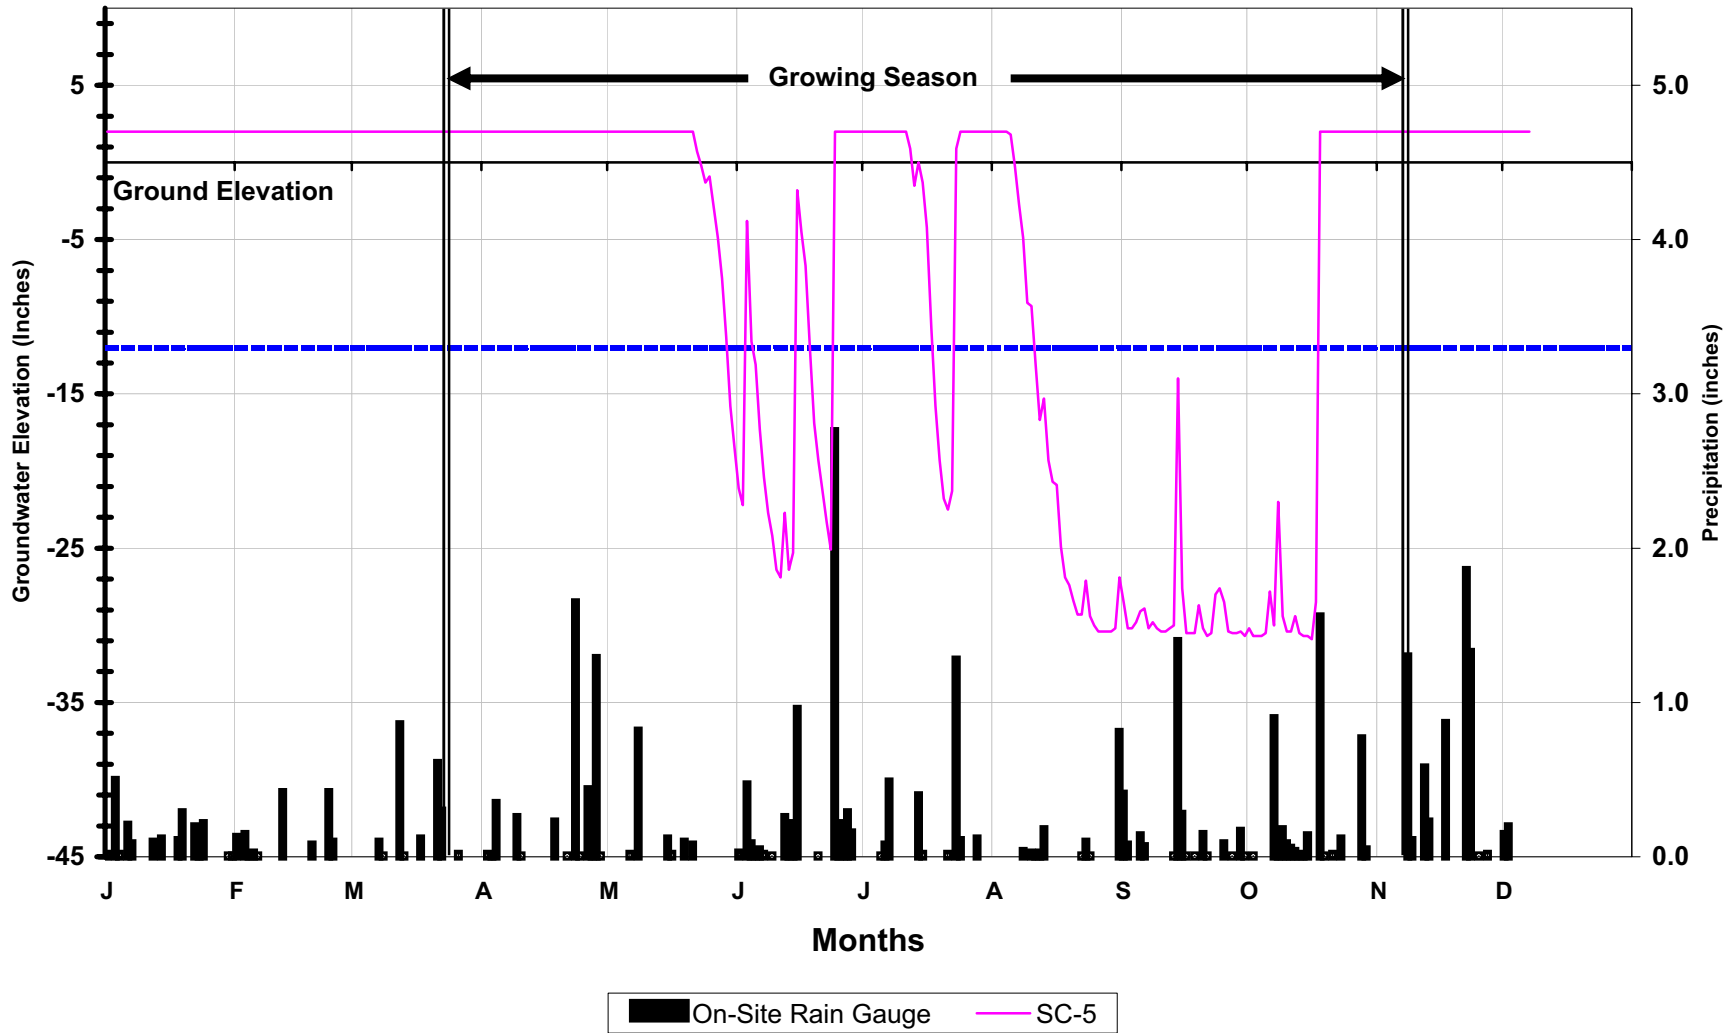
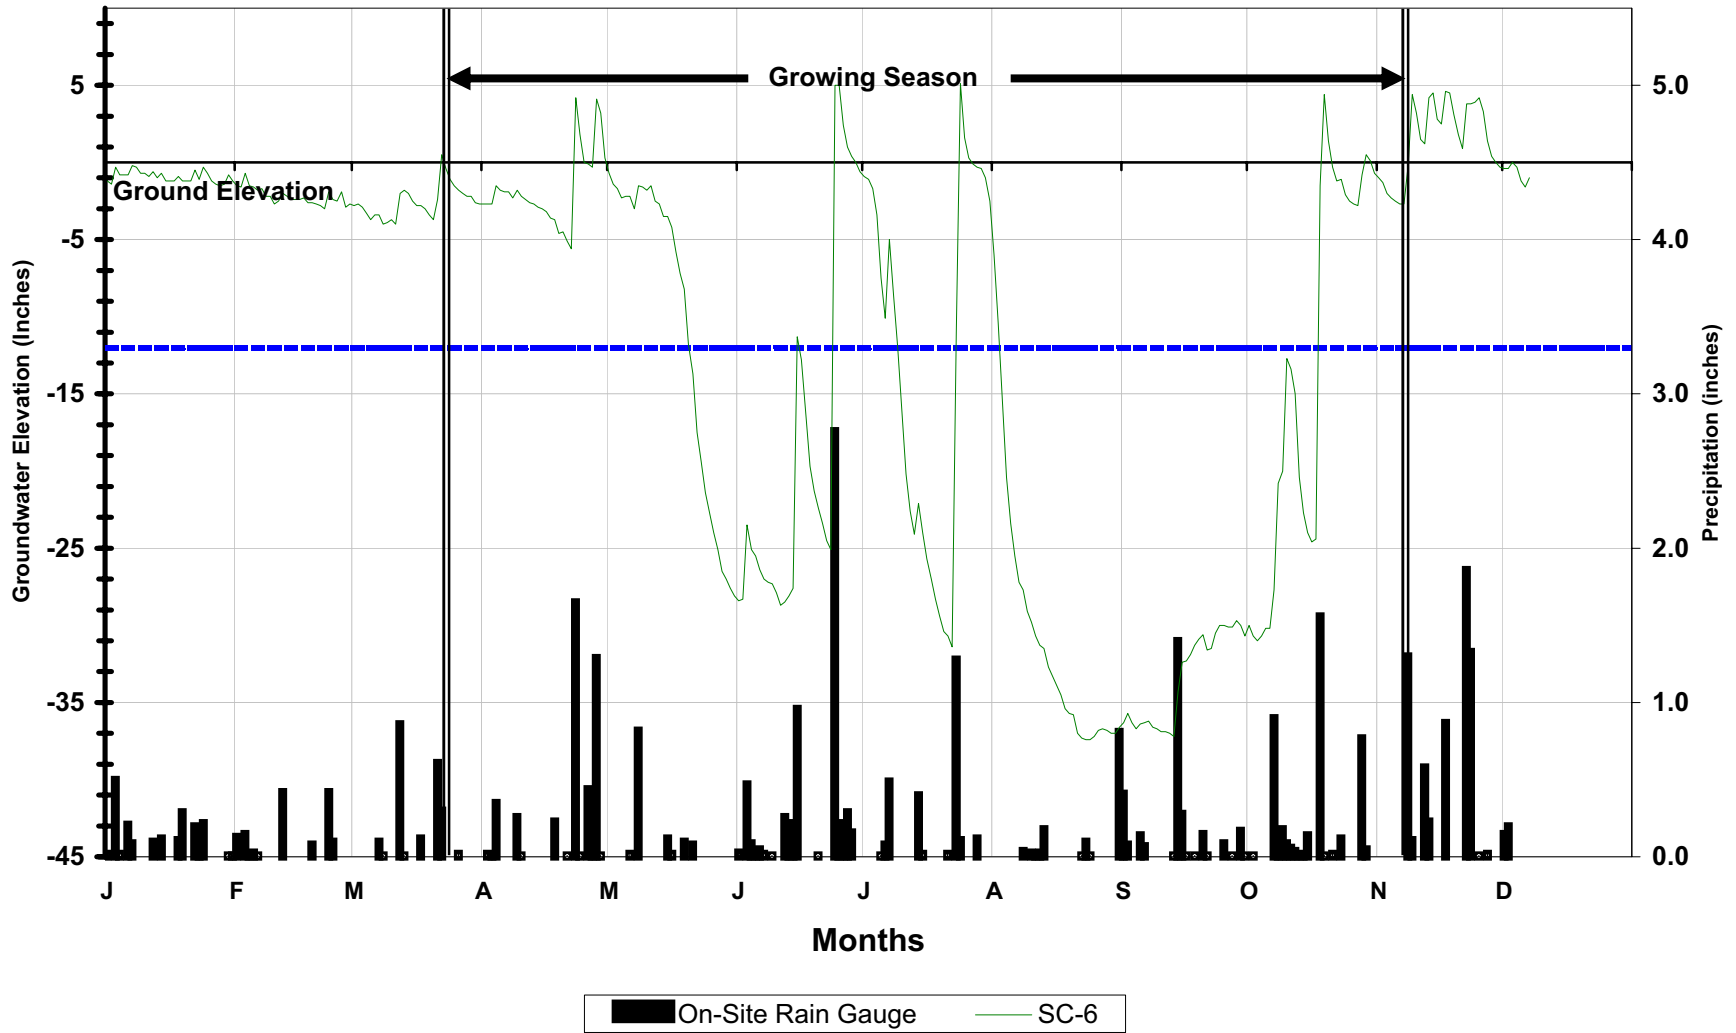
Figure 3
2006 Sandy Creek Groundwater Hydrograph

The maximum number of consecutive days that the groundwater was within twelve inches of the surface was determined for each gauge. This number was converted into a percentage of the 228-day growing season. Table V presents the 2006 results. Gauge SC-2 malfunctioned during the period and no data was recorded for this gauge. However, observations during monthly site visits indicated extended periods of inundation and saturation at SC-2. Based on these observations it is assumed that SC-2 met the hydrologic success criteria. Gauge SC-1 did not meet the success criteria for consecutive days of groundwater within twelve inches of the surface (less than 5 percent of the growing season). The remaining gauges SC-2, SC04, SC-5, and SC-6 met the success criteria at least once during the growing season. It is unknown why SC-1 did not meet the success criteria although much of the growing season received below normal rainfall (see Climate Data below). A hydrograph of the groundwater depth for each monitoring gauge is shown in Figure 3. Local precipitation events are included on the graphs as bars.

Gauge	<5 percent	5-8 percent	8-12 percent	>12.5 percent	Cumulative percent	Dates Meeting Success
SC-1	X				5.7	
SC-2				X*		*
SC-3				X	81.1	Mar 23- Jul 12
SC-4				X	68.8	Aug 30- Oct 4
SC-5				X	60.0	Mar 23- May 29
SC-6				X	46.9	Mar 23- May 20

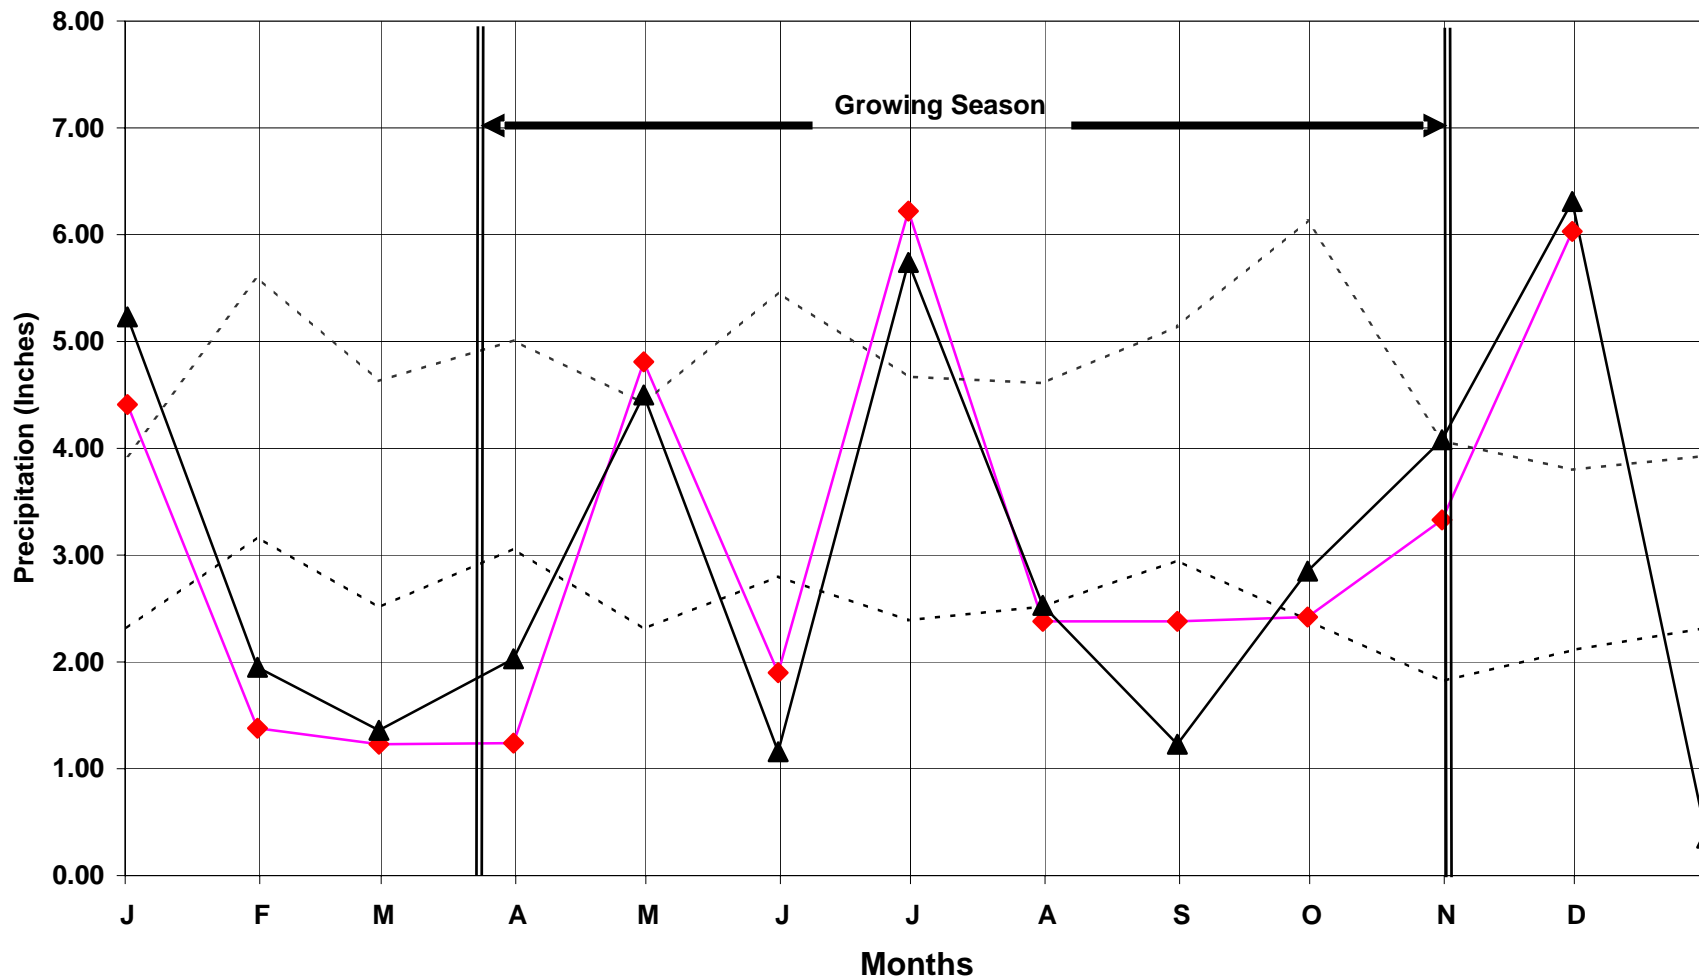
Figure 4
2006 Sandy Creek Precipitation

The historical rainfall data was collected from 1971 through 2000 (30 years). All rainfall data used in this analysis was obtained from the NC State Climate Office using the Asheboro weather station (Data from WETS Station: Asheboro 2 W, NC0286). Rainfall on the mitigation site correlated very closely to data collected at the weather station in Asheboro (Figure 4). A comparison with historical rainfall data shows much of 2006 was below normal in terms of precipitation (Table VI). Normal rainfall is based on between 30 percent and 70 percent of rainfall over a 30 year period (1971 to 2001). Seven of the eleven months with complete rainfall data are below normal. All of the remaining months have experienced above normal rainfall. Overall, 2006 experienced a below average rainfall year.

—◆— Asheboro Monthly Total - - - - - 30th Percentile - - - - - 70th Percentile —▲— Montly On-site

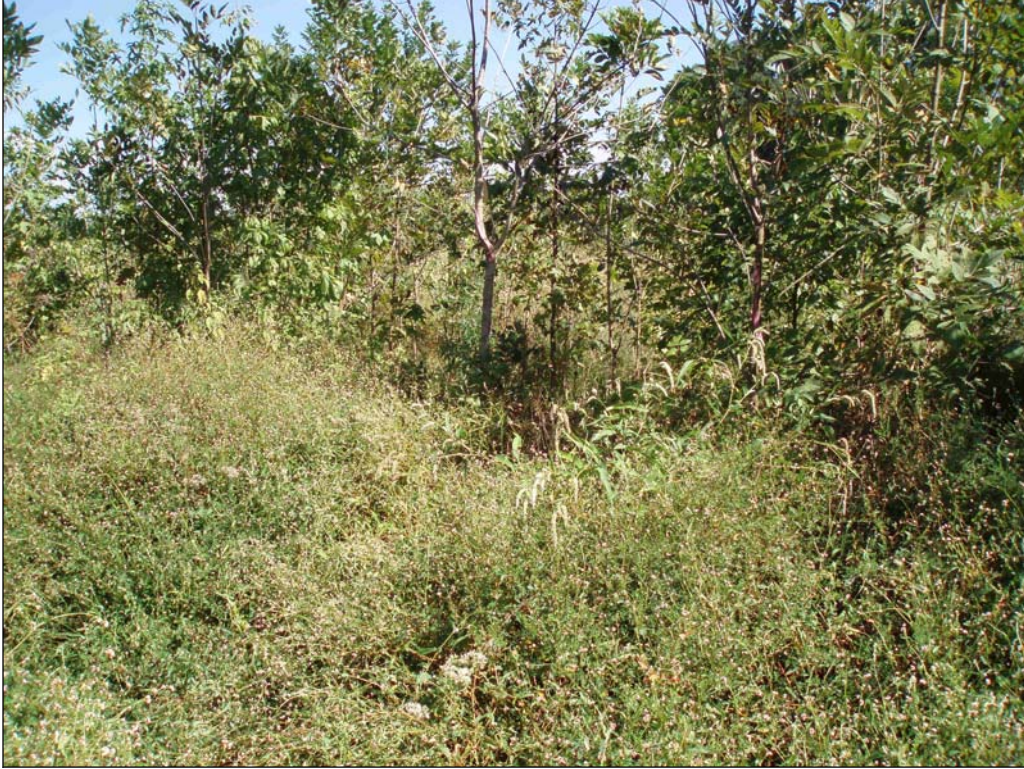
Sandy Creek 2006, Veg Plot 1

The herbaceous vegetation is dense in plots 1 and 2 with plot 3 having poor herbaceous coverage due to the dense overstory. Smart weed and tear thumb are the dominant species within the plots, but overall the site appears to have a moderately high diversity of herbaceous wetland vegetation. Other species noted: dog fennel, jewelweed, sedges, three species of smartweed, and various grasses.

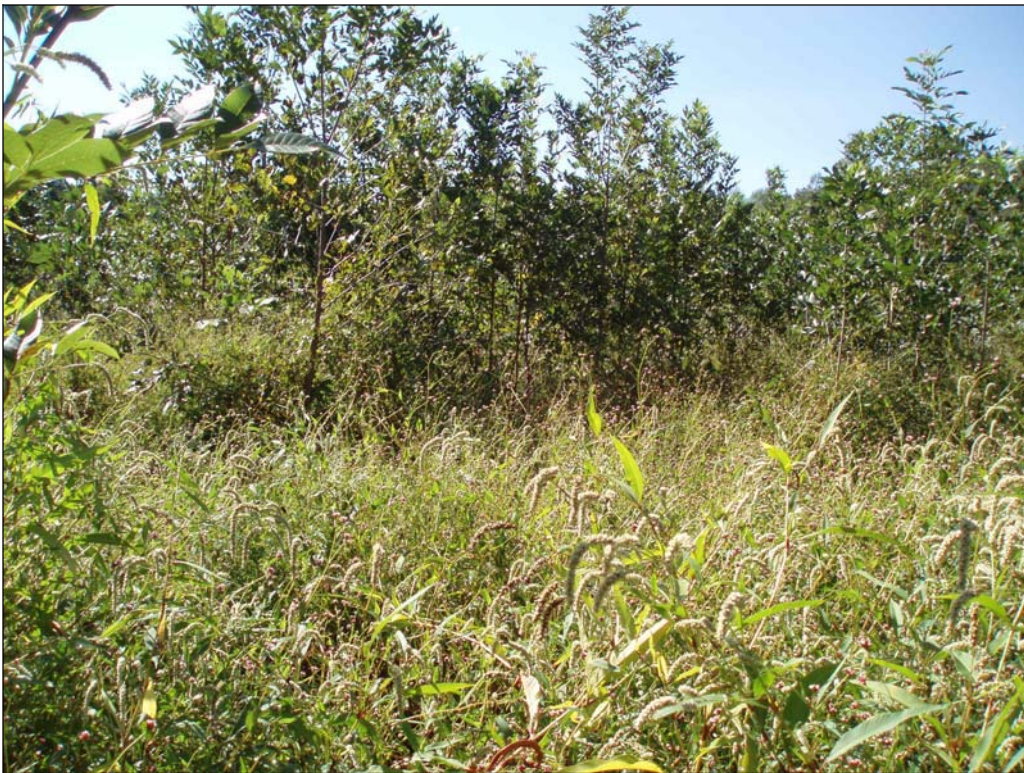
Sandy Creek 2006, Veg Plot 2

The average for all plots is 314 stems per acre (Table VIII). Only plot 2 has less than 240 planted stems per acre, only 11 stems were recorded (192 stems per acre). It is possible that some of the remaining volunteers were planted but the flagging had deteriorated and was not found. Beaver activity has also been noted in previous years and may also have accounted for a loss of planted stems. Total woody stems for each of the plots were also counted. All three have a high density of stems that is expected to naturally decline. Volunteer woody species recorded include box elder, green ash, tag alder, eastern baccharis, sweet gum, sycamore, slippery elm, tulip poplar, and willow oak. Although shrubs were not planted a few are now present.

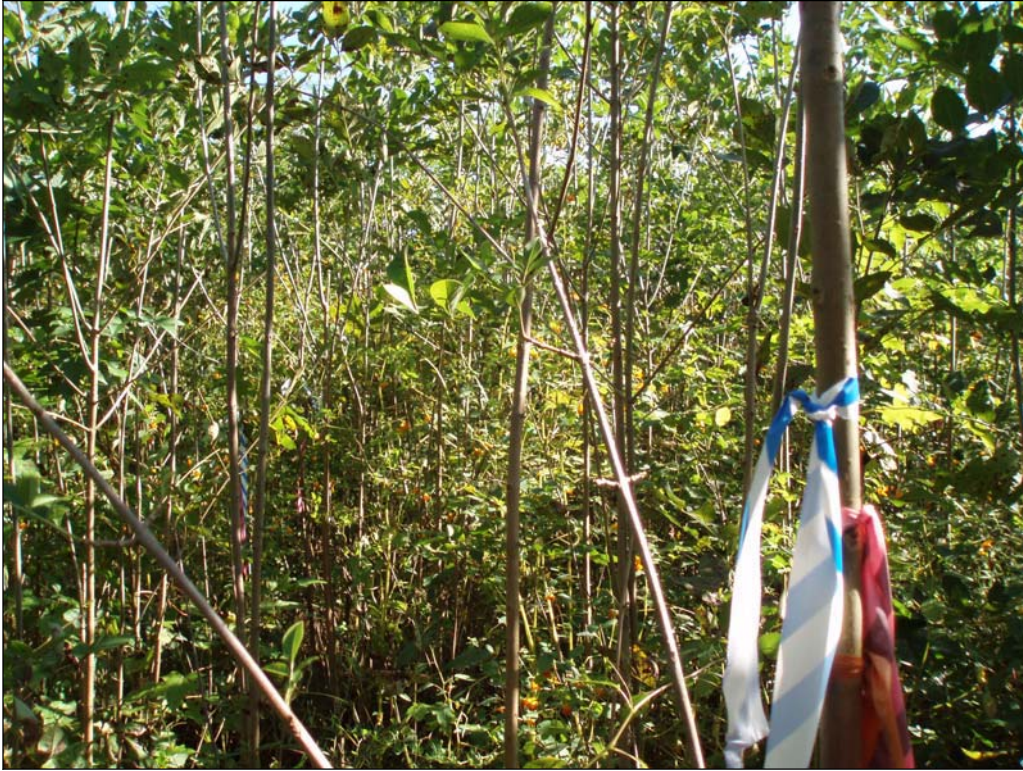
Sandy Creek 2006, Veg Plot 3

The three plots were surveyed for the 2006 monitoring season. The identification of individual flagged stems was difficult due to deterioration of flagging. Flagging was replaced on all stems identified with previous flagging. A significant number of volunteers are present. No reference area was studied; therefore no comparisons could be made to reference conditions. The previous 2004 and 2005 monitoring surveys did not find any black gum, southern red oak, or tulip poplar, within the plots. Water oak was not found in the 2005 survey. In addition to the planted stems, all stems in each plot were counted. Due to the high density in plot 3, green ash was subsampled at 10 percent.

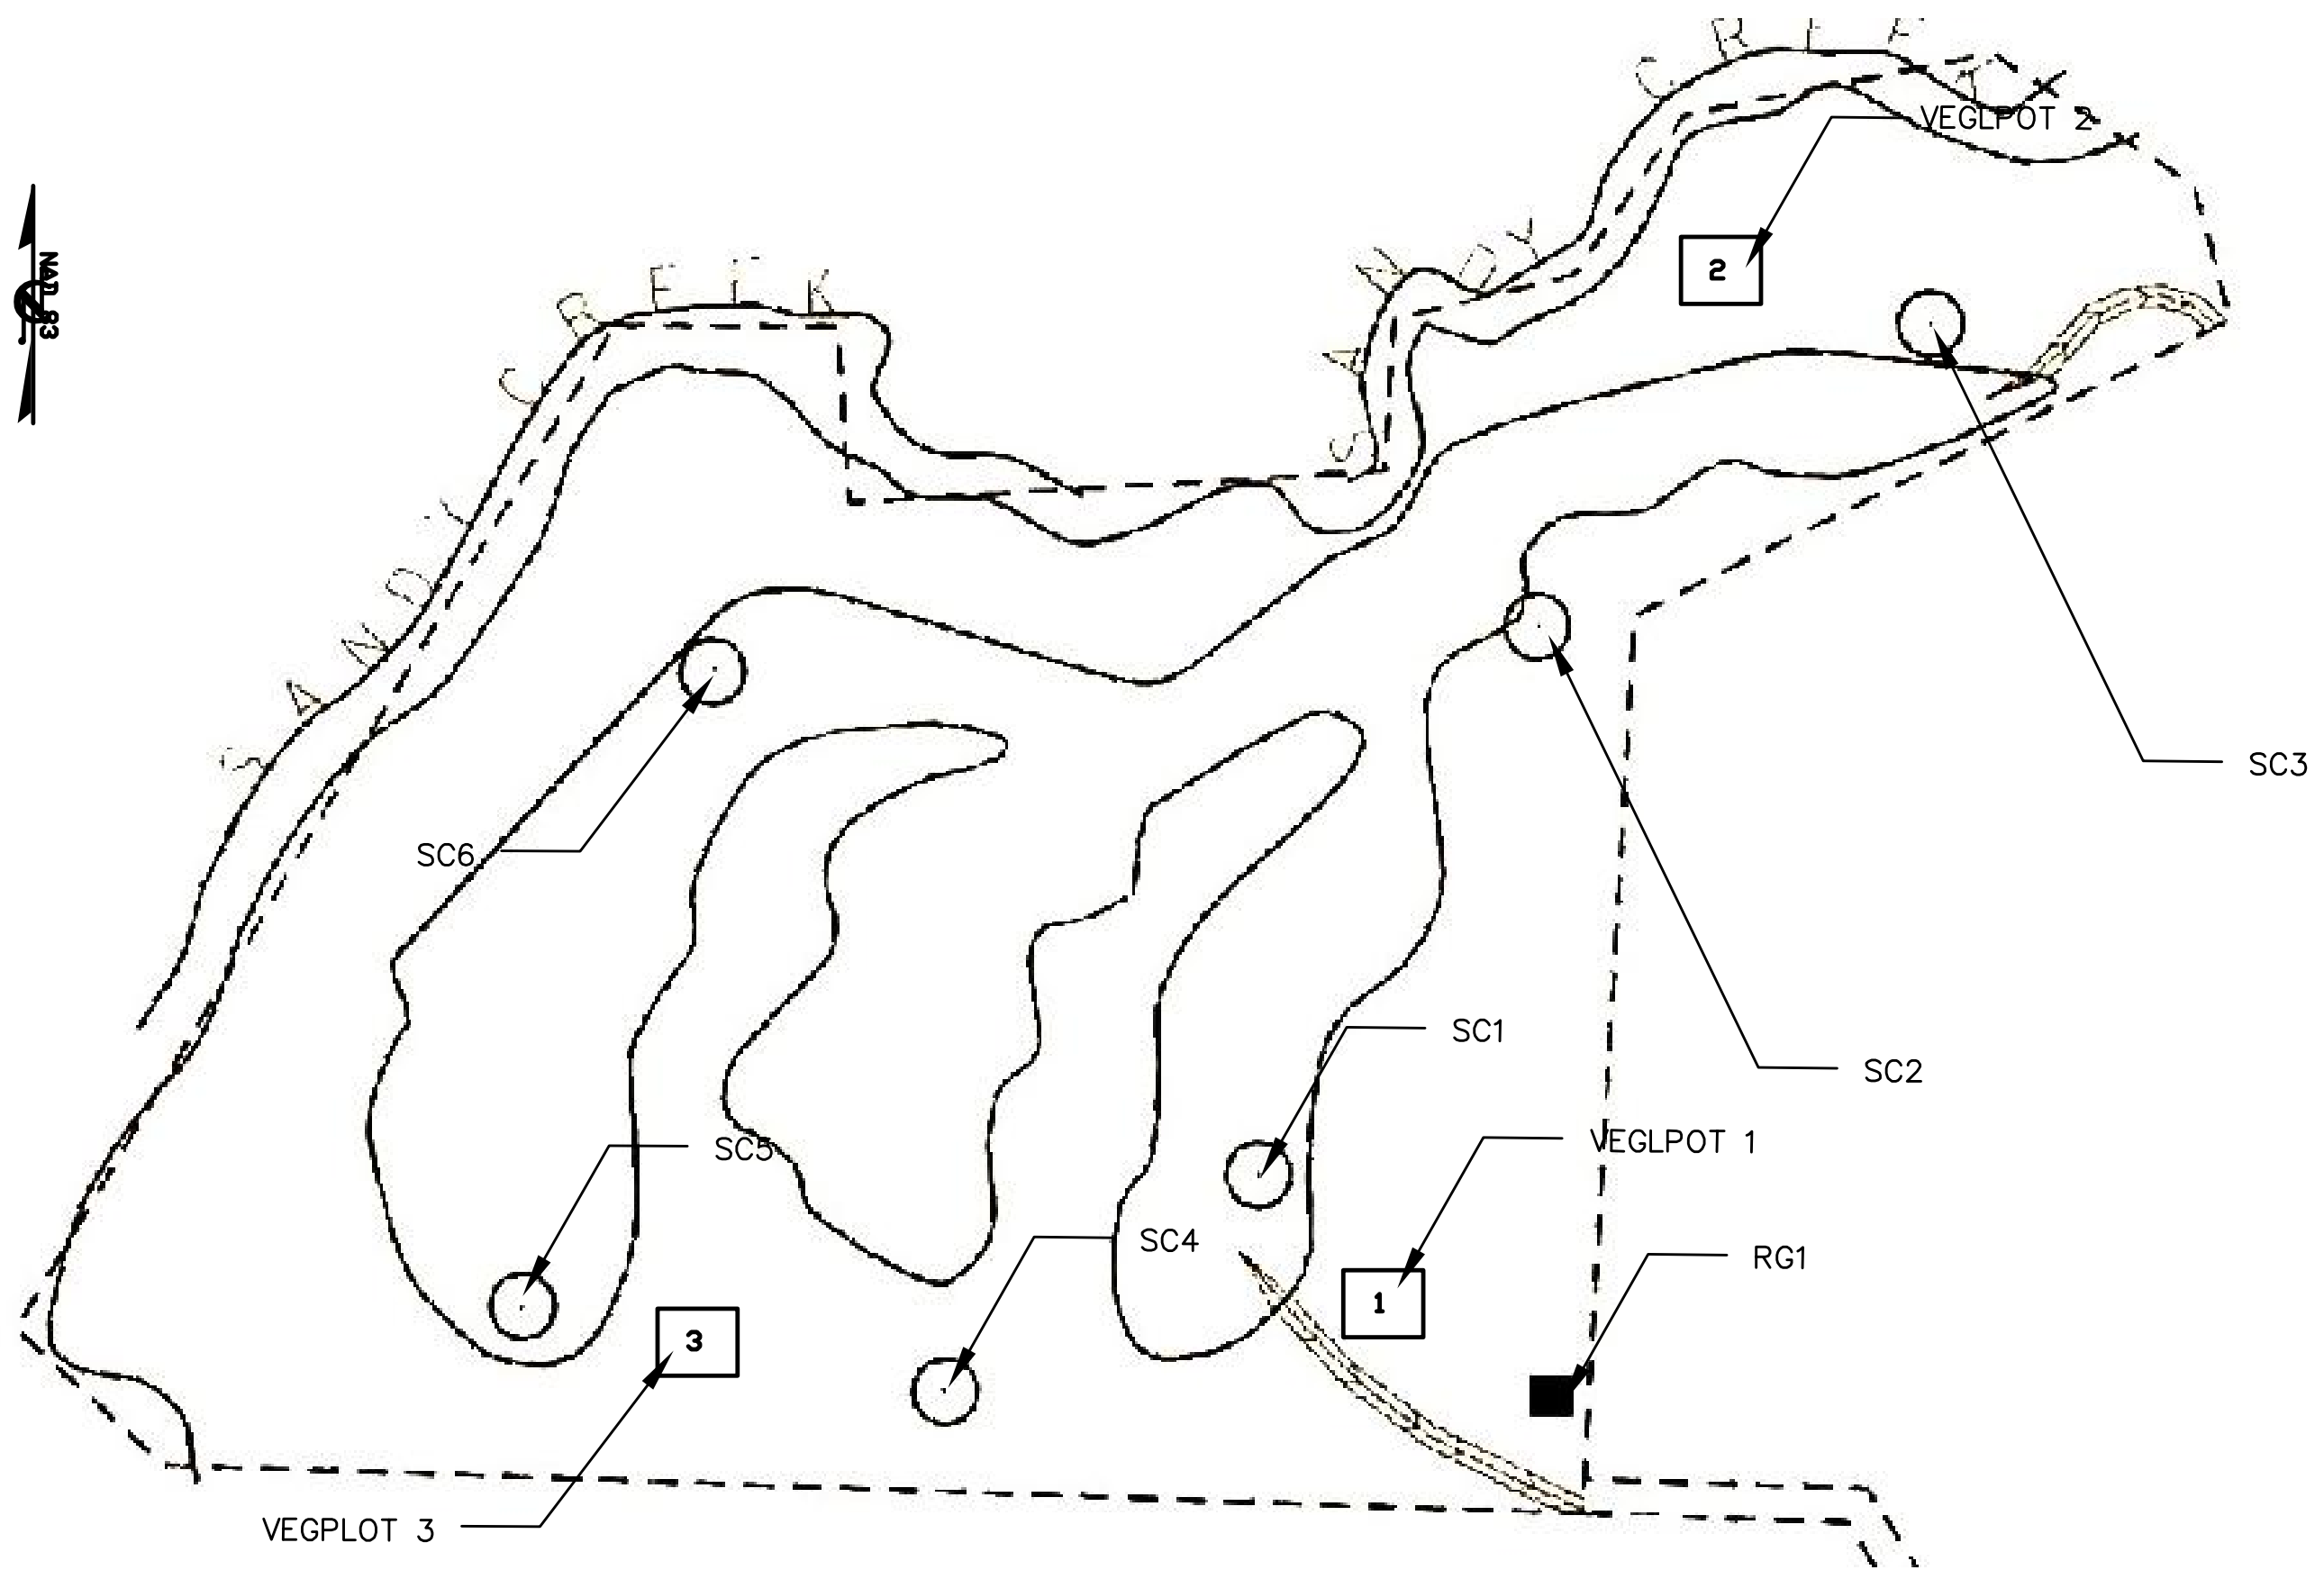
Integrated Project Problem Areas Plan View

No vegetative problem areas are present in Sandy Creek. Previous reports have identified beaver activity and inundation as potential vegetative problems. 2006 site visits have not recorded large scale herbivory or inundation sufficient to warrant re-planting or other remedial actions.
