**MONITORING YEAR 3  
ANNUAL BUFFER REPORT  
Final**

**SASSARIYA SWAMP MITIGATION SITE**

Johnston County, NC  
NCDEQ Contract No. 7425  
DMS ID No. 100040  
DWR Project No. 2018-0198  
RFP No. 16-007279  
Neuse River Basin  
HUC 03020201

Data Collection Period: September 2023  
Draft Submission Date: December 19, 2023  
Final Submission Date: February 7, 2024

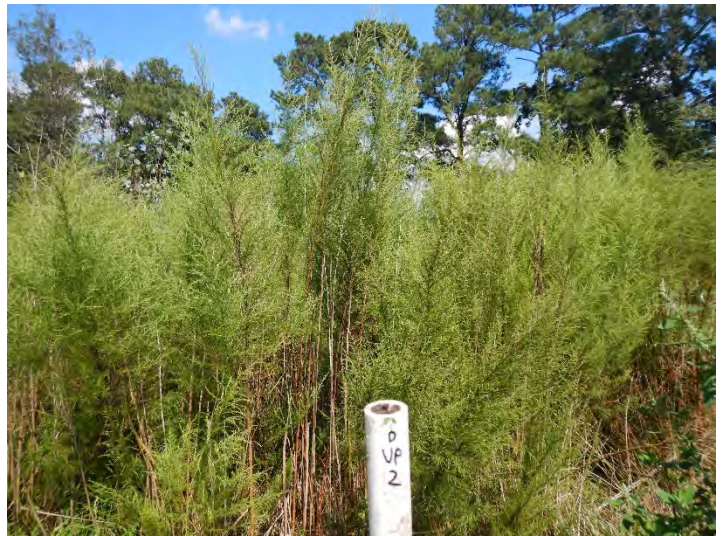
**FIXED VEG PLOT 2 (9/14/2023)**

Overall, the Site has exceeded the required vegetation success criteria for MY3. Nine of ten vegetation plots exceed the final success criteria, with vegetation plot 2 falling just short of the final success criteria. A supplemental planting on 0.55 acres was completed in February 2023 to accommodate for tree mortality along T1. Some mature trees that were avoided during construction were starting to decline in 2022, however their condition was stable in 2023 and a new understory layer is continuing to establish. An approximately 4.97 acre dense stand of Chinese privet along Sassarixa Creek Reach 3, as well as scattered stems throughout the remainder of the Site were treated in May 2023. Chinese privet throughout the Site will continue to be monitored and treated as necessary. The rest of the Site's vegetation layer established quickly and is greatly reducing the amount of nutrients and sediment entering the project streams. The Site boundary was walked, and fences are in good condition and are keeping livestock out.

Mitigation Plan Performance Standard	Current Year Stem Count					7		6		14		13		11
	Stems/Acre					283		243		567		526		445
	Species Count					6		4		5		8		7
	Dominant Species Composition (%)					29		50		29		23		27
	Average Plot Height (ft.)					2		3		3		1		3
	% Invasives					0		0		0		0		0
Post Mitigation Plan Performance Standard	Current Year Stem Count					7		6		14		13		11
	Stems/Acre					283		243		567		526		445
	Species Count					6		4		5		8		7
	Dominant Species Composition (%)					29		50		29		23		27
	Average Plot Height (ft.)					2		3		3		1		3
	% Invasives					0		0		0		0		0
