**MONITORING YEAR 2
ANNUAL BUFFER REPORT
Final**

SASSARIYA SWAMP MITIGATION SITE

Johnston County, NC
NCDEQ Contract No. 7425
DMS ID No. 100040
DWR Project No. 2018-0198
RFP No. 16-007279

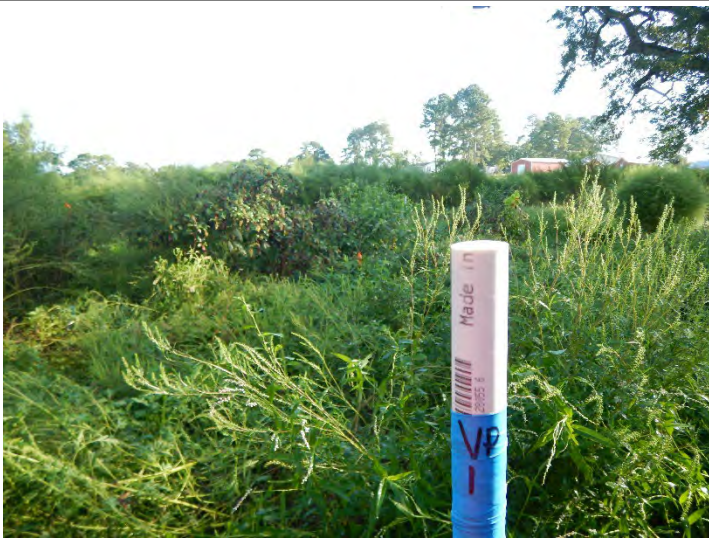
FIXED VEG PLOT 1 (9/9/2022)

Overall, the Site has exceeded the required vegetation success criteria for MY2. Vegetation plot 1 is not on track to meet the final success criteria. A replanting is planned for the winter of 2022/2023 to accommodate for tree mortality along T1. The Sassarixa Swamp II easement was replanted in February 2022. While replanting, the boundary expanded beyond originally outlined and extended into the DMS portion of the easement. A follow up treatment of the Chinese privet resprouts along Sassarixa Creek occurred in March 2022. As a preventative measure, Kudzu was treated outside the easement in July 2022. The rest of the Site's vegetation layer established quickly and is greatly reducing the amount of nutrients and sediment entering the project streams.

A 0.55-acre are of supplemental planting will occur in the winter of 2022/2023 to supplement the tree mortality that was assessed along T1 (Figure 4a). This area and any new species not included in the approved Mitigation Plan (Wildlands, 2019) and is currently under review by the IRT.
