November 2019

SASSARIXA SWAMP MITIGATION PLAN

Johnston County, NC
NCDEQ Contract No. 7425
DMS ID No. 100040

Neuse River Basin
HUC 03020201

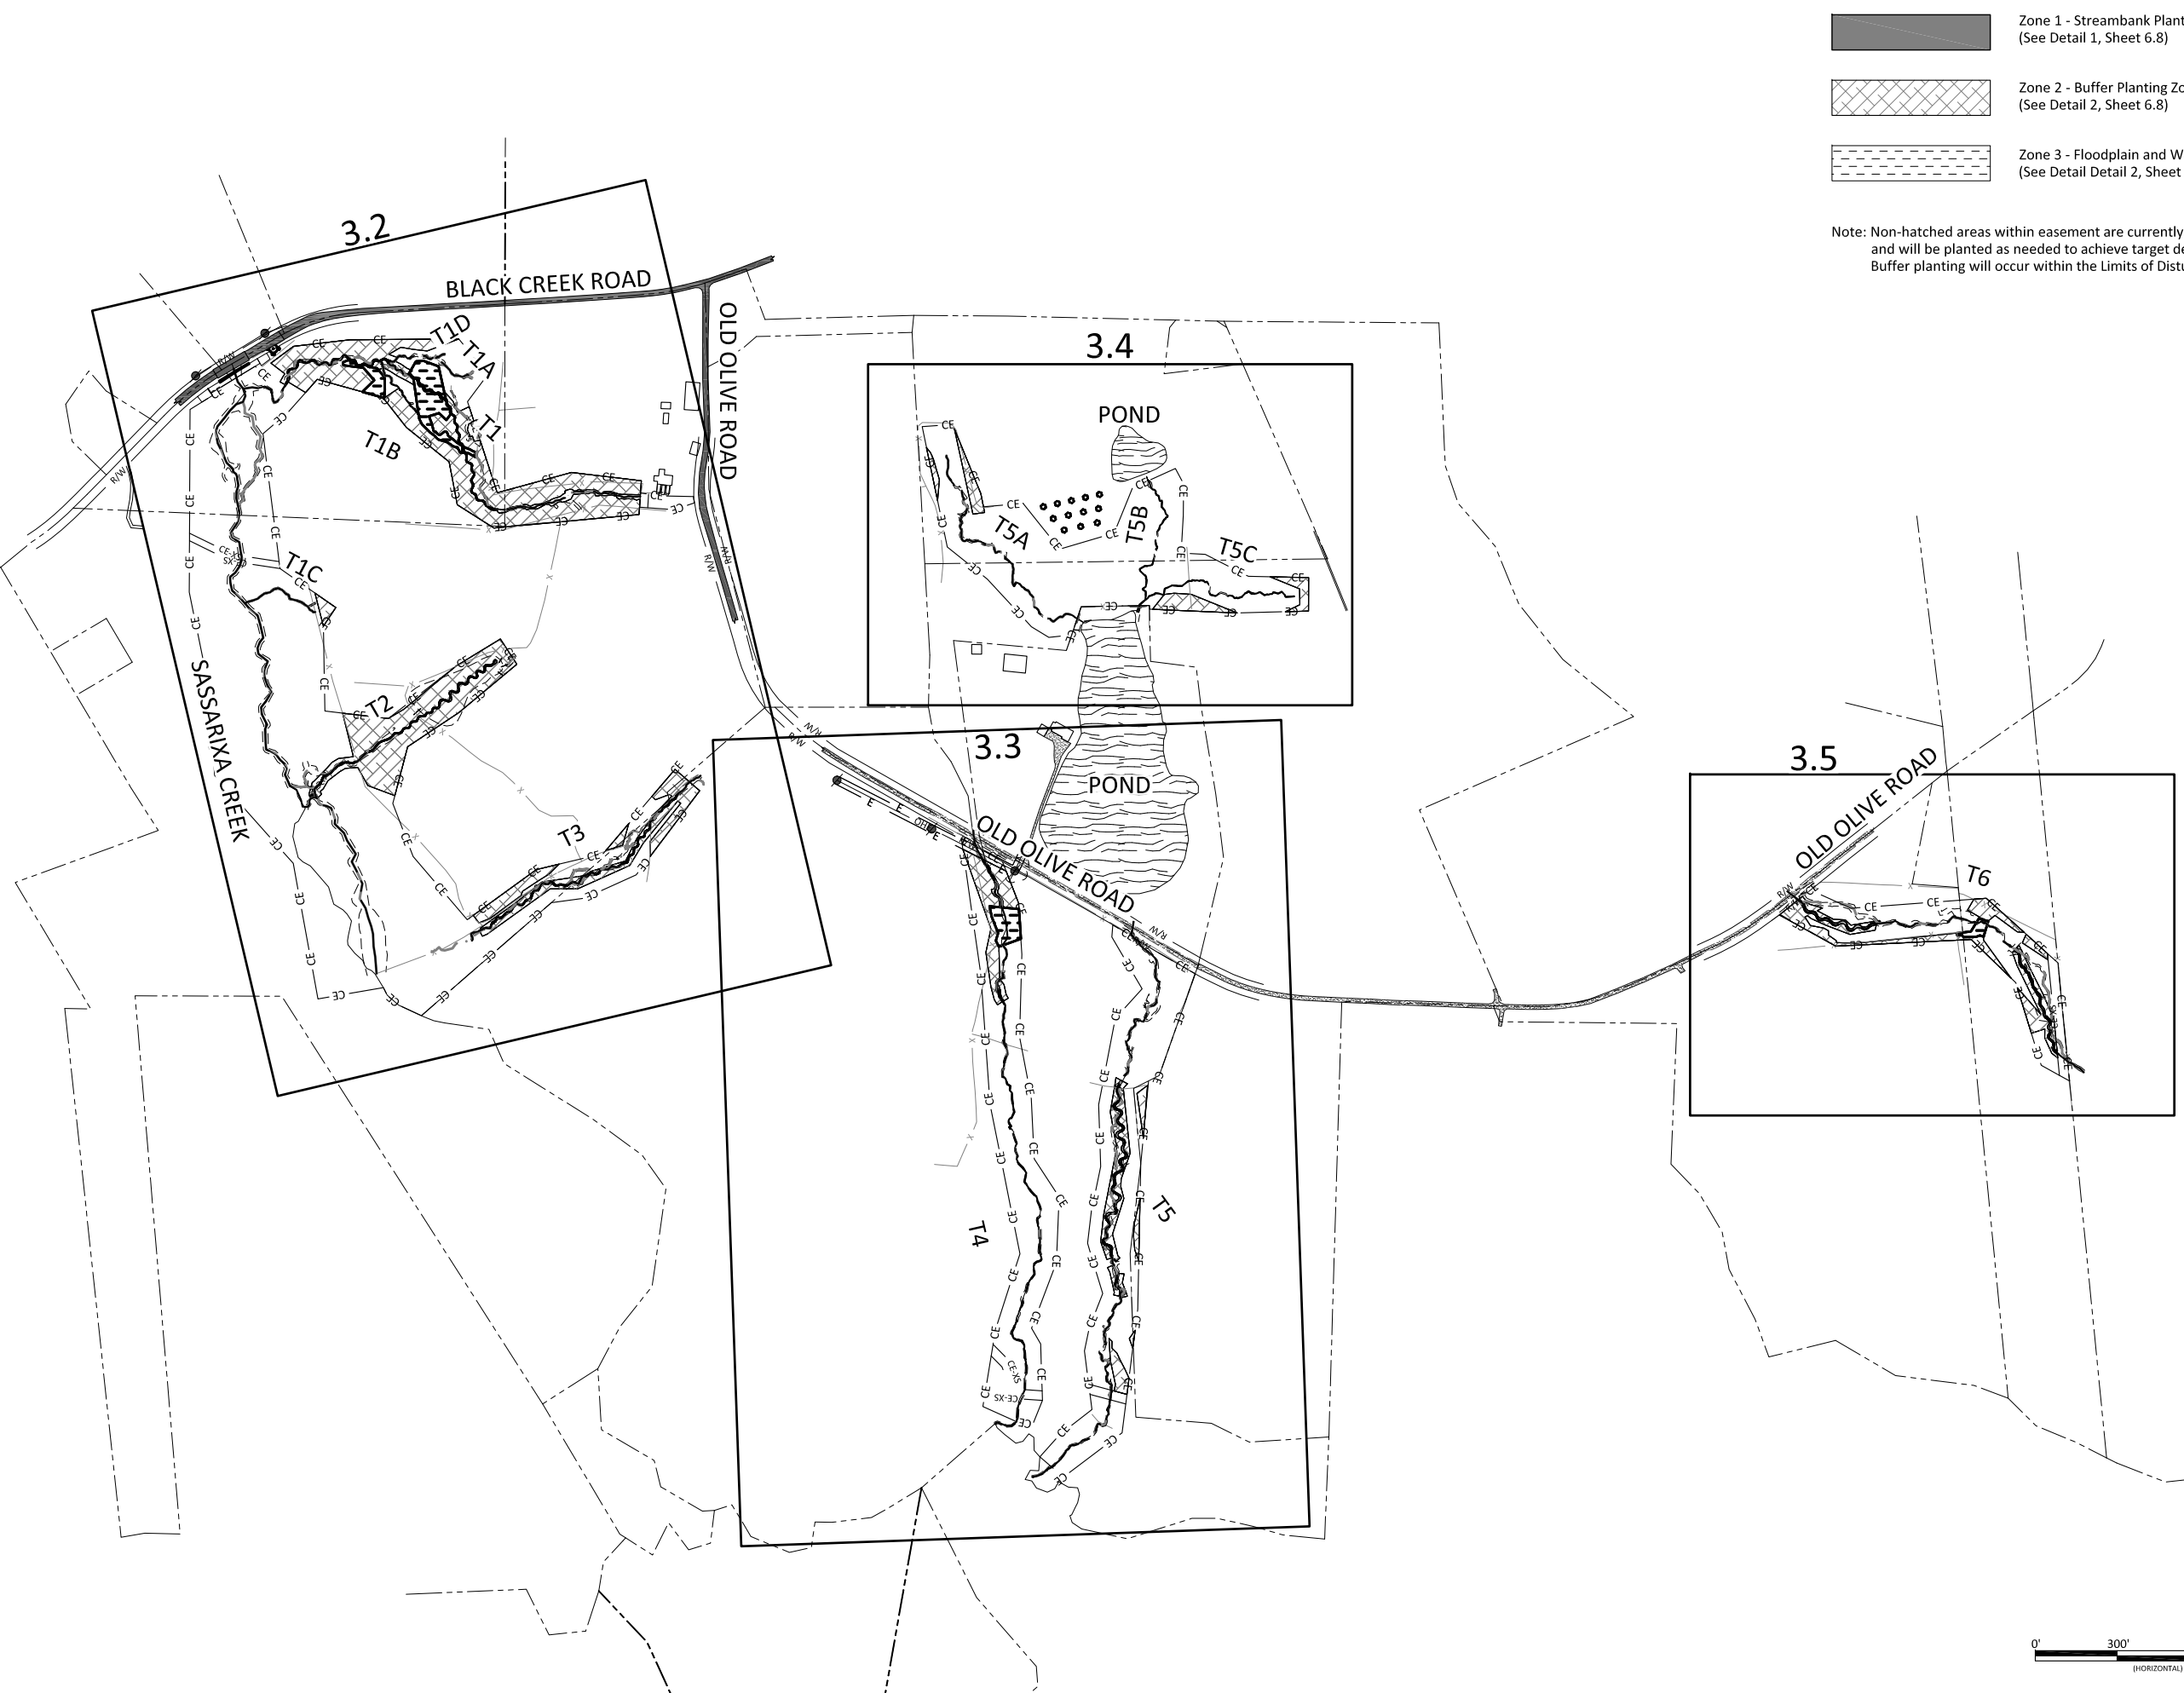
- Zone 1 - Streambank Planting Zone
(See Detail 1, Sheet 6.8)
- Zone 2 - Buffer Planting Zone
(See Detail 2, Sheet 6.8)
- Zone 3 - Floodplain and Wetland Planting Zone
(See Detail 2, Sheet 6.8)

Note: Non-hatched areas within easement are currently vegetated and will be planted as needed to achieve target density.
 Buffer planting will occur within the Limits of Disturbance
