SCALY BARK CREEK MITIGATION SITE
Stanly County, NC
DENR Contract 002030

Restoration Plan
May 14, 2010

SCALY BARK CREEK MITIGATION SITE Restoration Plan

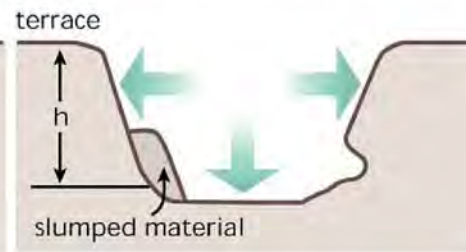
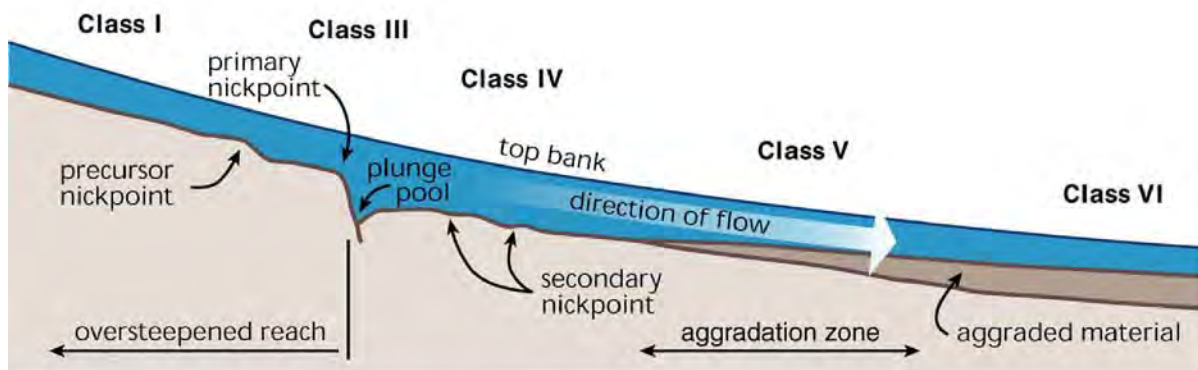
Figure 9. Simon Channel Evolution Model
 Scaly Bark Creek Mitigation Site
 Yadkin River Basin (03040105)
 May 14, 2010
 Stanly County, NC

Class I. Sinuous, Premodified
 $h < h_c$

Class IV. Degradation and Widening
 $h > h_c$

Class V. Aggradation and Widening
 $h > h_c$

Class VI. Quasi Equilibrium
 $h < h_c$

Fig. 7.14 – Channel evolution model..

Reach 1 of Scaly Bark Creek is currently in Stage 2 of Simon's channel evolution model, illustrated in Figure 9 (Simon, 1989). Portions of this reach are underlain by shallow bedrock, preventing further vertical degradation. Reach 1 exhibits sections of heavily trampled banks, however widening of the channel is only evident in the upstream pool section. As Scaly Bark Creek transitions to Reach 2 (downstream of UT2 confluence), the channel begins to exhibit both Stage 3 and Stage 4 evolution models. Since bedrock is much deeper through this portion of the channel and offers little to no stabilization, the channel bed is displaying degradation. Additionally, heavily trampled banks are present in areas with increased cattle activity. These areas are experiencing widening along with slumped material and sediment deposition. The remaining approximately 300 linear feet of the channel is in Stage 5. This portion of the reach is extremely over-wide and large mid-channel bars of aggraded material are present. Removal of cattle and restoration of a woody vegetated buffer along Scaly Bark Creek will help stabilize the channel. Construction of a stable cross-section and meandering pattern will reduce the slope and allow energy to be dissipated through meander bends.

UT2 demonstrates relatively tight meanders in the upstream portion of the reach and impacts from heavy cattle activity. This channel is in Stage 4 of channel evolution and is slightly over-wide in sections. Lack of stabilizing riparian vegetation allows for additional bank degradation and stability problems.

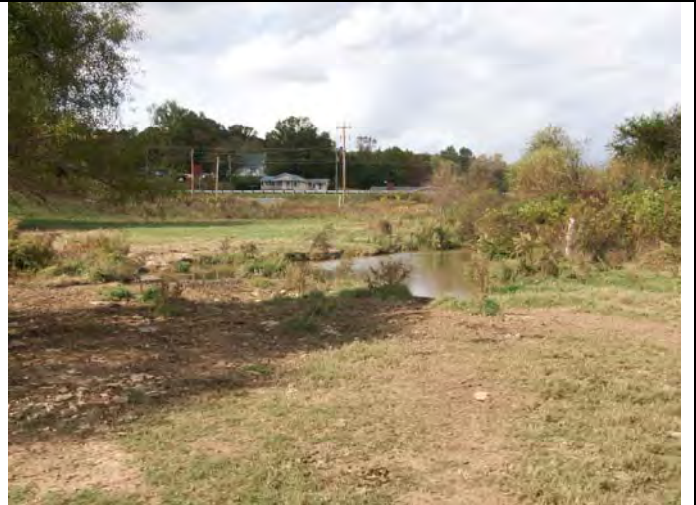
Photo 3-View of left bank erosion at Scaly Bark Creek XS 4.

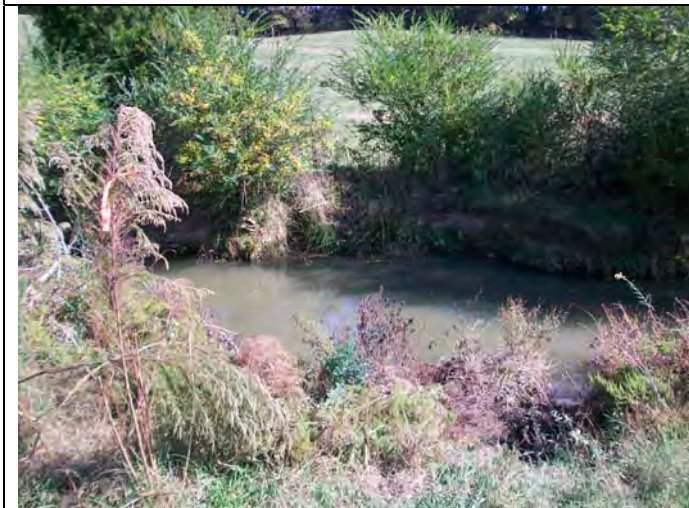
Photo 4-View of right bank erosion along Scaly Bark Creek, facing upstream.

The primary destabilizing force in Scaly Bark Creek is cattle access to the stream channel. Additionally, vertical stream banks and a lack of significant riparian vegetation and root depth provide further instability. Shallow bedrock in portions of Reach 1 provides some vertical stabilization to the channel bed. Reach 2 exhibits continued vertical bank erosion along with areas of over-widening. Due to this relatively shallow bedrock, Scaly Bark Creek is experiencing only minimal to moderate amounts of incision and vertical degradation; as a result, the channel does have access to the existing floodplain along portions of the reach. Continued cattle-access to the channel will reduce existing woody vegetation and prevent future stabilizing vegetation from becoming established, allowing for further bank degradation. Scaly Bark Creek is likely to continue to have stability problems without corrective action.

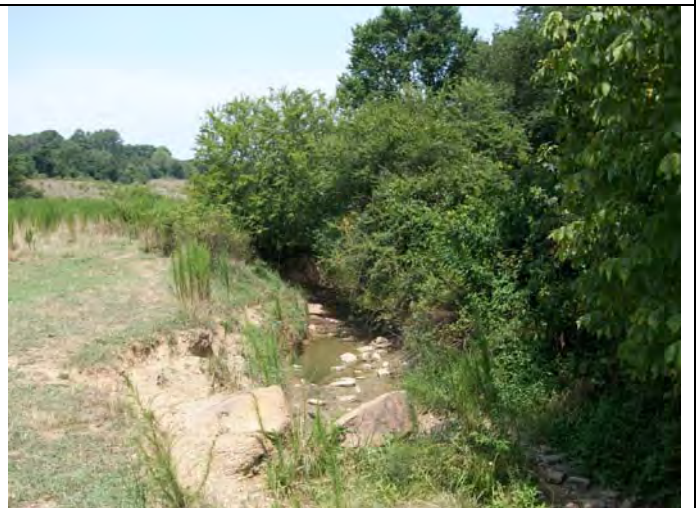
Photo 5- View of UT1 left bank erosion at XS 10.

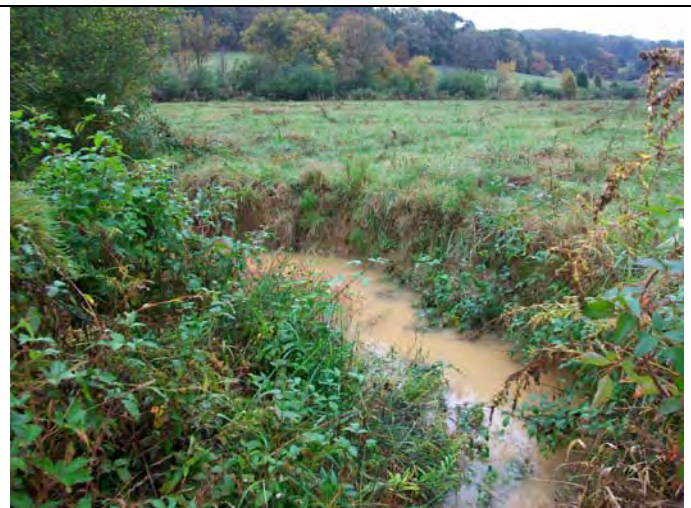
Photo 12-View of UT2 right bank erosion, facing downstream.

UT2, similar to Reach 2 of UT1, is actively impacted by cattle access and grazing. UT2 exhibits minor incision throughout the reach along with bare vertical banks. Further instability is caused by relatively tight meanders in the upstream portion of the reach and trampling of the banks by cattle. A narrow buffer of invasive species including Chinese privet and blackberry has been heavily managed, providing little to no canopy coverage for this channel.

UT2 exhibits reach-wide impacts from cattle access resulting in vertical banks, tight meander bends, and lack of stabilizing riparian vegetation. Table 7 summarizes total Bank Erosion Hazard Index (BEHI) values and estimated sediment export for Scaly Bark Creek, UT1, and UT2.

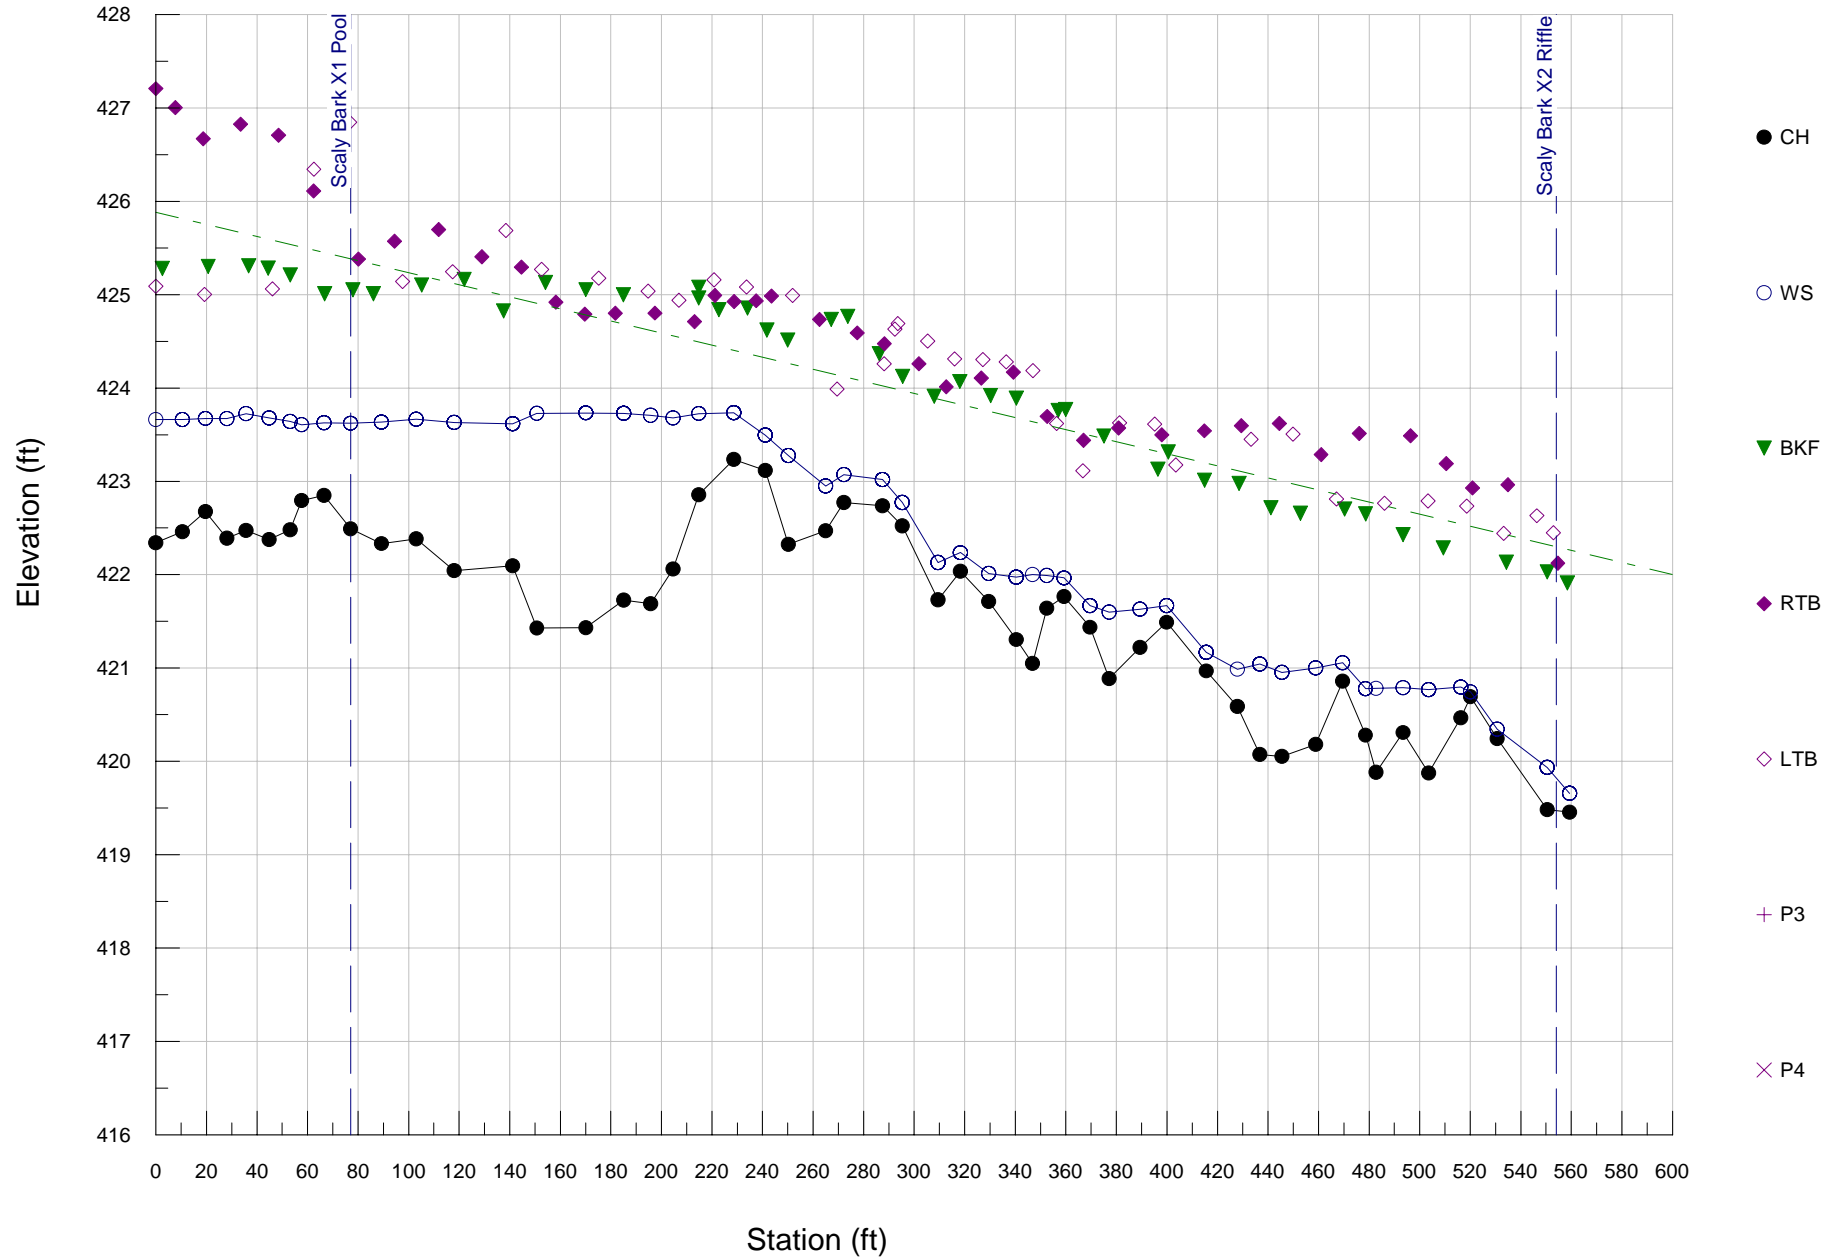
Scaly Bark Creek Reach 1 Profile

River Name: Scaly Bark Creek
 Reach Name: Reach 1
 Profile Name: Scaly Bark Reach 1 Profile
 Survey Date: 11/10/09

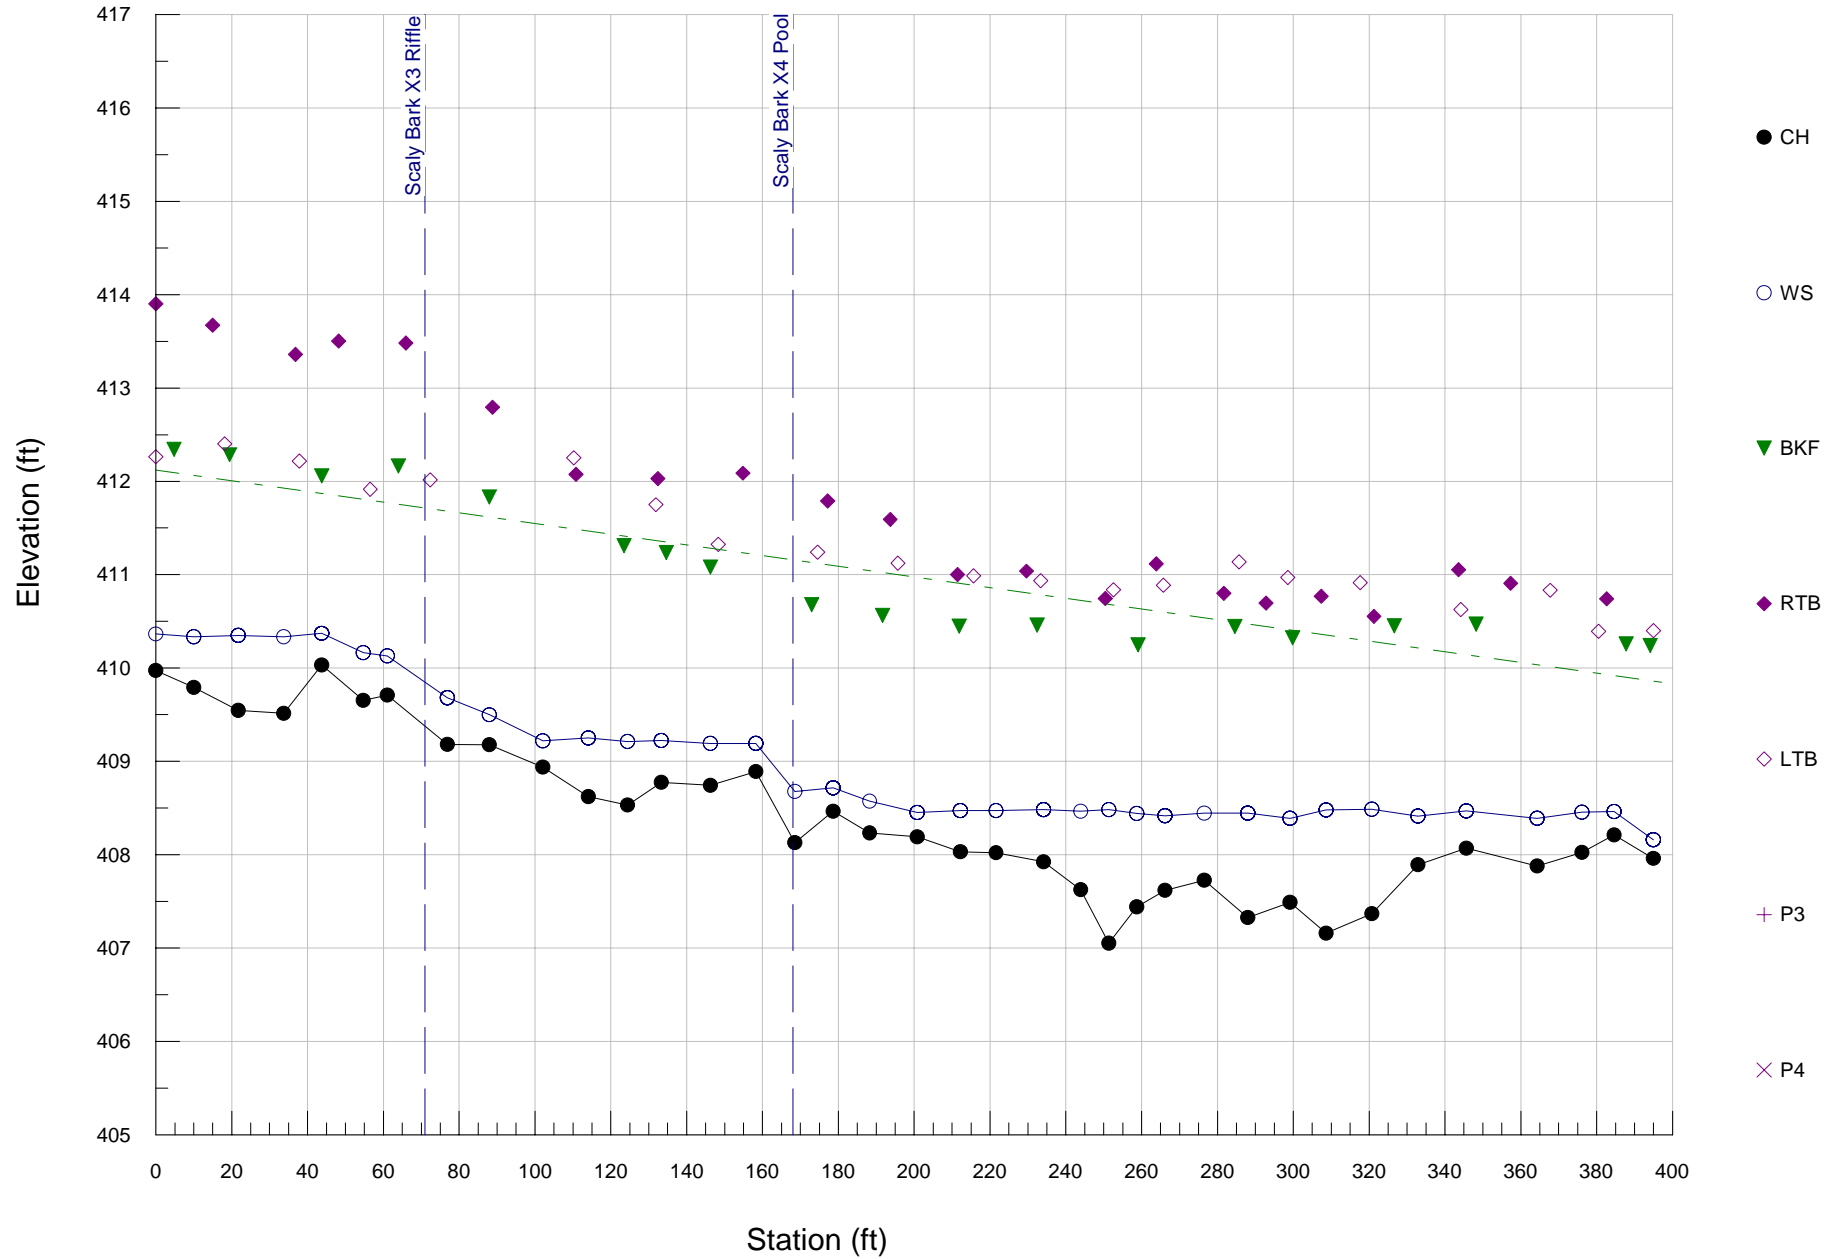
Scaly Bark Creek Reach 2 Profile

River Name: Scaly Bark Creek
 Reach Name: Reach 2
 Profile Name: Scaly Bark Reach 2 Profile
 Survey Date: 11/10/09

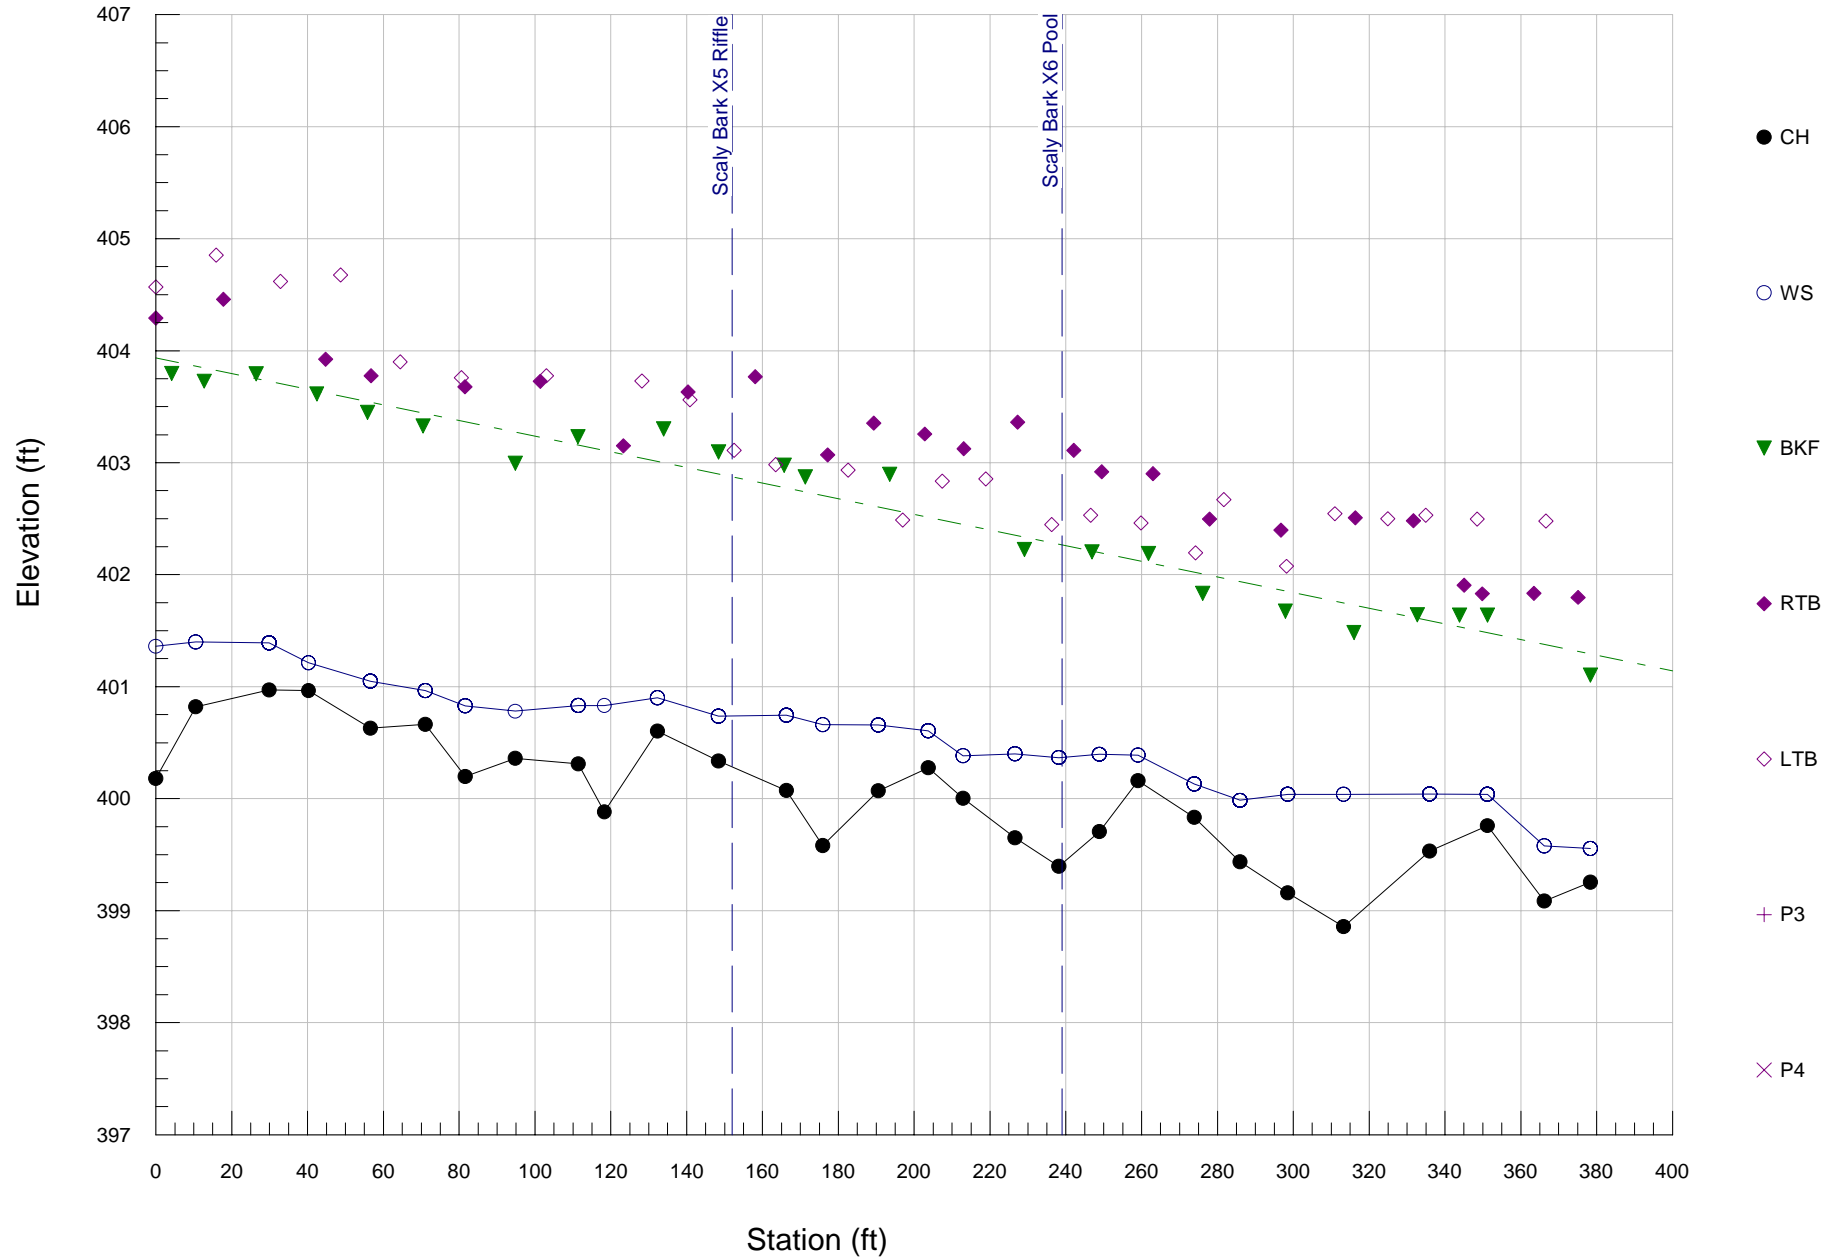
Scaly Bark Creek Reach 3 Profile

River Name: Scaly Bark Creek
 Reach Name: Reach 3
 Profile Name: Scaly Bark Reach 3 Profile
 Survey Date: 11/10/09

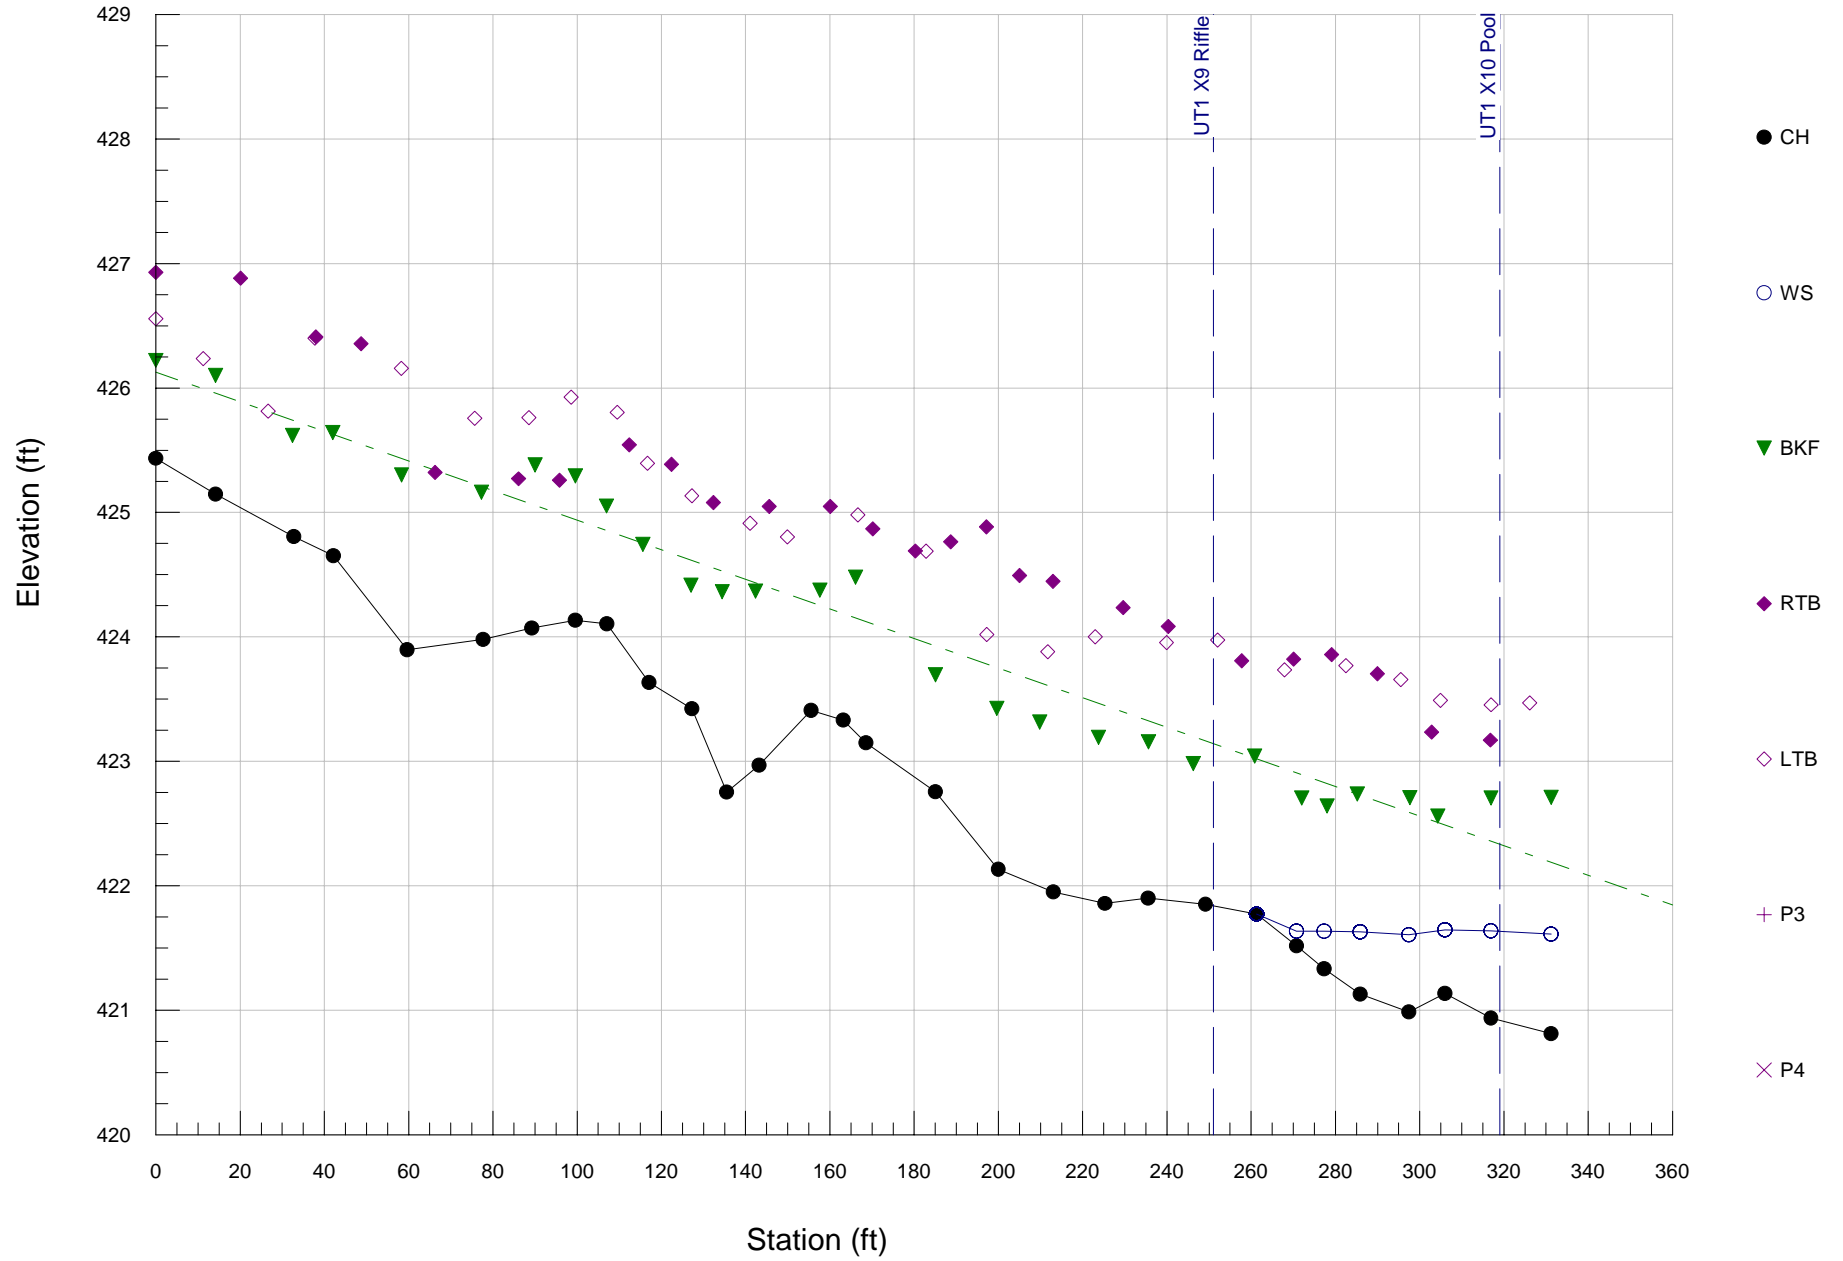
River Name: UT1
 Reach Name: Reach 2 (Restoration)
 Profile Name: UT1 Reach 2 Profile
 Survey Date: 11/10/09

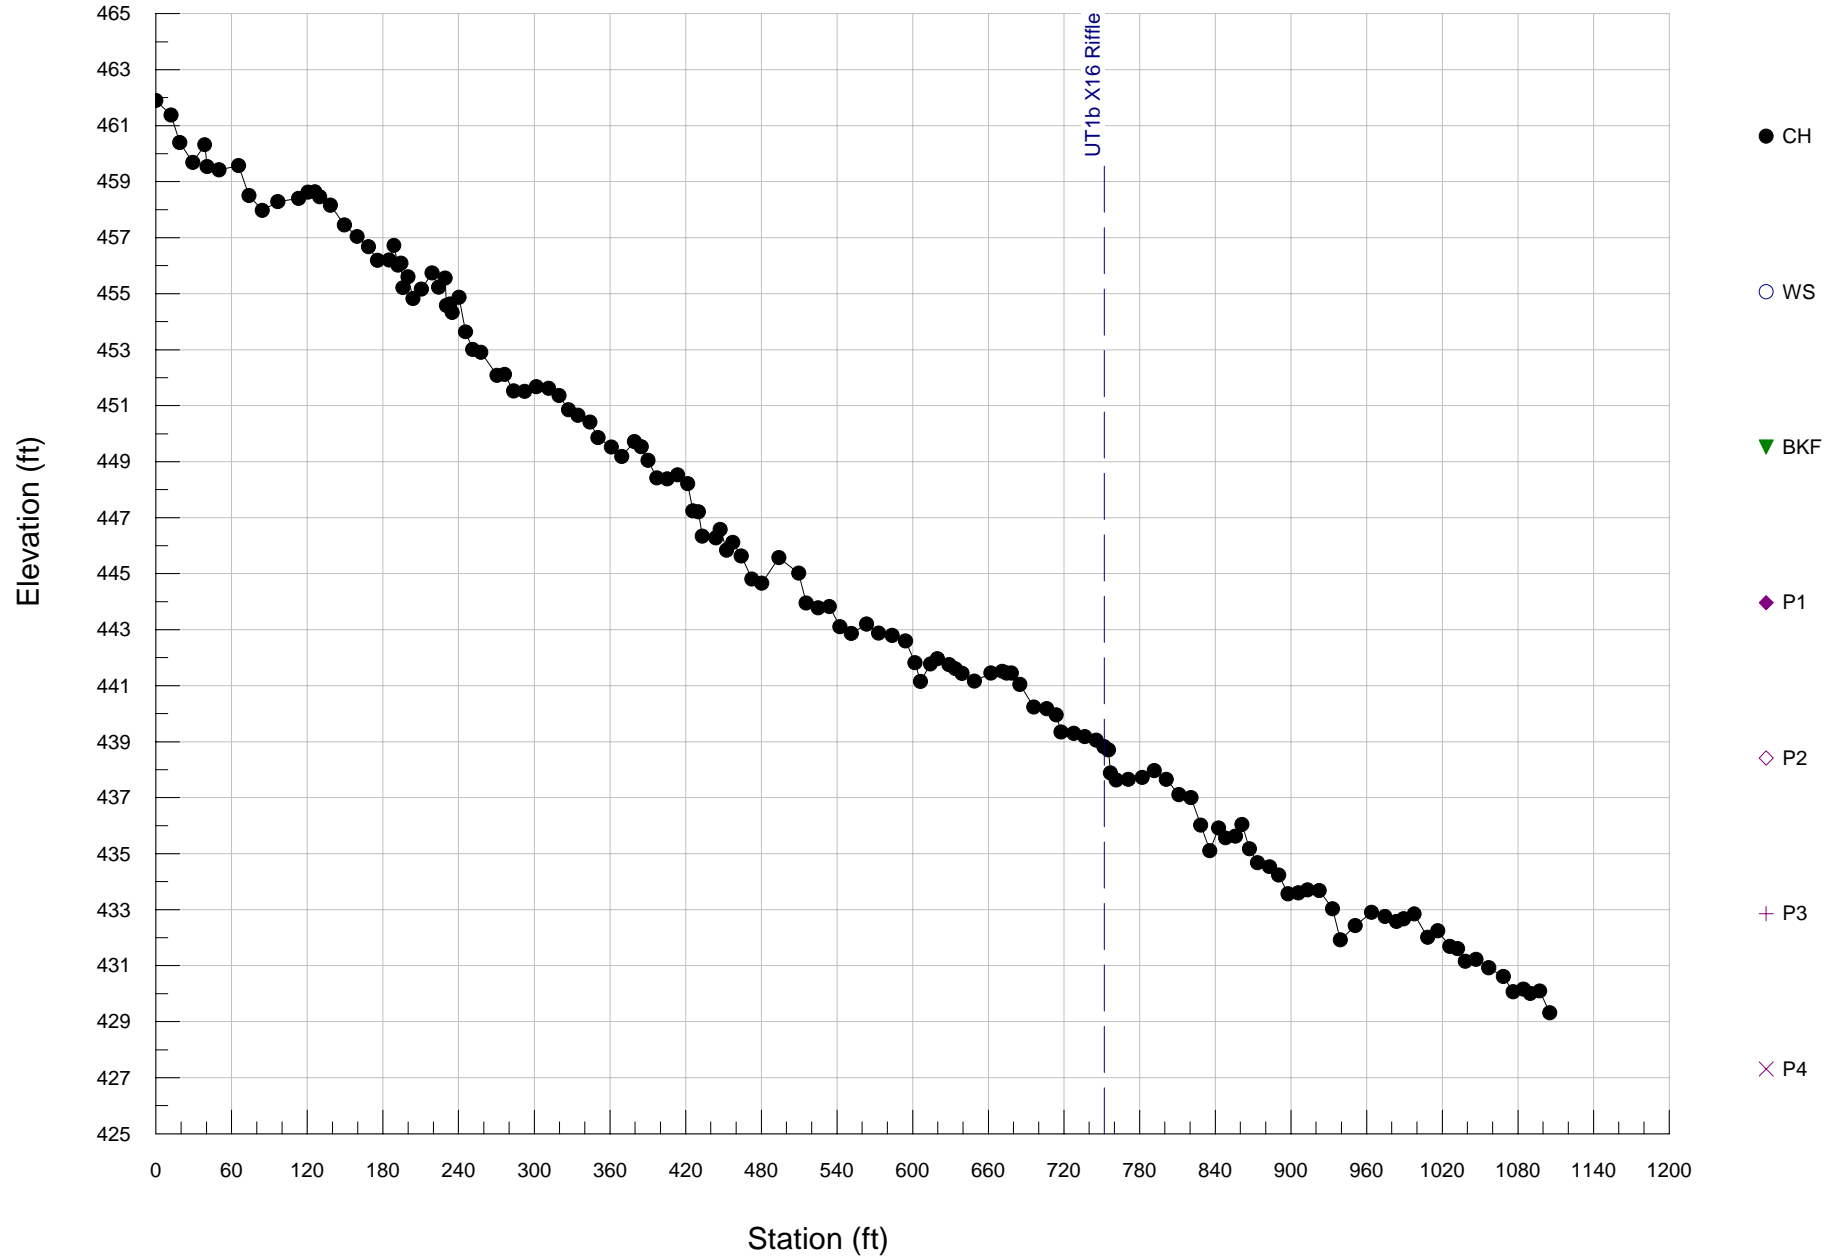
River Name: UT1
Reach Name: UT1b
Profile Name: UT1b Profile
Survey Date: 10/29/09

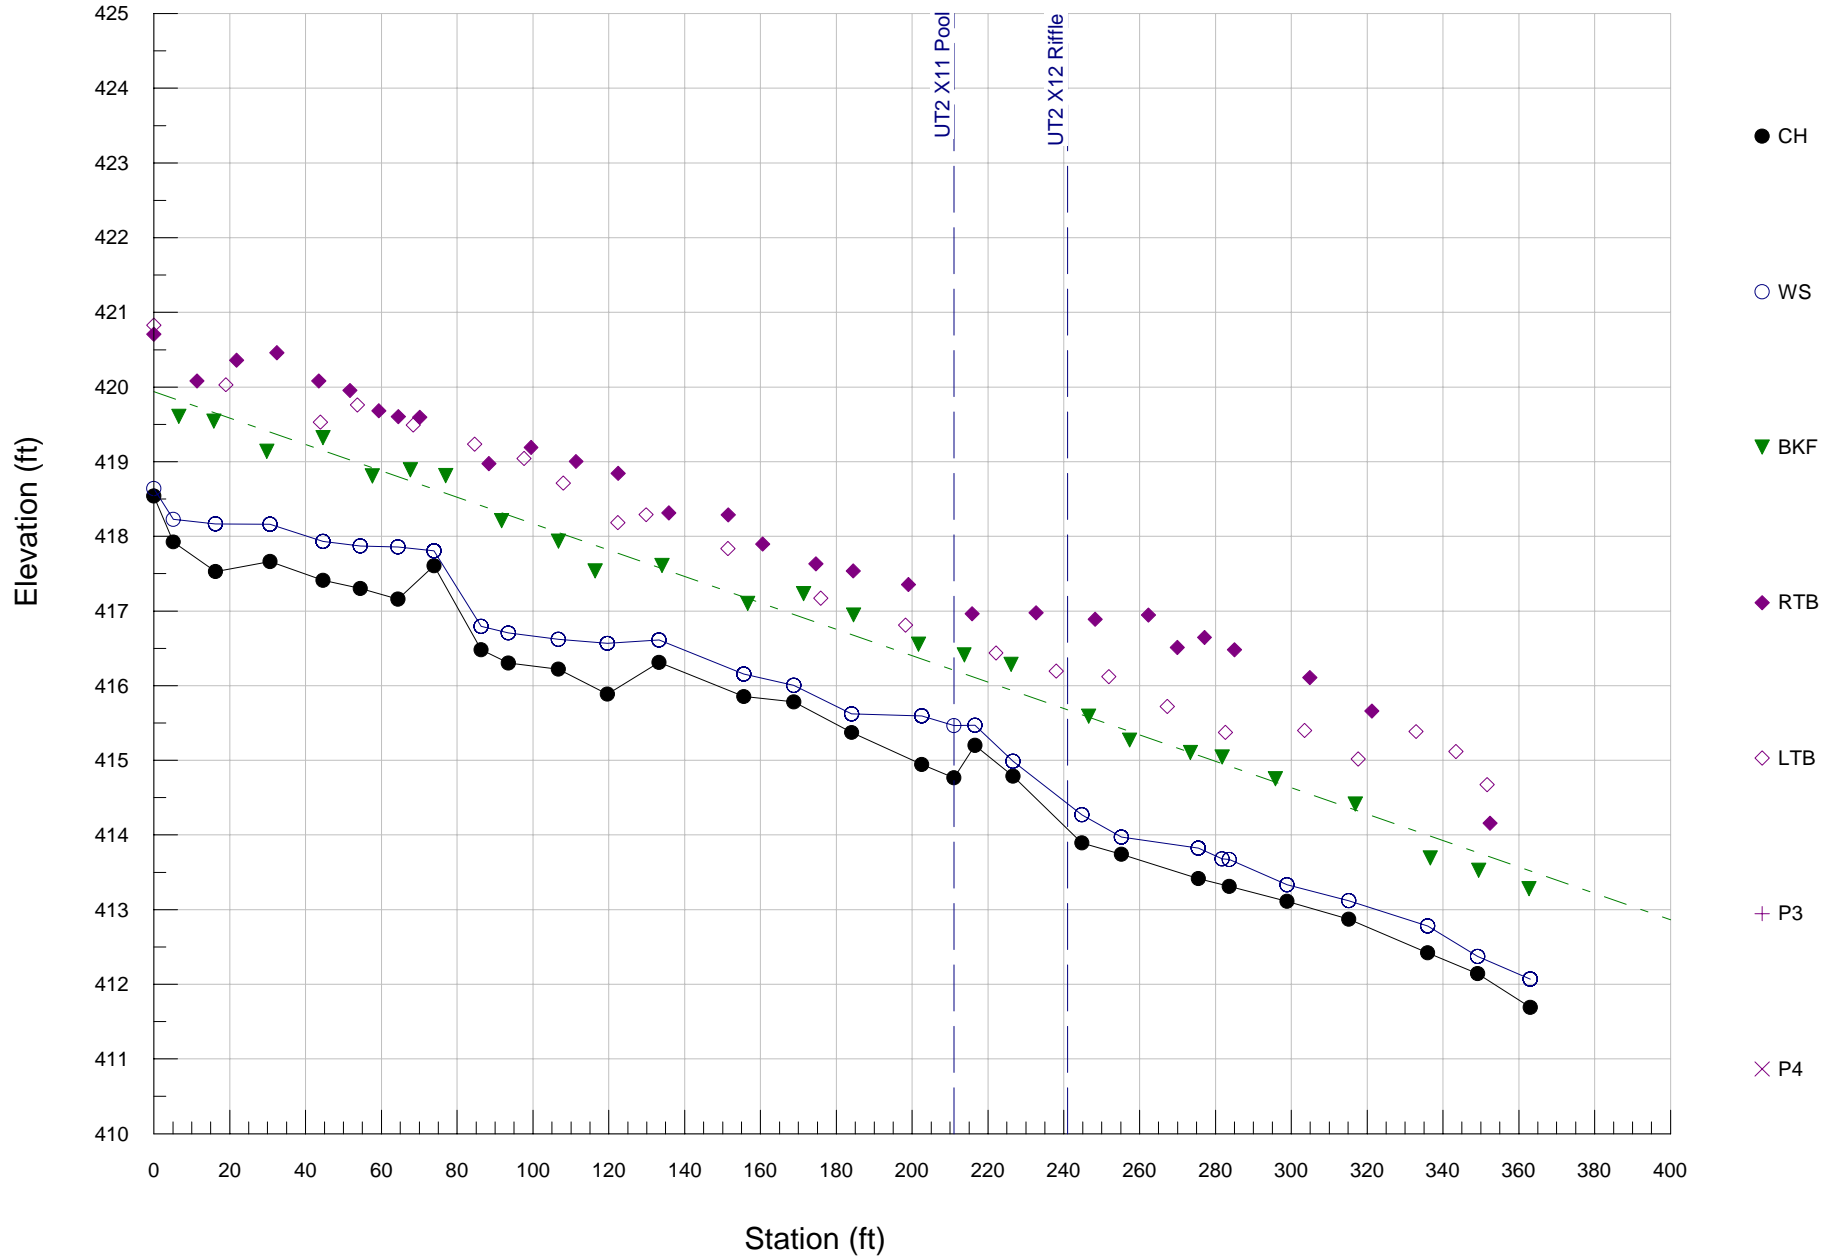
River Name: UT2
 Reach Name: Reach 1
 Profile Name: UT2 Profile
 Survey Date: 11/09/09

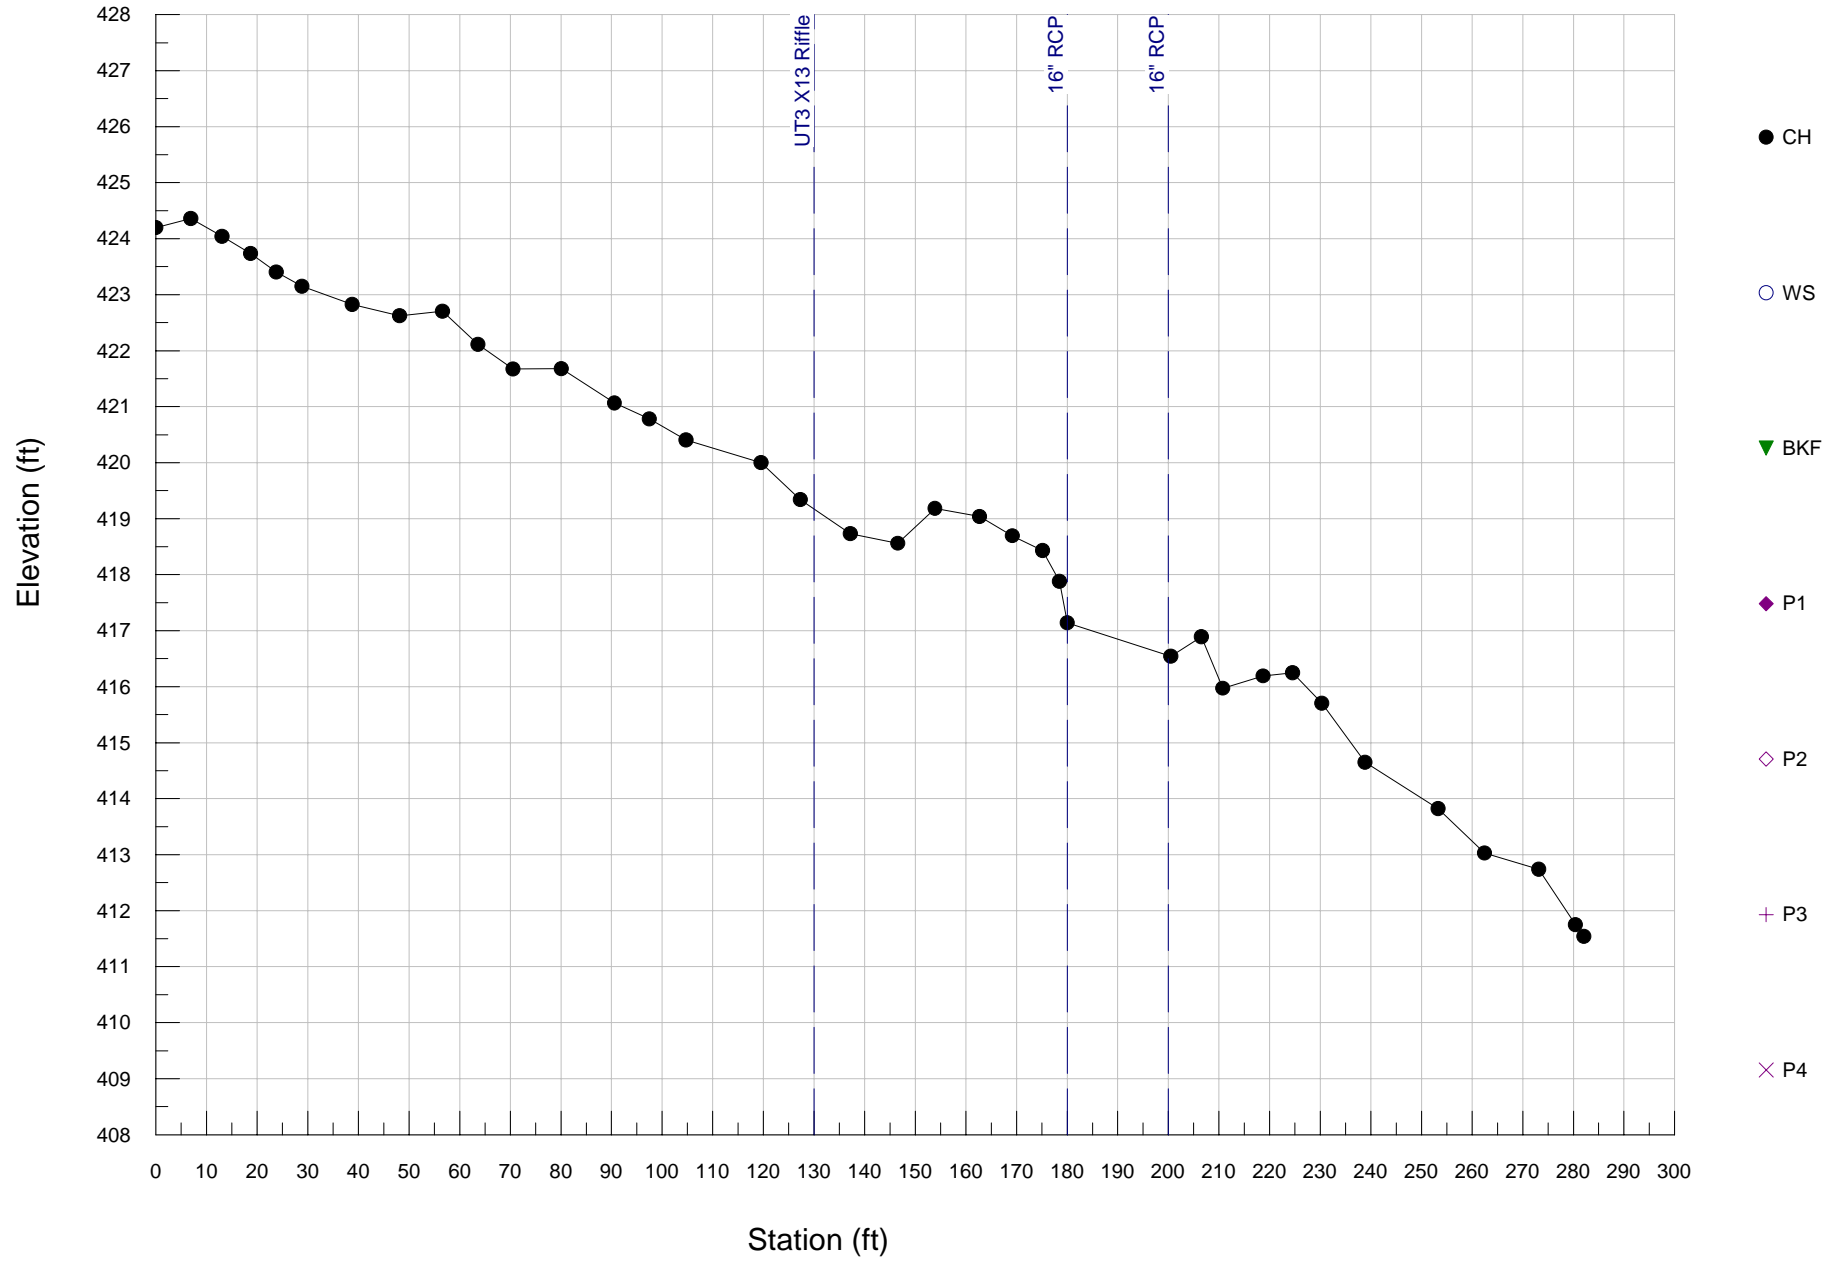
River Name: UT3
 Reach Name: Reach 1
 Profile Name: UT3 Profile
 Survey Date: 11/09/09

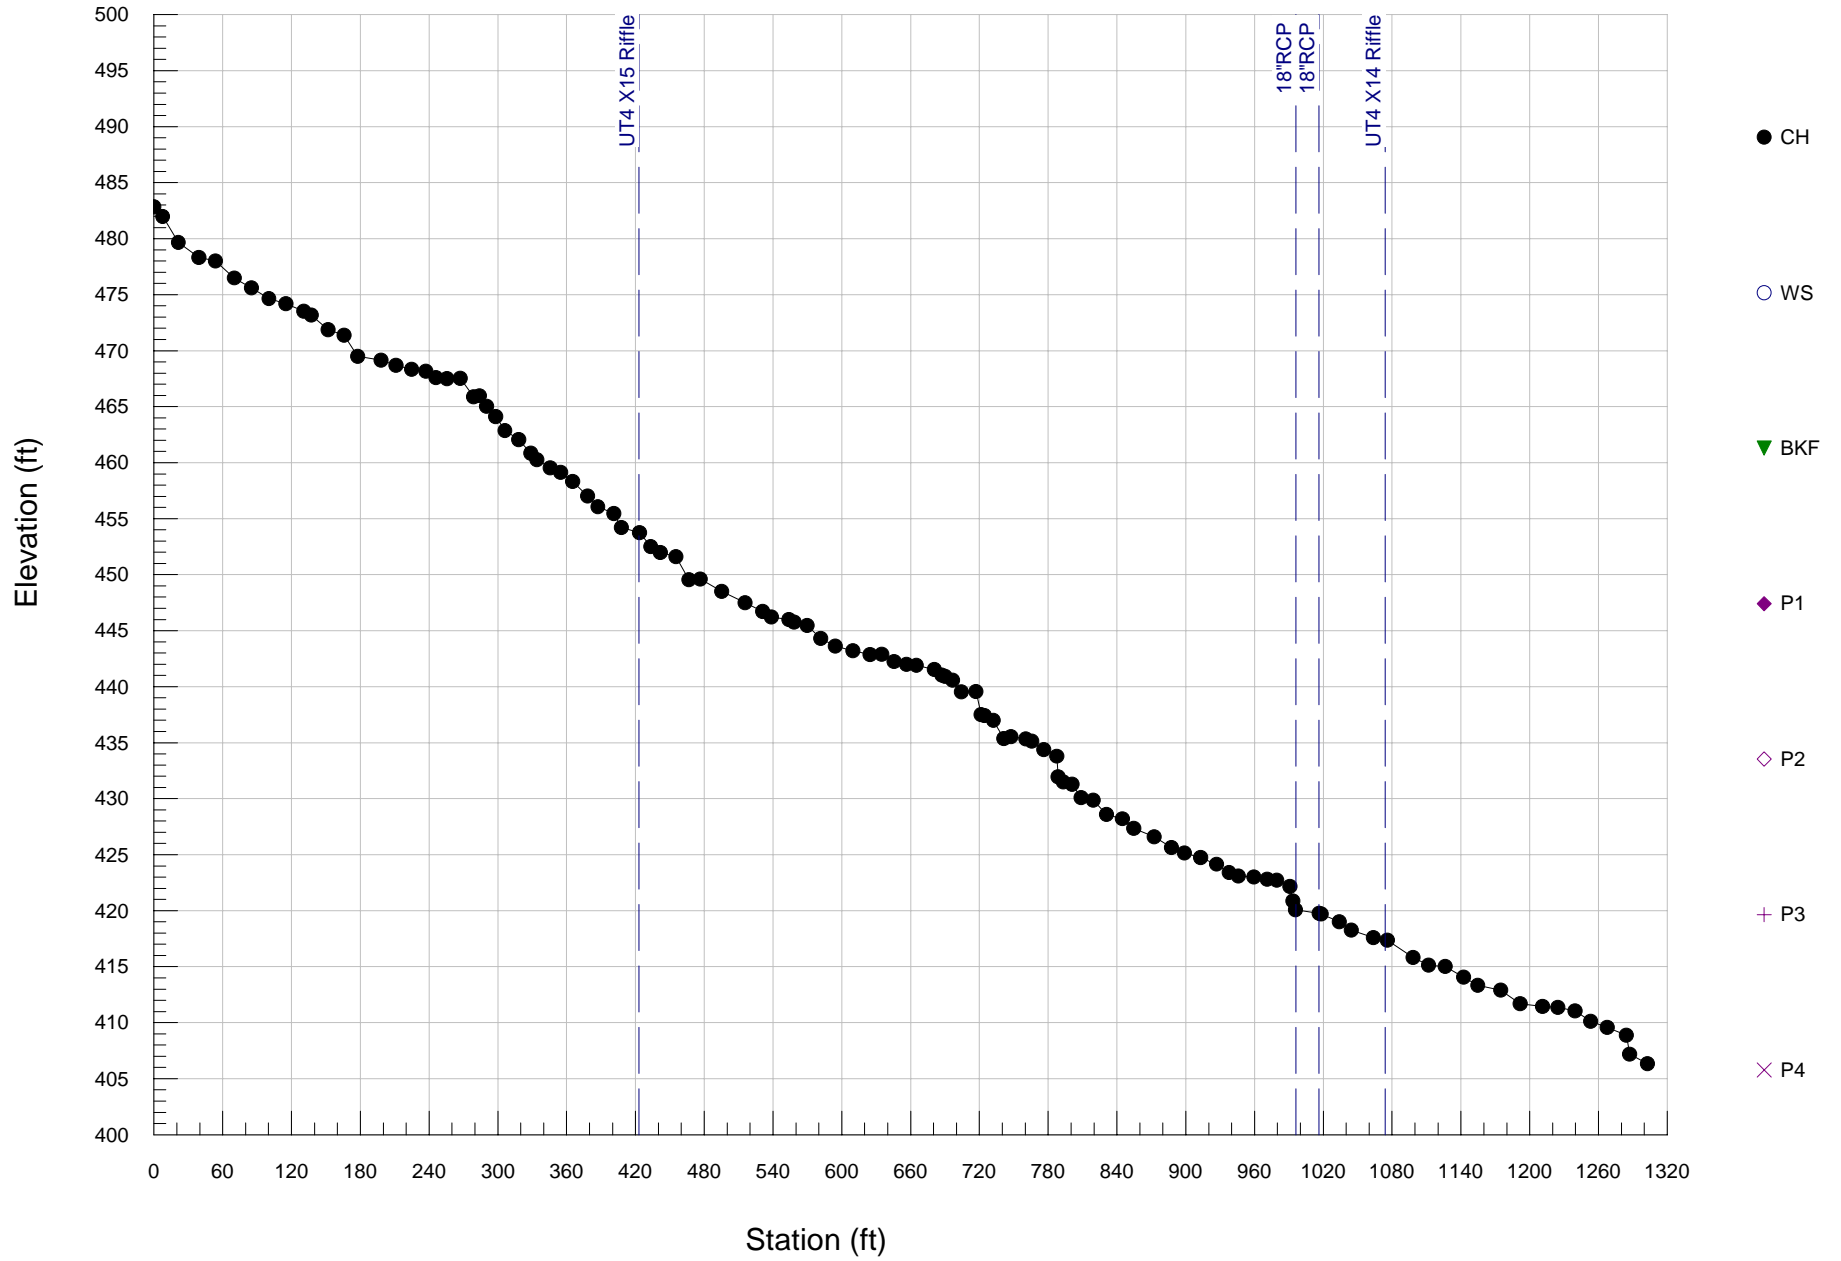
River Name: UT4
Reach Name: Reach 1
Profile Name: UT4 Profile
Survey Date: 04/06/10
